# National Transportation Safety Board

WPR24LA248

## **MATERIALS LABORATORY**

Factual Report 25-006

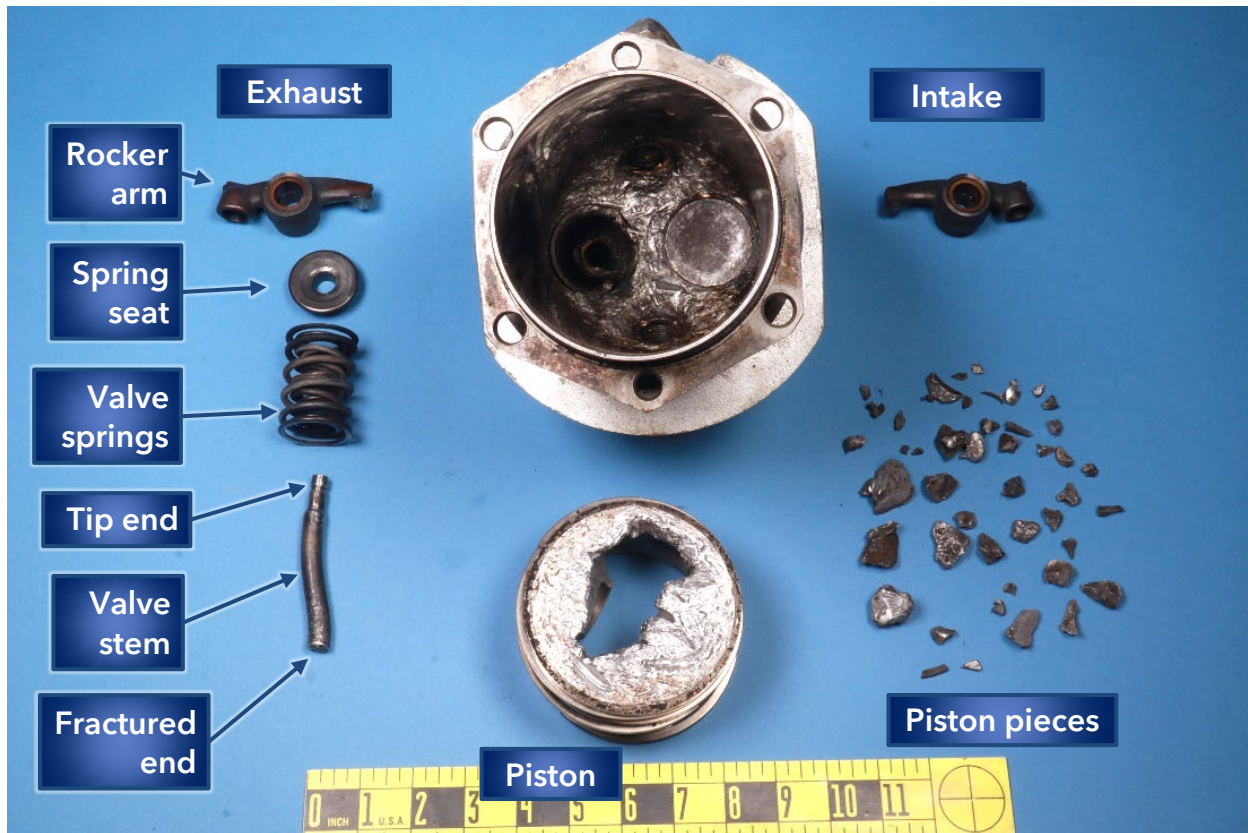
An overall view of the submitted components is shown in figure 1. The intake and exhaust rocker arms had been disassembled from the cylinder assembly as shown. The exhaust valve springs and spring seat were also separated, and both exhaust valve keeper halves were missing. The intake valve and springs remained installed in the cylinder assembly. The piston crown was fractured, and a collection of pieces from the piston were also received as shown in figure 1.

**Figure 1.** Overall view of the submitted components.

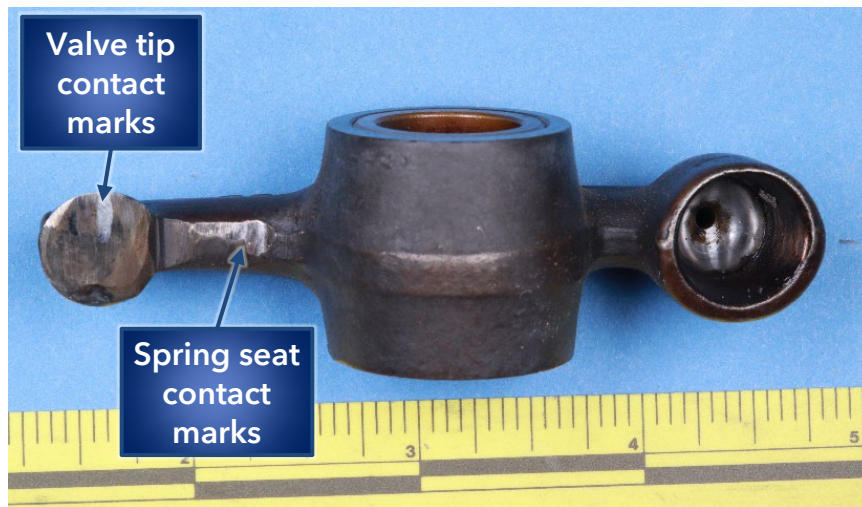
A closer view of the exhaust rocker arm is shown in figure 2. The rocker pad had grinding marks on varying faceted planes. Circumferential wear marks corresponding to contact with the valve tip were observed, and the center of the

circumferential marks was offset to the side of the rocker pad. Marks corresponding to contact with the spring seat were also observed on the arm adjacent to the rocker pad as shown in figure 2.

**Figure 2.** Exhaust rocker arm showing offset contact marks on the rocker pad and seat contact marks on the arm.

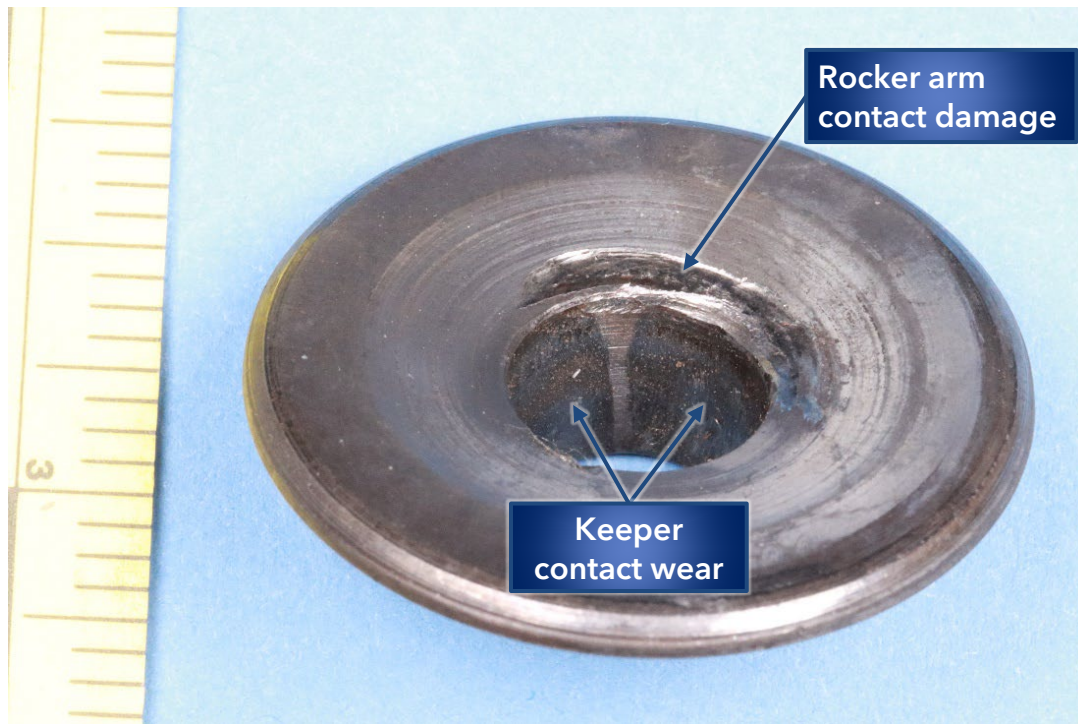
An oblique view of the exhaust spring seat is shown in figure 3. Contact damage was observed on the outboard surface near the inside diameter, a location corresponding to the spring seat contact damage observed on the rocker arm. Wear marks corresponding to contact with the exhaust valve keeper halves were also observed on the center hole bore as indicated in figure 3.

**Figure 3.** Spring seat showing wear marks from contact with the keeper halves and contact damage corresponding to contact with the rocker arm.

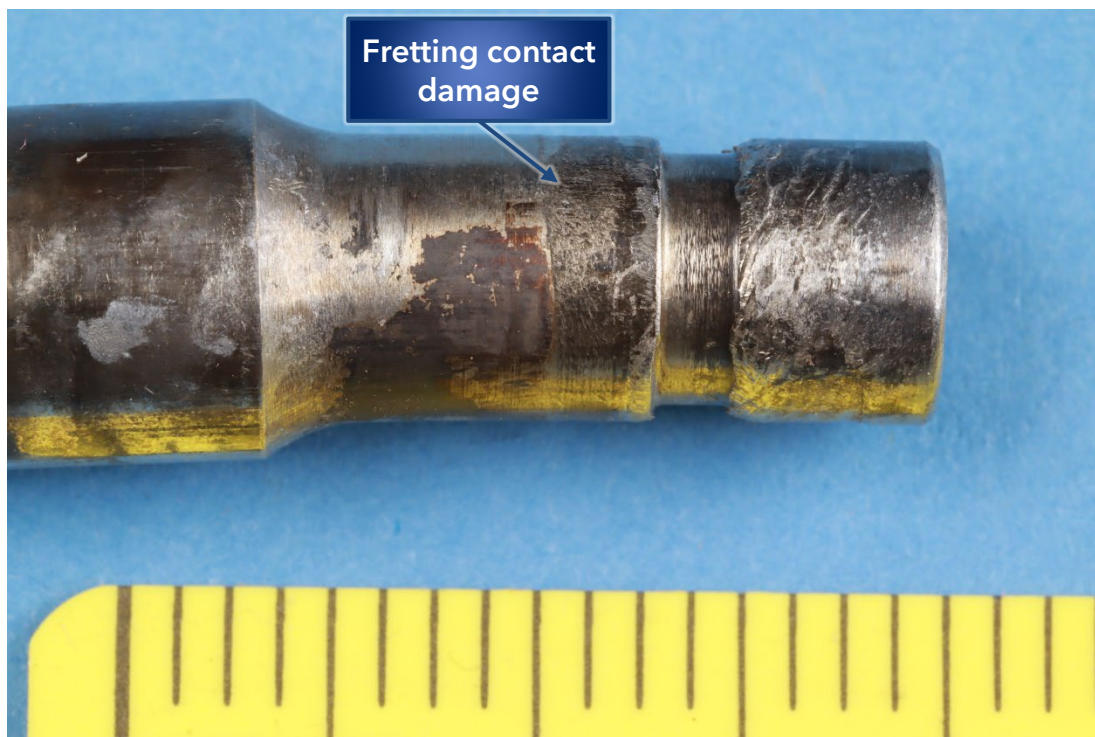
The exhaust valve was fractured through the stem near the valve head, and the stem was bent into an "S" shape. Fretting damage from contact with the keeper halves was observed at the shoulder near the valve tip as shown in figure 4. The valve stem fracture surface was damaged from post-fracture impacts, but remaining portions had a rough appearance with reflective features mixed with matte gray features when viewed under an optical stereomicroscope. The fracture surface was further examined using a scanning electron microscope (SEM), and a view of typical fracture features are shown in figure 5. The fracture surface showed a mix of flat facets with fine tear ridges and shallow dimple features surrounded by rough regions of dimple fracture, features consistent with overstress fracture.

**Figure 4.** Fretting contact damage on the exhaust valve stem at the shoulder for the keeper.

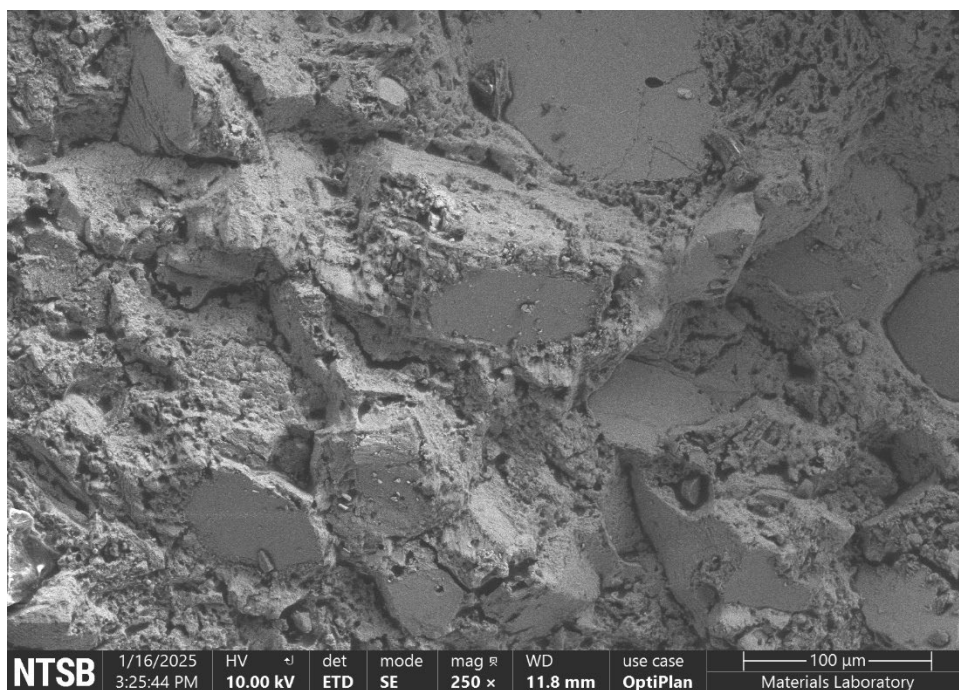
**Figure 5.** SEM image of typical fracture features on the exhaust valve stem fracture surface.
