# National Transportation Safety Board

WPR24LA248

## **AIRFRAME AND ENGINE EXAMINATION**

Location: Ritzville, Washington  
Date: July 15, 2024  
Time: 11:45 Pacific daylight time  
Airplane: Cessna 150M, N714PW

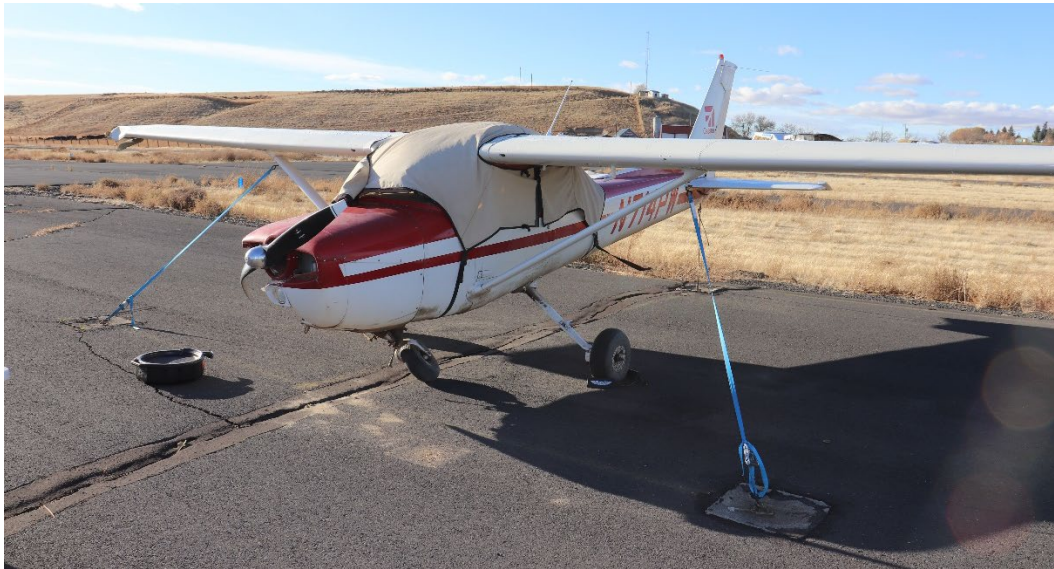
Examination of the recovered wreckage revealed that both wings, vertical stabilizer, horizontal stabilizer, both elevators, rudder, engine and engine mount remained attached to the airplane. The nose landing gear was impact damaged and collapsed under the fuselage. The flight control cables remained attached from the flight controls to their respective flight control surfaces. Flight control continuity was established from the cockpit flight controls to the respective flight control surfaces.

**Figure 1: Front view of airplane during examination.**

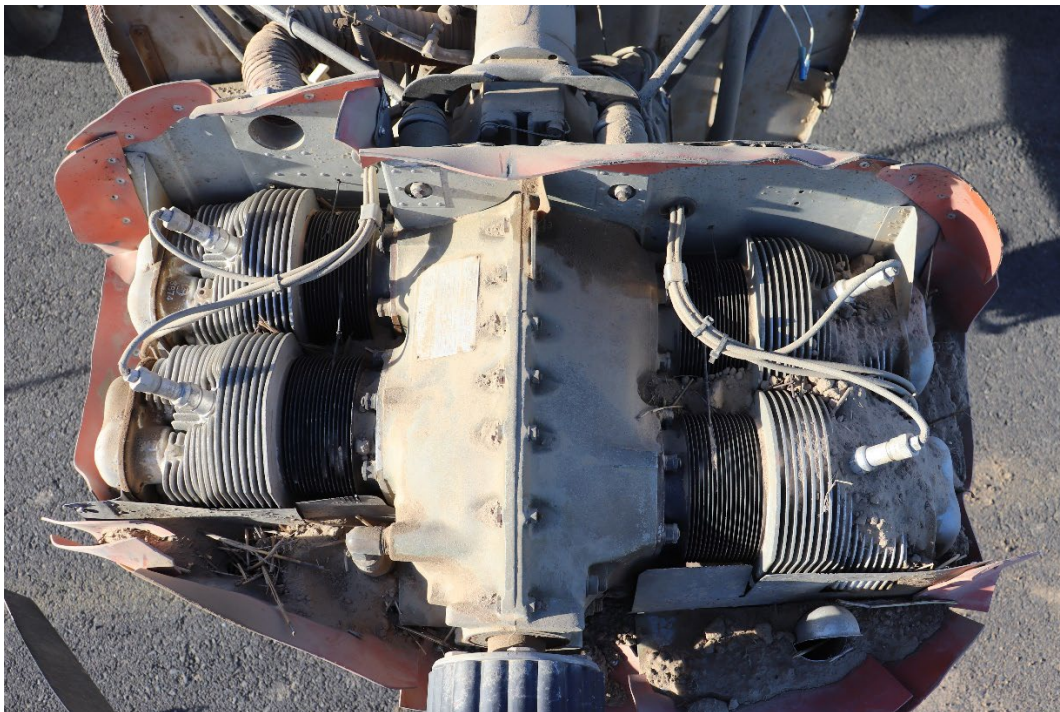
Examination of the recovered engine revealed that the engine remained attached to the airframe via the engine mounts. All four cylinders and all engine accessories remained attached. All fuel and oil lines that were removed were tight. No evidence of any mechanical damage was observed to the engine crankcase.

**Figure 2: View of airplane engine during examination.**

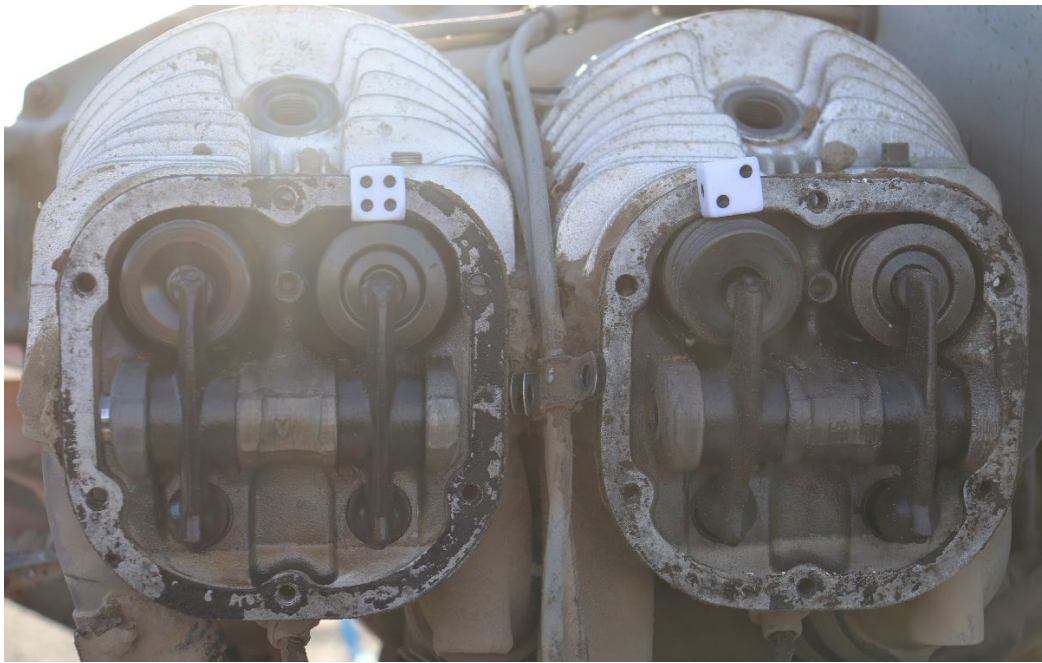
The rocker box covers were removed. The No. 2 cylinder exhaust valve was not in secure in the valve spring and the valve spring was fully extended. The intake and exhaust rocker arms on the No. 1, 3 and 4 cylinders were intact, and oil coated. The No. 1, 3 and 4 cylinders intake and exhaust valve springs were in place and visually appeared to be undamaged. The upper spark plugs were removed, and all four cylinders were examined internally using a lighted borescope. A normal amount of combustion deposits was observed within the combustion dome of each cylinder and piston face on the No. 1, 3 and 4 cylinders; the intake and exhaust valves were unremarkable. The No. 2 cylinder exhaust valve was missing, and damage was observed to the combustion dome and piston. The crankshaft was rotated by hand using the propeller. Rotational continuity was established throughout the engine and valve train. Thumb compression and suction was obtained on the No. 1, 3 and 4 cylinders.

**Figure 3: View of No. 2 and 4 cylinder rocker arms.**

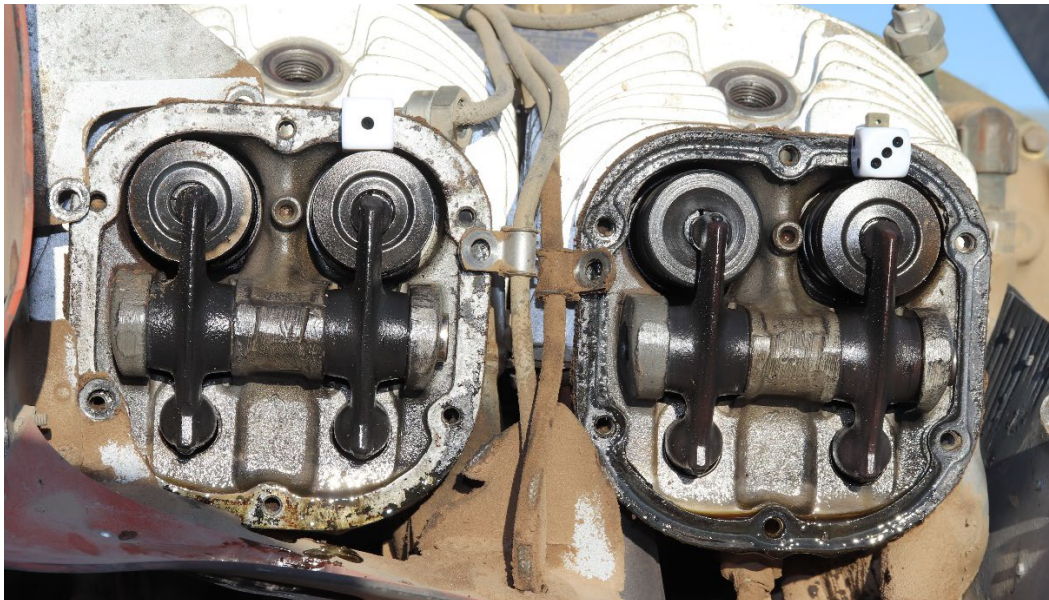
**Figure 4: View of No. 1 and 3 cylinder rocker arms.**

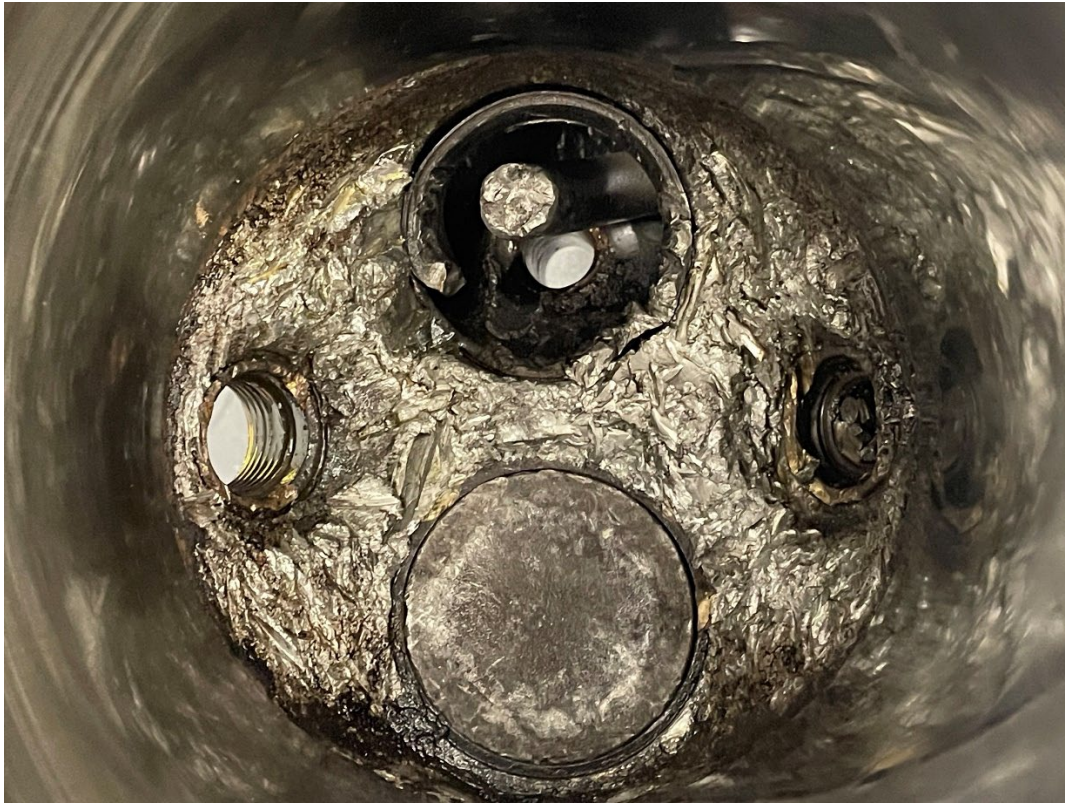
The No. 2 cylinder was removed. The exhaust valve was fracture separated from the valve stem and not observed within the cylinder or engine. The exhaust valve stem had exited the cylinder valve guide and was impaled into the cylinder head. Metallic debris was observed within the No. 2 cylinder. Remnants of the piston was observed with in the cylinder and oil sump.

**Figure 5: View of No. 2 cylinder combustion dome**

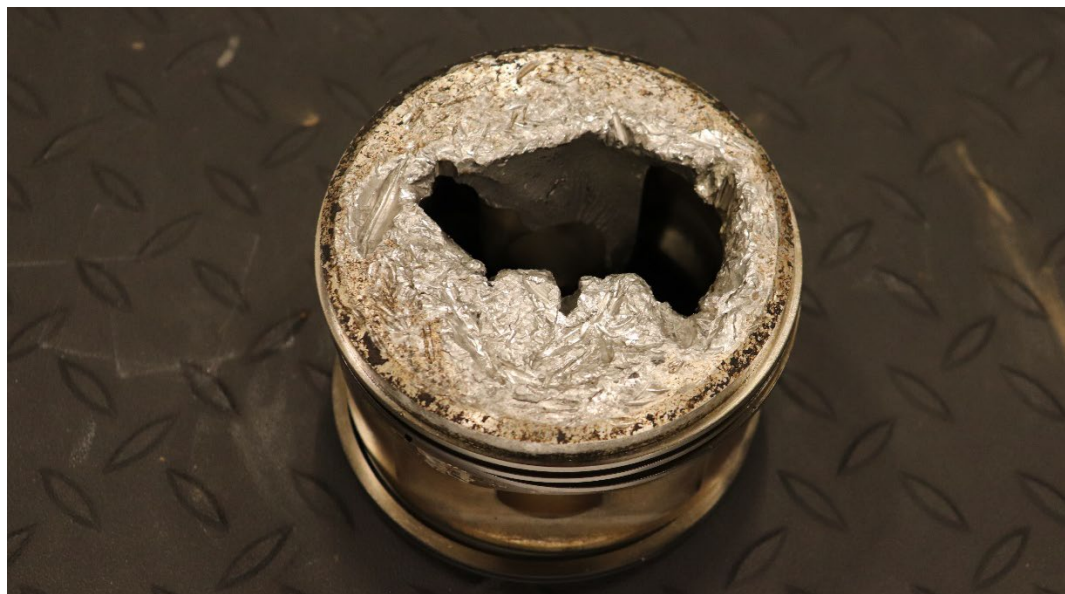
**Figure 6: View of No. 2 cylinder piston.**

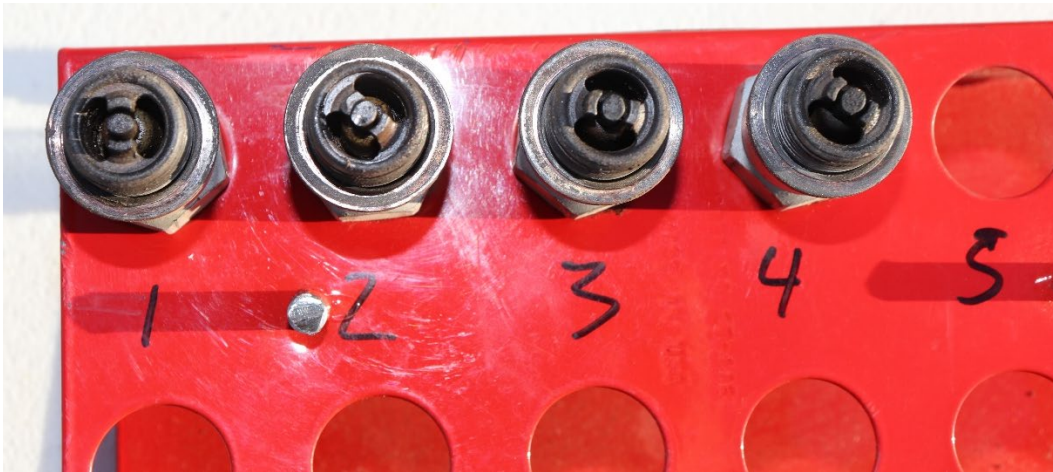
The top engine spark plugs were removed from the engine, and they were the massive electrode type. The sparkplugs exhibited black deposits within the electrode area. The spark plugs exhibited signatures consistent with NORMAL when compared to the Champion Check-A-Plug comparison chart. The No. 2 cylinder spark plug electrode area was damaged.

**Figure 7: View of top engine spark plugs.**

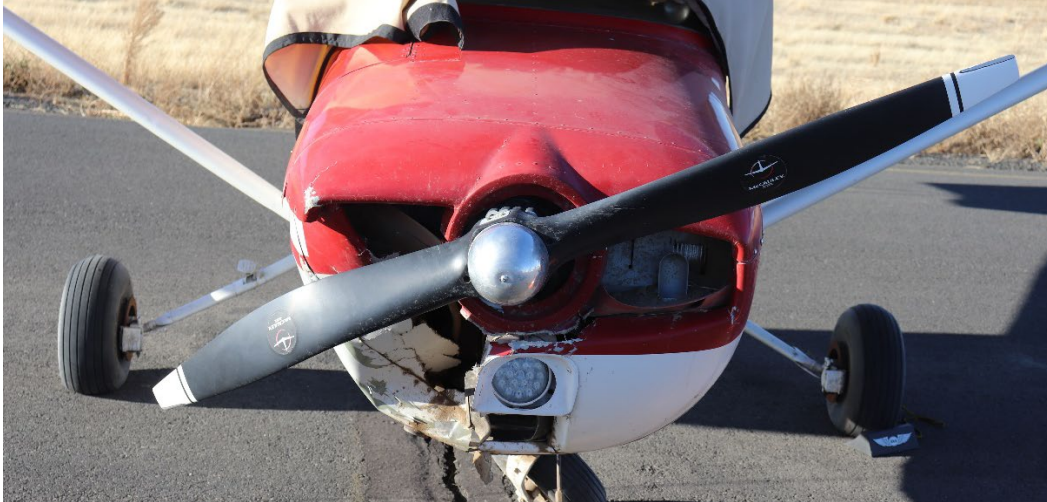
The airplane was equipped with a 2 blade McCauley propeller. Propeller blade B was bent aft about mid span and exhibited various striations on the cambered side of the blade.

**Figure 8: View of propeller.**

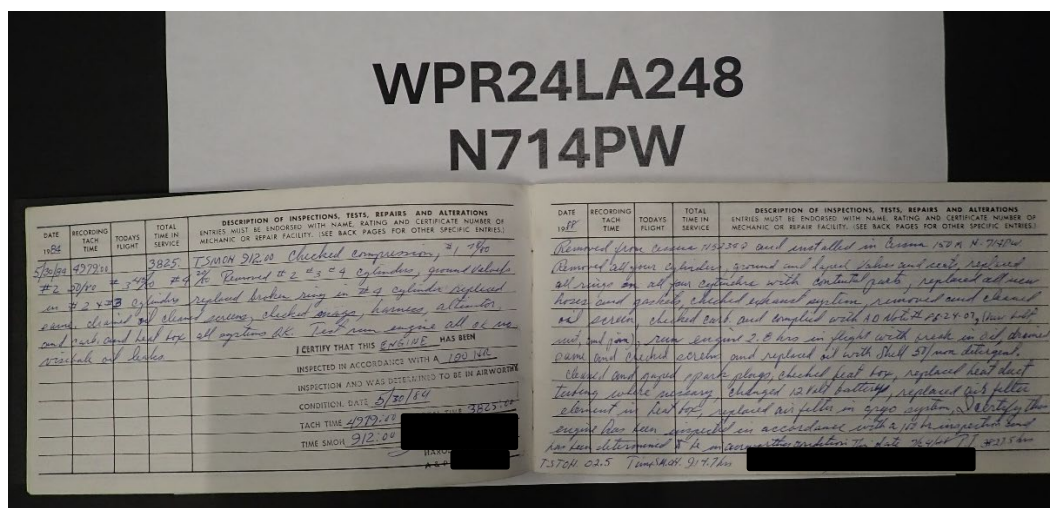
The engine had been removed from another airplane and installed on the accident airplane on May 30, 1984. At the time of installation, the time SMOH was 912.0, and the tach time was 3825.0.

Figure 11: View of engine logbook engine swap.

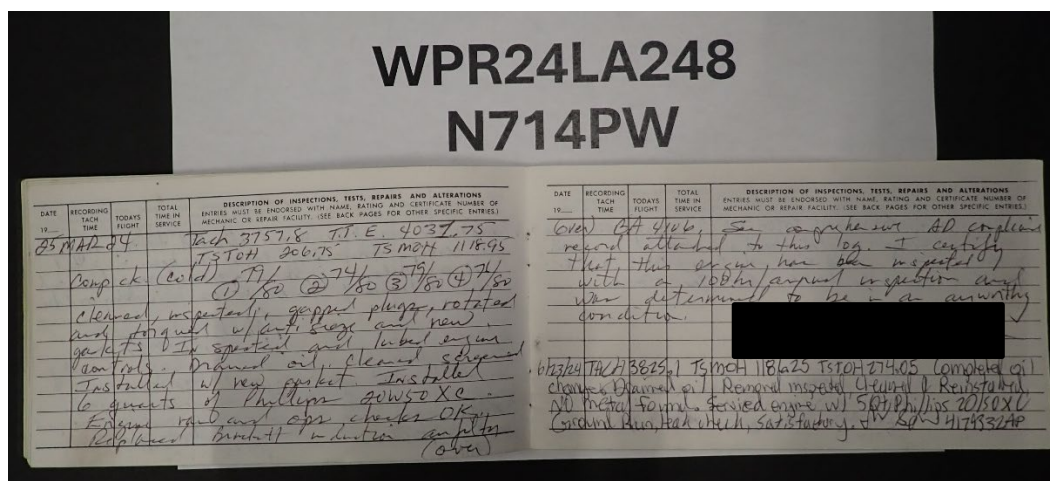
According to the airplane maintenance records, the annual inspection was conducted on March 25, 2024. At the time of the inspection, the observed tach time was 206.75 hours.

Figure 12: View of engine logbook annual inspection.

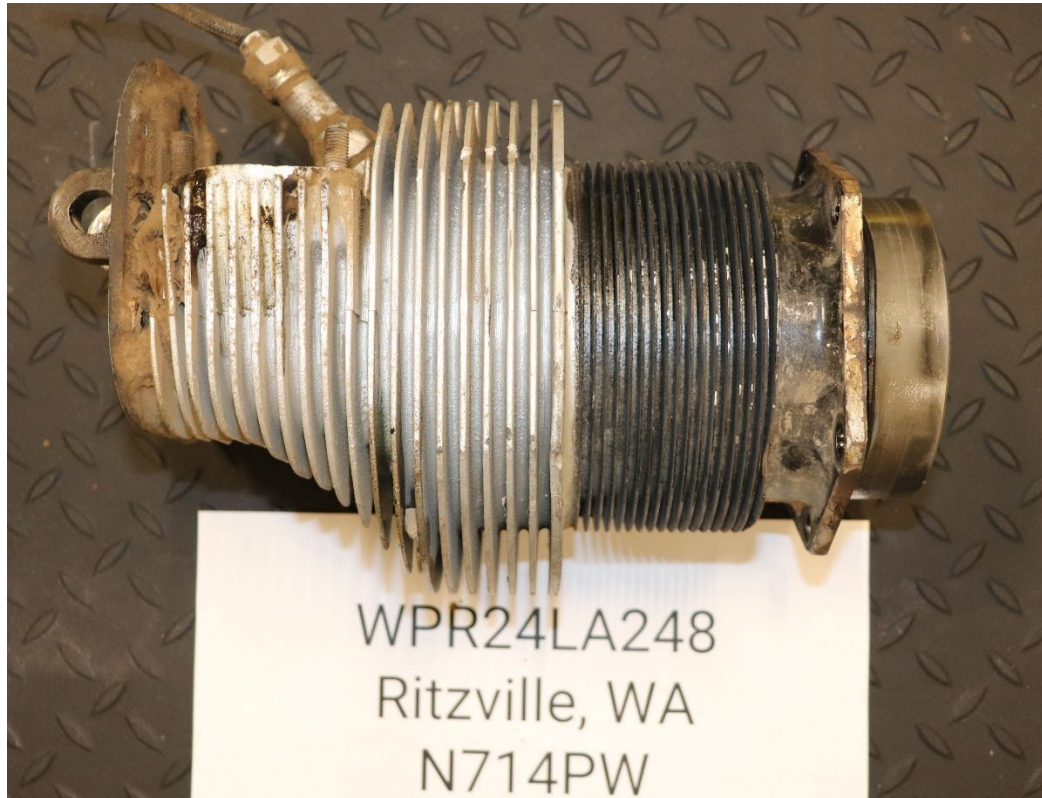
**Figure 13: View of the No. 2 cylinder.**

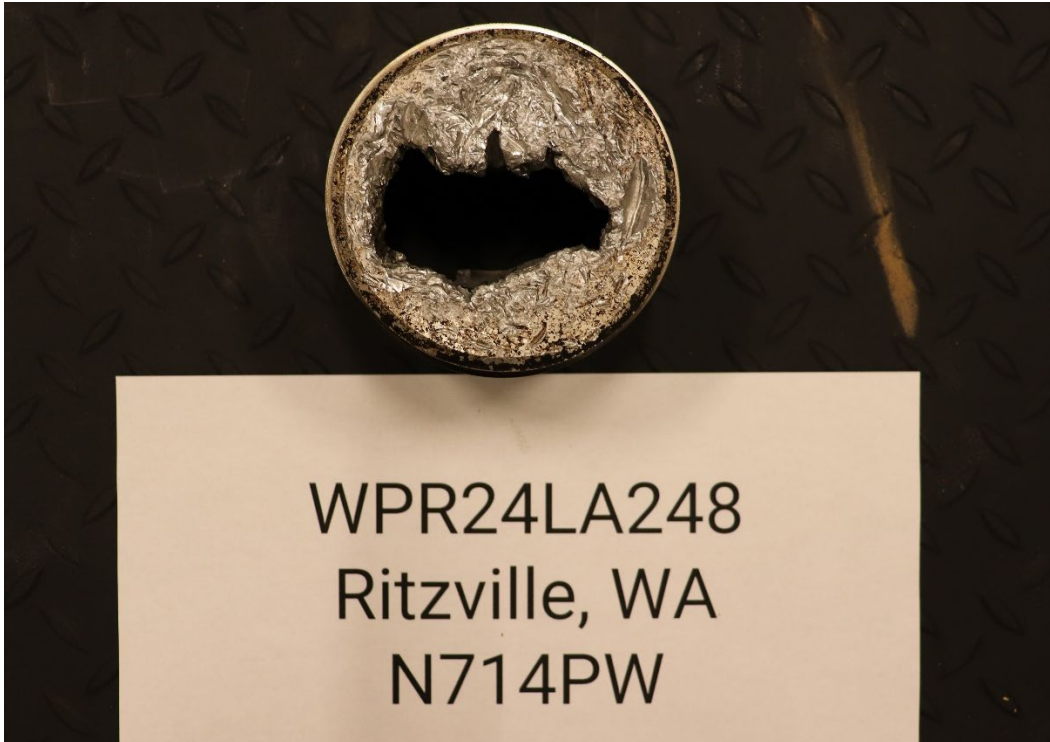
**Figure 14: View of No. 2 piston.**

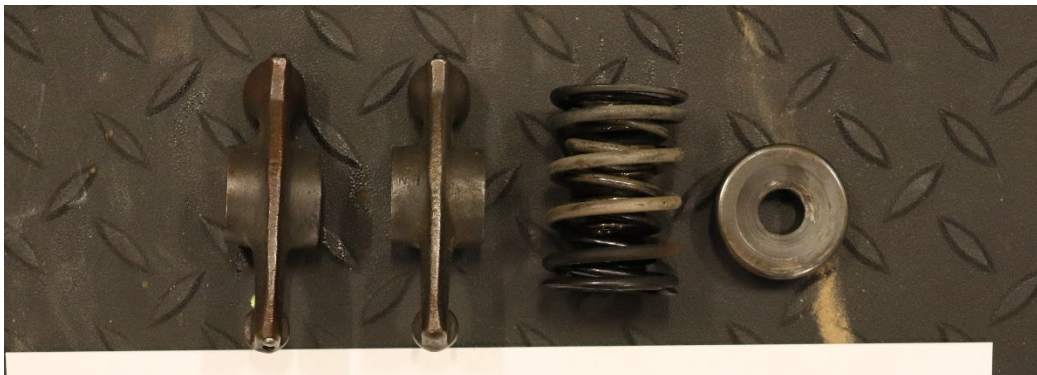
**Figure 15: View of No. 2 rocker arms and valve spring.**
