# National Transportation Safety Board

WPR24LA254

## **WRECKAGE EXAMINATION SUMMARY**

Location: Roy, Utah  
Date: July 24, 2024  
Time: 1555 MDT  
Airplane: N134MG, Piper PA-34-220T

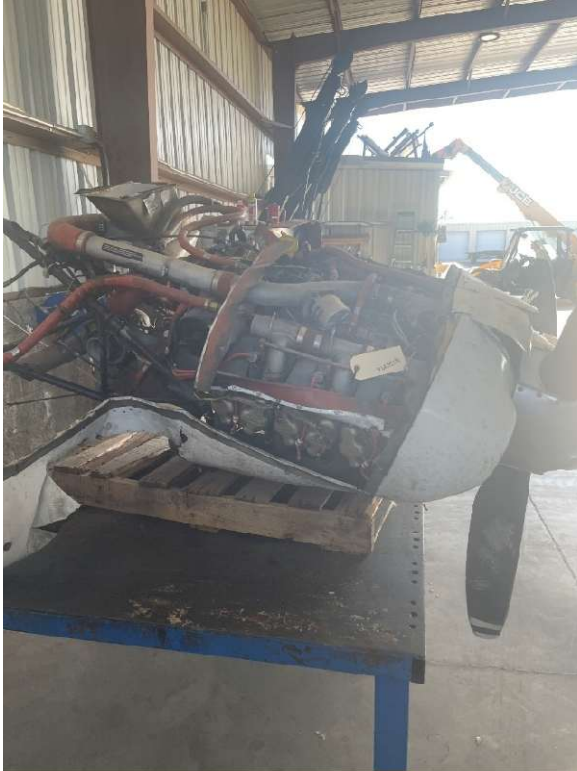
The left engine, a Continental Motors TSIO-360-KB, S/N 315272, was separated from the airframe. Throttle control rigging could not be determined.

Photo 1: Right Side View of Engine

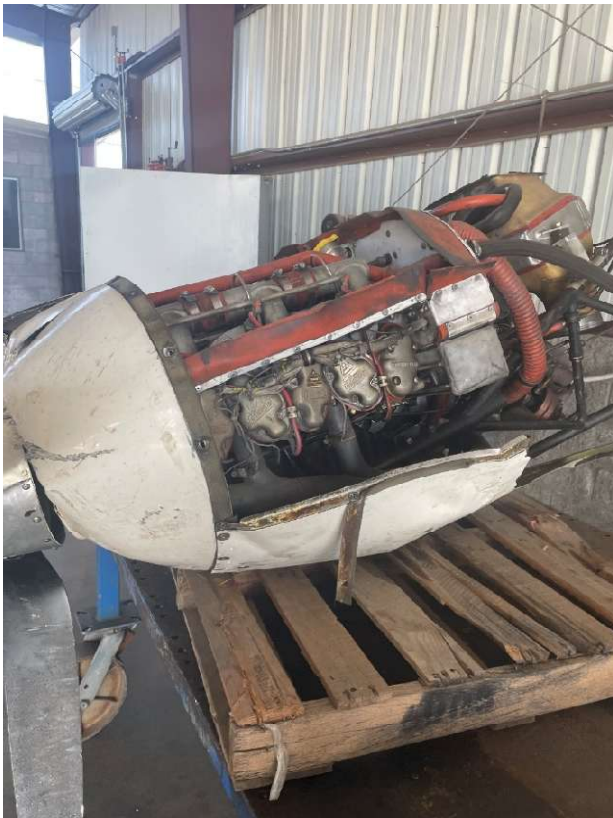
Photo 2: Left Side View of Engine

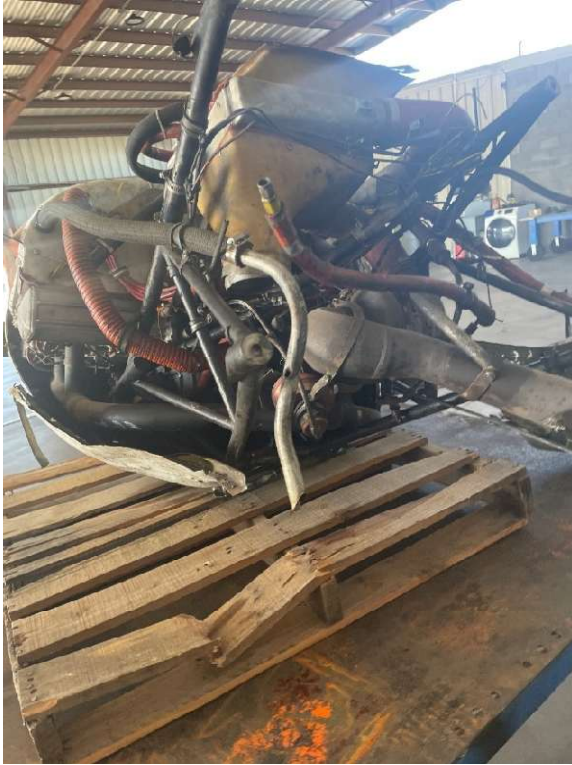
Photo 3: Rear View of Engine

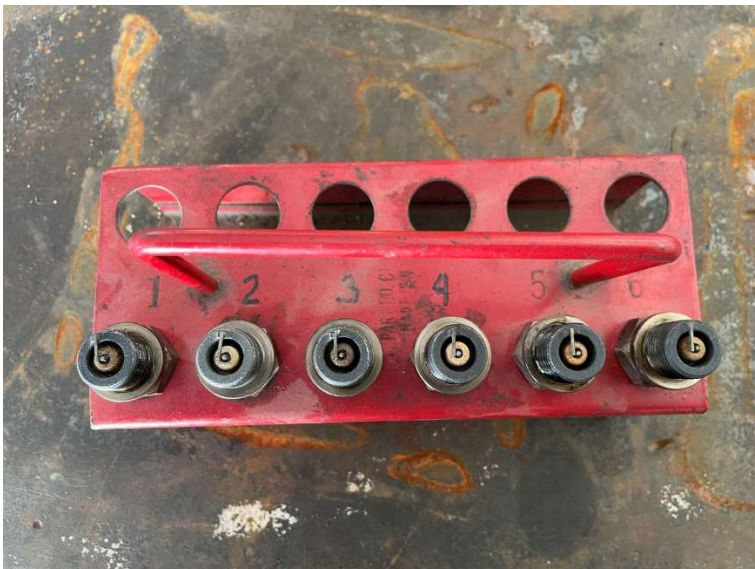
The bottom spark plugs were removed. All 6 fine wire spark plugs were in normal condition, with slight oil fouling on cylinders Nos 1, 3, and 5 likely as a result of the engine lying on its side.

Photo 4: Bottom Spark Plugs

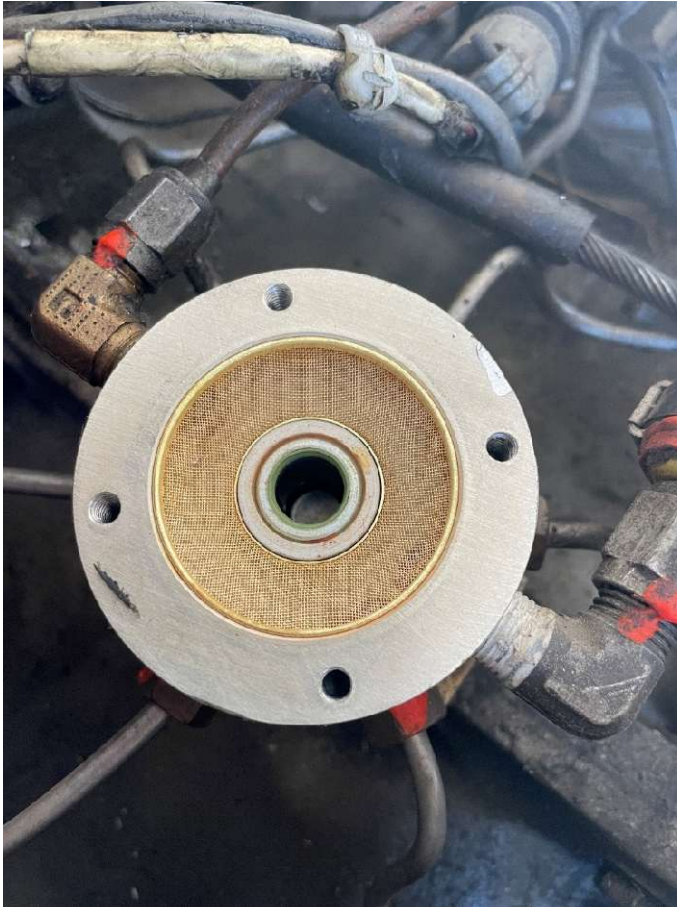
The fuel system was free of debris and intact. The fuel flow divider was disassembled; the diaphragm was pliable but felt slightly brittle, with no rips or tears observed. All 6 fuel injector nozzles were removed and were clear of obstructions.

Photo 5: Fuel Screen from Engine Fuel Flow Divider

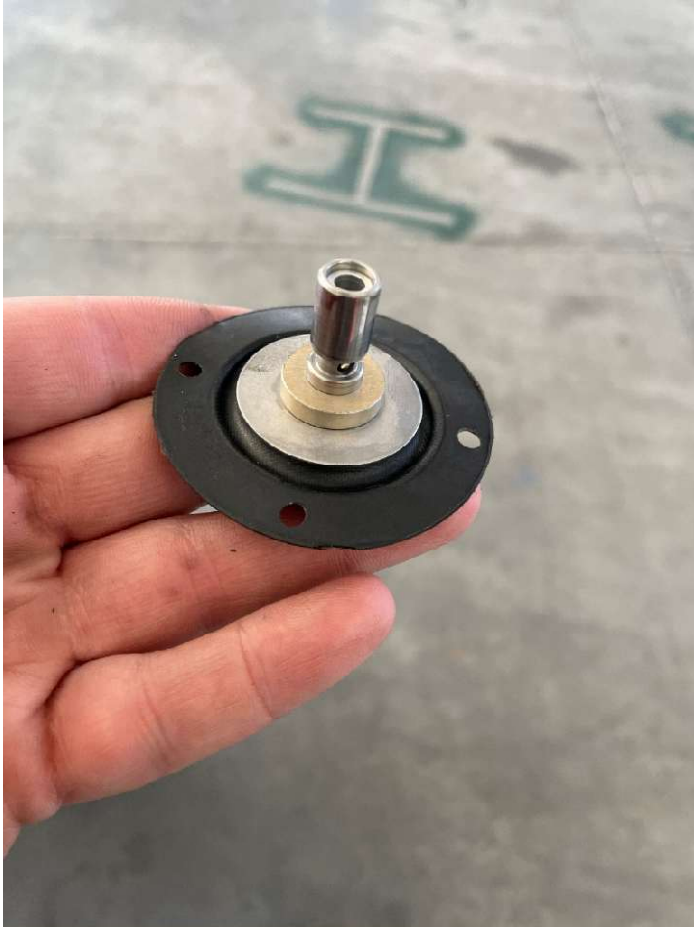
Photo 6: Diaphragm from Fuel Flow Divider

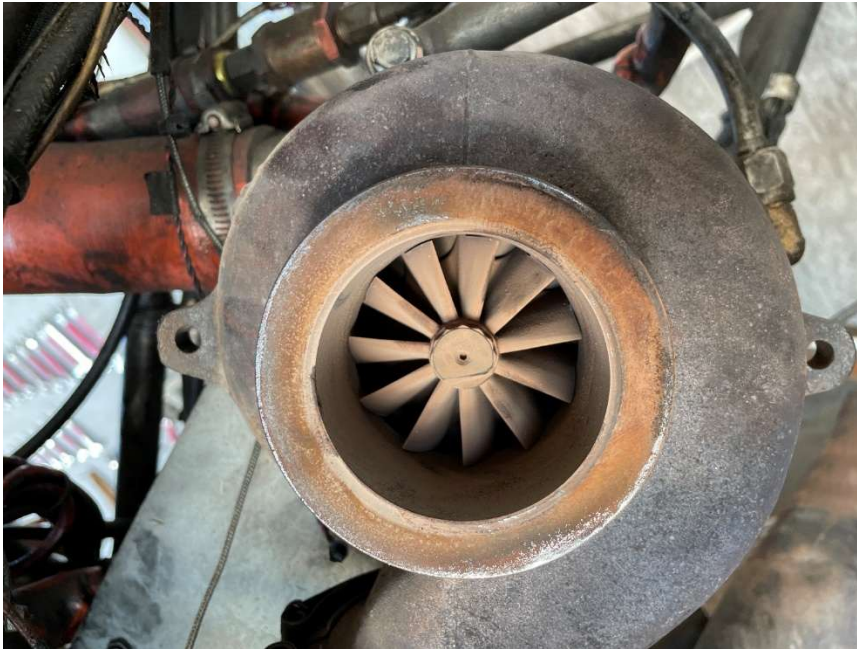
The turbocharger was not damaged and rotated freely with no axial or radial play. The wastegate moved when actuated by hand, and it was connected to its supply lines; the wastegate was damaged by impact forces. The turbo pressure relief valve moved when manually actuated with a hand tool.

Photo 7: Turbocharger

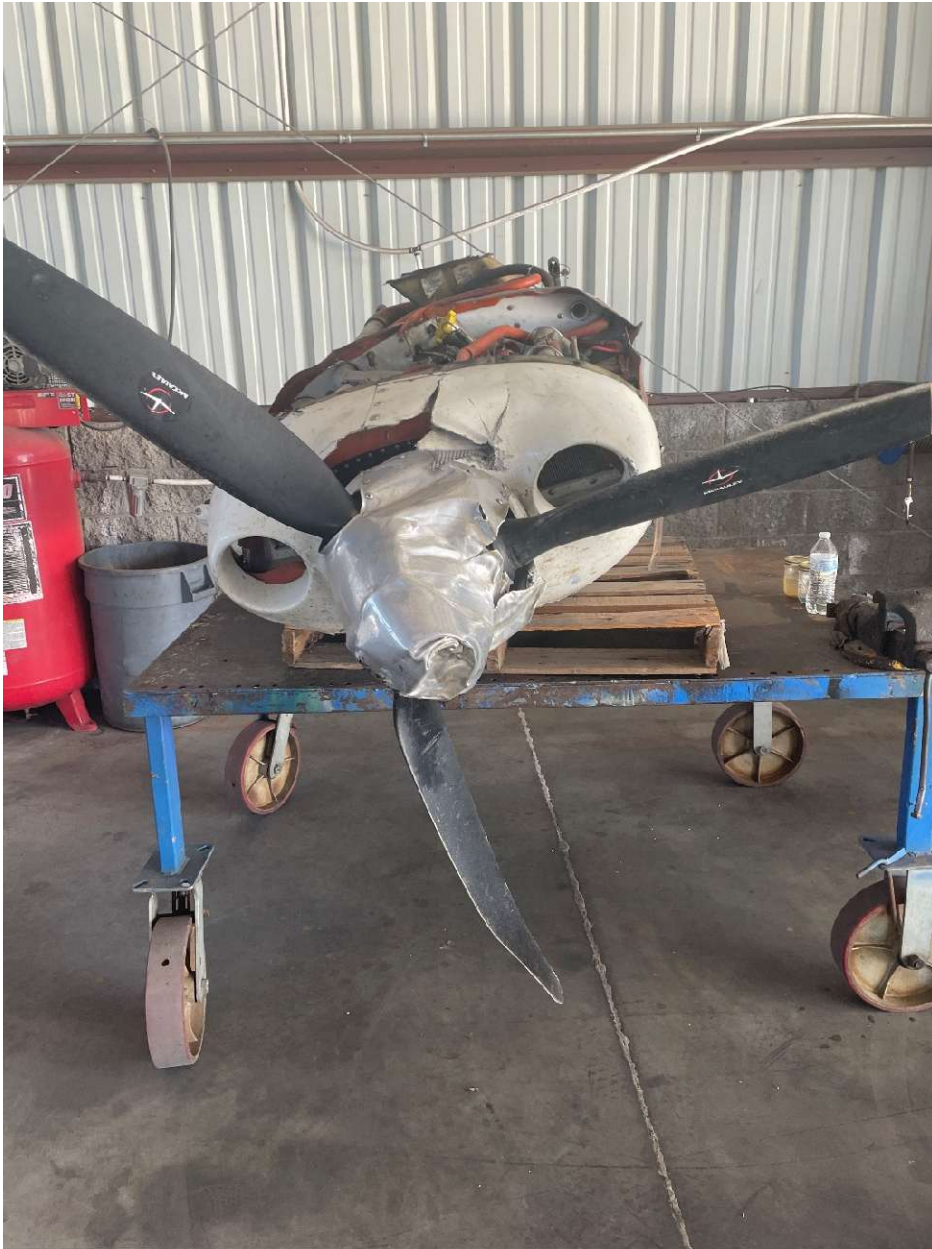
One propeller blade was secured in the hub, and the other two blades were loose in the hub. One blade was bent aft, and the other two displayed mild S-bending. All blades displayed chordwise gouging along the leading edge.

Photo 8: View of Propeller Blades
