# National Transportation Safety Board

WPR24LA259

## **WRECKAGE EXAMINATION SUMMARY REPORT**

Location: Elko, Nevada  
Date: July 28, 2024  
Time: 0815 local  
Airplane: Beech C23

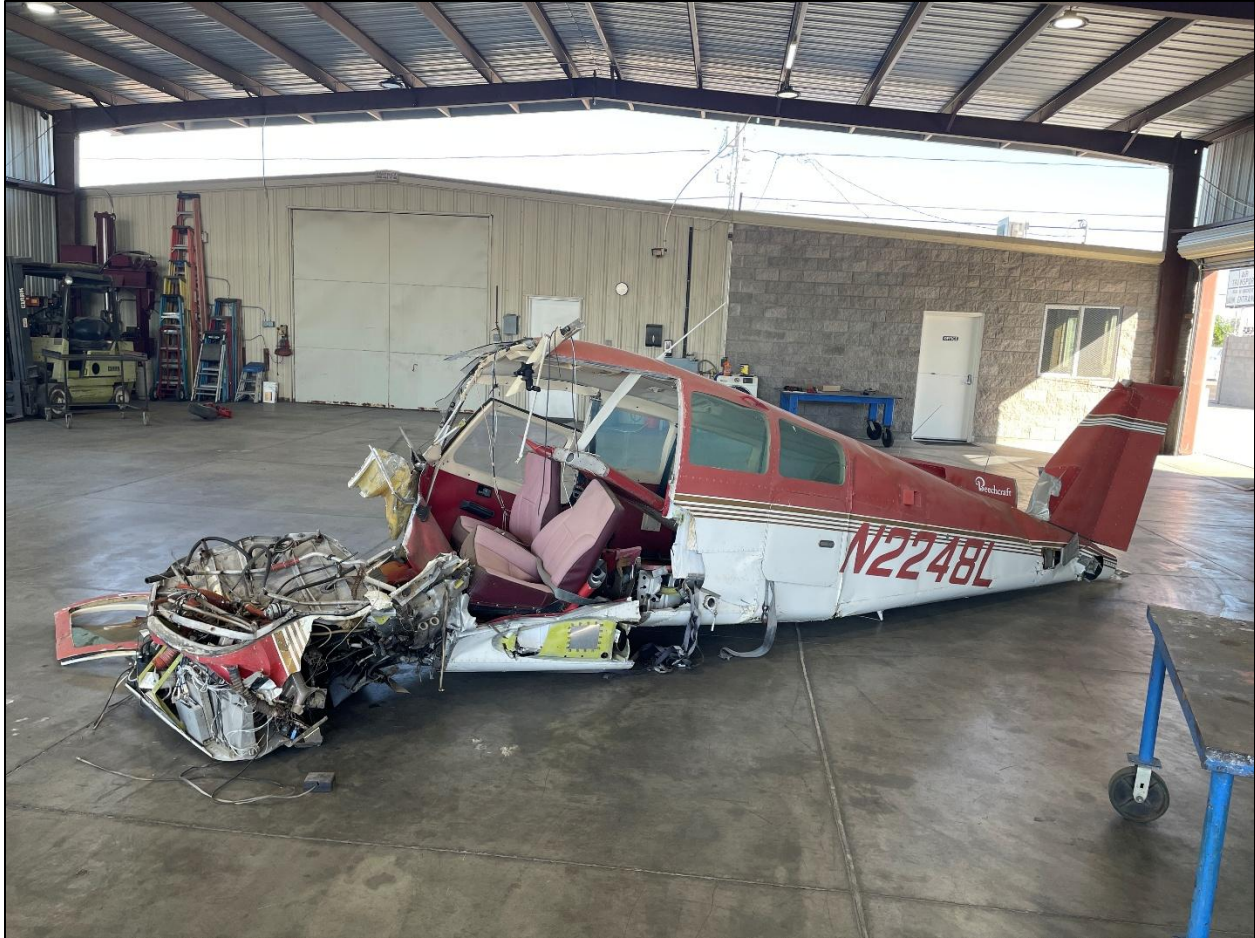
Both flaps sustained impact damage and remained attached to their respective wings. The control pushrods from the torque tube to each flap fractured. The left aileron exhibited extreme crushing from the trailing edge forward. The right aileron sustained crush damage at the outboard end.

**Figure 1-Follow-up examination, main wreckage.**

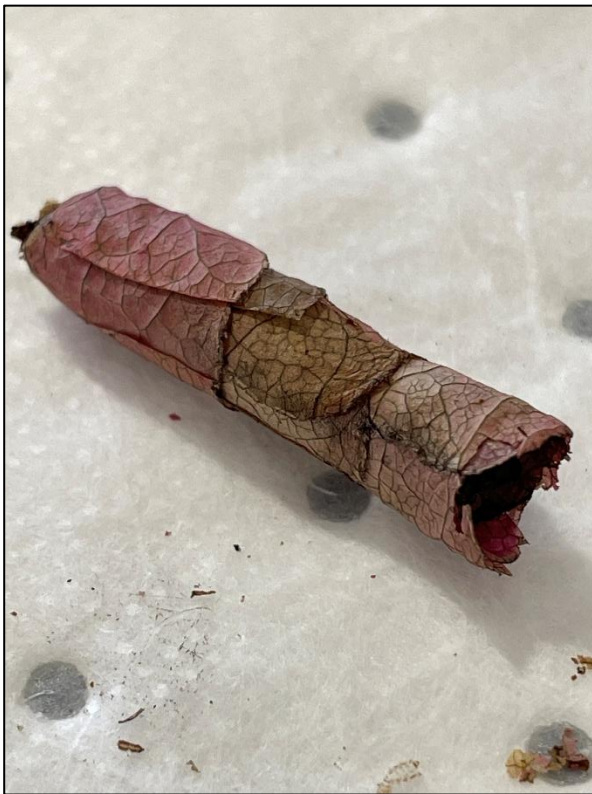
There was no fuel present in the fuel system at the examination. Both wing tank fuel caps were installed on their respective tank, both caps' seals appeared age hardened and cracked. Both fuel tanks appeared clean and there were no apparent fuel tank structure breaches. Both fuel tank outlet finger strainers were clean. The left tank flexible outlet tube was cut during the wreckage recovery efforts. The right tank flexible outlet tube was fracture separated at the inboard fitting. The plumbing from both wing roots to the fuel selector valve were found unobstructed and attached to the valve. The fuel selector handle and valve were in between the Left and Off position. The fuel selector was unobstructed and functioned correctly with air passed through it. The handle moved with positive position detents. The outlet plumbing was fracture separated between the fuel selector valve and the fuel strainer. The fuel strainer was disassembled and the screen and bowl appeared clean. The outlet plumbing was fracture separated. The fuel boost pump inlet fitting and control wiring were sheared off the pump and was not tested. The boost pump open inlet port was obstructed by pink organic material. The boost pump screen was clean but there were several pink colored tube-shaped formations in the boost pump. After examination they appeared to be insect larva wrapped in bougainvillea leaves. The

check valve adjacent to boost pump also had fracture separated inlet plumbing and also contained the same larva material that was contained in the boost pump.

**Figure 2-Organic material.**

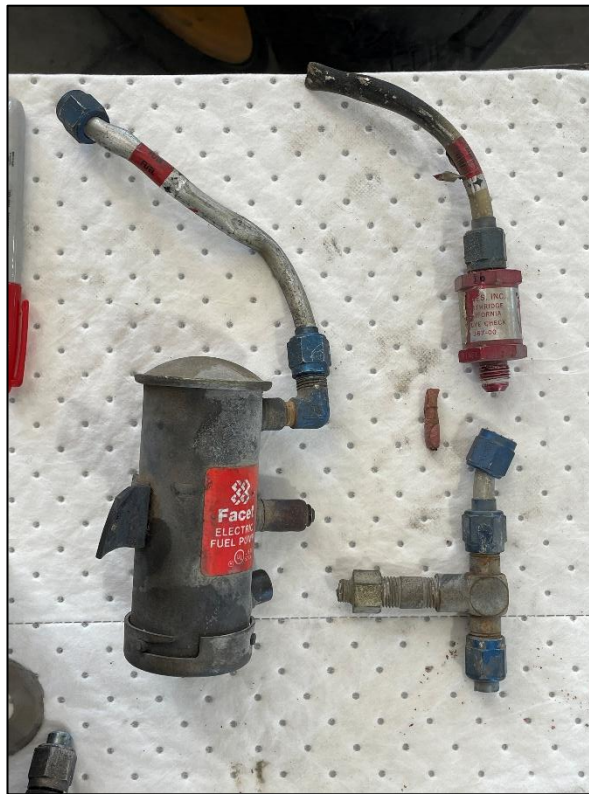
**Figure 3-Fuel system components.**

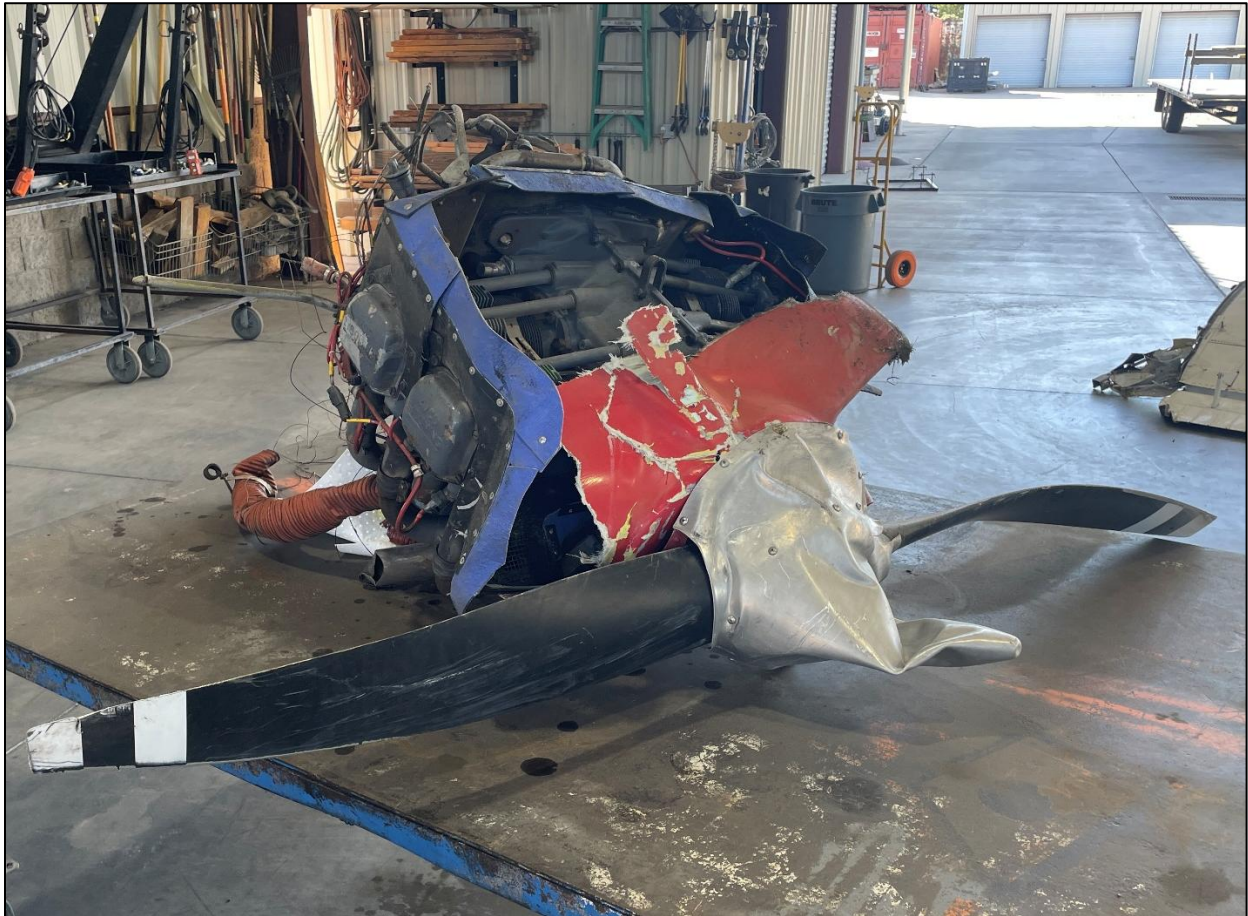
The Lycoming O-360-A4K engine, serial no.: L-23830-36A, separated from the firewall. Portions of the engine mounting assembly remained attached. Multiple engine control cables, and fluid lines were cut during the recovery process. The propeller remained attached to the crankshaft propeller flange. The oil dipstick was removed and did not show any indication of oil in the sump. The oil sump drain was missing its valve. About a cup of oil drained from the engine during the examination. A small portion of the lower cowling remained attached near the propeller back plate. The propeller blades had leading edge scuffing near the tips. One blade was

bent slightly forward and the other slightly aft. The damaged propeller spinner back plate was crushed aft and was pulled forward to clear the starter motor housing. The spinner was crushed and remained attached to the hub.

**Figure 4-Engine and propeller assembly.**

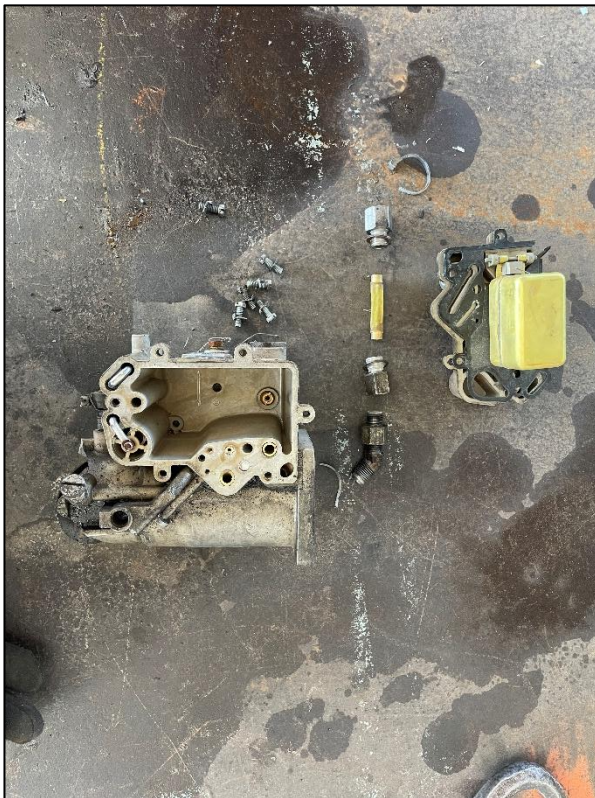
The carburetor separated from its mounting flange and remained attached to several damaged control cables. The carburetor was removed and disassembled. The inlet finger screen was removed and had no obstructions. The float assembly was removed from the bowl and no anomalies were noted. The carburetor mounting flange remained attached to the engine. The throttle cable remained attached to the throttle linkage which located on the portion of the carburetor mounting flange. The butterfly valve remained attached to the carburetor. No fuel was present during the examination.

**Figure 5-Carburetor**

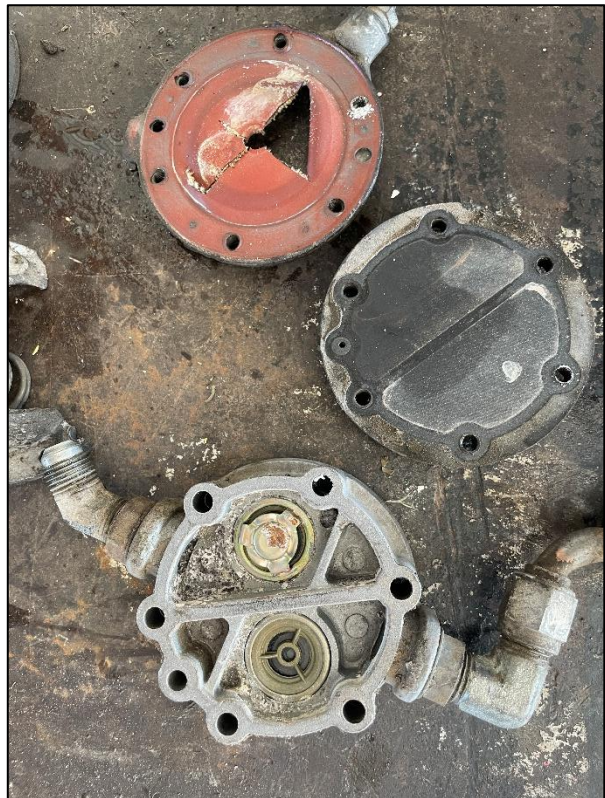
The fuel pump separated from its mounting flange and remained attached to both inlet and outlet lines. The fuel pump housing was damaged and the internal spring and diaphragm control rod was not in its designed position. The fuel pump

was disassembled, and the diaphragm was torn and separated from the control rod attachment. The fuel pump mounting flange remained attached to the engine.

**Figure 6-Fuel pump.**

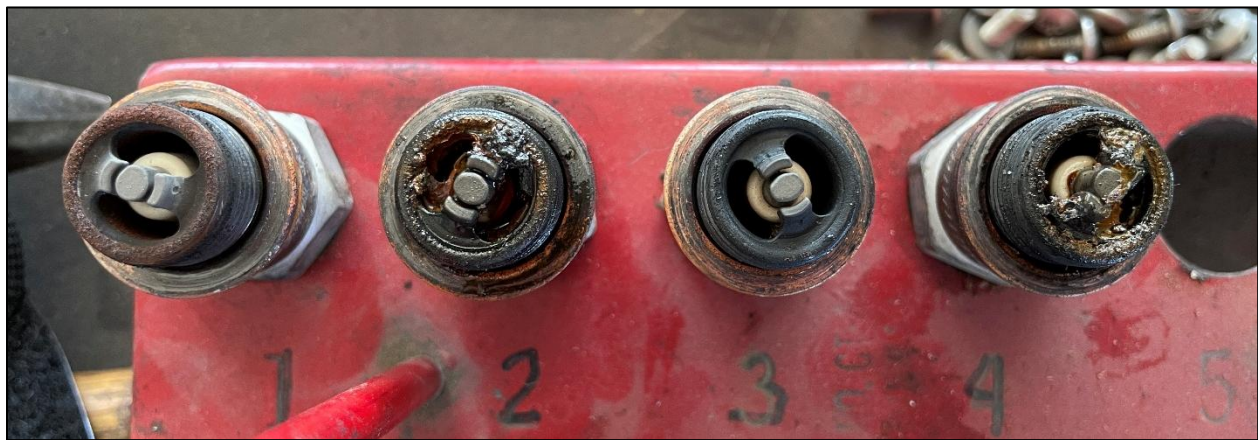
The upper spark plugs were removed from the cylinders. The Nos. 2 and 4 spark plugs were oil soaked and with some corrosion deposits. The Nos. 1 and 3 spark plugs had "Normal-Worn Out" wear conditions when compared to the Champion spark plug chart. The electrode areas were grey in color and had light combustion deposits.

**Figure 7-Upper spark plugs.**

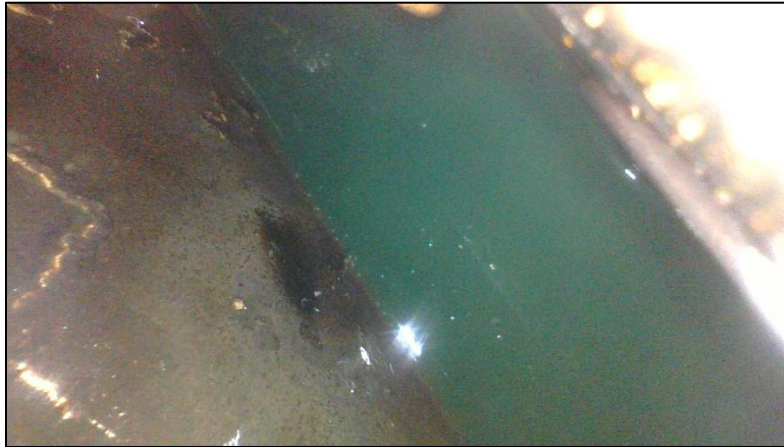
The cylinder combustion chambers were examined with a lighted boroscope and revealed normal combustion deposits and the valve heads revealed normal operating conditions. The Nos. 2- and 4-cylinder combustion chambers had a small amount of pooled oil that had a blue-green color. The valve covers were removed, and the cylinder overhead components were undamaged and were covered in residual oil.

**Figure 8-Oil pooled in cylinder No. 2 combustion chamber.**

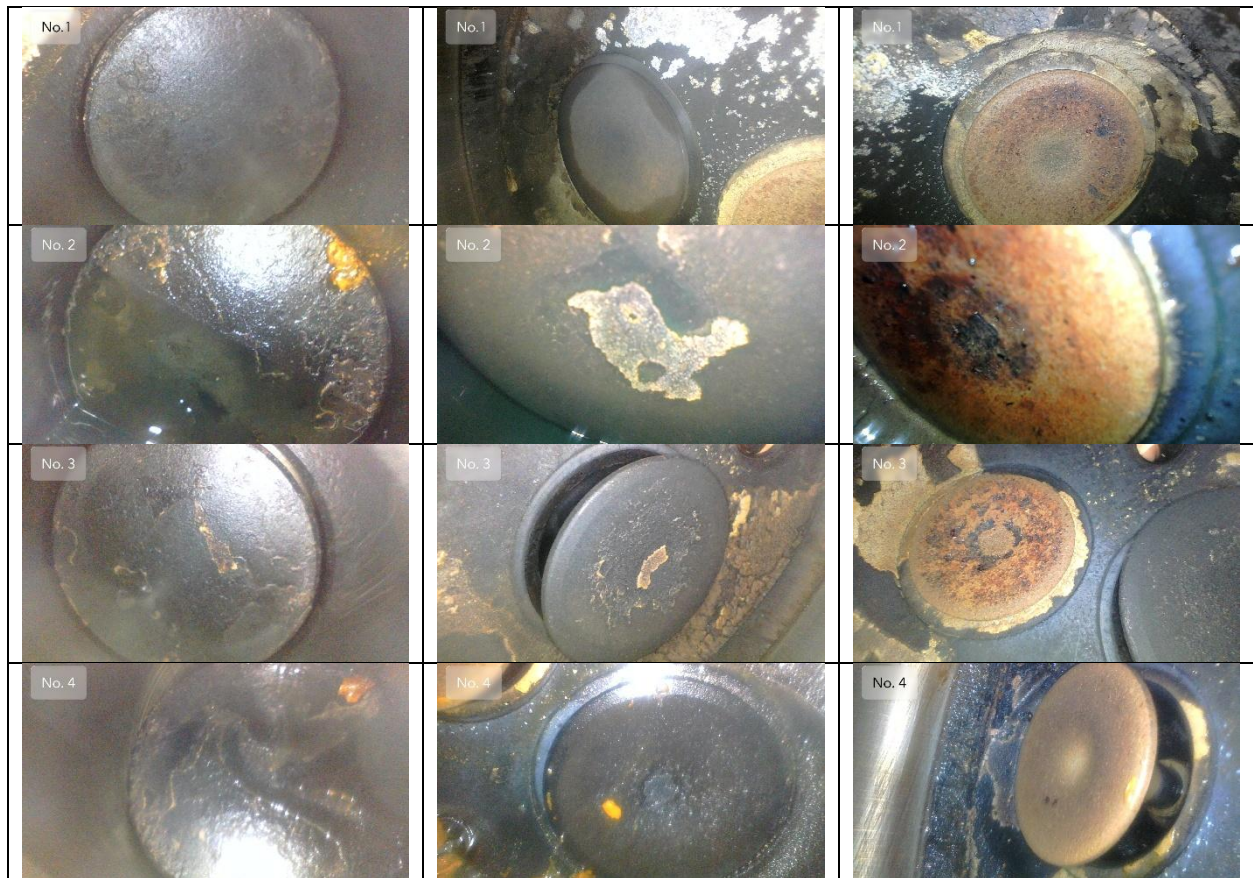
**Figure 9-Images of the combustion chambers, piston heads and valves.**

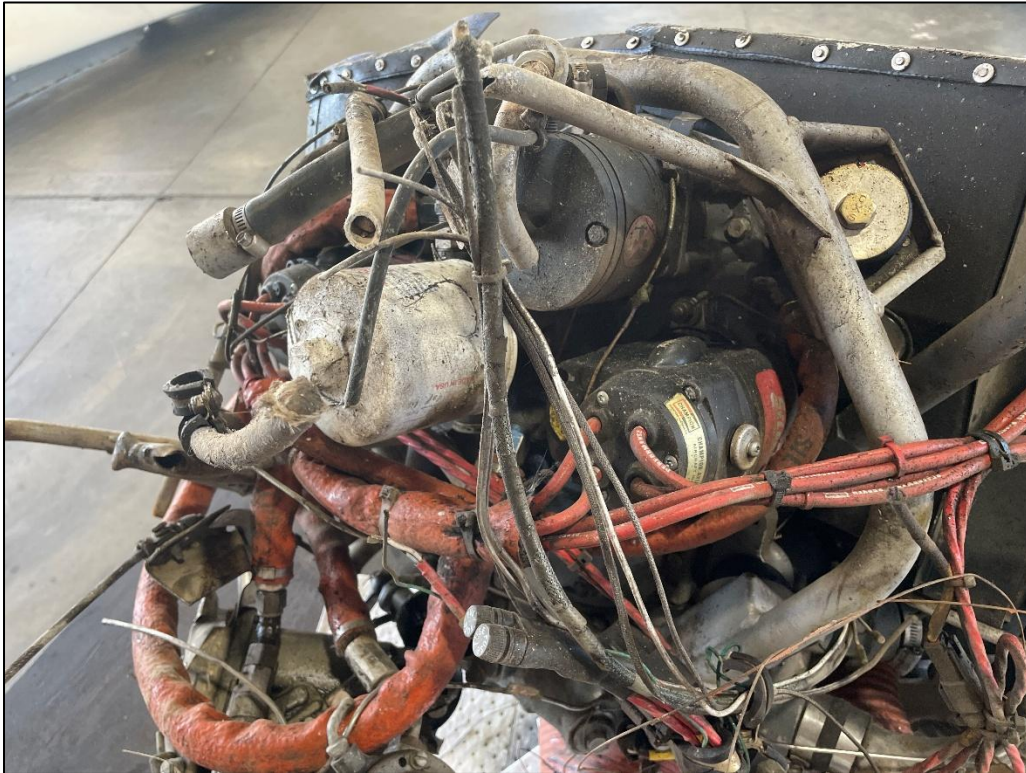
The propeller was rotated by hand and the starter gear remained engaged with the starter ring gear. During rotation of the crankshaft, gear continuity was established to the accessory section, overhead valve movement was observed, and cylinder compression was obtained. Spark was also observed from the left magneto ignition lead ends. The right magneto was removed from the engine and the drive shaft was rotated with a hand drill and spark was observed from the ignition lead ends.

**Figure 10-Accessory side of the engine.**

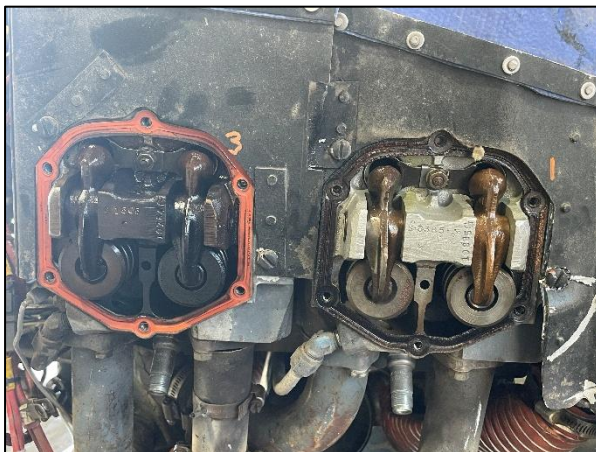
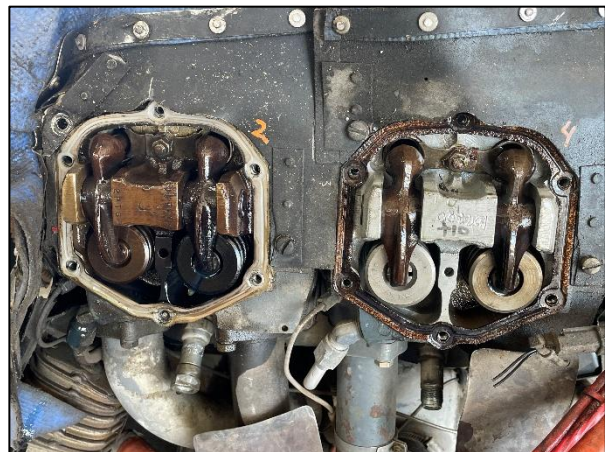
**Figure 11-Cylinder overhead components.**

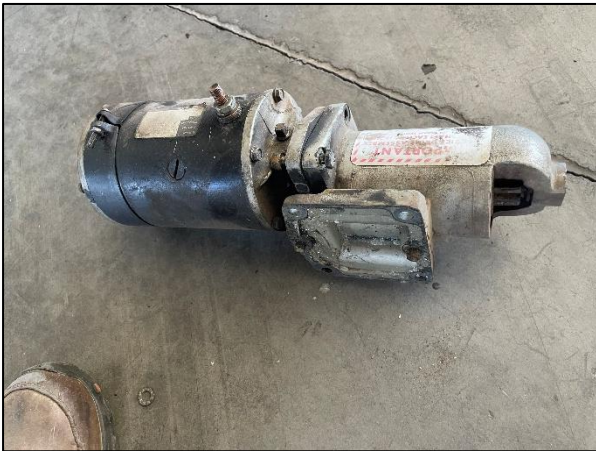
The starter remained engaged with the starter ring gear during the examination of the engine. The starter ring gear showed some wear in some areas. The starter was removed from the engine and the gear remained in the engaged position. The starter motor was removed, and the starter control shaft and housing were undamaged. A small amount of spring resistance was observed in the pinon gear spring but would not retract to its resting position. The assembly was connected with electrical power and the motor spun up normally and the pinon gear rotated but would not retract to its resting position. The motor and spring shaft connection area had sufficient grease and gears were undamaged. No thermal discoloration was noted.

**Figure 13-Starter motor.**

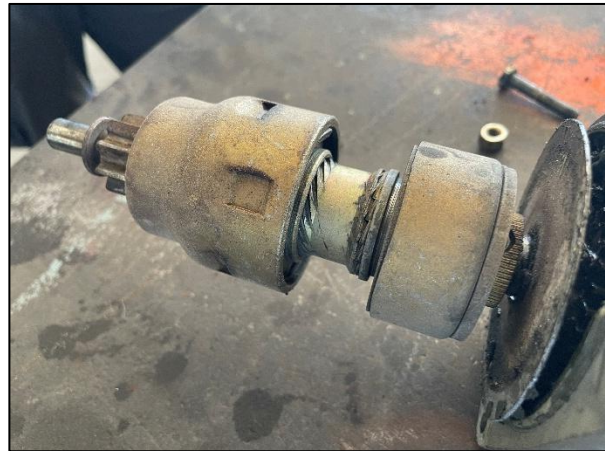
**Figure 14-Starter motor shaft and pinon gear.**

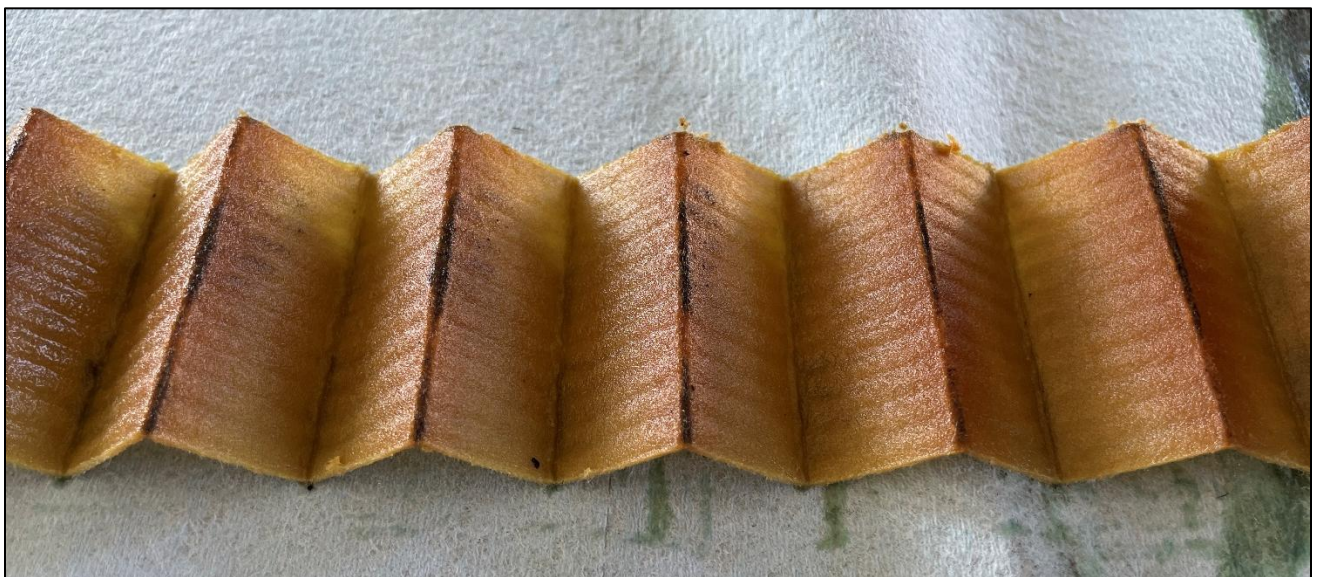
The oil filter was removed from the engine and writing on the side of the filter was not legible. The filter was disassembled, and no metallic debris was noted in the element folds.

**Figure 15-Oil filter element.**
