# National Transportation Safety Board

WPR24LA260

## **MATERIALS LABORATORY**

Factual Report 25-037

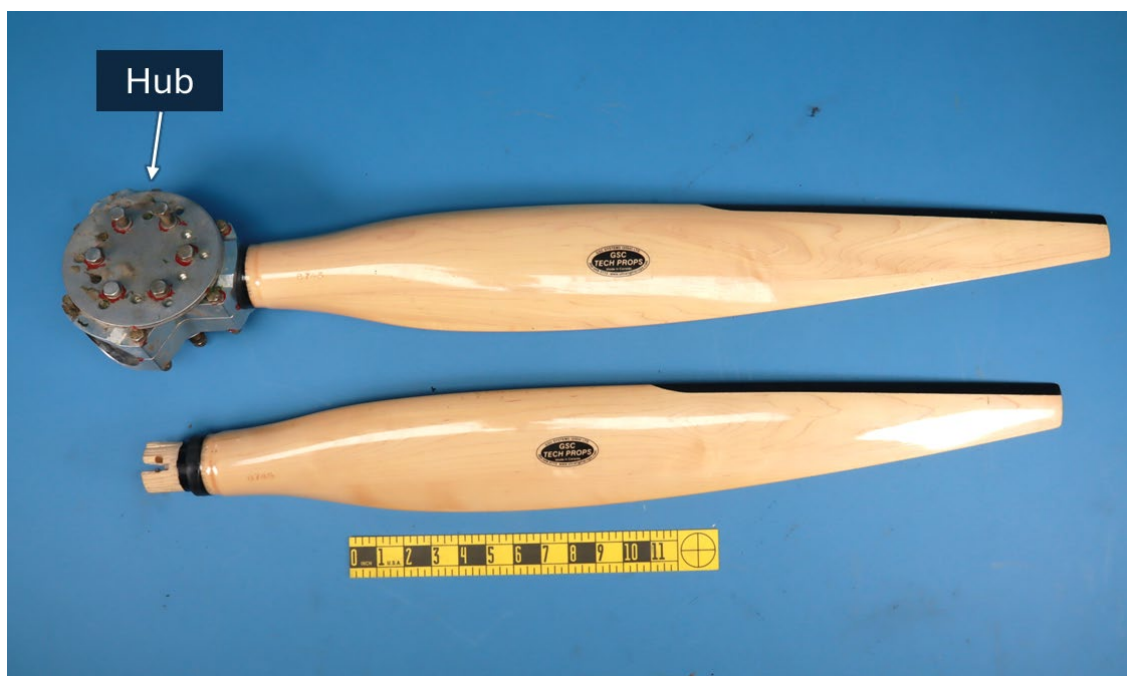
Pieces of a ground-adjustable-pitch three-blade propeller assembly (GSC Systems) were submitted for examination at the materials laboratory (Figure 1). The components consisted of a metal three-blade-bore hub, two wooden propeller blades, and two blade roots that were retained by the hub. The blades were constructed of laminated wood with a black polymer cap (approximately 0.05 inch thick) covering the root of each blade. The grains of the laminate layers were oriented parallel to the length of the blade. The blade roots were installed in the hub, which consisted of two aluminum halves held together by hex head bolts. Each blade retaining lug of the hub contained two bolts (one on either side of the propeller blade). These bolts appeared to have been left in place post-accident. The center of the hub contained six bolts arranged in a circular pattern. Three of these bolts (alternating bolts in the circle) fed through machined holes in the roots of the blades, securing them into the hub. The remaining three bolts held the two halves together. The nuts on the six bolts from the hub center appeared to have been removed and then re-threaded onto the bolts. One identifying mark was found on the hub; the number "25" was stamped into the outboard end of one retaining lug.

**Figure 1.** Propeller blades and hub as received.

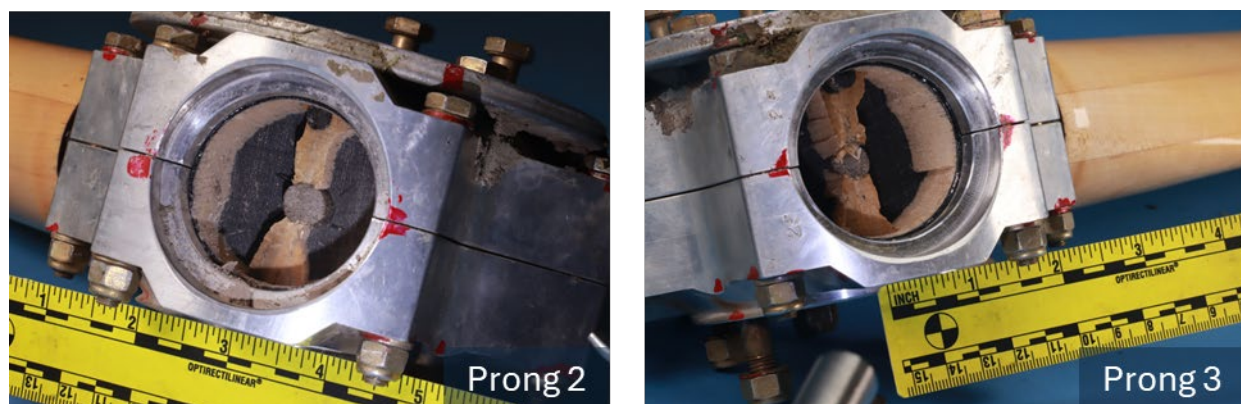
As received, one blade was retained by the hub, one blade was separated from the hub, and the third blade was separated and not recovered. Two of the blade bores contained sections of a blade root (Figure 2). The blade positions were arbitrarily numbered '1-3' for tracking purposes, where the position with the retained blade was labeled '1', the position containing the root that matched to the separated blade (based on fracture surface geometries) was '2', and the position containing the root of the missing blade was '3'. The blades had separated from the polymer cap at

the butt end of the propeller, leaving behind portions of wood attached to the walls of the cap and below the securing bolt.

**Figure 2.** (Left) The blade root in lug 2. (Right) The blade root in lug 3.

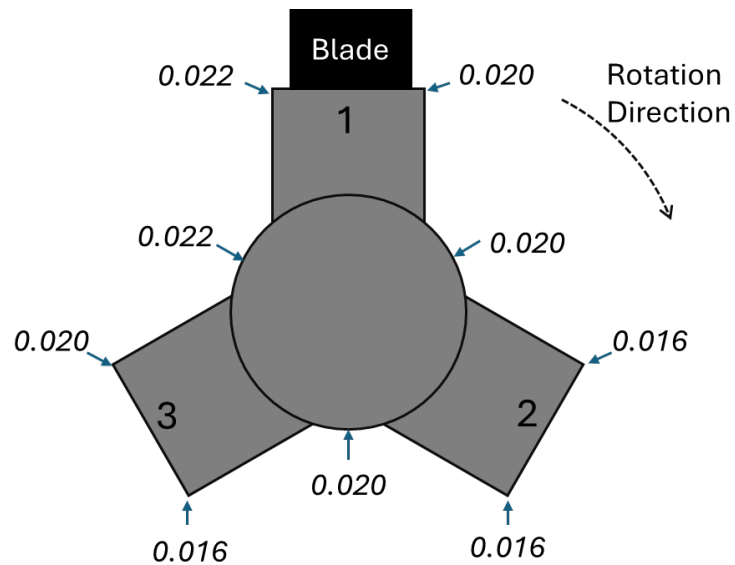
The spacing between the two halves of the hub was checked by fitting shims of known thickness into the gap between the upper and lower half. The spacing ranged between 0.016 and 0.022 inch. Figure 3 shows a schematic of the spacing measurements. The tightening torques of the two bolts in the lug around blade 1 were measured with a torque transducer. The transducer was attached to the bolt head, and increasing clockwise torque was applied until the bolts started to turn. The tightening torque on the bolt near the leading edge of the propeller blade was measured at 32.4 in-lbs. Recorded data was not captured for the trailing bolt; however, qualitative observation of the transducer's display during testing showed a similar tightening torque. Instructions from the manufacturer call for a tightening torque between 75 and 100 in-lbs, leaving a gap of 0.030 inches between the two halves of the hub.<sup>3, 4</sup> The previously-cited service bulletin warned that overtightening of the hub bolts could lead to "premature blade failure resulting in injury or death."

**Figure 3.** Schematic (not to scale) of the propeller hub viewed from the aft, looking forward. Labels in *italics* indicate the measured spacing, in inches, between the two halves of the hub.

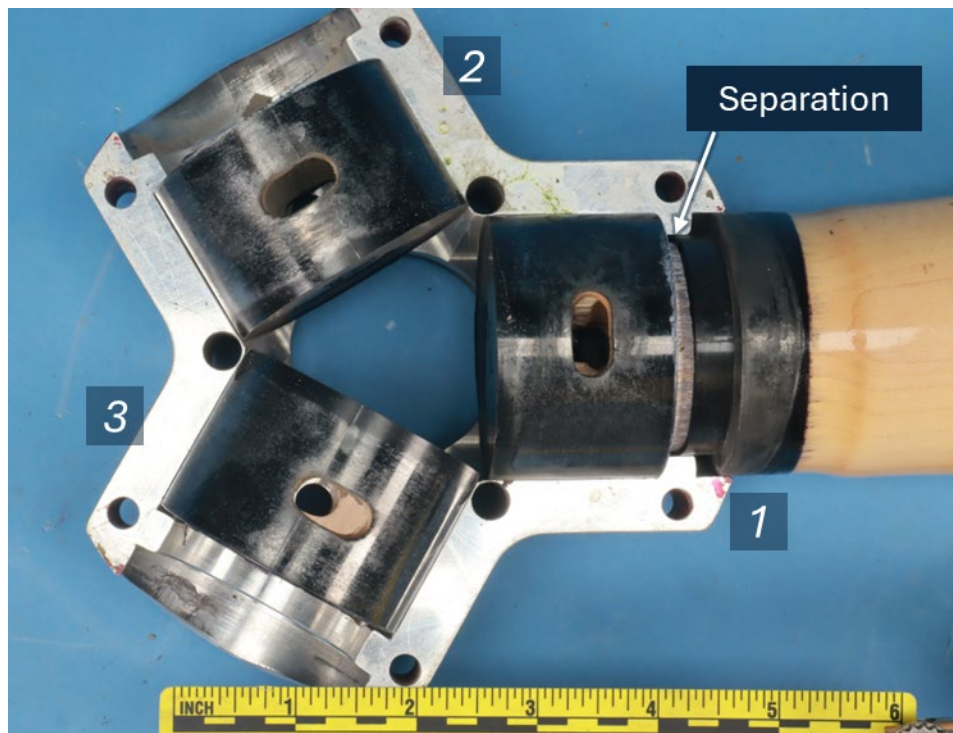
Disassembly of the hub revealed that the blade installed at position 1 had started to separate near the inboard corner of a circumferential groove in the root (Figure 4). The gap between the two pieces of the root (where wood was visible) was approximately 0.105 inch at the leading edge and 0.150 inch at the trailing edge. The separation was also visible in the attachment bolt through-hole. The other two blade roots showed separation at similar locations. Blade 1 was wedged into one half of the hub; a rubber mallet was used to remove the blade from the hub. Rubbing wear was observed on all root surfaces that had been in contact with the metal hub. Black material was also visible on the inside surface of the blade retention lugs where they had been in contact with the blade roots, especially near the split line of the hub (Figure 5).

**Figure 4.** Propeller hub with the front half of the casing removed.

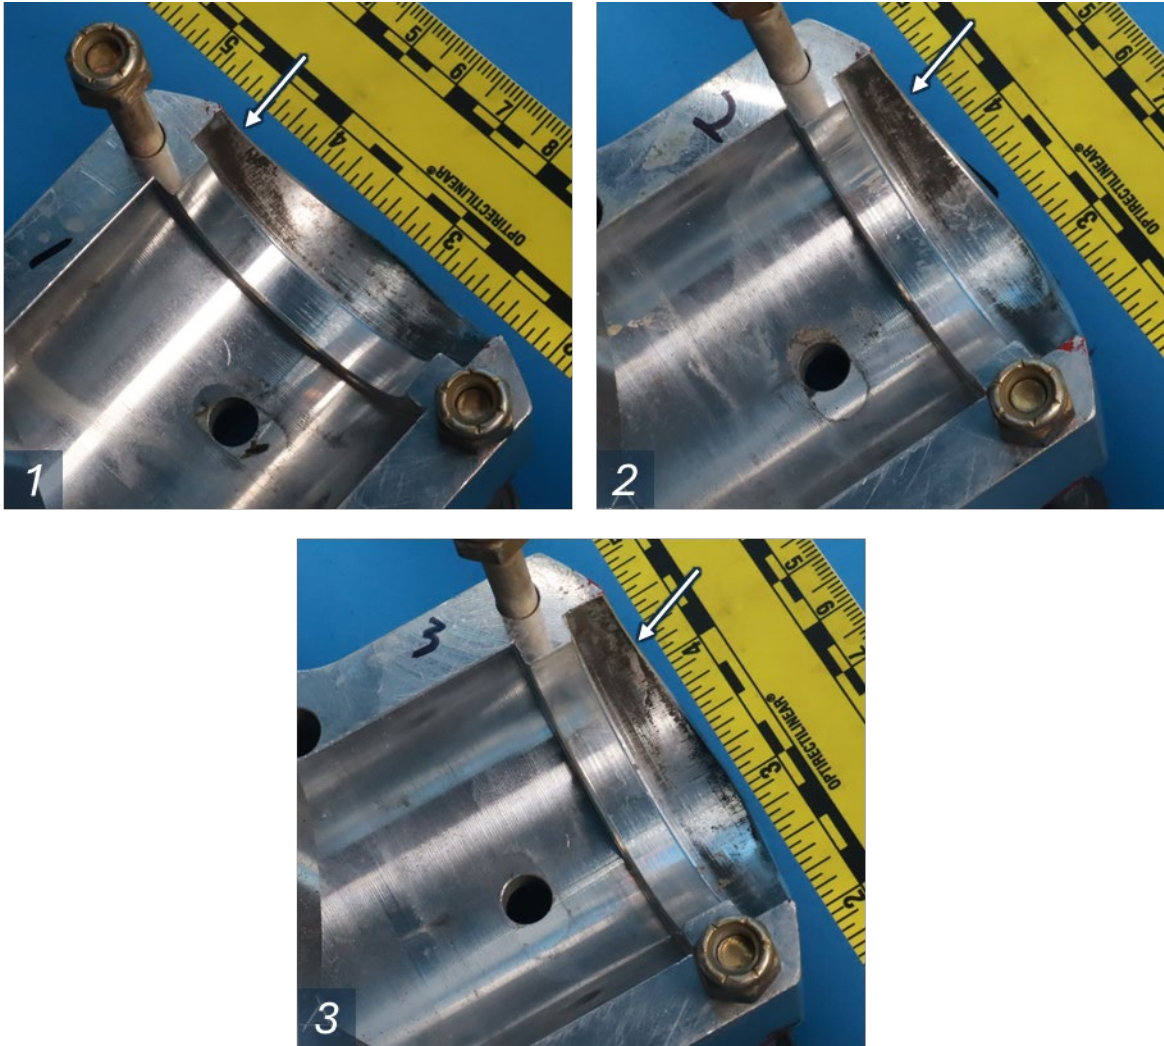
**Figure 5.** The three blade retaining lugs of the forward half of the hub (lug label in the lower left-hand corner of each image). The white arrows point to black residue was visible near the split line of all three lugs.

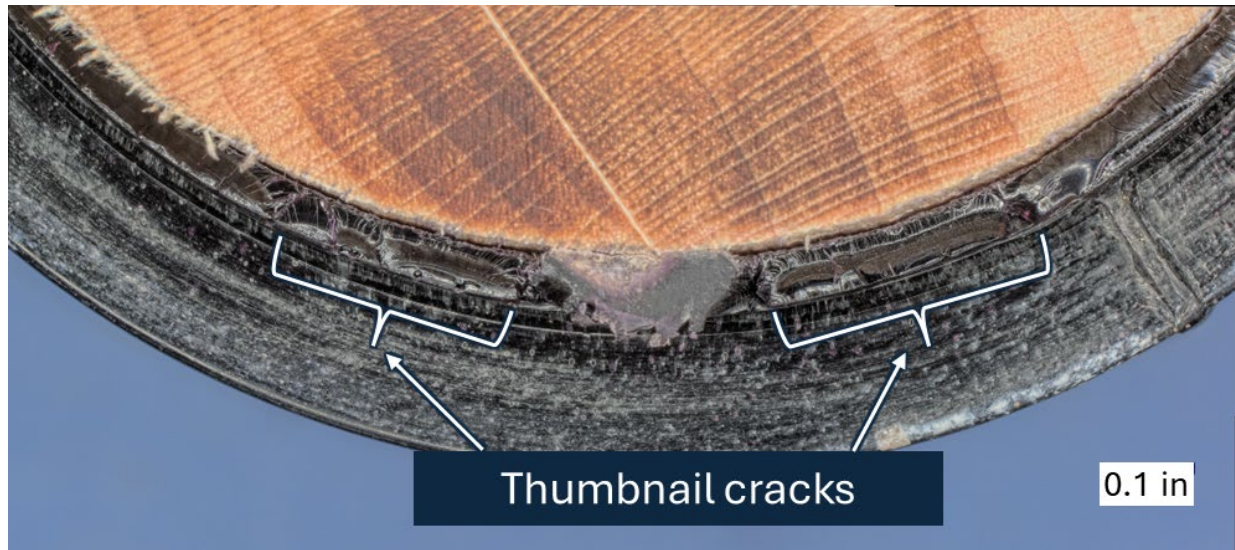
Blade 1 was cross-sectioned in the separation region to view the fracture surface on the cap. The blade roots were rinsed in water and subjected to examination using optical microscopy. Inspection of the fracture surfaces on the polymer cap from all three blades revealed features consistent with progressive cracking. Thumbnail cracks were visible at the 4:00 and 5:00 positions on the cap from blade 1, each approximately 0.25 inch wide and 0.03 inch deep (Figure 6).<sup>5</sup> Similar features were intermittently visible extending around the aft portion of the blade towards the 7:00 position. The cap on the blade 2 root showed a thumbnail-shaped crack with progressive beach marks extending from the outside edge of the sleeve at approximately the 4:00 position (Figure 7). The crack was approximately 0.5 inch across and extended approximately 0.02 inch at a 45° angle inboard from the plane of the adjacent groove face. The cap on the blade 3 root showed a series of adjacent thumbnail cracks approximately centered around the 6:30 position (Figure 8). In total, the cracks covered a 1-inch arc of the fracture surface, and the deepest point was approximately 0.03 inch.

**Figure 6.** Thumb nail cracks in the plastic cap on the root of blade 1 near the 4:00 and 5:00 positions.

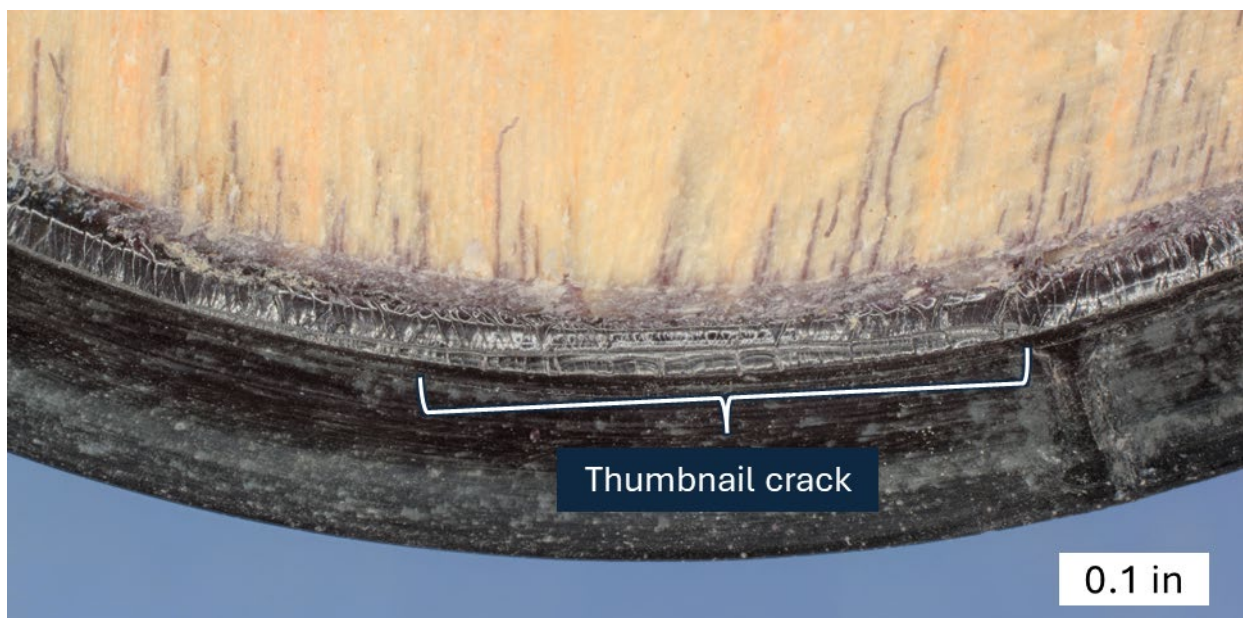
**Figure 7.** Thumb nail crack in the plastic cap on the root of blade 2 near the 4:00 position.

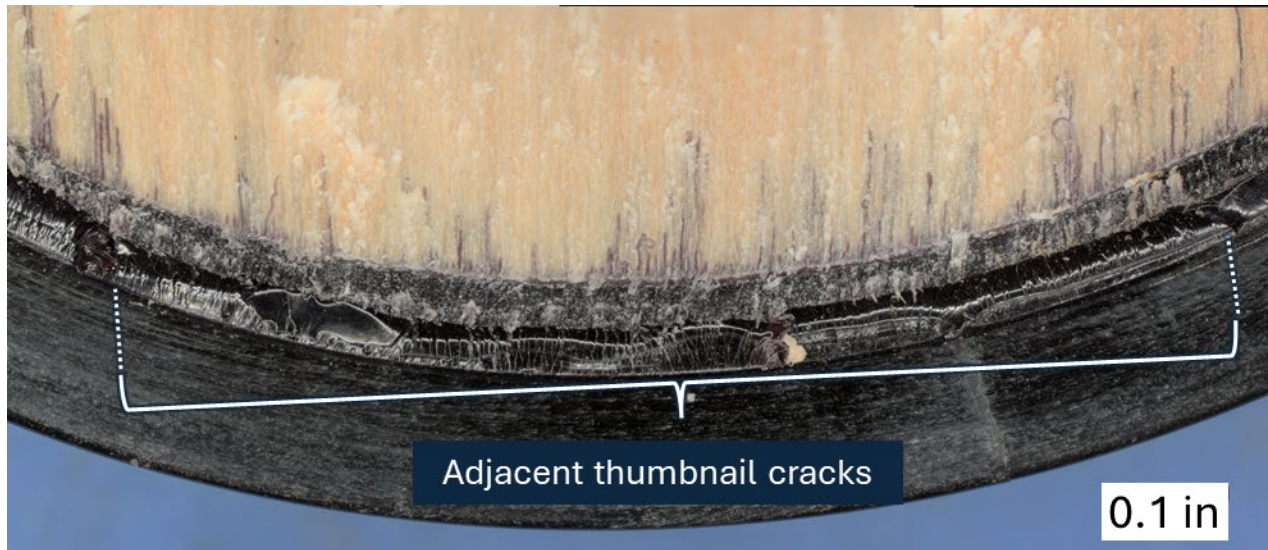
**Figure 8.** Thumbnail cracks in the plastic cap of the root of blade 3 near the 6:30 position.

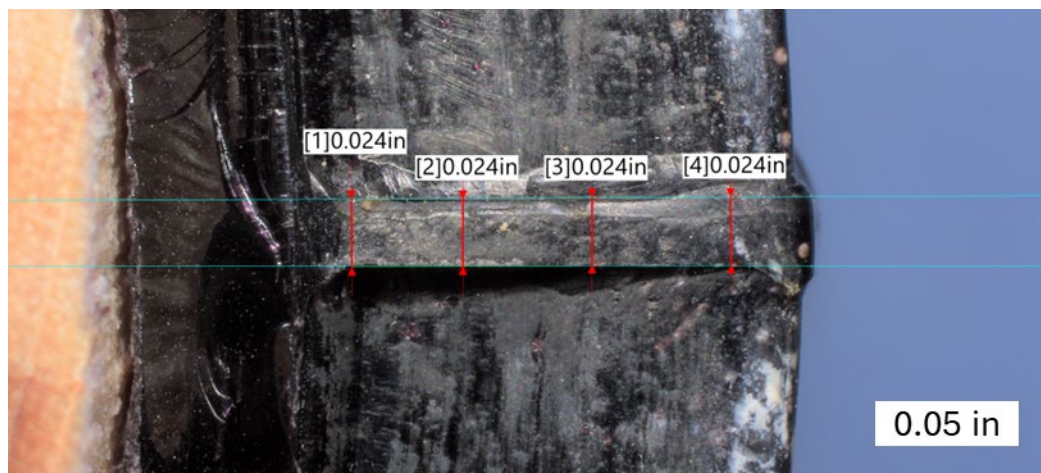
The plastic caps on all three blade roots showed an impression left by the split line of the hub. This impression was visible in the groove surfaces and extended down the lead and trailing sides of the cap. The widths of the impressions on each cap were measured using Keyence VHX-7000 software. Figure 9 shows an exemplar measurement of an impression. Table 1 contains the average impression width measured on the trailing and leading edge of each cap. The metal edge of the hub in the corresponding locations (that would have been in contact with these areas of the caps) showed little or inconsistent bevel, with some showing no bevel.

**Figure 9.** Exemplar measurements of the split line impression on the cap of the blade 1 root.

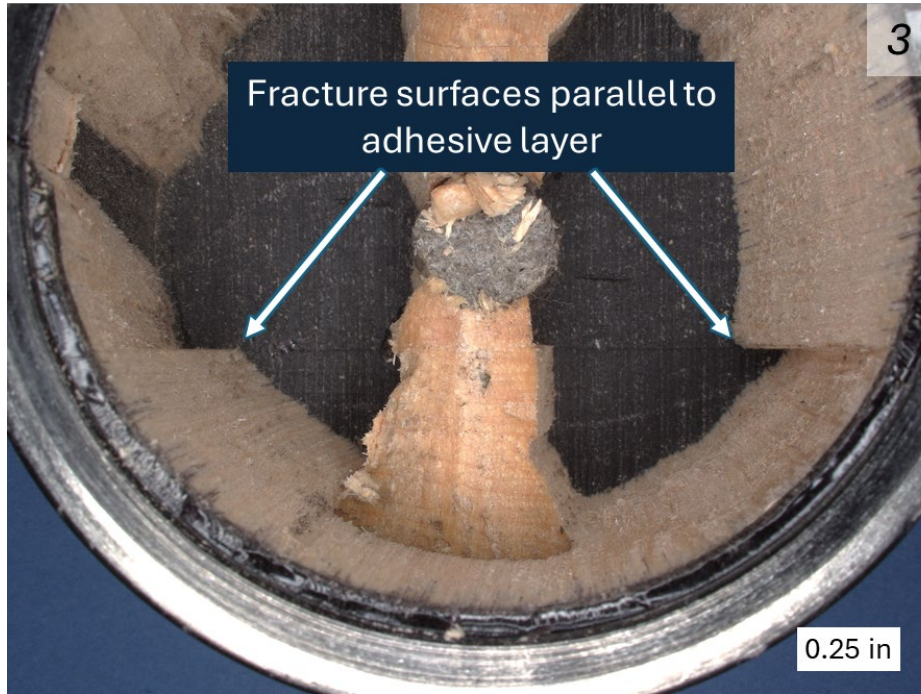
Examination of the fractured wood surfaces from the hubs showed shearing damage mostly parallel to the wood grain. No evidence of moisture or staining was visible on the wood fracture surfaces. The root of blade 3 showed sections of angled surface where the wood had separated at or near layers of adhesive in the root (Figure 10). The root was cross-sectioned and examined with an optical stereoscope. No separation or porosity was noted in the cross-sectioned portion of the adhesive layers (Figure 11).

**Figure 10.** Angled fracture surfaces following the adhesive layer between wood laminates in the blade 3 root.

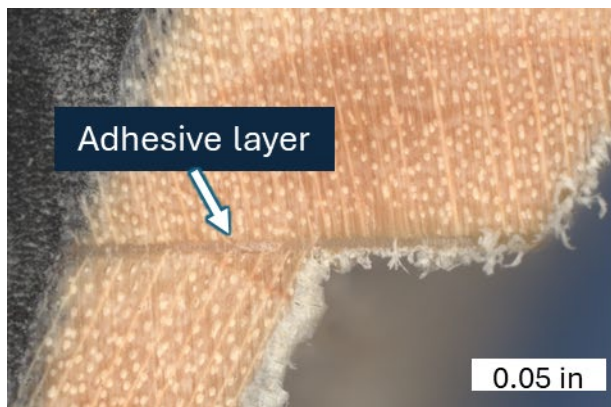
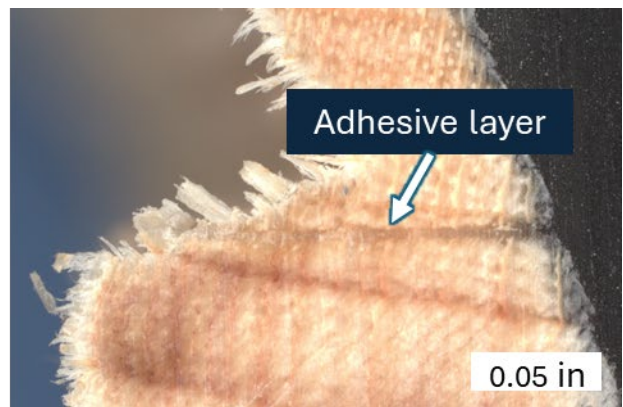
**Figure 11.** (Left) Cross-sectioned blade 3 root showing the fracture surface partially following the adhesive layer. (Right) The crack did not follow the adhesive layer on the opposite side of the fracture surface.
