# National Transportation Safety Board

WPR24LA261

## **MATERIALS LABORATORY**

Factual Report 25-083

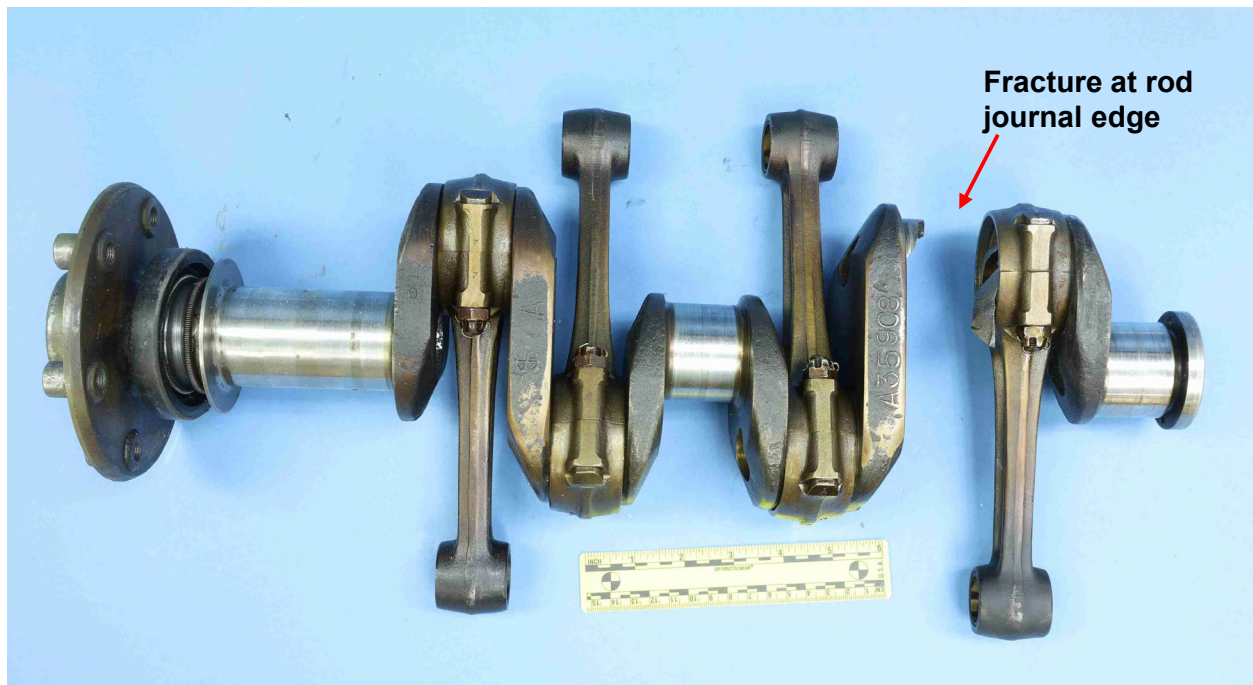
Figure 1 is an image showing the overall crankshaft as-received with an arrow pointing to the separation area. The as-received images in figure 2 are of the fracture surfaces on the number 1 connecting rod journal edge (left) and the web (right) part of the crankshaft.

**Figure 1.** As-received overall crankshaft showing separation at the connecting rod journal.

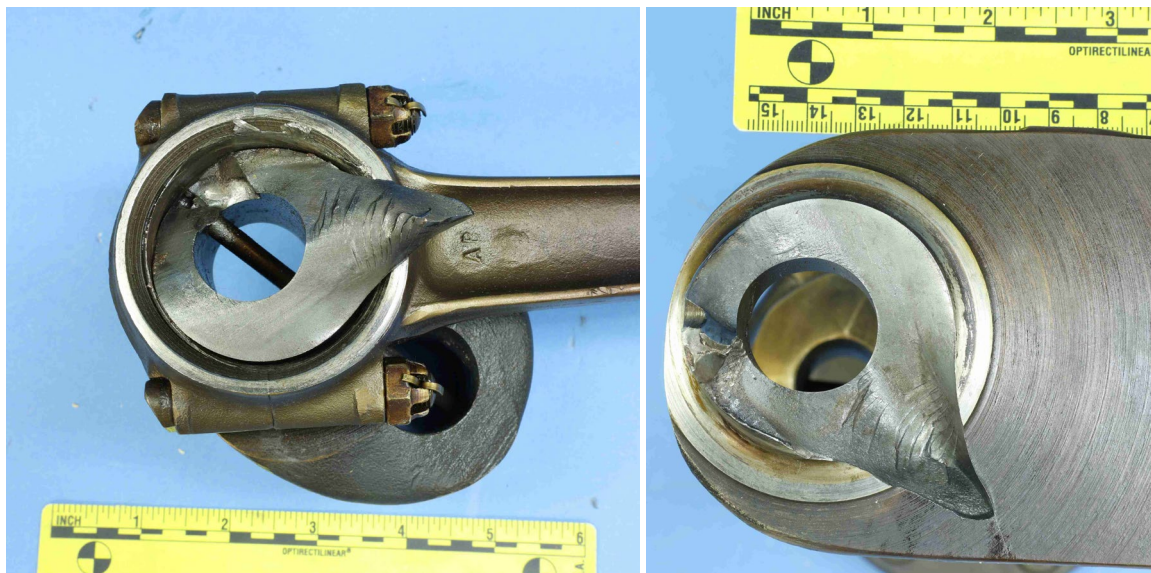
**Figure 2.** As-received images of the journal fracture surfaces at journal edge (left image) and at the web (right image).

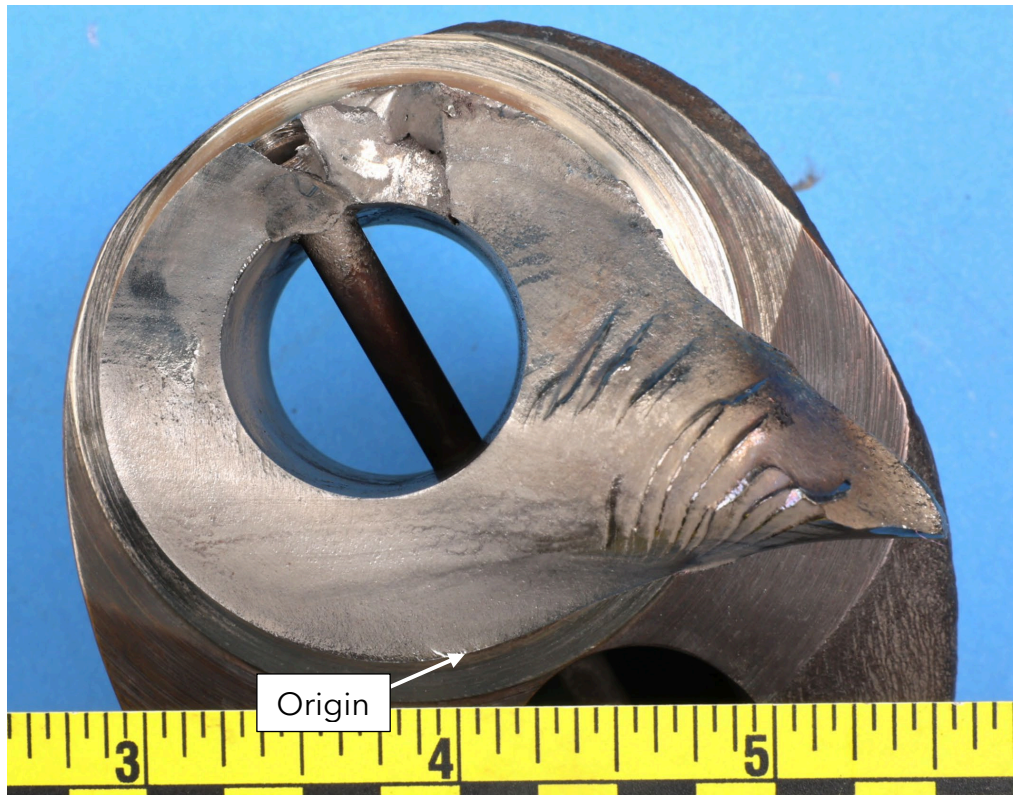
The image in figure 3 shows the journal fracture surface after the connecting rod and bearings were disassembled from the journal and cleaned in acetone. The crankshaft fractured at the forward edge of the number 1 connecting rod journal at the transition radius to the crankshaft cheek. The fracture surface was comparatively flat across almost the entire fracture and it exhibited beach marks, consistent with high-cycle fatigue over multiple duty cycles. The beach marks were traced back to an origin that was approximately 19° off bottom center of the journal (figure 3). The fractured journal surface was free of scratches and gouges as shown in figure 4.

**Figure 3.** Connecting rod journal fracture surface after disassembly of rod and bearings.

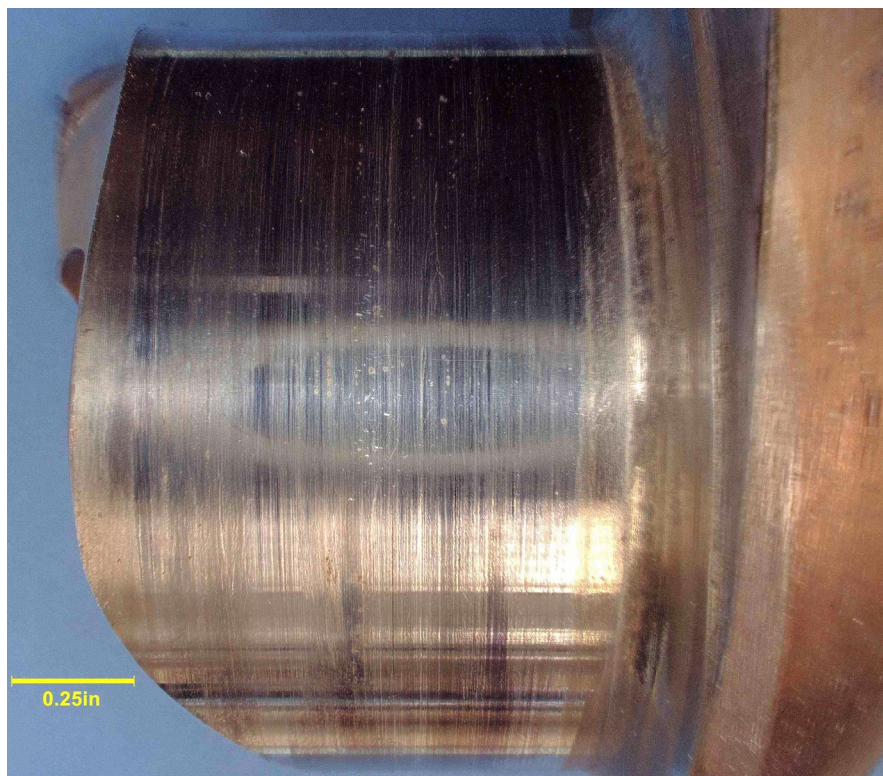
**Figure 4.** Representative area of the fractured journal surface.
