# National Transportation Safety Board

WPR24LA265

## **POWERPLANTS**

Group Chair's Factual Report

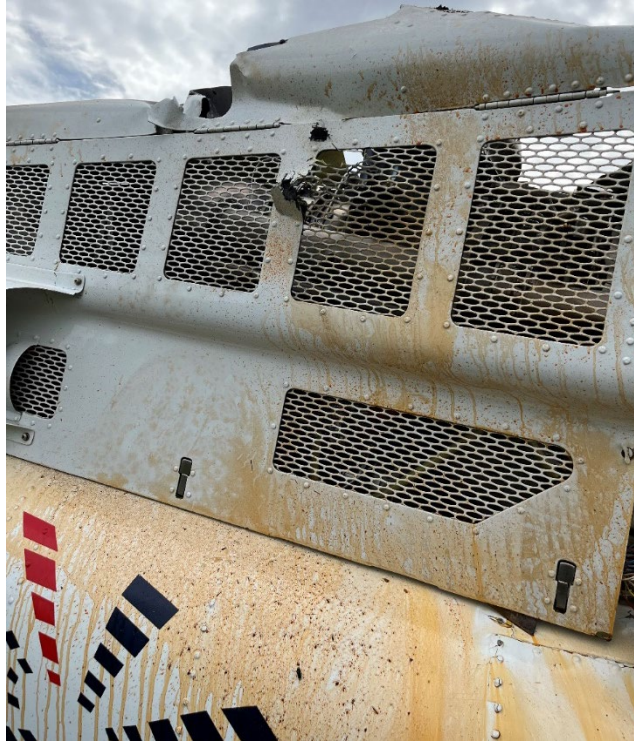
In Section 1.3 titled "Torquemeter Assembly", engine torque is measured in terms of oil pressure and is a function of torque transmitted through the helical gears in the accessory gearbox. Loss of oil quantity and oil pressure would eventually result in torque out-of-range faults. On scene photographs of the wreckage site showed the right side of the helicopter heavily oil stained in a vertical pattern consistent with the oil spraying onto the surface while the helicopter was stationary (**PHOTO 4**).

**PHOTO 4: HELICOPTER FUSELAGE, RIGHT SIDE, COVERED IN OIL - WRECKAGE SITE**

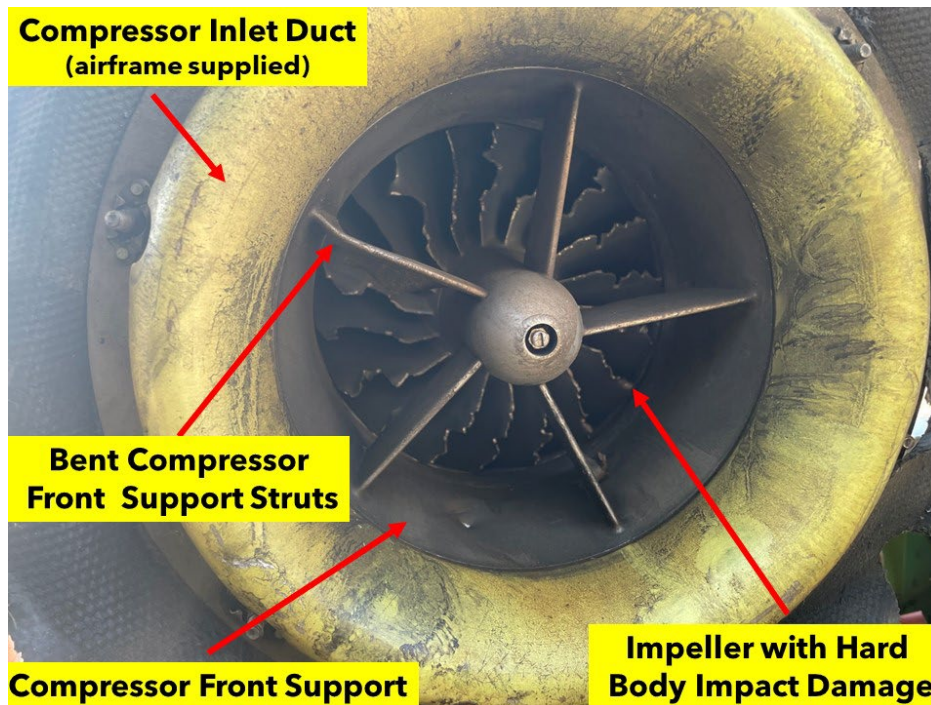
The inlet duct, an airframe supplied part, appeared intact and undamaged but was discolored/sooted. The compressor consists of a single titanium centrifugal stage impeller with 36 equally spaced blades located on the forward face that are curved in a clockwise direction ALF. The 36 inducer blades consist of 18 full length blades and 18 short inducer blades equally spaced between the full-length blades. With the compressor impeller installed in the compressor support, the 18 full length blades are visible, and the leading edges of all the full-length blades exhibited hard body impact damage, tears/rips, missing material, and distortion (**PHOTO 5**); the damage was in the direction opposite rotation. One of the compressor front support struts appeared bent.

**PHOTO 5: COMPRESSOR IMPELLER HARD BODY IMPACT DAMAGE**

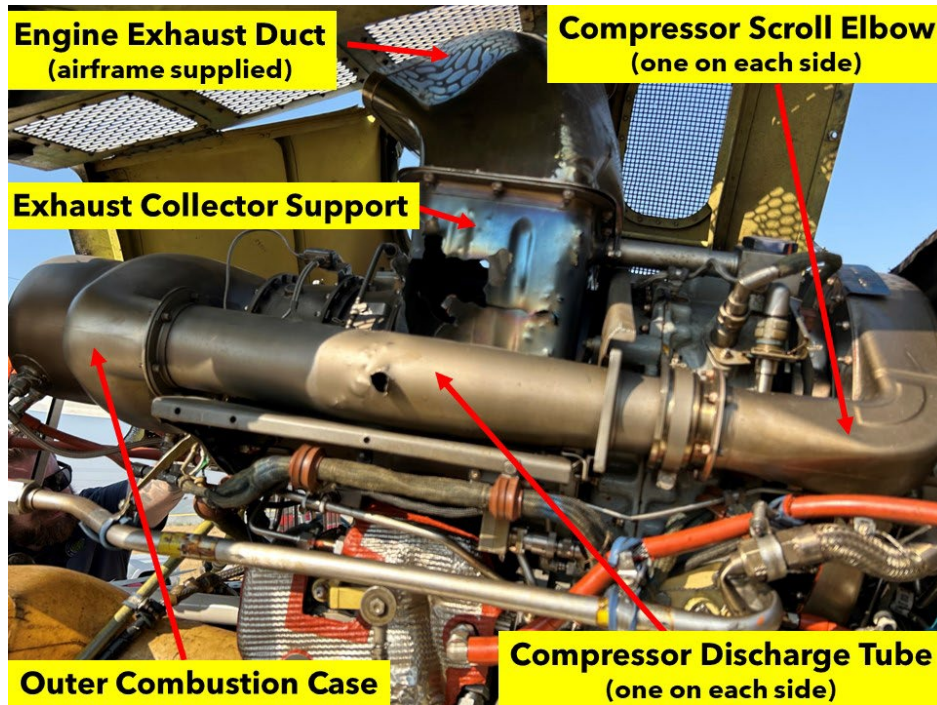
On-scene photos only showed the right side of the engine; therefore, no description of the left side of the engine could be made at this time. The right side of the engine exhaust duct, which is an airframe supplied part and is mounted to the engine exhaust collector support, was pot-marked outwards. The right side of the engine exhaust collector support was pot-marked outwards, and the right side exhibited a large exit penetration through-hole. The edges of the through-hole folded were folded outwards and was missing material (**PHOTOS 6** and **7**). The compressor scroll collects the air from the diffuser and directs it to two elbows; each elbow, integral compressor scroll, directs air rearward to the two compressor discharge tubes. The right compressor scroll elbow appears to be intact and undamaged. Compressor discharge air tubes, integral with combustion assembly deliver compressed air from the outlet of the elbows to the combustion outer case. The right compressor discharge tube was pot-marked outwards and exhibited a small exit penetration through-hole. The connected right air tube adapter that connects the compressor scroll elbow to the compressor discharge tube was intact and the tubes remained clamped together.

**PHOTO 6: RIGHT SIDE OF ENGINE - EXIT PENETRATION THROUGH HOLES IN THE EXHAUST DUCT, EXHAUST COLLECTOR SUPPORT AND COMPRESSOR DISCHARGE TUBE**

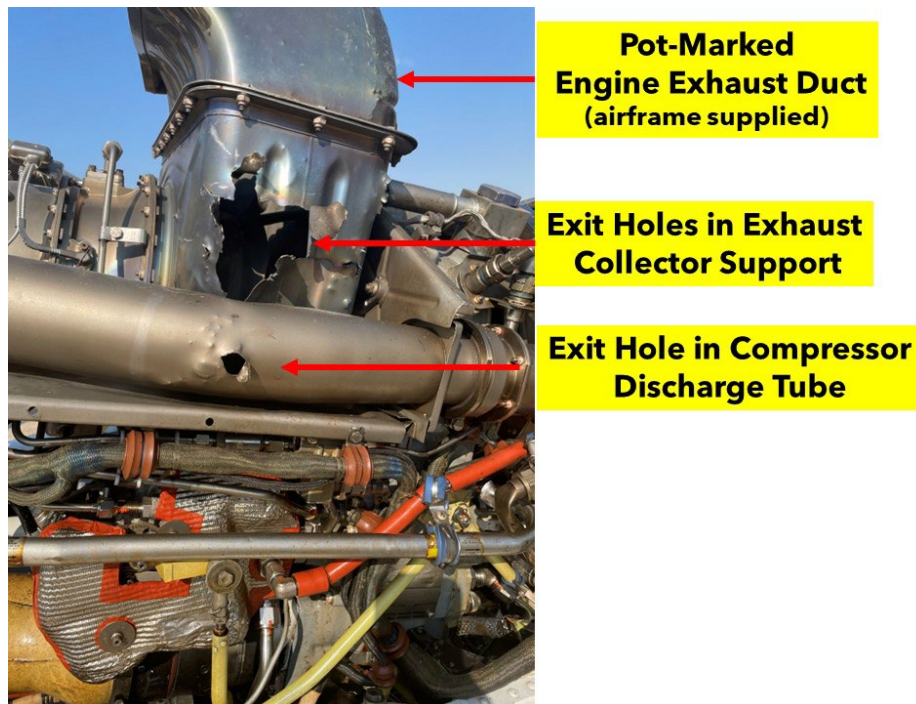
**PHOTO 7: RIGHT SIDE OF ENGINE - EXIT PENETRATION THROUGH HOLES IN THE EXHAUST DUCT, EXHAUST COLLECTOR SUPPORT AND COMPRESSOR DISCHARGE TUBE**

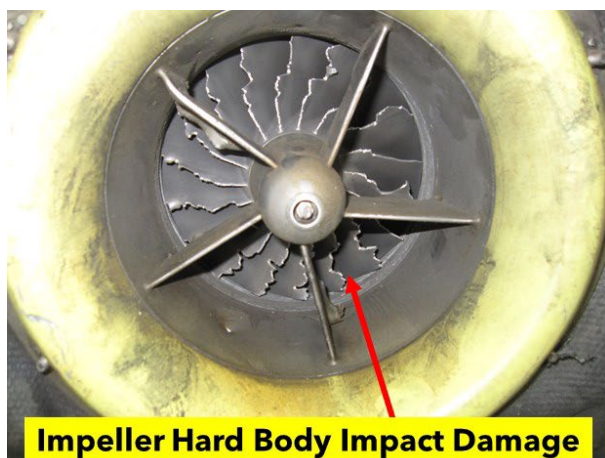
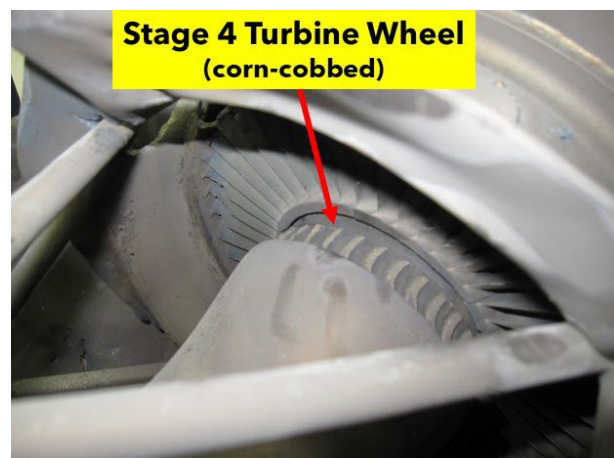
The engine was removed from its shipping container and placed in a work stand. The compressor exhibited hard body impact damage (**PHOTO 8** - left) and turned freely by hand; continuity was confirmed with the accessory gearbox. Multiple hard body impact locations showed similar size and shape impacts, and material transfer was observed. Several of the struts in the compressor front support exhibited trailing edge impact damage consisting of tears and rips and were pushed forward. Looking through the exhaust collector support, the stage 4 turbine wheel (PT stage 2 turbine wheel) was observed. The stage 4 turbine wheel was completely corn-cobbed with all the airfoils fractured transversely across the platform (**PHOTO 8** - right).

**PHOTO 8: COMPRESSOR DAMAGE (LEFT) AND CORN-COBBED STAGE 4 TURBINE WHEEL (RIGHT)**

All the blades of the stage 4 turbine wheel were fractured near the root and exhibited and exhibited rub damage to the leading edges of the remnant blade material and the aft rim face (See **PHOTOS 8, 22, and 24**). The aft curvic teeth were completely rubbed away and the forward curvic teeth were rubbed to approximately one-half height (See **Photo 24**). Visual examination of the blade fracture surfaces did not find any evidence of fatigue. One representative blade was removed from the wheel for detailed examination using optical and backscattered SEM images. Detailed SEM images of the fracture surface revealed dendritic features and ductile dimples consistent with overload.

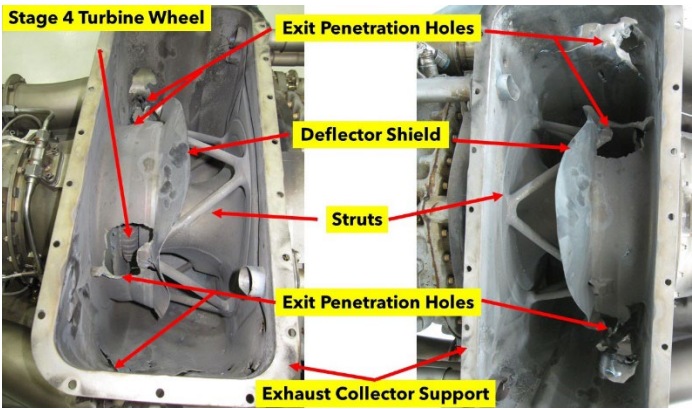
The exhaust collector support exhibited multiple exit hole penetrations on the right left, left side and bottom (**PHOTO 9**). The deflector shield within the exhaust collector support also exhibited exit holes. The horizontal firewall shield assembly exhibited a hole at the bottom of the shield near the drain port; the shield did not exhibit any signs of thermal distress or fire damage (**PHOTO 10**).

**Photo 9: Exit Penetration Holes in Exhaust Collector Support**

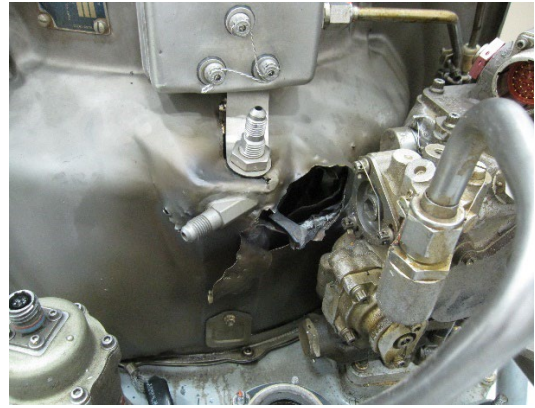
**PHOTO 10: EXIT PENETRATION HOLE IN HORIZONTAL FIREWALL SHIELD**

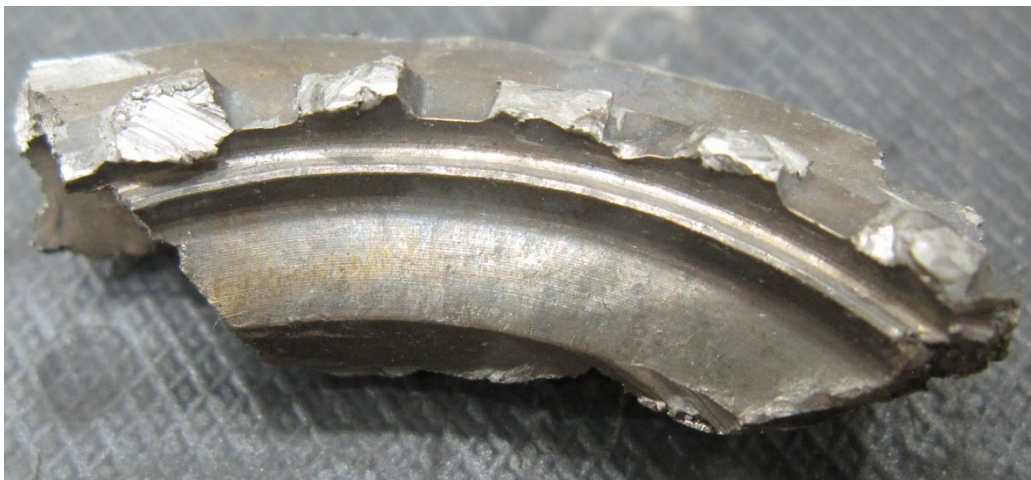
A fragment of curvic coupling was found between the horizontal fire shield and the turbine case (**PHOTO 11**). The fragment has five partial teeth with each tooth smeared over and flattened.

**PHOTO 11: RECOVERED FRAGMENT OF CURVIC COUPLING TEETH**

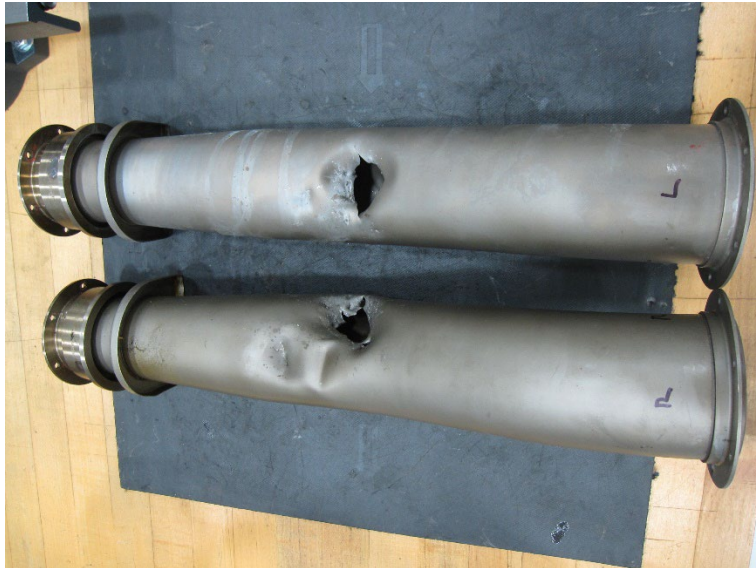
Both the right and left compressor discharge tubes exhibited exit penetration holes (**PHOTO 12**). The outer combustion case and combustion liner were removed from the engine. The outer combustion case was in good condition with no burn-throughs or exit holes.

**PHOTO 12: EXIT PENETRATION HOLES IN THE COMPRESSION DISCHARGE TUBES**

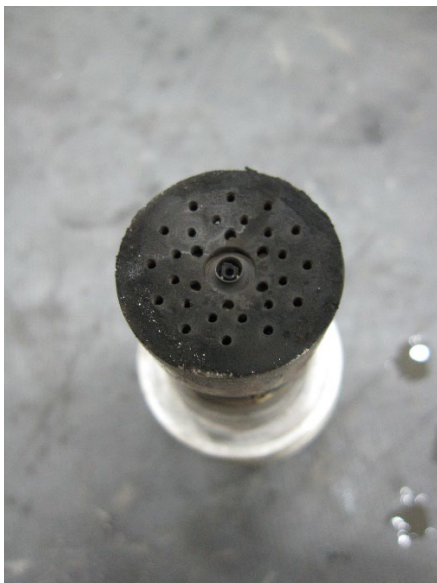
The combustion liner was intact and did not exhibit any significant heat distress, burn-throughs, or signs of fuel nozzle streaking such as localized hot spots. No visible cracks were observed in the cooling air holes or the louver liner holes. The swirl vanes and fuel nozzle port were in good condition as were the spark igniter ports; no anomalies were noted. The fuel nozzle port exhibited light rub/contact wear consistent with contact from the fuel nozzle tip. The fuel nozzle tip exhibited similar rub/contact wear consistent with contact with the combustion liner fuel nozzle port. The fuel nozzle also exhibited a build-up of black coking on the spray tip, but the fuel holes appeared to be unobstructed (**PHOTO 13**). The igniter plug also exhibited coke build up on the tip (**PHOTO 14**).

**PHOTO 13: COKE BUILD-UP ON FUEL NOZZLE TIP**

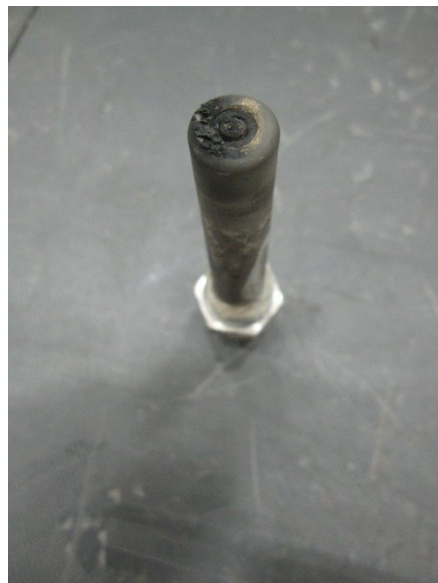
**PHOTO 14: COKE BUILD-UP ON IGNITER PLUG**

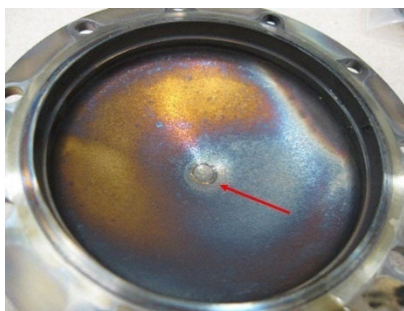
The No. 8 ball bearing oil sump cover was removed from the GPT bearing support and the inner surface of the cover exhibited a circular impact mark consistent with the head of the tie bolt and tie bolt spanner nut (**PHOTO 15**). The tie bolt was fractured towards the forward end aft of the stage 2 turbine wheel support land (**PHOTO 16**) and slid out easily through the stage 1 turbine wheel stub shaft. The fractured tie bolt measured about five inches in length. The tie bolt spanner nut remained attached to the aft portion of the tie bolt and the lock tabs on the crimp washer were crimped. The No. 8 bearing oil jet was present, secure, and intact. The No. 8 bearing looked in good condition and the stage 1 wheel spun freely by hand.

**PHOTO 15: NO. 8 BALL BEARING SUMP COVER  
IMPACT**

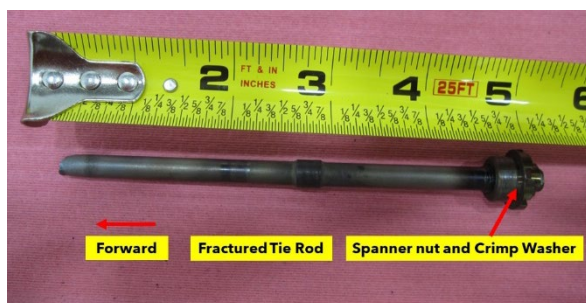
**PHOTO 16: FRACTURED TIE BOLT**

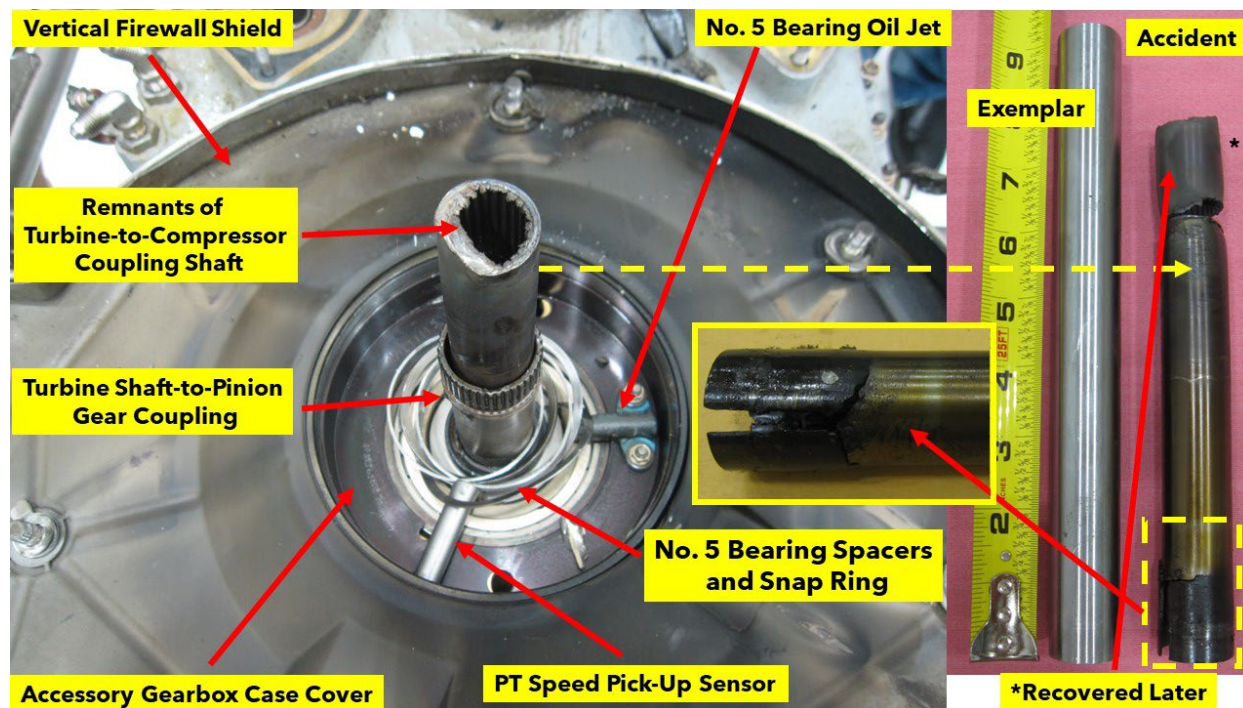
The turbine module was removed from the accessory gearbox cover. The turbine-to-compressor coupling shaft was found fractured circumferentially and the fractured end, sticking out of the accessory gearbox/turbine shaft-to-pinion gear coupling, was distorted, bent, and compressed (**PHOTO 17** - left side). When placed against an exemplar turbine-to-compressor coupling shaft, the accident shaft found still installed in the accessory gearbox cover was about 3 inches short (**PHOTO 17** - right side); the fractured shaft measured about 6.25 inches (longer piece). The turbine-to-compressor coupling shaft was removed from the accessory gearbox and the forward part of the shaft that engages the helical pinion gear was fractured

longitudinally, exhibited thermal distress and material transfer, and the end was flared out (**Photo 17** - center yellow box).

**PHOTO 17: FRACTURED TURBINE-TO-COMPRESSOR COUPLING SHAFT**

The turbine shaft-to-pinion gear coupling was bound/stuck within the helical pinion gear in the accessory gearbox cover and would not slide out. The helical pinion gear aft face was deformed/flattened consistent with contact from the power turbine shaft. The oil jet that supplies oil to the No. 5 thrust bearing was secure and intact. The N2 (PT speed) magnetic pickup, which is mounted on the right top of the accessory gearbox cover and supplies the N2 speed signal to the ECU, was intact (See **PHOTO 17**).

The turbine to compressor coupling shaft was fractured in two places: at about the interface of the PT outer shaft and stage 4 turbine wheel and about the interface between the stage 4 turbine wheel and stage 3 turbine wheel. The fracture surfaces were flared outboard and heavily smeared. The forward end of the turbine to compressor coupling exhibited axial and circumferential cracks (See **PHOTOS 17, 19, and 20**). The fracture surface exhibited structure dominated features consistent with brittle overload fractures. No features consistent with fatigue progression were observed.

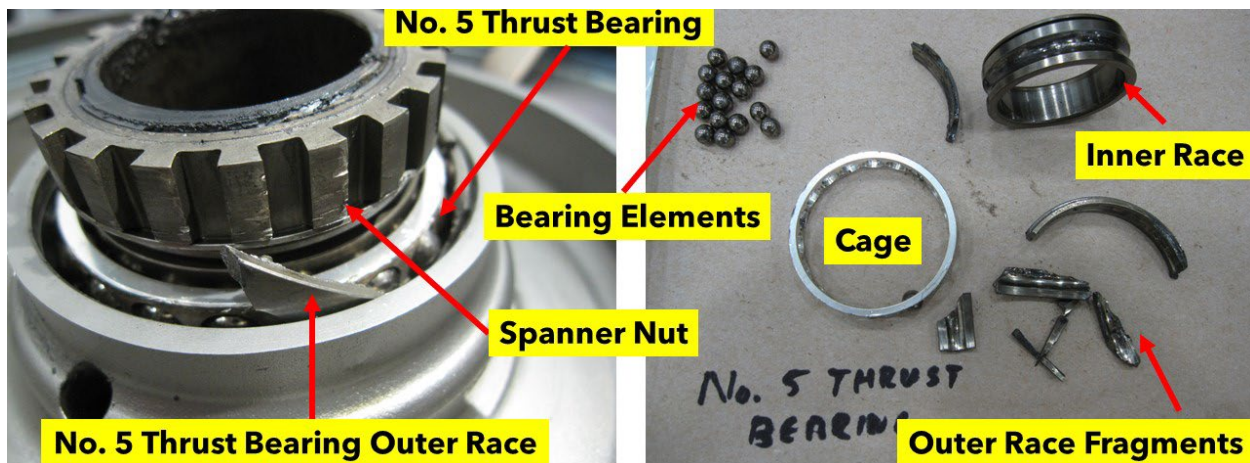
The No. 5 thrust bearing (ball bearing), which is retained and supported in the exhaust collector support, remained attached to the stage 4 turbine wheel stub shaft. All the No. 5 thrust bearing rolling elements appeared shiny, intact and in good condition. The No. 5 thrust bearing cage and inner race were in good condition (**PHOTO 18** - right); however, the outer race was fractured (**PHOTO 18**). The No. 5 thrust bearing spacers and the snap ring had become disengaged from the bearing housing and were found lying on the accessory gearbox cover (See **PHOTO 17**). The No. 5 thrust bearing would not rotate on the stage 4 turbine wheel stub shaft. The No. 5 thrust bearing spanner nut secures the No. 5 bearing to the stage 4 turbine wheel stub shaft (PT stage 2) and serves at the N2 speed sensor; it was intact and exhibited slight contact on the spanner flats consistent with contact with the magnetic pickup (**PHOTO 18** - left).

**PHOTO 18: NO. 5 THRUST BEARING DAMAGE**

The No. 5 bearing thrust bearing was in relatively good condition except for the fractured outer race. The outer race fragments were subjected to SEM

imaging which showed chevron marks and ductile dimples features consistent with overload failure. Roller ball indentations from the raceway onto the forward and aft shoulders and the overload fractures were consistent with a non-uniform load in the power turbine shafting.

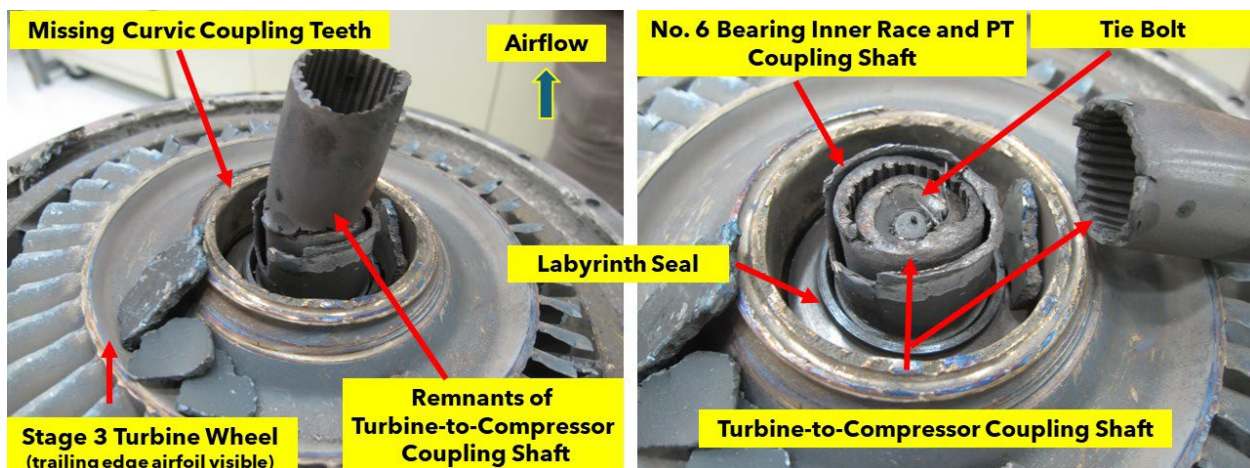
All the blades of the stage 3 turbine wheel (PT stage 1) were present and fractured transversely across the airfoil at various span lengths; all the blade tips were missing (**PHOTO 19** - left). The airfoils were slightly bent in the direction opposite rotation and exhibited rips, tears, and slight heat discoloration. The curvic coupling teeth on the front side of the stage 3 turbine wheel that connects it to the stage 4 turbine wheel was fractured and missing. A fractured section of the turbine-to-compressor coupling shaft, about 1.75 inches long, was found resting loose; it was distorted and exhibited heat distress and material transfer (**PHOTO 19** and see **PHOTO 17** for dimension). The No. 6 roller bearing inner race and PT coupling shaft were fractured in-line with both the front end of the tie bolt and the fractured turbine-to-compressor coupling shaft (**PHOTO 19** - right).

**PHOTO 19: FRAGMENTS OF TURBINE-TO-COMPRESSOR COUPLING SHAFT AND FORWARD END OF TIE BOLT**

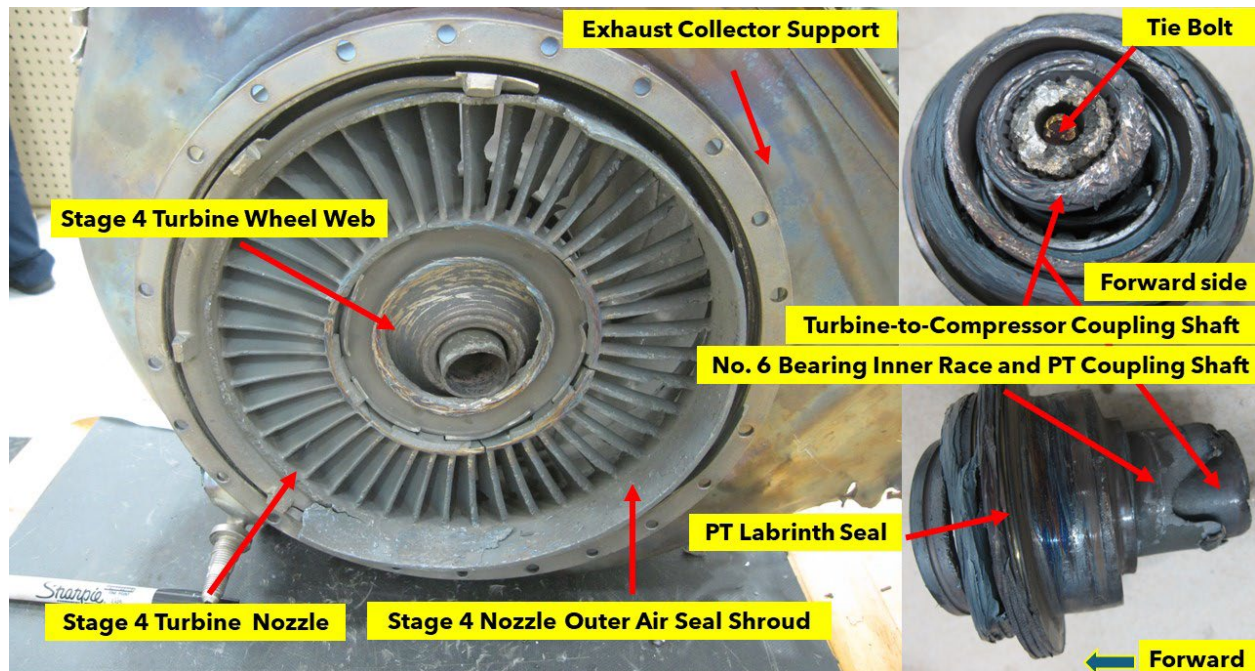
All the stage 4 turbine nozzles (PT stage 2) were present, intact, and exhibited some leading edge impact damage but considerably more trailing edge impact damage consisting of rips, tears, and missing material. Integral with the stage 4 turbine nozzle is an outer air seal shroud, which acts as a seal for the stage 3 turbine wheel blade tips; the outer shroud was fractured about 180° around (**PHOTO 20** - left).

**PHOTO 20: STAGE 4 TURBINE NOZZLE AND PT LABRINTH SEAL DAMAGE**

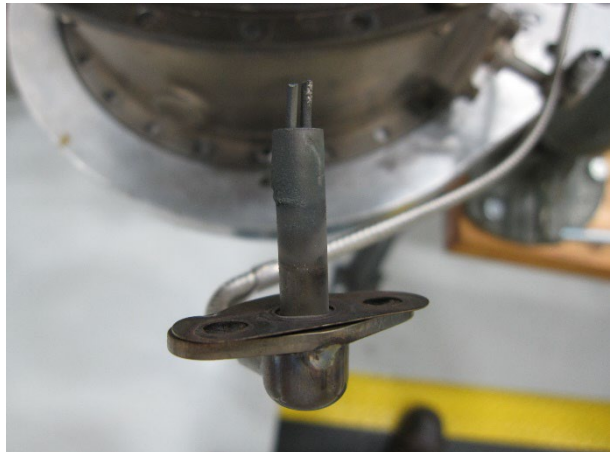
There are four equally spaced MGT thermocouple probes mounted to the PT support; the bare wires of the thermocouple probe extend through the PT support and the outer band of the stage 3 turbine nozzle shield and into the gases leaving the GPT rotor. When all four were removed, the wire ends were fractured (**PHOTO 21**).

**PHOTO 21: FRACTURED THERMOCOUPLE PROBE**

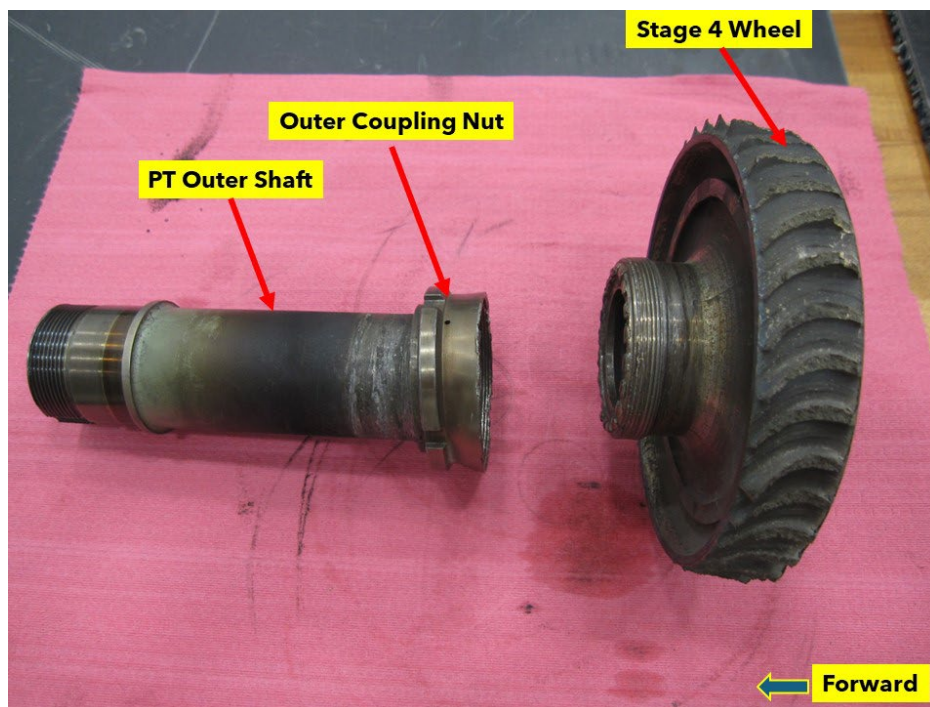
The stage 4 wheel and PT outer shaft were removed from the exhaust collector support (**PHOTO 22**).

**PHOTO 22: STAGE 4 WHEEL AND PT OUTER SHAFT DAMAGE**

The PT outer shaft and outer coupling nut was found disconnected from the stage 4 turbine wheel (See **PHOTOS 22** and **23**). The aft face of the PT outer shaft exhibited eccentric rub damage that resulted in obliteration of the curvic teeth and other defining features of remnant shafting material inside the PT outer shaft. According to RR, the rub damage between the pinion gear and PT outer shaft is consistent with contact following loss of axial control in the No. 5 bearing and loss of continuity in the turbine shaft-to-pinion gear coupling.

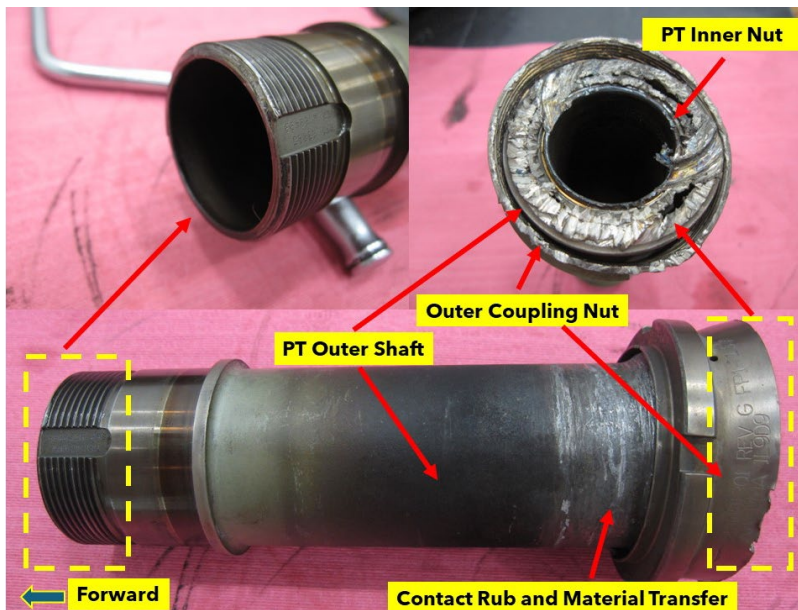
The PT outer shaft exhibited circumferential contact rub, and material transfer near the back part of the shaft (**PHOTO 23**). The front of the PT outer shaft exhibited contact rub and smeared material consistent with contact with the aft end of the gearbox pinion gear (**PHOTO 23** -top left) and the aft face exhibited heavy rotational contact rub, wear, smeared material, and heat distress (**PHOTO 23** -top right). All the curvic coupling teeth from the aft end of the PT outer shaft were obliterated.

The outer coupling was distorted, missing material, and heavily rubbed on the forward end consistent with contact with the stage 4 wheel web (**PHOTO 23** -top right).

**PHOTO 23: PT OUTER SHAFT DAMAGE - CLOSE UP**

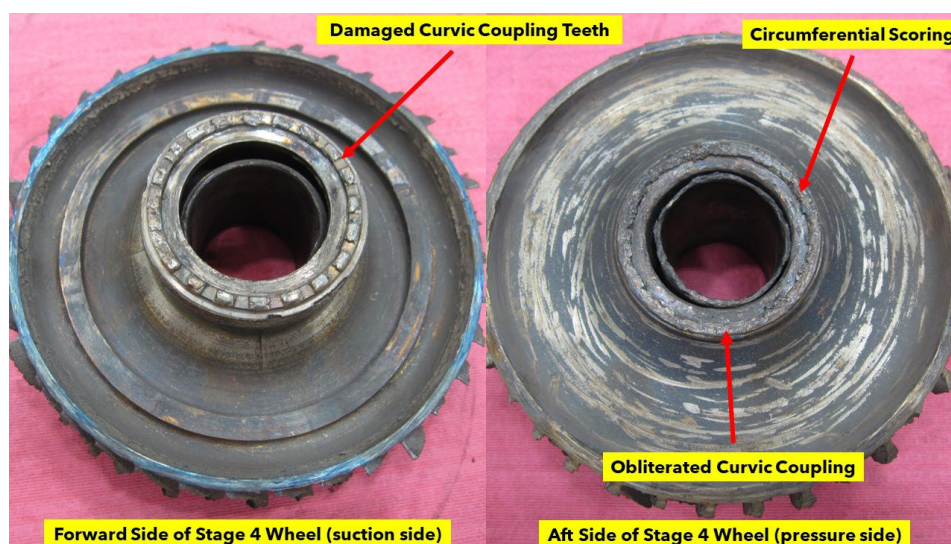
As previously documented, the stage 4 turbine wheel was corn-cobbed with all the blades fractured transversely at the blade platform. The small fragments of blade airfoil that remained were bent in the direction opposite rotation. The curvic coupling teeth on the front of the wheel were still present and visible but heavily damaged and smeared. The curvic coupling teeth on the aft side of the stage 4 turbine wheel were obliterated. Circumferential rub marks were noted on the aft side of the stage 4 turbine wheel web (**PHOTO 24**).

**Photo 24: Stage 4 Wheel Damage**

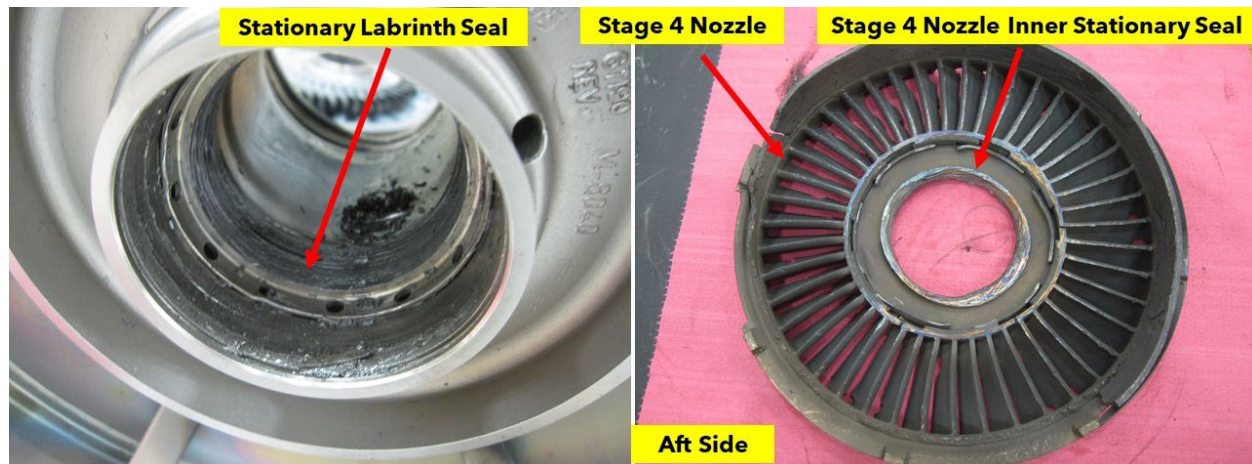
The stationary labyrinth seal remained captured in the exhaust collector support. The knife edges were heavily worn down (**PHOTO 25** - left). All the stage 4 nozzle airfoils were present, and the leading edges exhibited minor damage while the trailing edges exhibited more extensive airfoil damage consisting of rips, tears, and missing material. The stage 4 nozzle inner stationary seal was distorted, pushed outwards, exhibited heat distress and the knife edges were obliterated (**PHOTO 25** -right).

**PHOTO 25: PT ROTATING LABRINTH SEAL AND STAGE 4 NOZZLE STATIONARY SEAL DAMAGE**

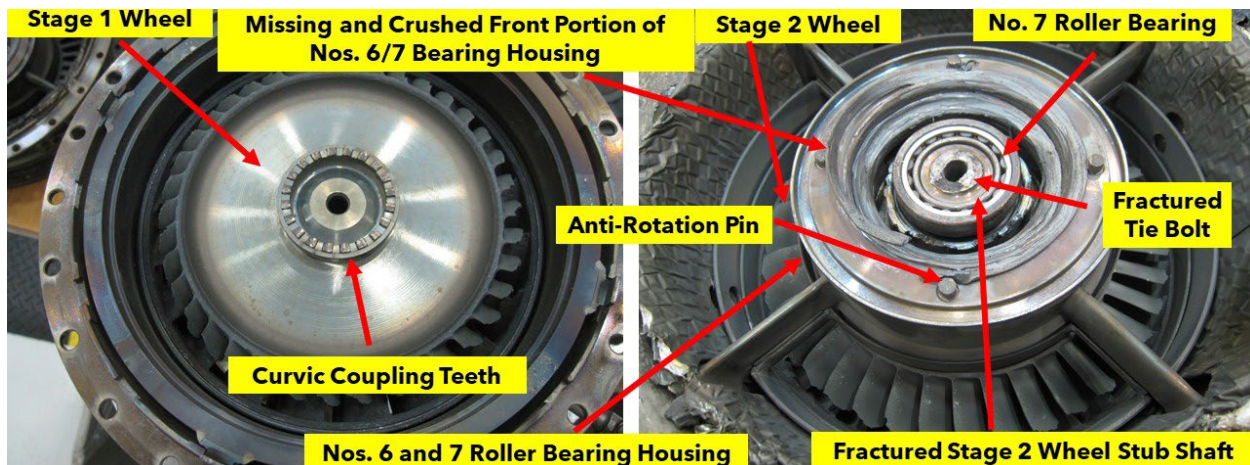
All the blades on both the stage 1 and 2 turbine wheels were present and fractured transversely across the airfoil; the stage 1 turbine wheel blades were fractured about 50% span while the stage 2 turbine wheel blades at about 75% (**PHOTO 26**). The curvic coupling on the stage 1 turbine wheel was present; however, the curvic teeth exhibited damage and were flattened and rounded (**PHOTO 26** - left). The Nos. 6 and 7 roller bearing housing remained attached to the GPT support and the anti-rotation pins were in good condition. The No. 7 roller bearing was intact, and the roller elements were all present and whole; however, the No. 7 bearing was seized and would not rotate. A piece of the fractured stage 2 wheel stub shaft and tie bolt were visible (**PHOTO 26**- right) in the center of the No. 7 roller bearing. The forward part of the Nos. 6 and 7 bearing housing was compressed and exhibited rotational and thermal damage with a considerable amount of the forward end missing. The airfoils on the stage 1 and 2 nozzles were all present and exhibited varying degrees of impact damage, tears, and missing material.

**PHOTO 26: GPT WHEEL DAMAGE**

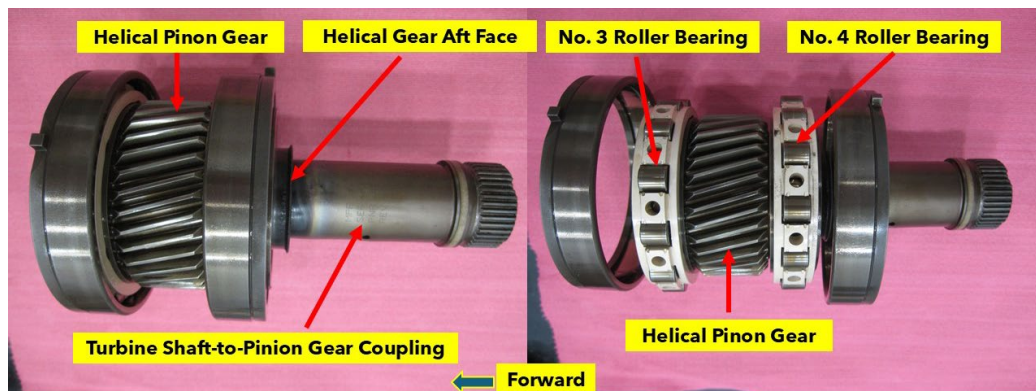
The helical pinion gear assembly with the turbine shaft-to-pinion gear coupling still attached was removed from the accessory gearbox cover. The Nos. 3 and 4 roller bearing were in good condition and spun freely by hand (**PHOTO 29**). All the teeth on the helical pinion gear were intact and in good condition. The aft face of the pinion gear exhibited heat distress and was compressed (mushroomed outward) consistent with contact with the PT outer shaft (**PHOTO 30**). The turbine shaft-to-pinion gear coupling was fractured and no longer coupled to the inside spur teeth of the helical gear but remained seized within the helical gear bore. It also exhibited heat distress/discoloration near the aft face of the helical gear.

**PHOTO 29: HELICAL GEAR AND NOS. 3 AND 4 BEARING CONDITION**

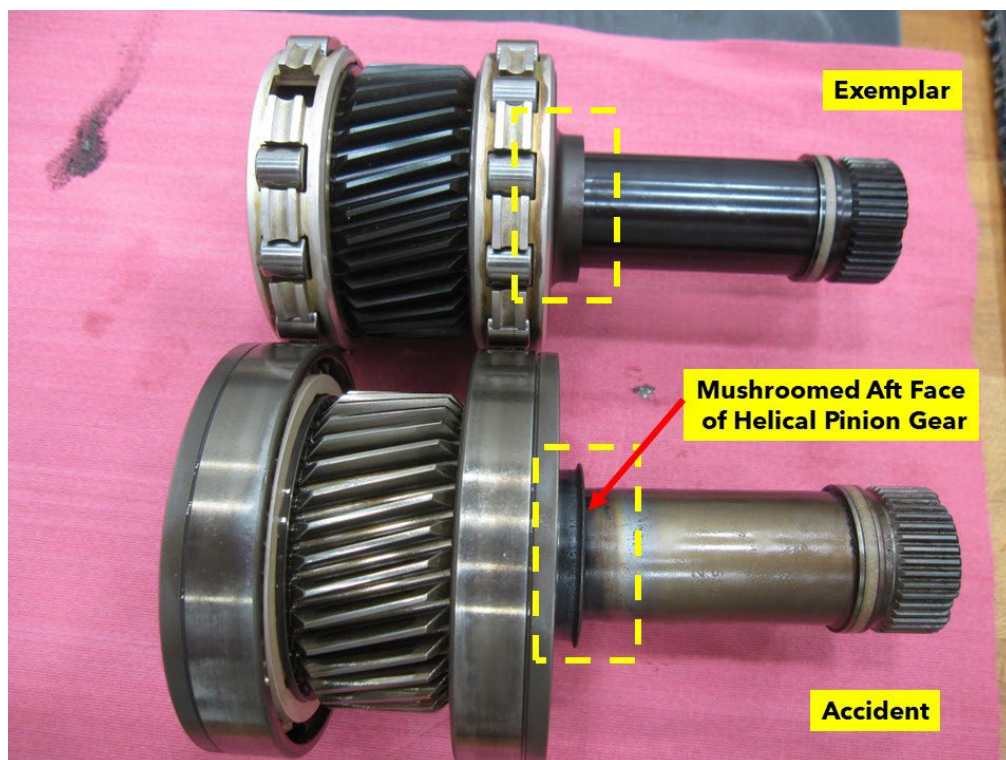
**PHOTO 30: HELICAL GEAR AFT FACE DAMAGE**

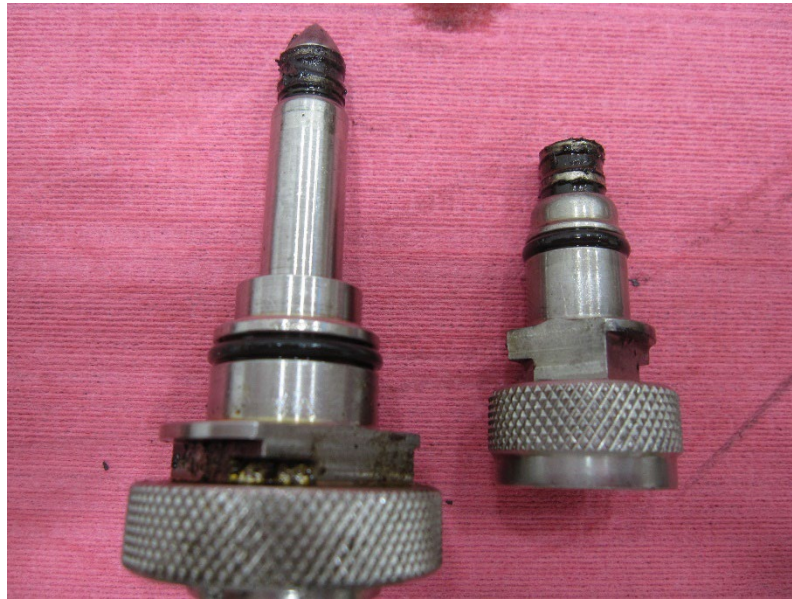
Both magnetic chip detectors were removed from the accessory gearbox housing. Both exhibited minor debris (**PHOTO 31**).

**PHOTO 31: MAGNETIC CHIP DETECTORS FROM THE ACCESSORY GEARBOX HOUSING**

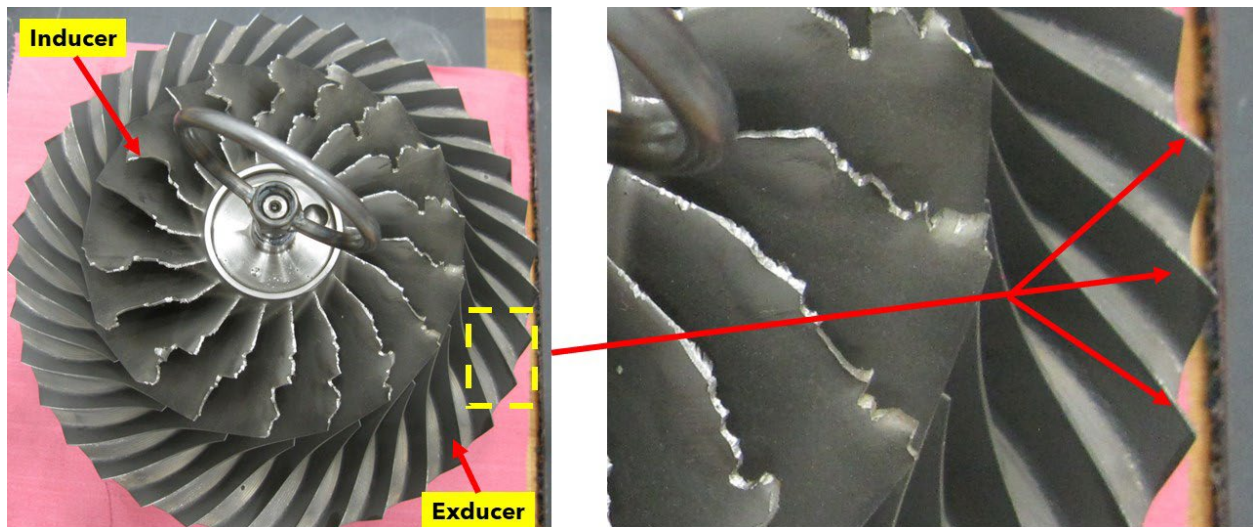
The compressor spun freely and smoothly by hand. The compressor impeller and the diffuser were removed for examination. The impeller inducer part of the airfoil exhibited hard body damage while the exducer part of the airfoil exhibited shiny contact wear consistent with contact with the shroud housing (**PHOTO 32**). The shroud housing exhibited material transfer in the inducer section and circumferential rub along the mid body and exducer end as the air heads into the diffuser (**PHOTO 33**). The diffuser airfoils exhibited impact damage consisting of tears, rips, and material loss; all the airfoils were present but not all exhibited impact damage (**Photo 34**).

**PHOTO 32: IMPELLER IMPACT DAMAGE AND CONTACT RUB**

The impeller base material and the areas of material transfer were subjected to backscattered electron scanning electron microscopy (SEM) images with energy dispersive X-ray spectroscopy (EDS). The areas of transferred material had high concentrations of iron alloy type material, the impeller is made of a titanium alloy, as well as nickel, cobalt, and molybdenum which are not found in the base material.

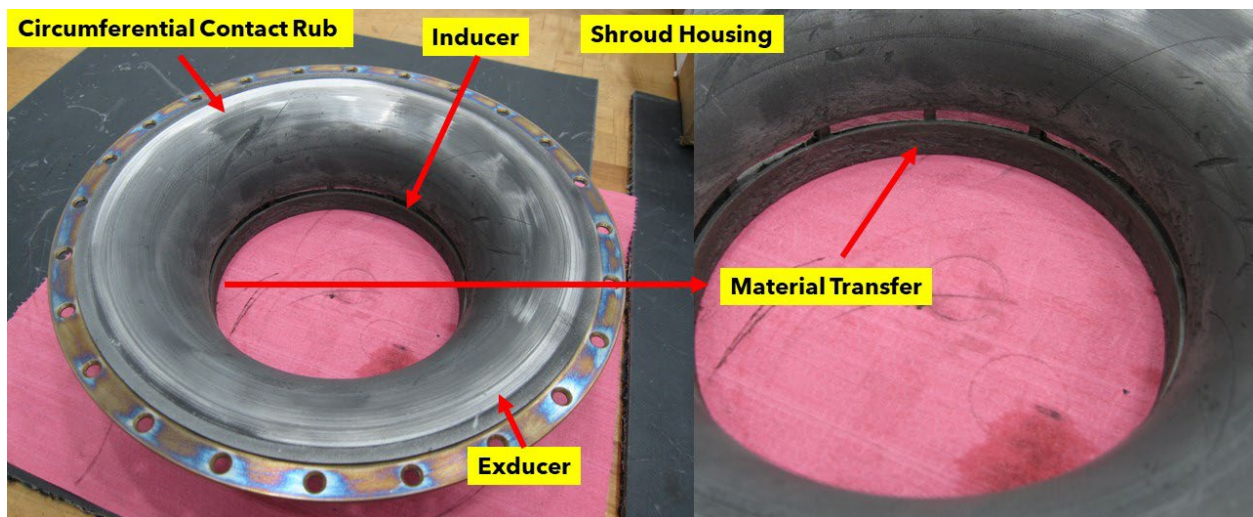
**PHOTO 33: IMPELLER SHroud HOUSING CONTACT RUB AND MATERIAL TRANSFER**

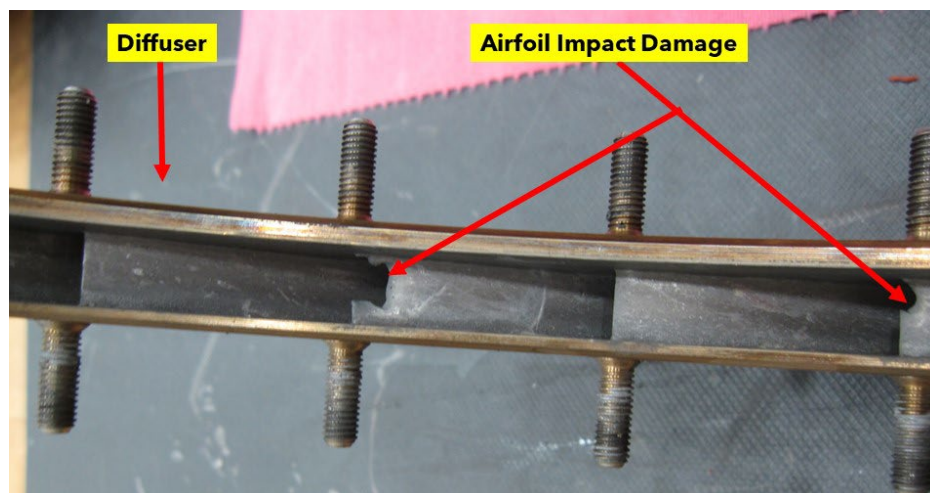
**PHOTO 34: DIFFUSER AIRFOIL IMPACT DAMAGE**

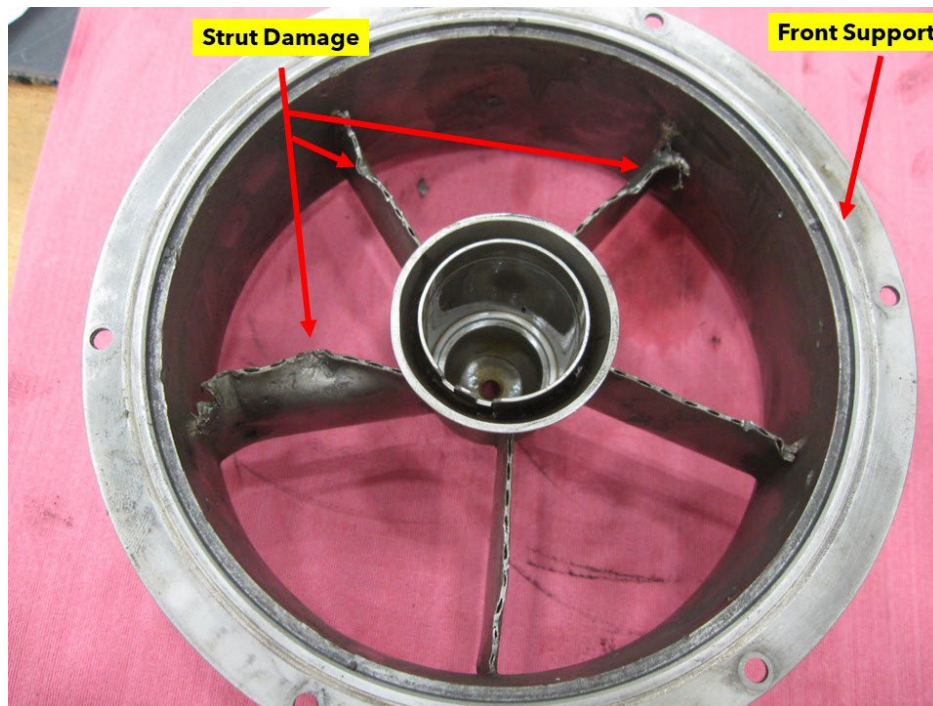
The compressor front support struts exhibited trailing edge impact damage, and the trailing edges were bent in the direction of rotation (**PHOTO 35**).

**PHOTO 35: TRAILING EDGE DAMAGE OF THE COMPRESSOR FRONT SUPPORT**

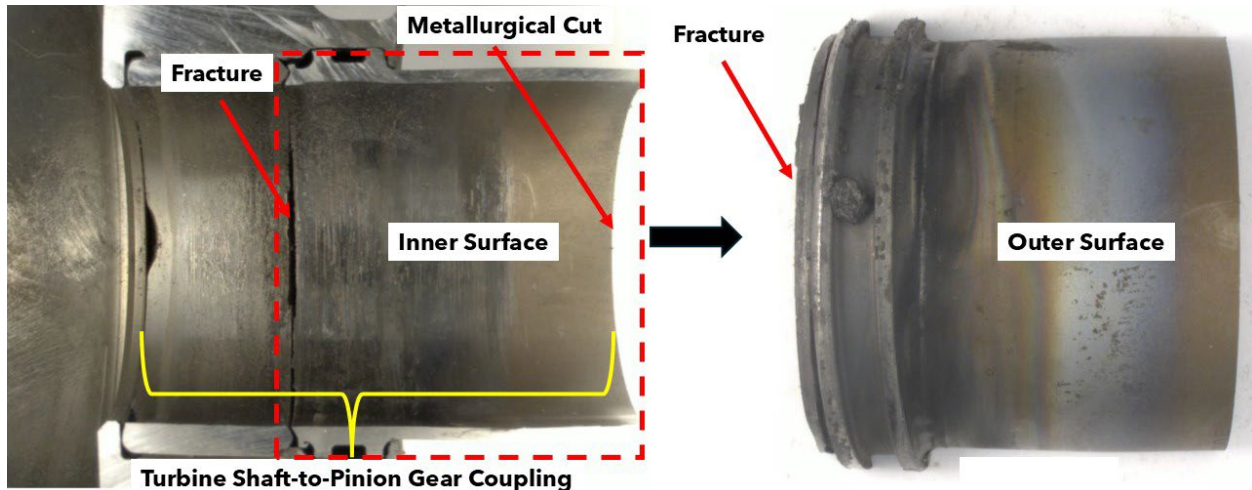
The forward end of the turbine shaft-to-pinion gear coupling the forward splines were seized inside the helical pinion gear and the aft face of the helical gear was deformed and heat distressed (See **PHOTOS 29** and **30**). The turbine shaft-to-pinion gear coupling exhibited a circumferential fracture aft of the forward splines (**PHOTO 36**). The forward Teflon seal was not present in the Teflon seal groove. The pinion gear coupling was thermally distressed at the fracture and aft into the forward Teflon seal groove.

**PHOTO 36: TURBINE-TO-PINION GEAR COUPLING FRACTURE**
