# National Transportation Safety Board

WPR24LA265

## **MGT INDICATOR EXAM**

Location: Raft River, Idaho  
Date: August 2, 2024  
Helicopter: Bell 407, N20BH

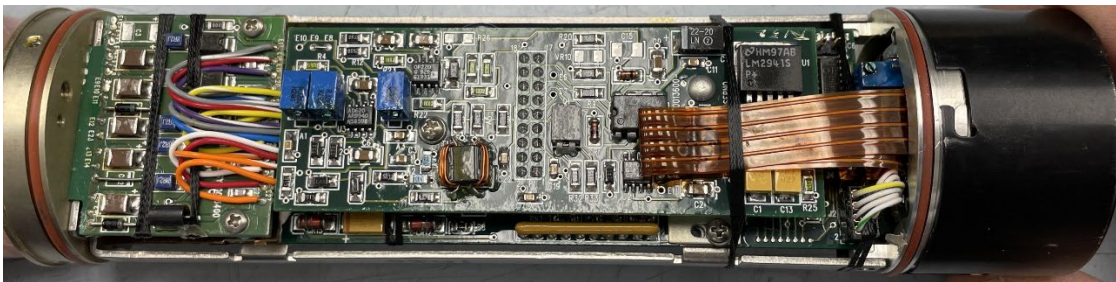
The unit was then disassembled and examined. There was no evidence of dry solder joints, burnt components or damaged wires (see figure 1). It was powered up and tested while multiple components including the crystal oscillators, CPU, and supervisory processor were pressed with a probe in an attempt to induce an error<sup>3</sup>. The unit performed appropriately throughout.

**Figure 1 - Indicator with case removed**

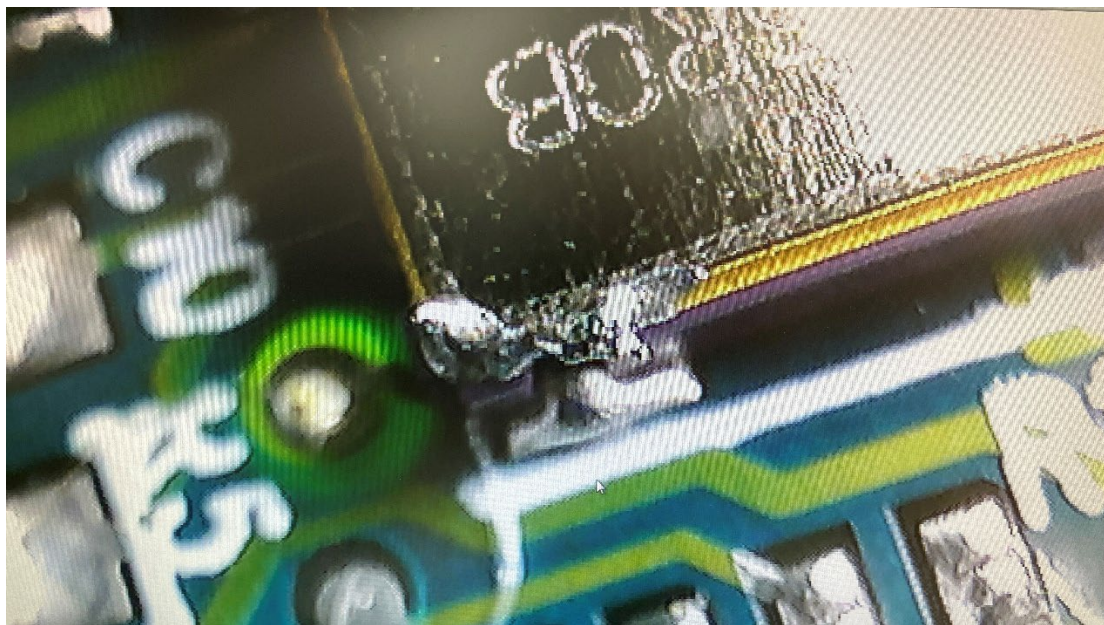
The only physical discrepancy noted was to pin 4 (frequency output pin) of the crystal oscillator. A blob of solder had bonded to the gold edge of the oscillator case next to that pin (figure 2). Electrical continuity was tested between the case and the pin, with no evidence of a short circuit<sup>4</sup>.

**Figure 2 - Solder "blob" on crystal oscillator case just above pin 4**

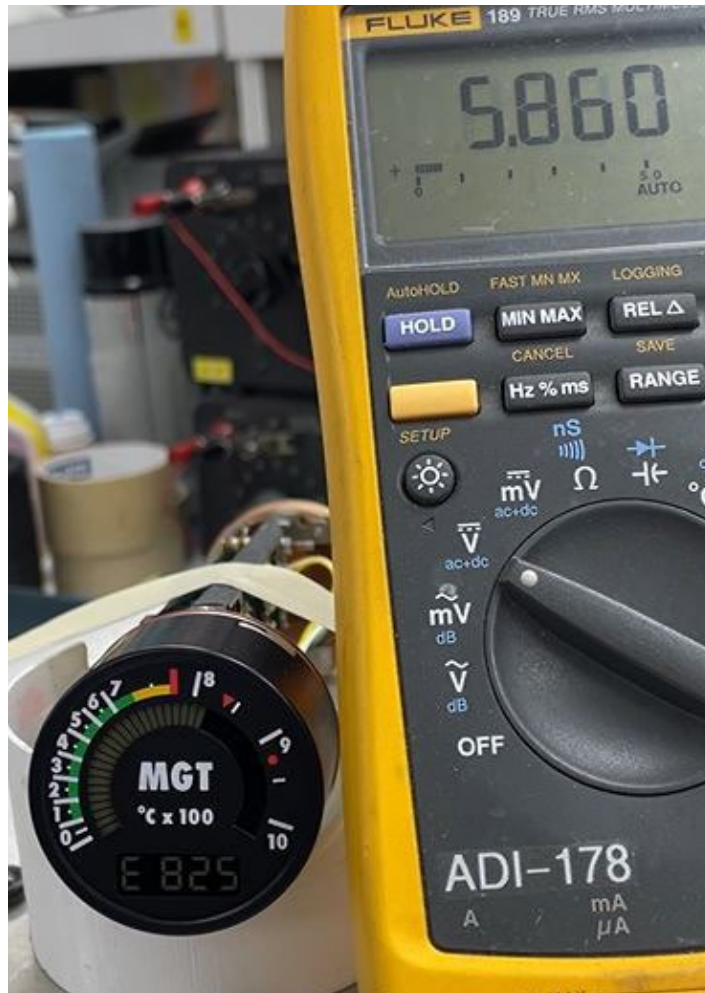
The final test performed was to see how the unit would perform as its supply voltage was lowered. The starting voltage was 28v, and as it was reduced though to 12v the display began to dim. At 6v the indicator value began to climb over the red line limit (figure 3). Four tests were performed, and on the last test after the indicator values began to climb, the numeric display showed random characters, and segments of the

**Figure 3 - MGT value increasing as supply voltage drops below 6v**

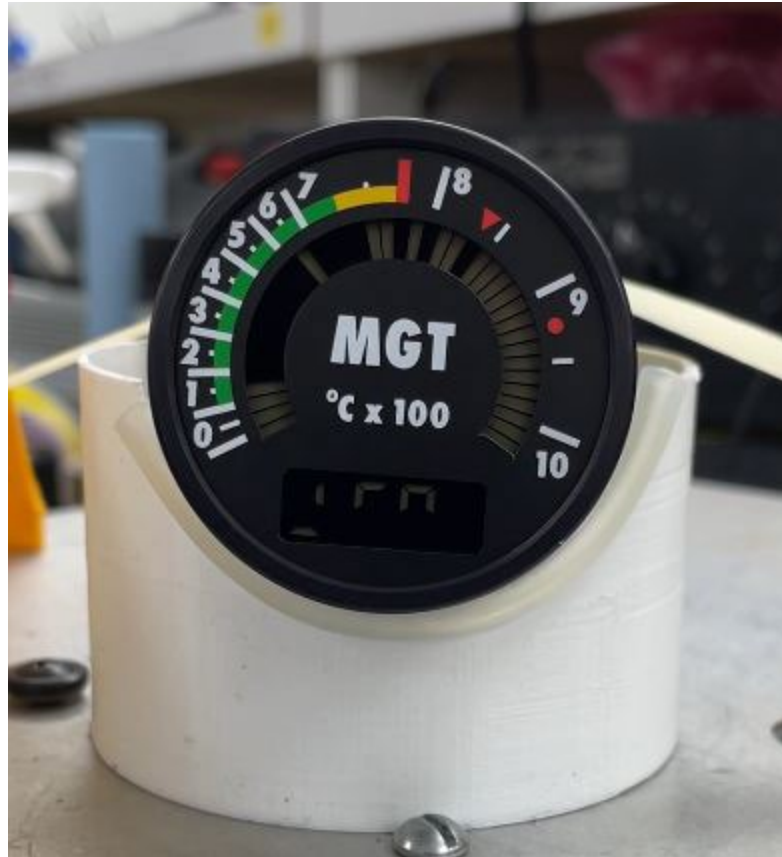
indicator began to turn off (figure 4). As the voltage continued to be reduced, the unit shut down, and once power was reapplied, it performed a bit check and returned to the normal reading.

**Figure 4 - Random screen characters as supply voltage drops below 6v**
