WPR24LA267

## INVESTIGATION PHOTOGRAPHS

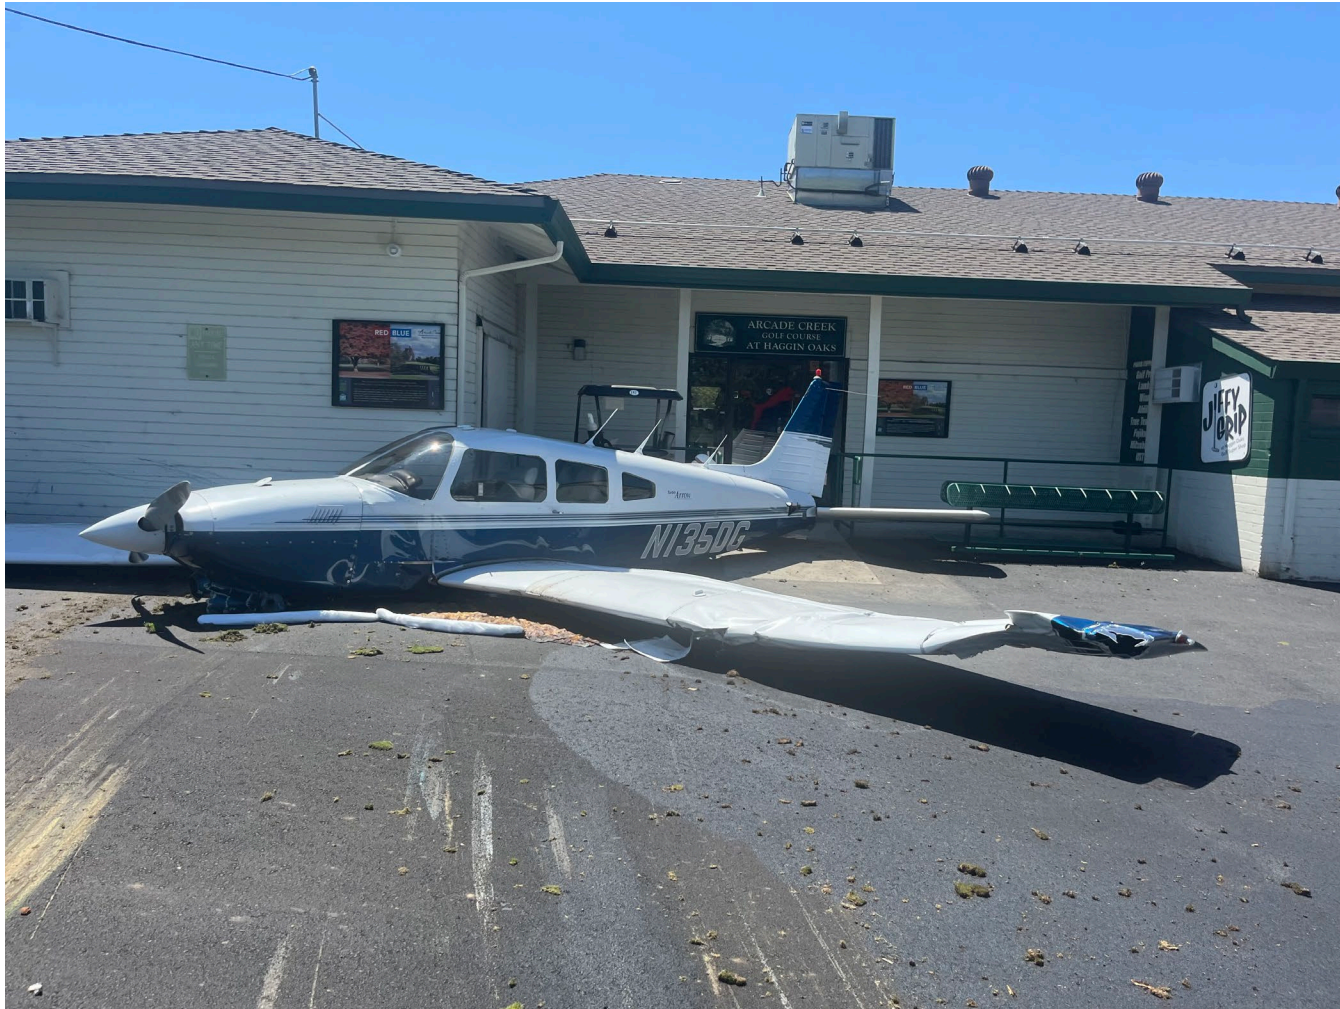
**Photograph 1 - View of accident airplane with left wing and fuselage damage (Courtesy of the FAA)**

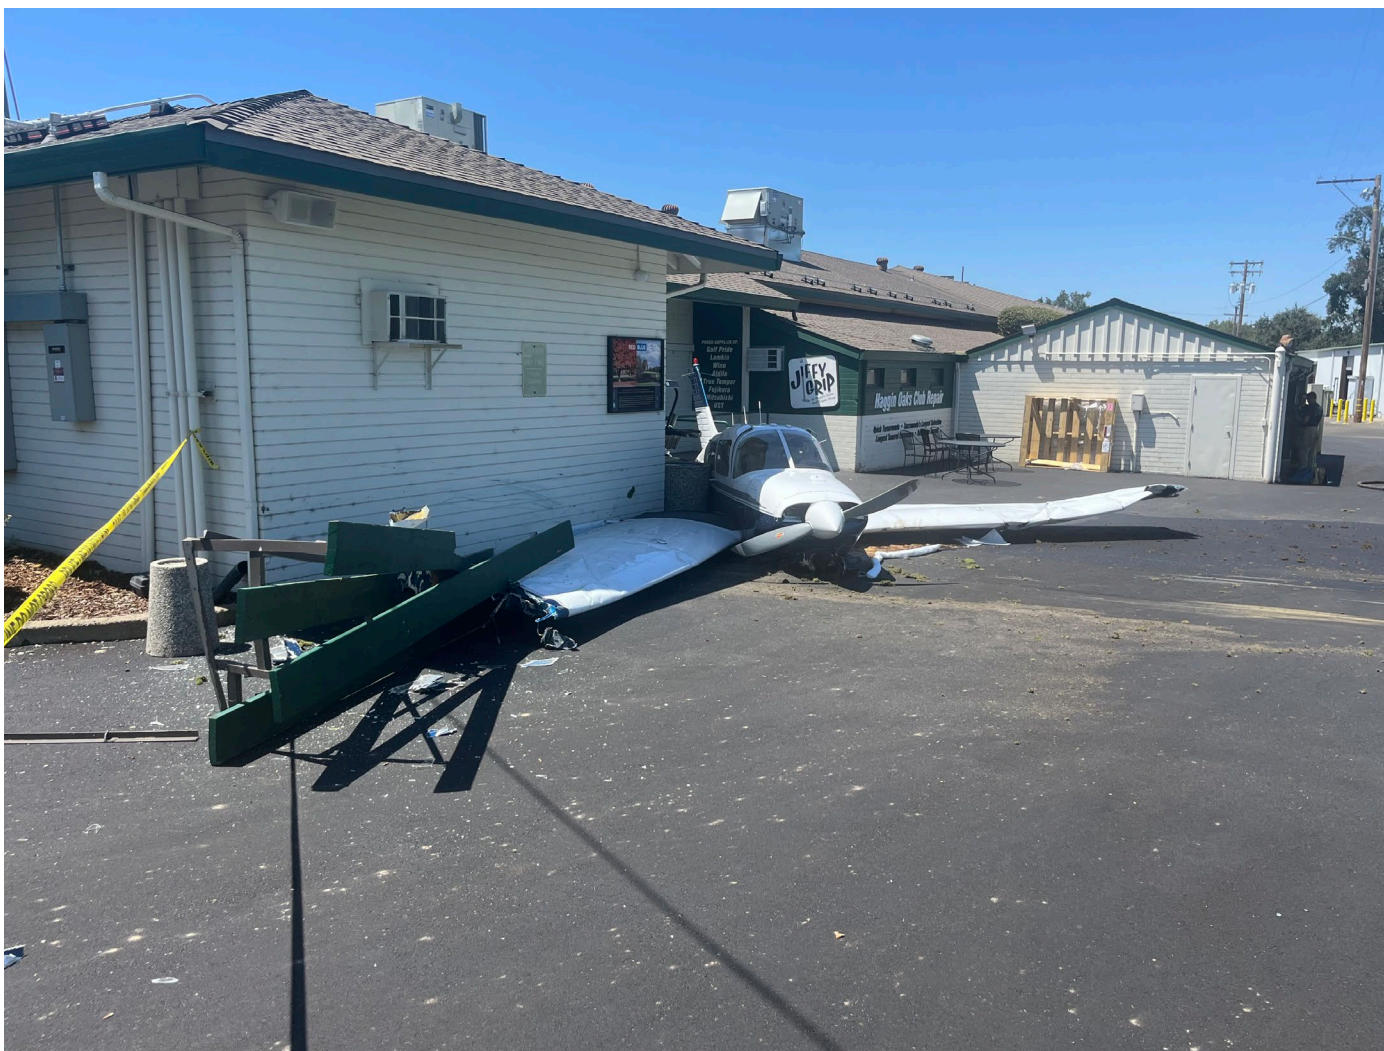
**Photograph 2 - View of accident airplane adjacent a building with damage to both wings  
(Courtesy of the FAA)**
