# National Transportation Safety Board

WPR24LA267

## **ENGINE EXAM ATTENDEES**

Location: Sacramento, California  
Date: August 4, 2024  
Time: 1315 Pacific daylight time (PDT)  
Airplane: N135DG

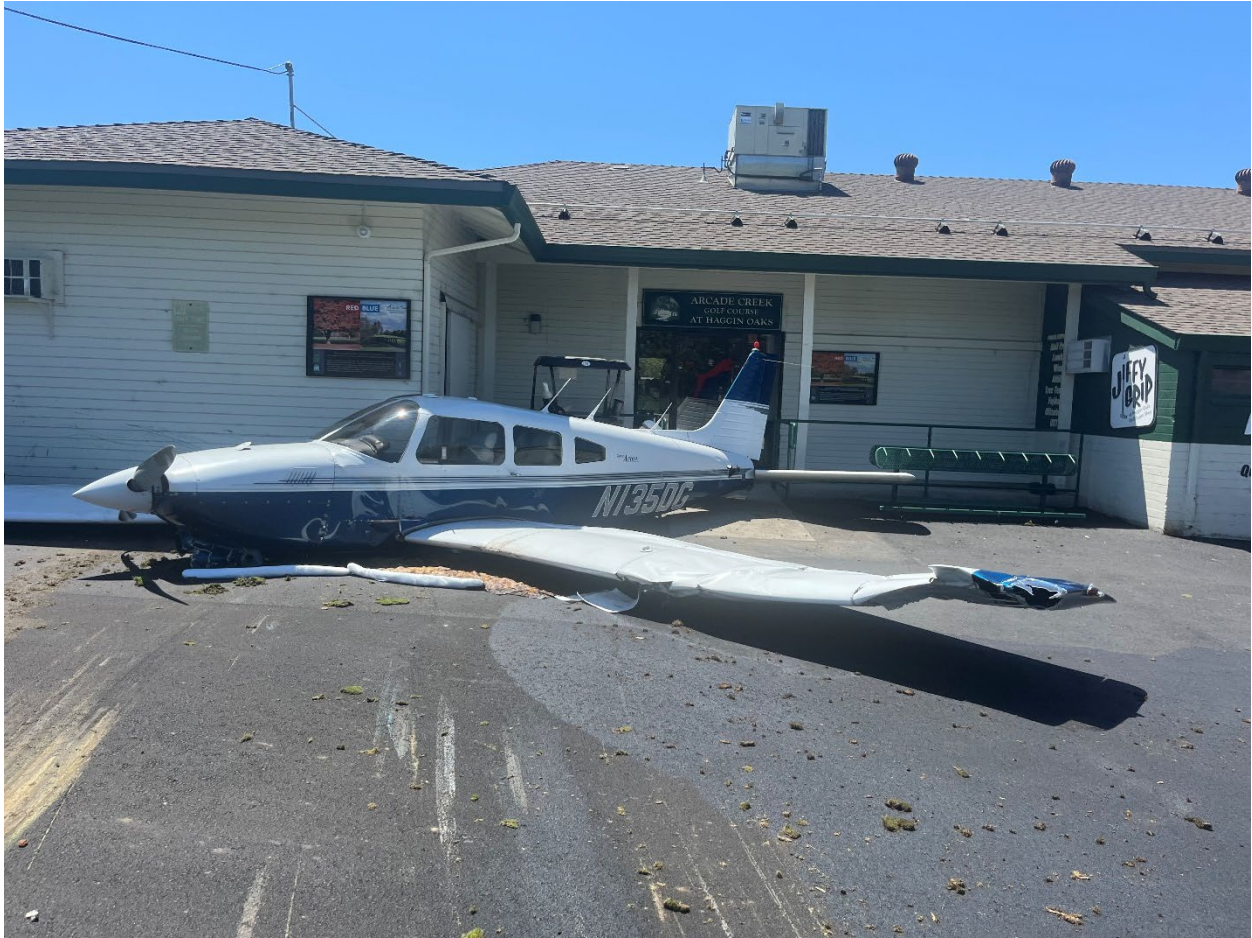
The pilot initiated a 180° turn back to the airport as soon as he noticed the propeller had stopped spinning. He then turned the fuel boost pump to the "high" position and declared an emergency with the local air traffic control tower. As he realized he would not be able to make it to the airport, the pilot initiated a forced landing to a nearby golf course. During the off-airport landing sequence, the airplane impacted the ground and subsequently slid into a building before it came to rest upright (figure 1). Postaccident examination of the airplane revealed that both wings were substantially damaged.

**Figure 1. View of accident airplane at wreckage site**

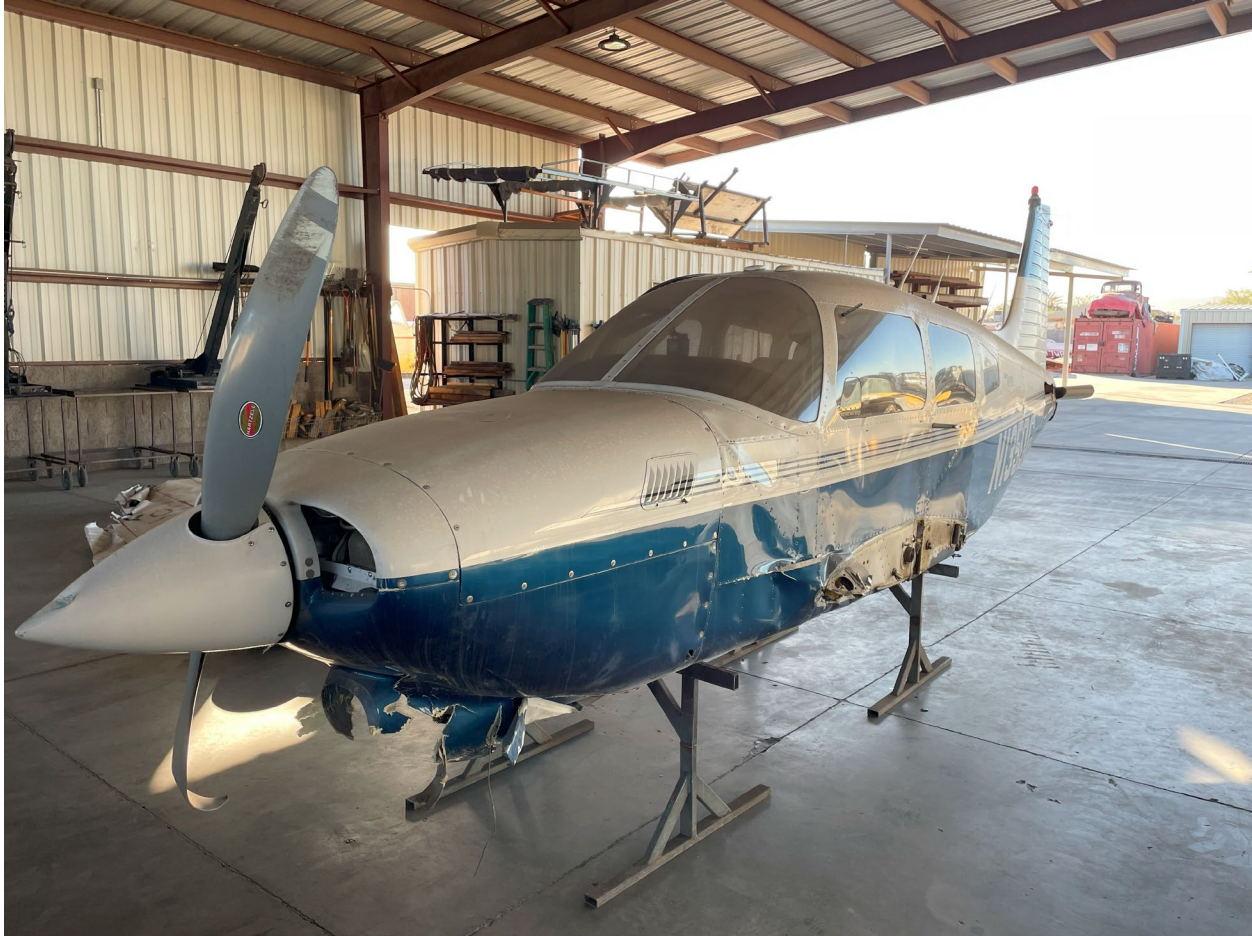
The follow-up engine examination took place on January 10, 2025, at Air Transport in Phoenix, Arizona (figure 2). Both wings were removed and both horizontal stabilator were manually cut to transport. The fuselage, at each wing root area, and each wing were substantially damaged.

**Figure 2. View of airplane at wreckage exam.**

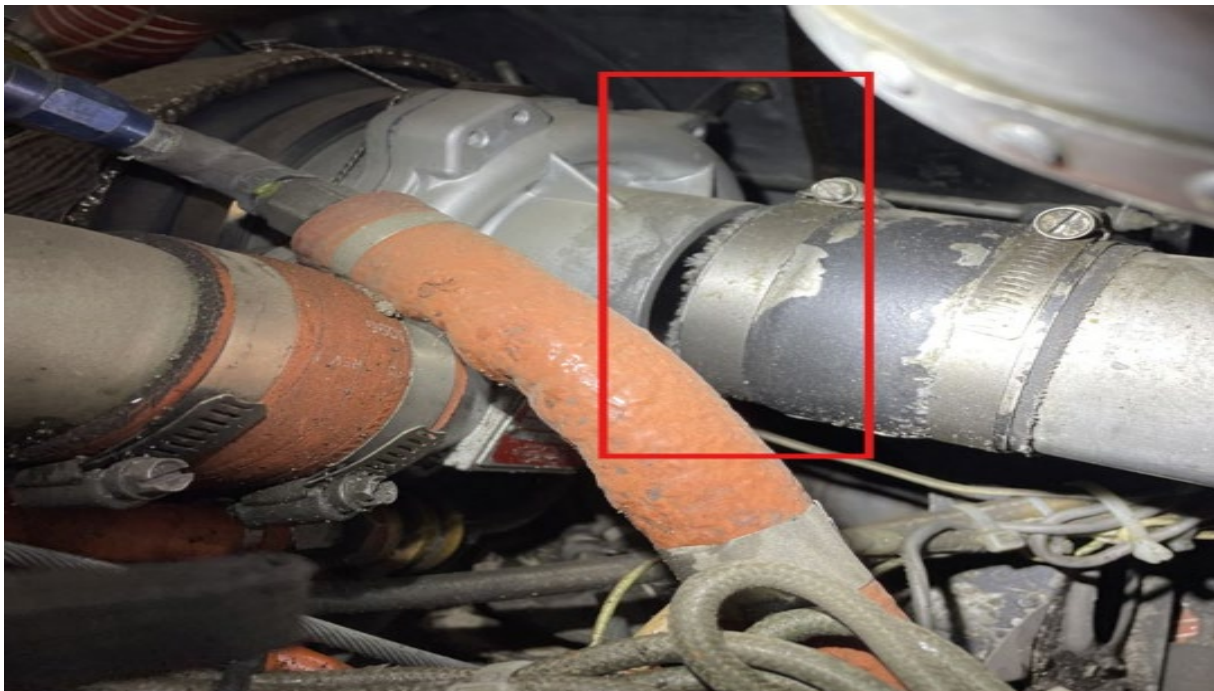
The turbocharger ambient air inlet tube was found unsecured with the rubber interconnect sleeve and corresponding clamps still torqued down on the interconnect sleeve (figure 3).

**Figure 3. View of detached ambient air inlet tube from the compressor side of the turbocharger.**

According to the manufacturer Airplane Parts Catalog, the clamp to be installed is part number 554-641(MS21920-26), a Military Standard flat banded, T-bolt, latch style hose clamp. T-bolts are typically used to fasten flexible, rubber or silicon hoses to pipe ends using a 360-degree tightening band. Inspection of the tightening clamp on the turbo inlet sleeve revealed that it was a lined worm gear clamp (see figure 3). Typically, a lined worm gear clamp often has less gripping force and usually does not withstand vibration as well as a T-bolt clamp.

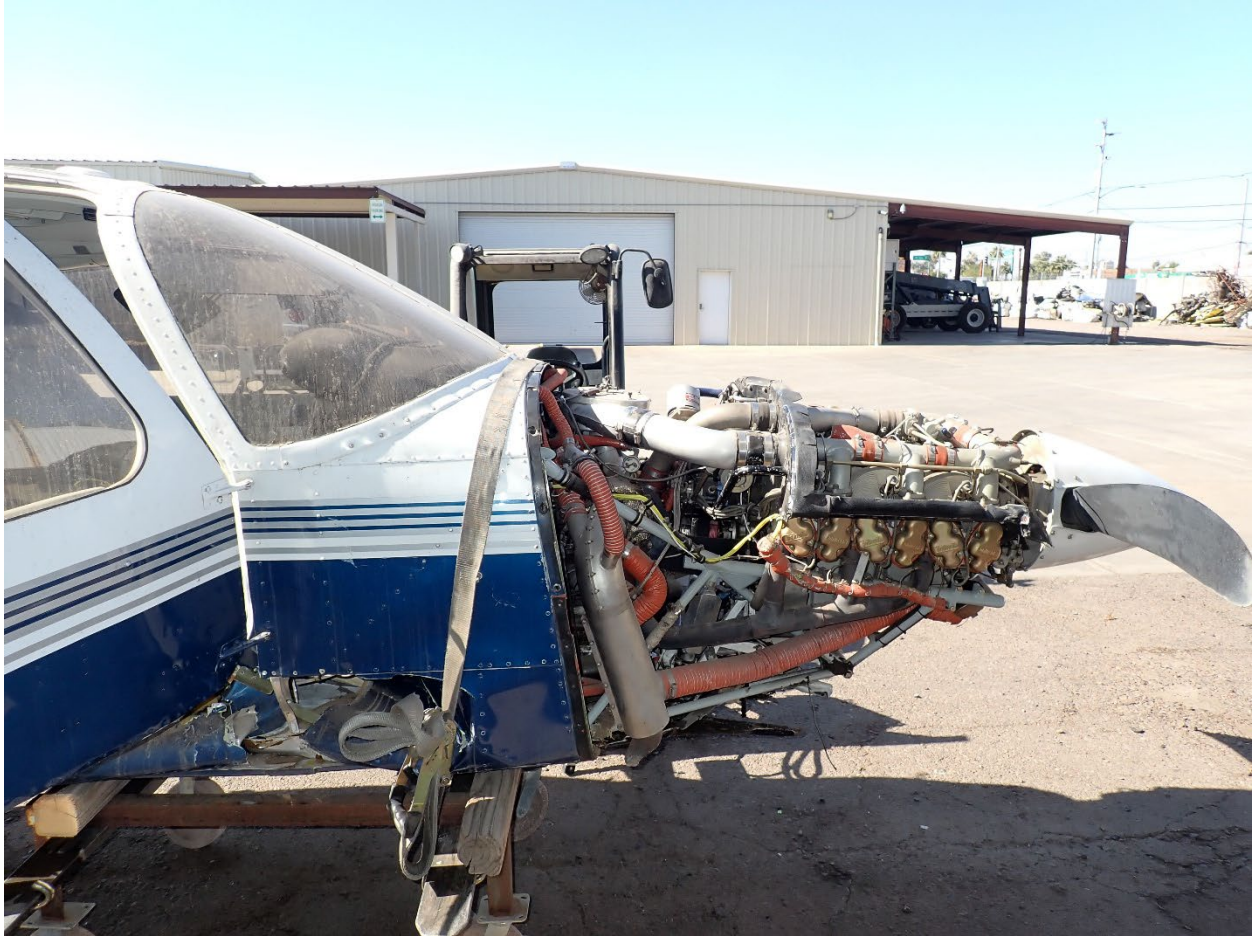
**Figure 6. View of engine prior to engine run. Photo courtesy of Continental Aerospace Technologies.**

The engine (see figure 6) was started with the manufacturer's pilot operating handbook (POH) found in the aircraft. The engine started on its first attempt and ran continuously for 5 minutes at a range of about 50-60% throttle setting which translated to about 1300-1500 rpms, with which takeoff RMP is about 2575 RPM. Due to impact damage to the engine truss, the engine was not run at full power. The engine was shutdown using the POH without anomalies. Inspection of the engine post engine run revealed that the ambient air inlet sleeve was again detached from the turbocharger. The gascolator was removed and no fuel contaminants were observed (see figure 7).

A subsequent engine run was completed on January 31, 2025. The engine plugs and its respective spark plug connectors were replaced. The sheared quick-drain plug was replaced, and 5 quarts of oil was added to the engine. An external fuel tank was connected to the inlet bypassing the fuel selector valve. The ambient air inlet sleeve that was found detached during the examination was reattached. The originally installed clamps were used to hold the sleeve.

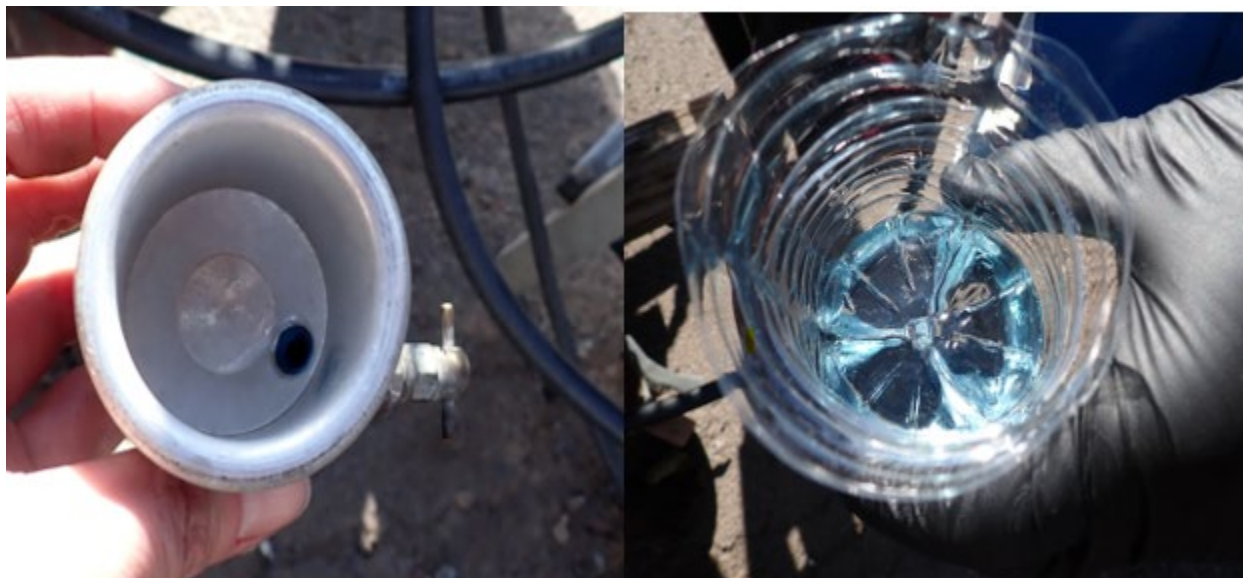
**Figure 7. Left photo: view of removed gascolator; right photo: view of recovered fuel from gascolator. Photo courtesy of Continental Aerospace Technologies.**
