WPR24LA268

## INVESTIGATION PHOTOGRAPHS

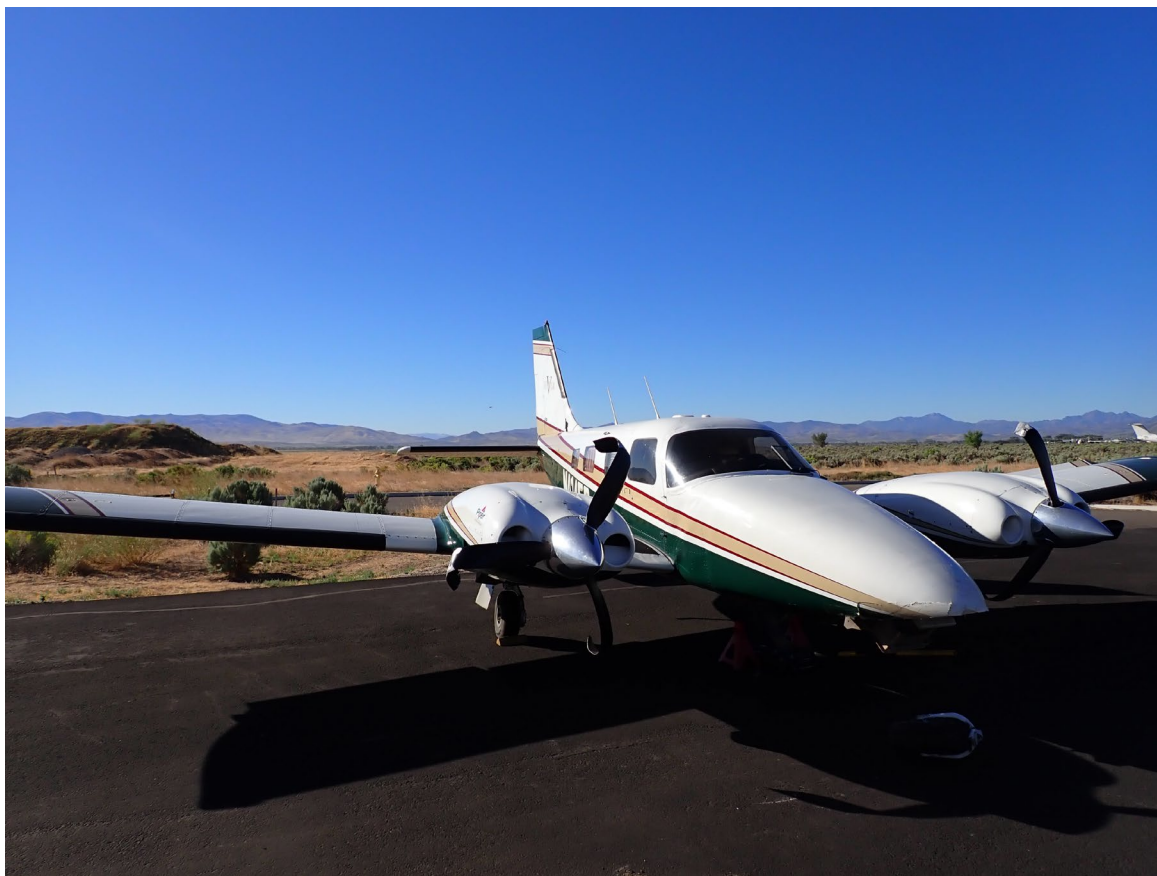
**Photograph 1 - Front view of accident airplane during examination**

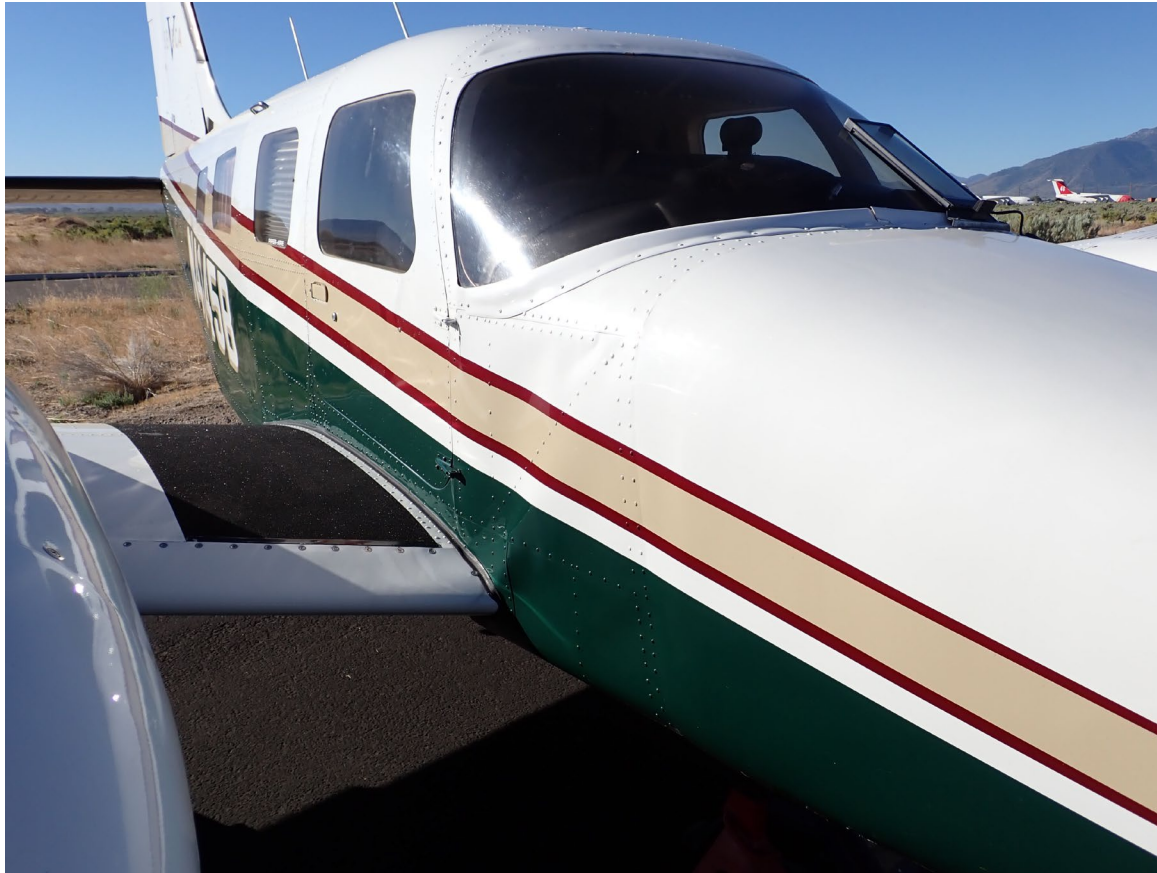
**Photograph 2 - View of damage to forward fuselage**

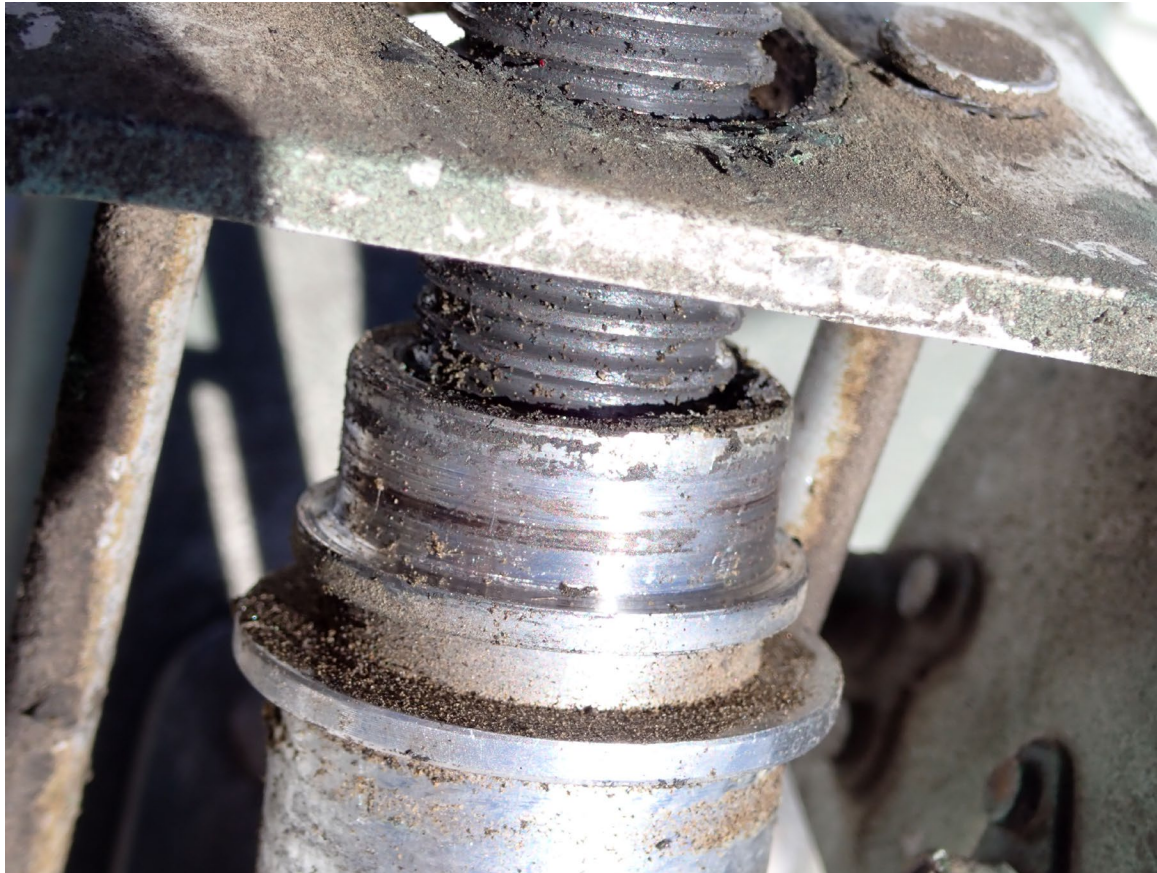
**Photograph 3 - View of stabilator trim screw assembly**

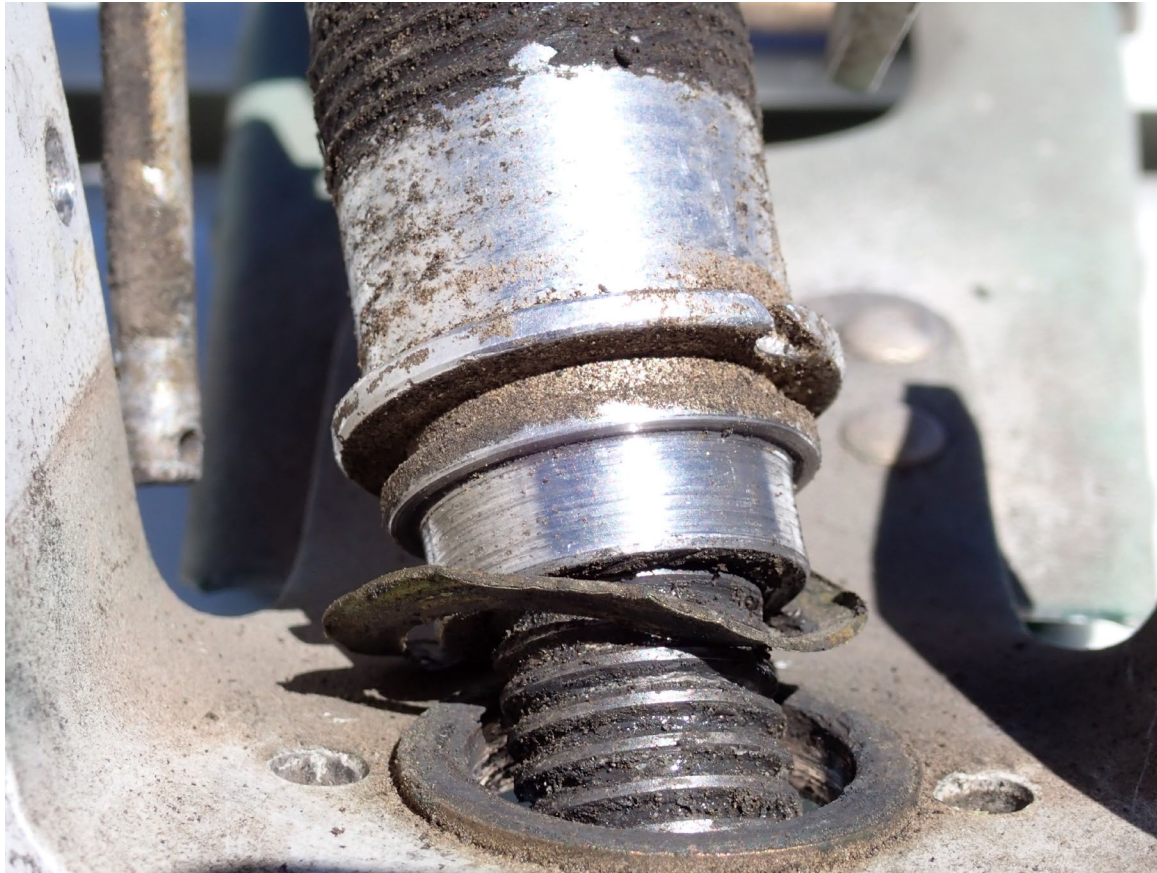
**Photograph 4 - View of stabilator trim screw assembly**
