# National Transportation Safety Board

WPR24LA268

## AIRFRAME EXAMINATAION

Location: Minden, Nevada  
Date: August 5, 2024  
Time: 0900 Pacific daylight time  
Airplane: N4145B, Piper PA-34-220T

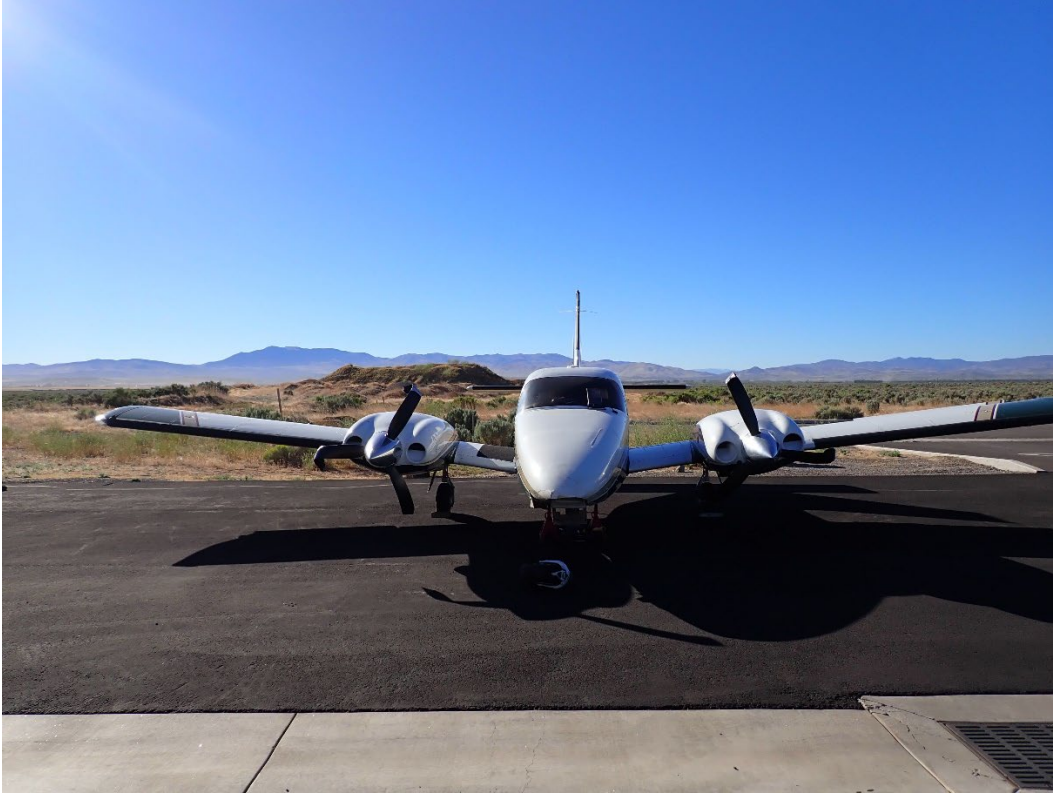
Examination of the recovered airframe revealed buckling and bending on the forward fuselage near left and right wing. Buckling and bending was also observed above the windscreen on the fuselage. The nose landing gear was fracture separated and damage was observed to the nose landing gear wheel well. The observed hobbs meter time was 1455.5 hours.

**Figure 1: View of accident airplane during examination.**

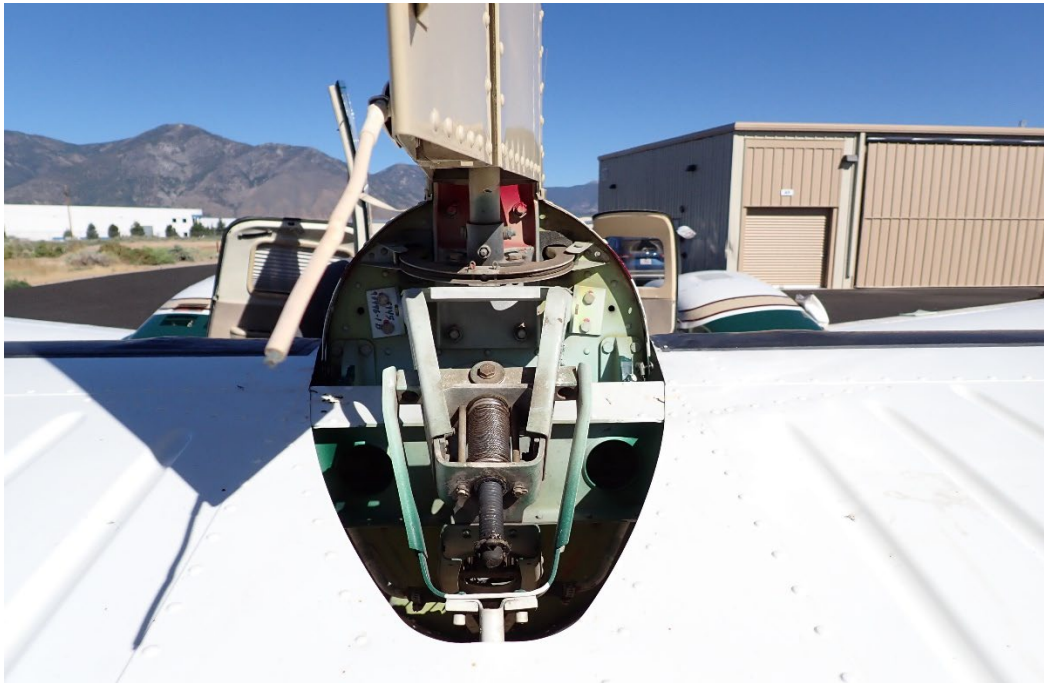
The stabilator trim control wheel was observed in the full nose down position. Force was needed to rotate the stabilator trim control wheel to the neutral position, when rotated by hand. Binding was noted on stabilator trim control. Using the airplanes battery, power was applied to the electric trim controls. When the stabilator trim was placed in the full nose down position, the electric trim servo was heard operating, but would not move the stabilator trim cable. The stabilator trim control wheel was rotated by hand to the neutral position, and the electric stabilator trim control would move the stabilator trim cable. A visual examination of the stabilator trim control cable was conducted, no damage was observed. The empennage flight control cover was removed, and a visual inspection of the trim screw assembly was conducted. Corrosion was observed on the trim screw assembly. The trim screw assembly was moisture free. The exposed shaft of the trim screw was free of lubrication, the ends exhibited minimal lubrication. The trim screw assembly had radial and axial play when moved by hand, consistent with excessive wear on the upper and lower barrel mount bearings. The trim screw assembly was disassembled,

and circular grooves were observed on the outer sections of the upper and lower barrel mount bearings.

**Figure 2: View of stabilator trim assembly.**
