LOCATION OF ACCIDENT - NORTH END OF THE ALVORD DESERT

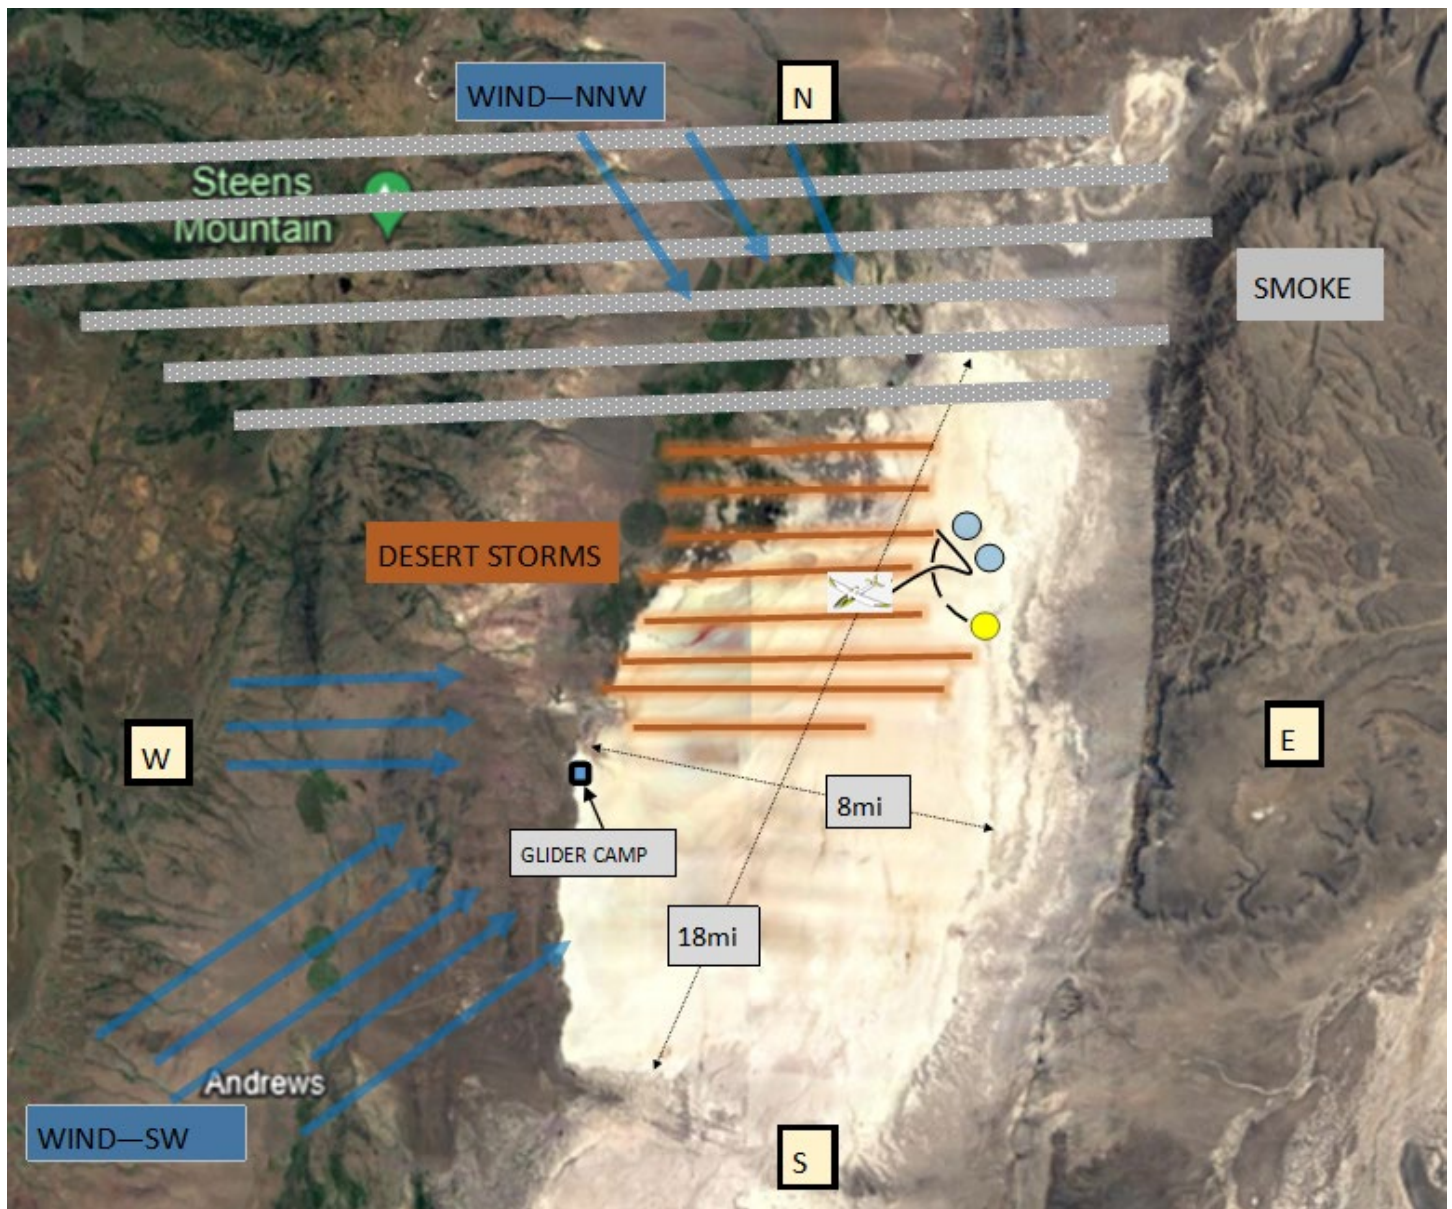
YELLOW CIRCLE: A CLOUD THAT HAD BEEN SHEARED OFF BY THE TIME I FLEW UNDER IT TO FIND LIFT. NO LIFT

BLUE CIRCLES: WHERE STRONG THERMALS HAD PREVIOUSLY BEEN. I RETURNED BACK TO THIS AREA TO FIND LIFT SO I COULD REGAIN ALTITUDE. NO LIFT. ALL THERMALS HAD BEEN BLOWN OUT FROM SUDDEN SHIFT IN THE WEATHER, HIGH WINDS AND MIGRATING SMOKE.

AFTER LOOSING 2,000 FT. OF ALTITUDE, I DID NOT HAVE ENOUGH ALTITUDE TO MAKE IT AROUND THE STORM FRONTS THAT HAD SUDDENLY EXPANDED – EXPANDING BOTH VERTICALLY AND HORIZONTALLY.

THE LOSS OF ELEVATION DUE TO ZERO THERMAL ACTIVITY, HIGH WINDS AND SMOKE MIGRATION, FORCED ME TO MAKE THE DECISION TO LAND-OUT IN BETWEEN TWO DESERT DUST STORMS. ALTITUDE WAS APPROX 5.200 MSL AFTER PICKING MY LANDING SPOT AND SETTING UP FOR A BASE TO FINAL APPROACH. AROUND 500 FT AGL ON FINAL APPROACH, I EXPERIENCED SEVERE DOWN DRAFT AND A LOSS OF AIRSPEED. MY AIRSPEED WAS 64KTS ON BASE AND ON FINAL I PITCHED THE NOSE DOWN TO GAIN AIRSPEED. ON BASE I TRIMMED AIRSPEED AT 65KTS AND WHILE ON THE BEGINNING PHASE ON FINAL, I WAS AT 54KTS. I CONTINUED TO PUSH THE NOSE DOWN TO REGAIN AIRSPEED. THERE WAS A SIGNIFICANT HEADWIND COMING FROM THE SW AS EVIDENT OF THE CONTINUED DECREASE IN AIRSPEED. THERE WAS ALSO SIGNIFICANT THERMAL ACTIVITY THAT LASTED AROUND 30 SECONDS AT 200 FT AGL - PUSHING THROUGH THERMALS, AS WELL AS A HEAD WIND, I CONTINUED TO PUSH THE NOSE DOWN TO REGAIN AIRSPEED. UPON FLARING, JUST PRIOR TO TOUCHING DOWN, AIRSPEED WAS INDICATING 40 KTS. (STALL SPEED FOR THIS MAKE/TYPE OF GLIDER IN SMOOTH AIR IS 36KT). THE HEADWIND, DOWN DRAFT AND LIFT PRIOR TO TOUCHDOWN AND A POSSIBLE TAIL WIND CAUSED A WIND GRADIENT THAT CAUSED THE GLIDER TO STALL APPROX 3-4 FT OFF THE GROUND AND A HARD LANDING OCCURRED. AIRBREAKS WERE CLOSED THE WHOLE DURATION ON BOTH BASE AND FINAL. WINGS WERE LEVEL UPON LANDING AND NOT DAMAGE TO THE WINGS OCCURED.

HOWEVER, THE IMPACT ON THE LANDING GEAR CAUSED THE UNDERBELLY OF THE FUSELAGE (APPROX 8-10 INCHES AFT THE LANDING GEAR) TO SUSTAIN FOUR CRACKS IN THE FIBERGLASS. TWO CRACKS ON EACH SIDE OF THE FUSELAGE (APPROX. 3-4 INCHES IN LENGTH) – WITH THE OTHER TWO CRACKS IN BETWEEN THE TWO OUTER CRACKS (APPROX. 6-8 INCHES IN LENGTH) IS THE EXTENT OF THE GLIDER'S DAMAGE.
