# National Transportation Safety Board

WPR24LA275

## **LANDING GEAR SYSTEM EXAMINATION REPORT**

Location: Concord, California  
Date: August 8, 2024  
Time: 1959 Pacific daylight time  
Airplane: Piper PA-30 (N8458Y)

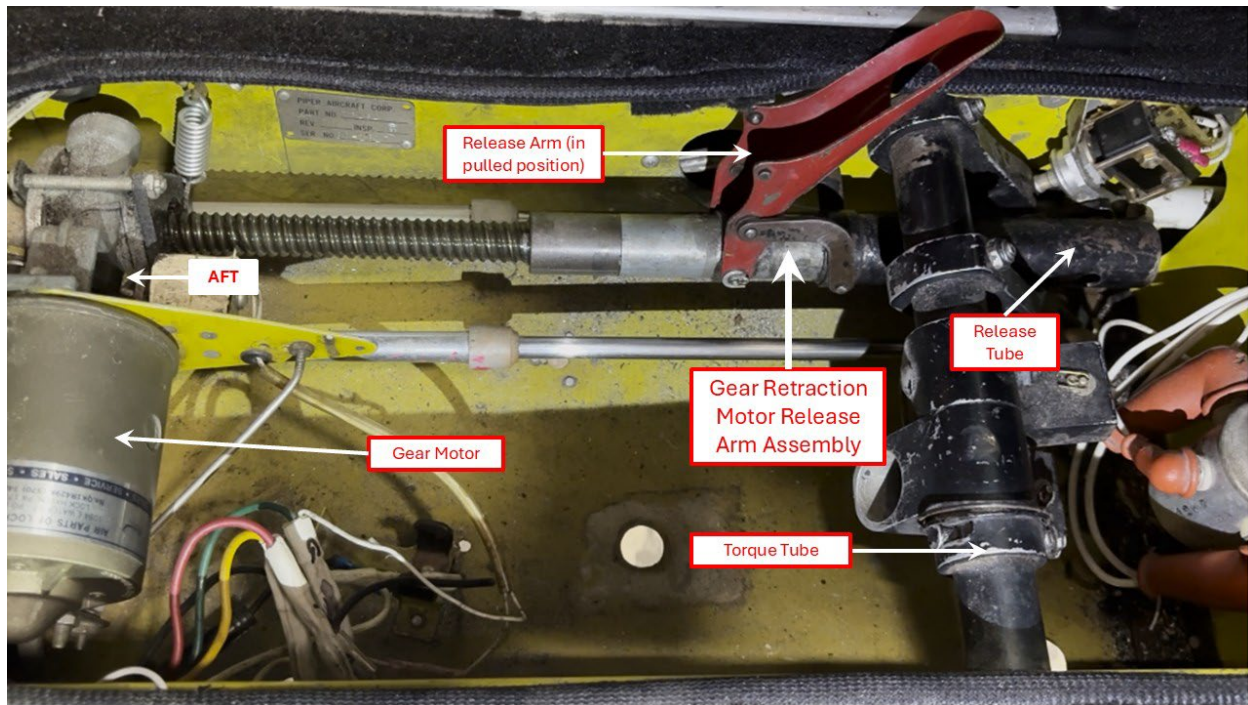
During the test, the release arm was pulled upward and forward, consistent with the manual instructions; however, the landing gear would not manually release until the release arm was pushed to the right side, which was met with significant resistance. This happened repeatedly during three separate attempts to extend the landing gear manually. Visual inspection of the manual system revealed that the hardware that secured the release arm to the transmission nut shaft was loose, which allowed the release arm to rotate in place. According to the release arm drawing, the clevis pin bushing hole should be 0.129", which was the measurement of the bushing hole on the accident airplane.

The push/pull rod clevis was binding against a side wall on the left side structure that housed the manual extension system. When the manual release arm was pulled up and pushed forward, the lightening hole was preventing the bolt on the left side of the push/pull rod clevis from moving aft and the torque tube from rotating. When the release arm was pushed to the right, the bolt was liberated from the hole allowing the torque tube to rotate and the landing gear to fall.

**Figure 1: Manual extension system with release arm in pulled position, gear retraction arm assembly and torque tube**
