WPR24LA275

## INVESTIGATION PHOTOGRAPHS

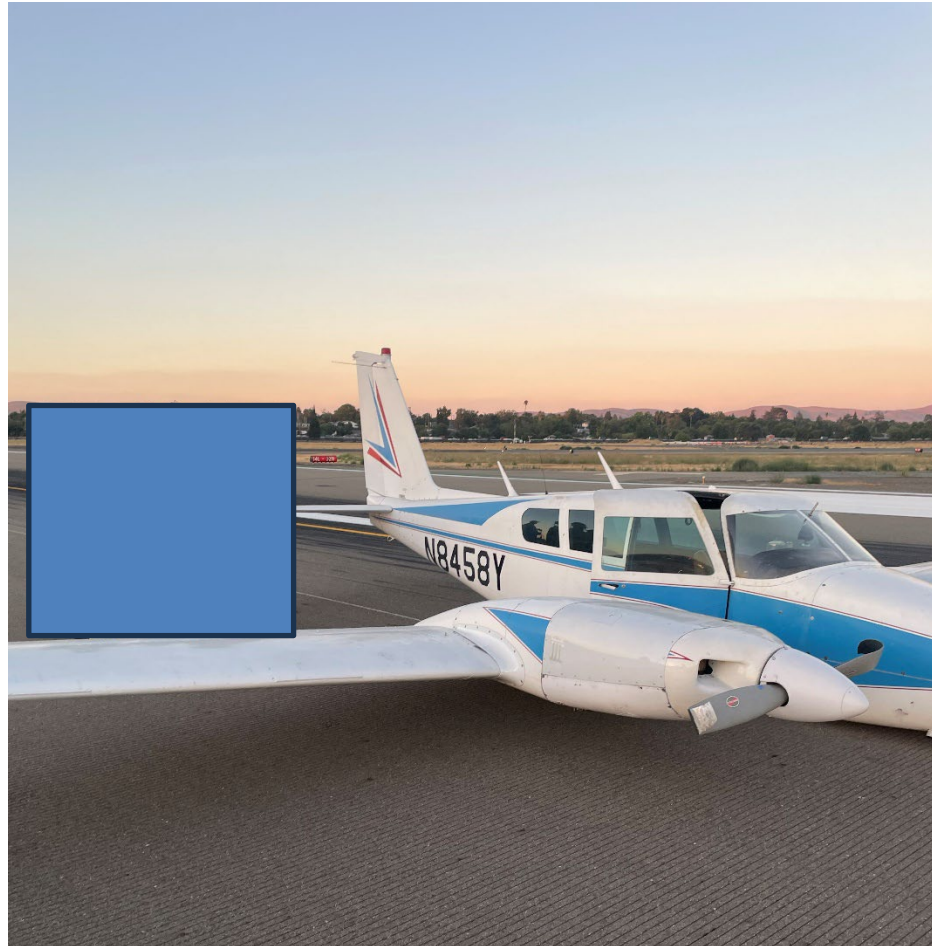
**Photograph 1 - Forward quartering view of airplane at accident site (courtesy of Concord Airport Operations)**

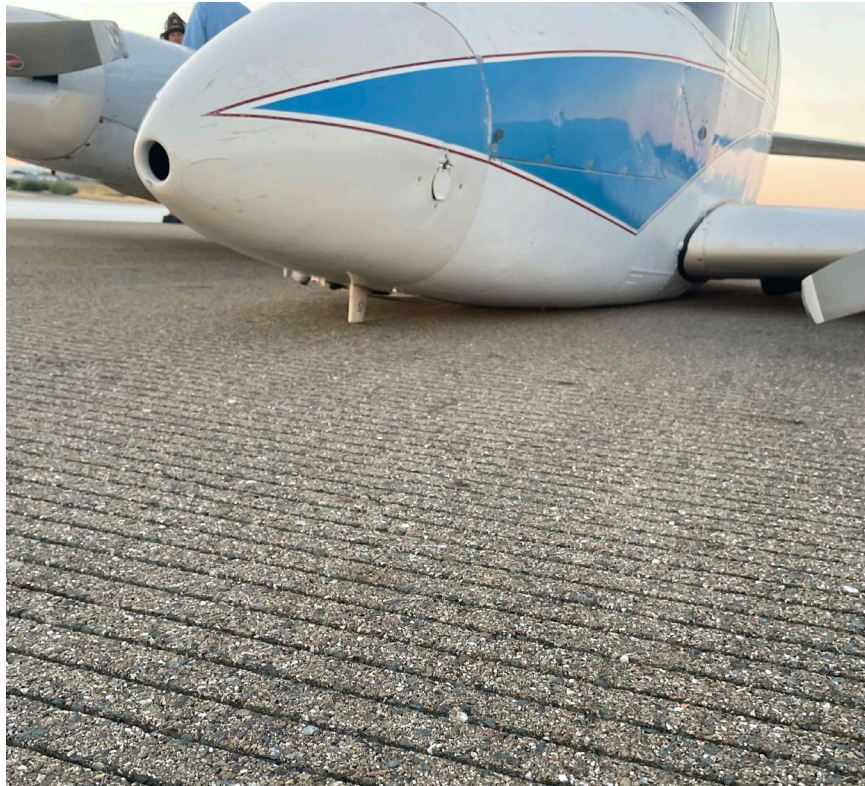
**Photograph 2 - View of fuselage to ground contact (courtesy of Concord Airport Operations)**

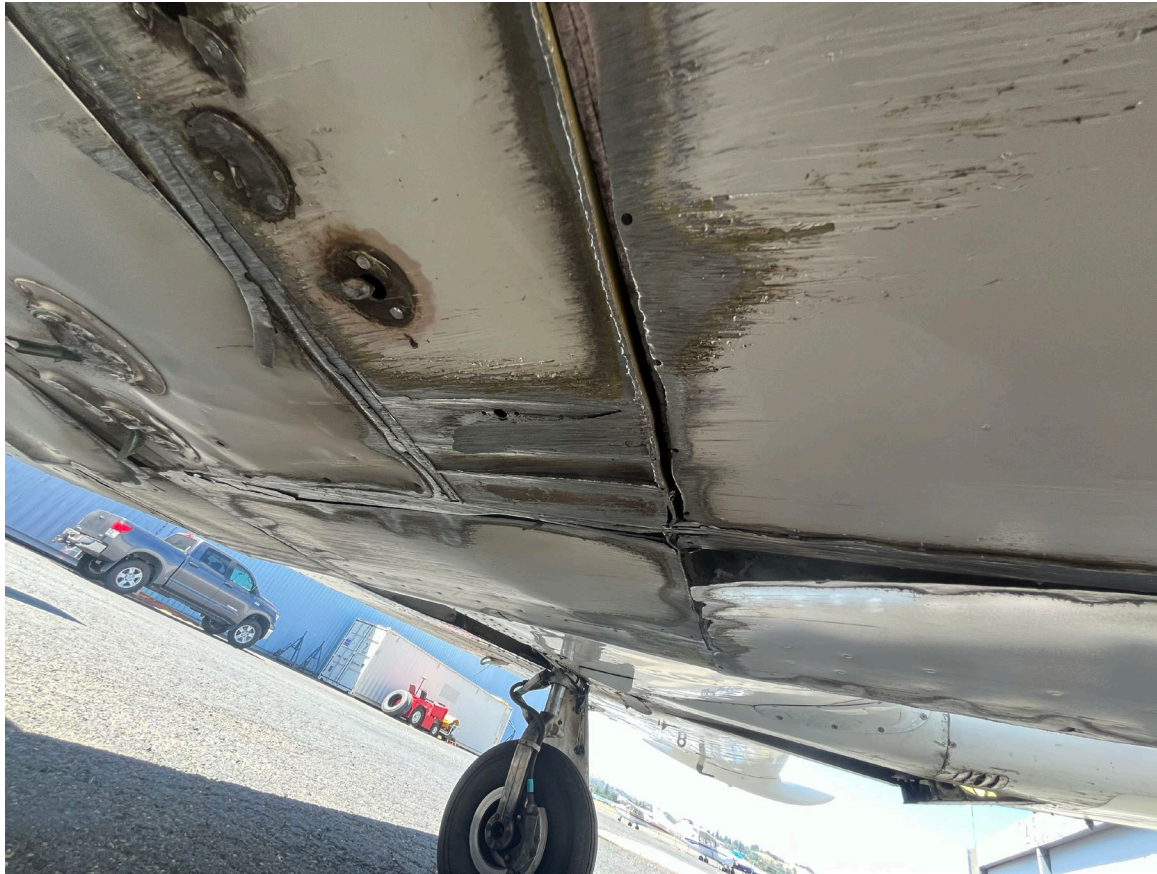
**Photograph 3 - Lower fuselage (Courtesy of Concord Airport Operations)**

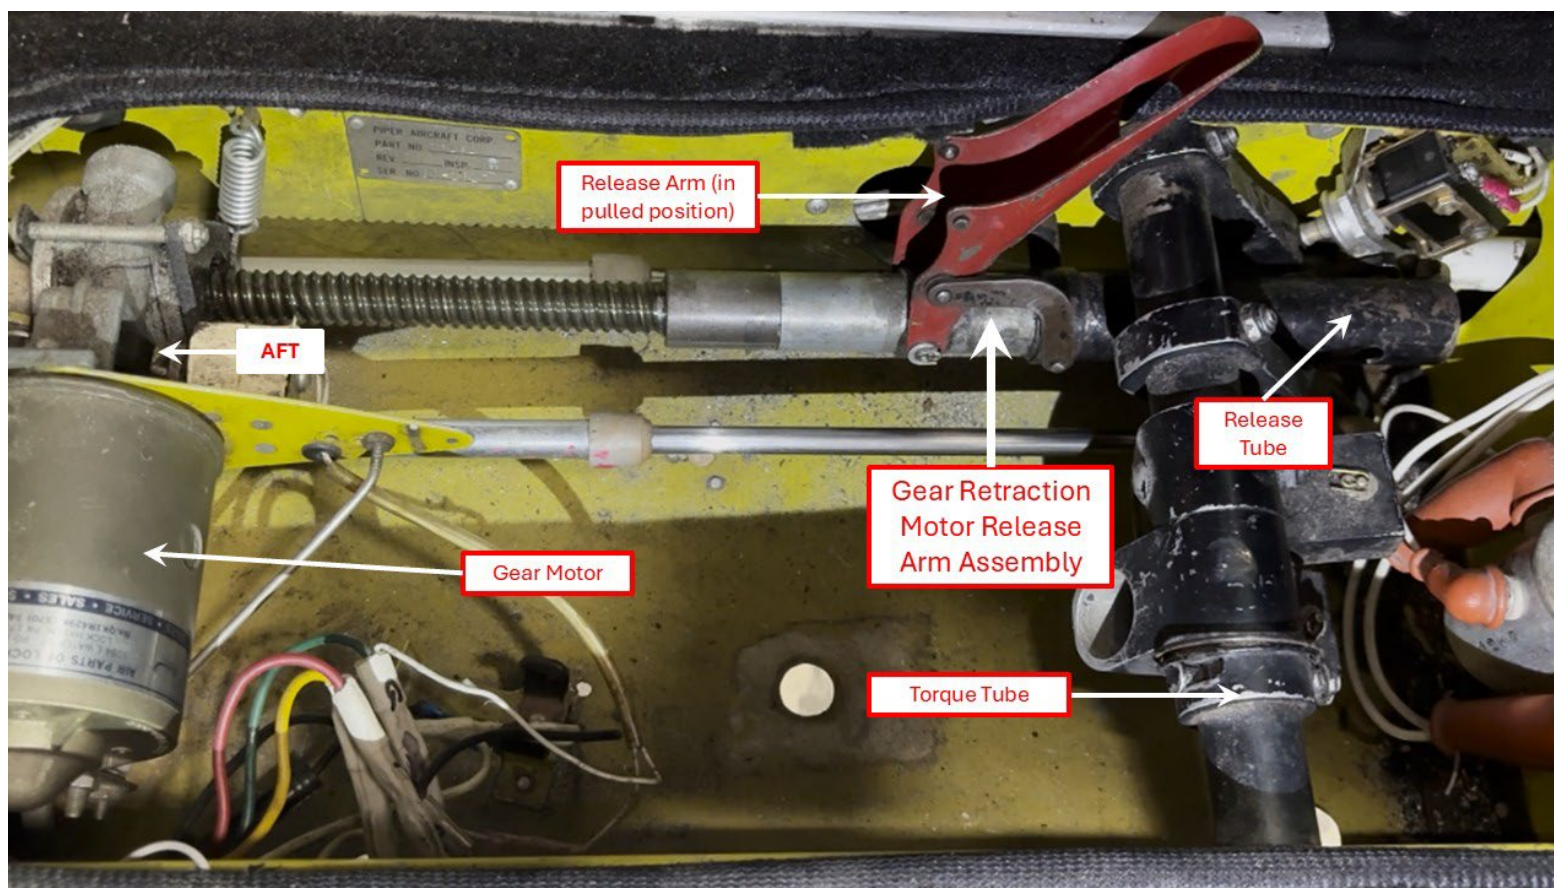
**Photograph 4 - View of manual release assembly, gear motor, and torque tube**

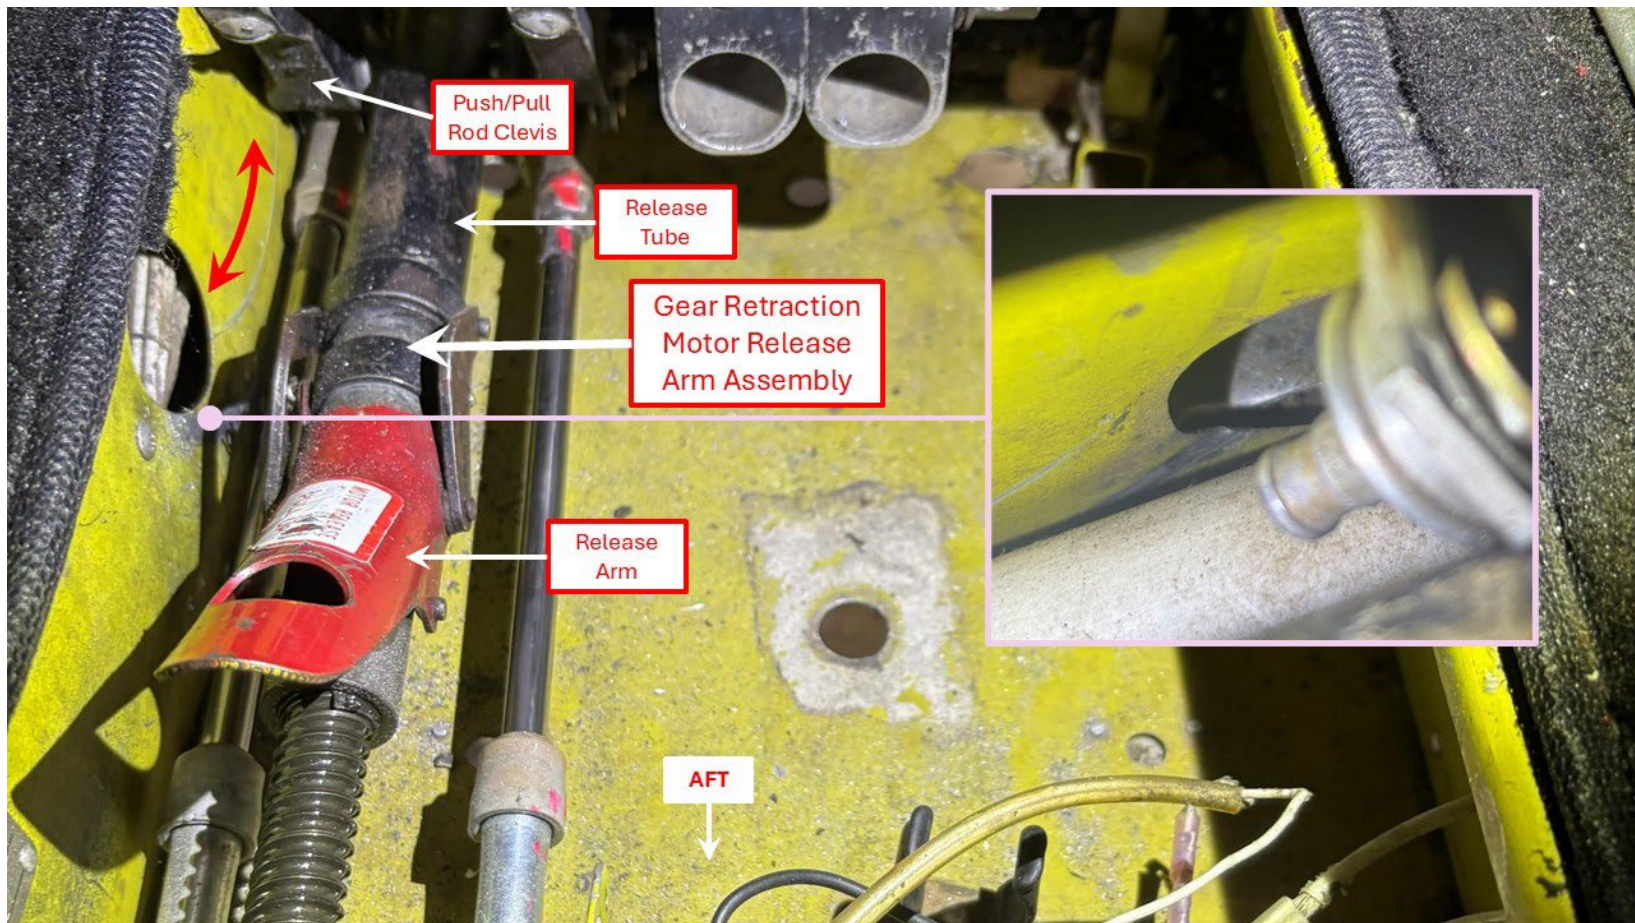
**Photograph 5 - Manual release assembly housing and damage to side structure inhibiting movement of torque tube**
