# National Transportation Safety Board

WPR24LA281

## **AIRFRAME AND ENGINE EXAMINATION SUMMARY**

Location: Grants-Milan Municipal, Grants, NM  
Date: 08/15/2024  
Time: 1335 MDT  
1935 UTC  
Airplane: N272JT Harmony LSA

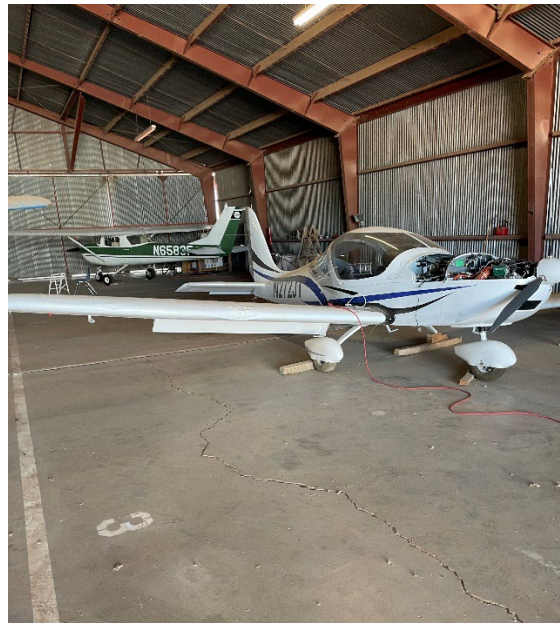
The airplane was stored in the hanger, with the left gear strut that had separated, supported by some wood blocks. Because the wood block support was lower than the right main landing gear, the airplane was positioned in about 15° of left bank.

The left wing was relatively intact; some minor imperfections were noted on the top of the wing. The left flap and aileron were attached. The left aileron trim was about in the neutral position. The right wing sustained leading edge damage about mid span and on the outboard portion. The right flap and aileron were attached. The bottom portion of the right flap was separated and the trailing edge of the flap where it attached to the fuselage sustained crushing damage. The flaps were retracted.

**Photograph 1: Airplane as viewed from the right side.**

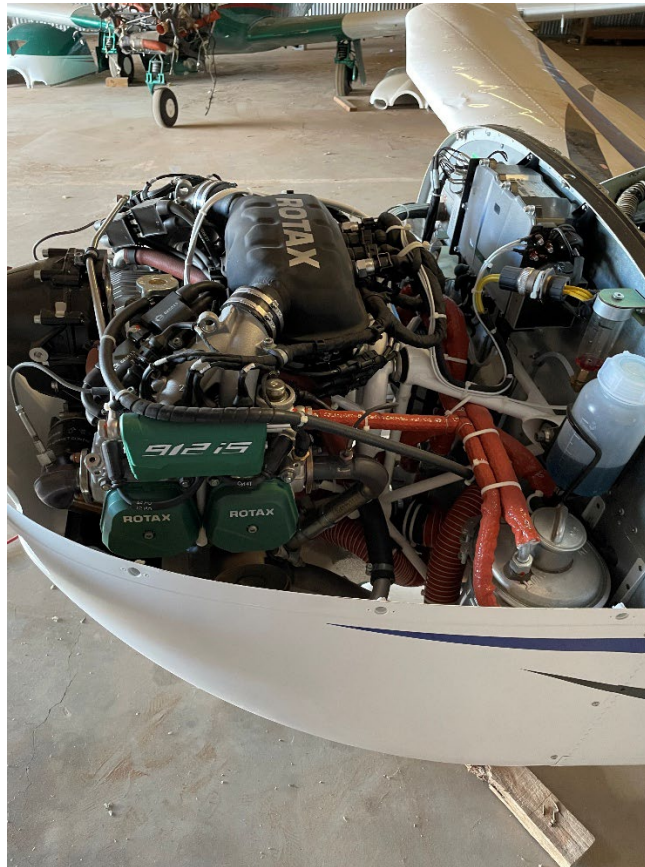
The Rotax 912iS2 engine was attached to the fuselage and was intact. The engine cowling was removed, and no external damage was noted. The top sparkplugs were removed and examined. All the sparkplug electrodes showed normal like new conditions and were light grey in color, when compared to the Champion Check-A-Plug chart. The engine was manually rotated through the propeller, and thumb compression was established at each cylinder, and appropriate valve movement was noted.

**Photograph 2: Left side view of the engine during examination.**

The examination of the engine revealed no evidence of pre-impact mechanical anomalies or malfunctions that would have precluded normal operation.

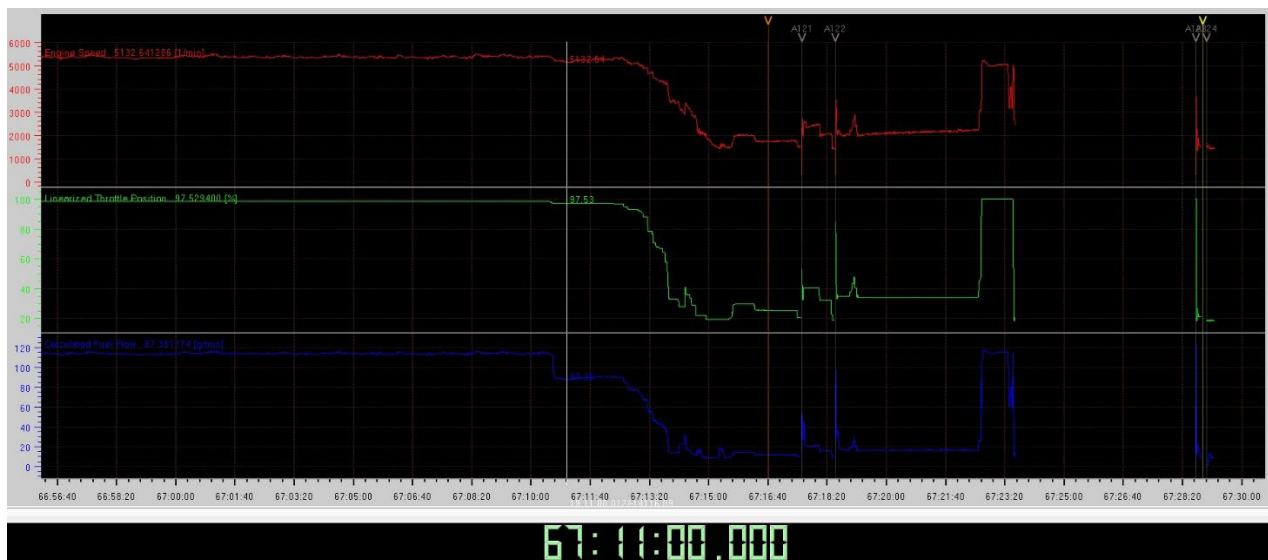
The ECU engine graph data indicated that the engine RPM dropped and fluctuated shortly after takeoff, while the throttle position remained at 100%, confirming that the engine experienced a loss of power.

The ECU recorded the engine startup at a timestamp of 67:18:34.400 and the total loss of engine power at 67:23:38.500. This reflects a total elapsed time of 5 minutes and 4 seconds from engine startup to the complete loss of engine power.

The engine speed is relatively stable initially but begins to fluctuate toward the end of the data. It shows a noticeable drop in the final data points, consistent with a decline in power output.

The "Linearized Throttle Position" is consistently high and steady throughout the dataset, indicating a sustained command for engine power. There were no significant changes or fluctuations in throttle position.

The "Calculated Fuel Flow" shows consistent values initially but begins to exhibit a gradual decline in the final data points. This decline reflects a reduction in the flow rate toward the end of the dataset.

Overall, after reviewing the engine data, the declining fuel flow and reduction in fuel injection mass point preceded other engine parameters changes, consistent with fuel starvation.

**Figure 3: Accident flight Engine Speed, Linearized Throttle Position, and Calculated Fuel Flow parameters.**

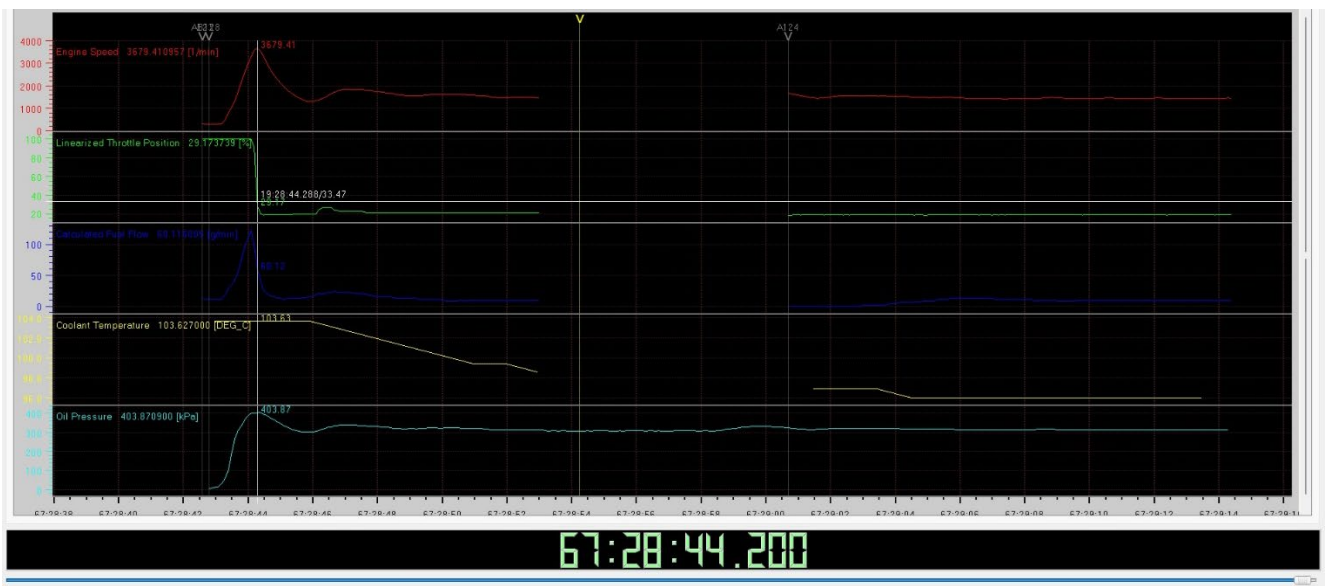
The ECU engine graph data shows that after 5 minutes and 7 seconds following the total loss of engine power, the engine was re-started for 31 seconds before it was shut down again.

**Figure 4: Second Engine Start Parameters.**
