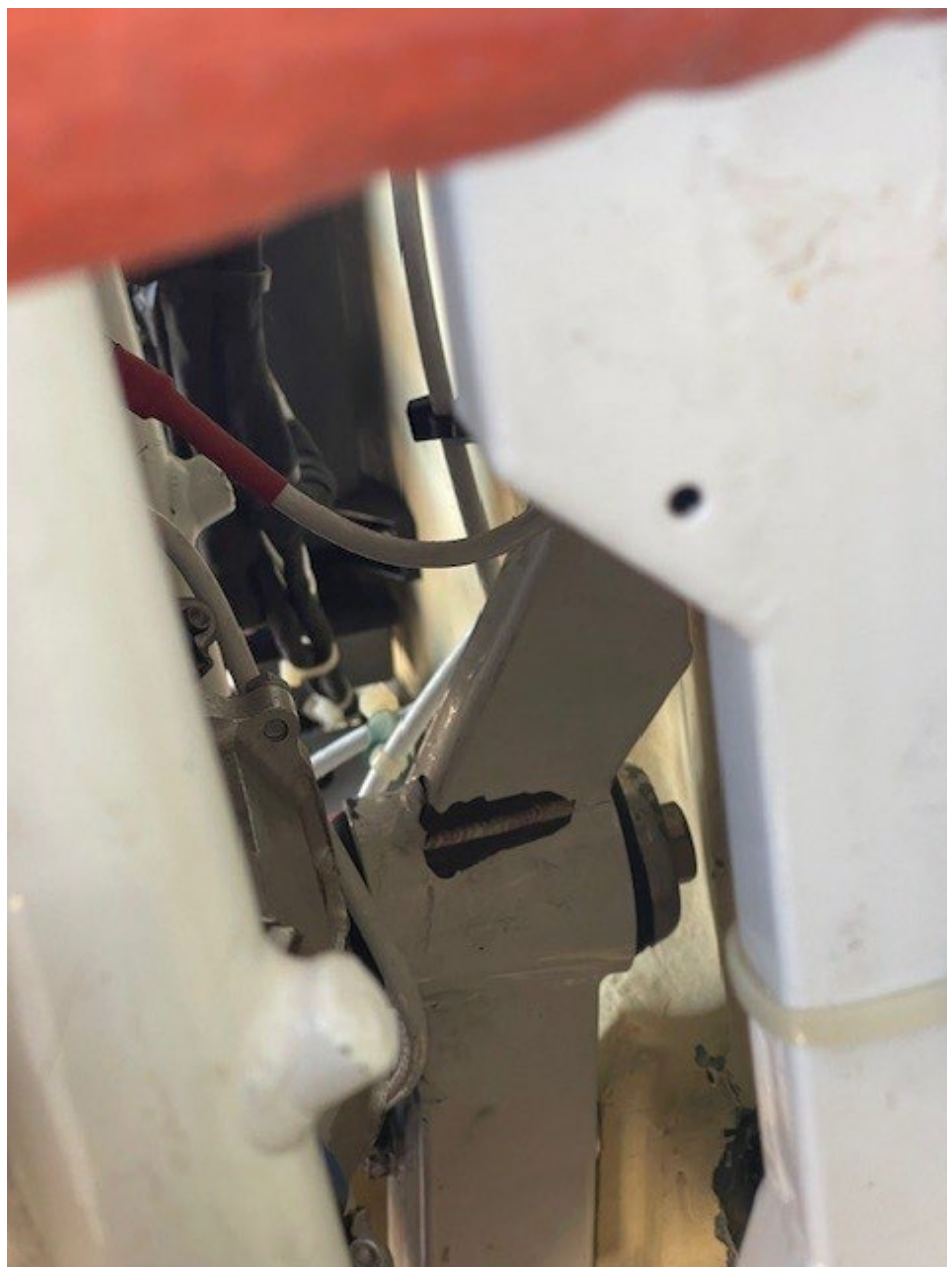
**Photo 1 – View of substantial damage to N116MJ. Source owner.**

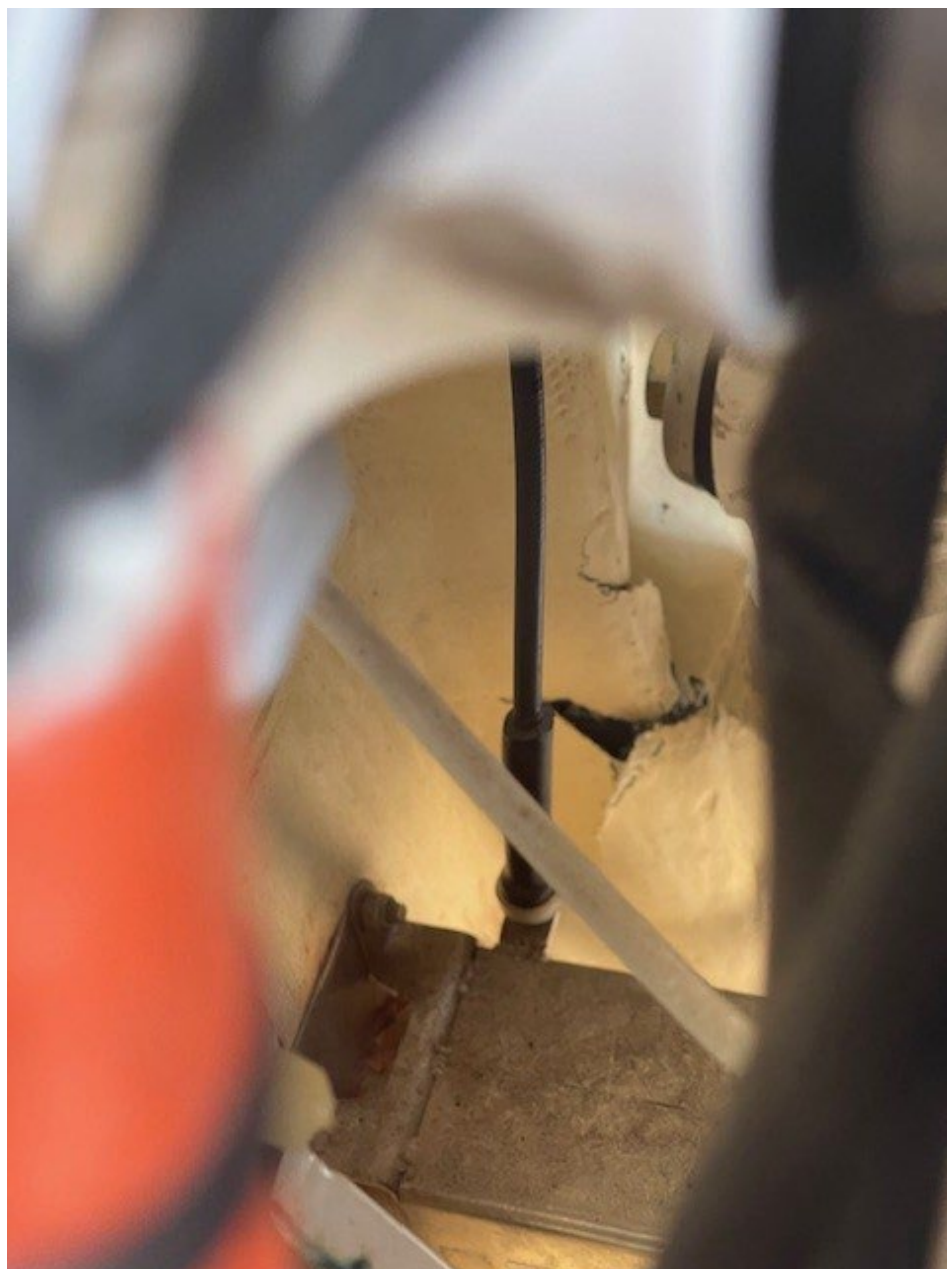
**Photo 2 – View of substantial damage to composite material. Source owner.**

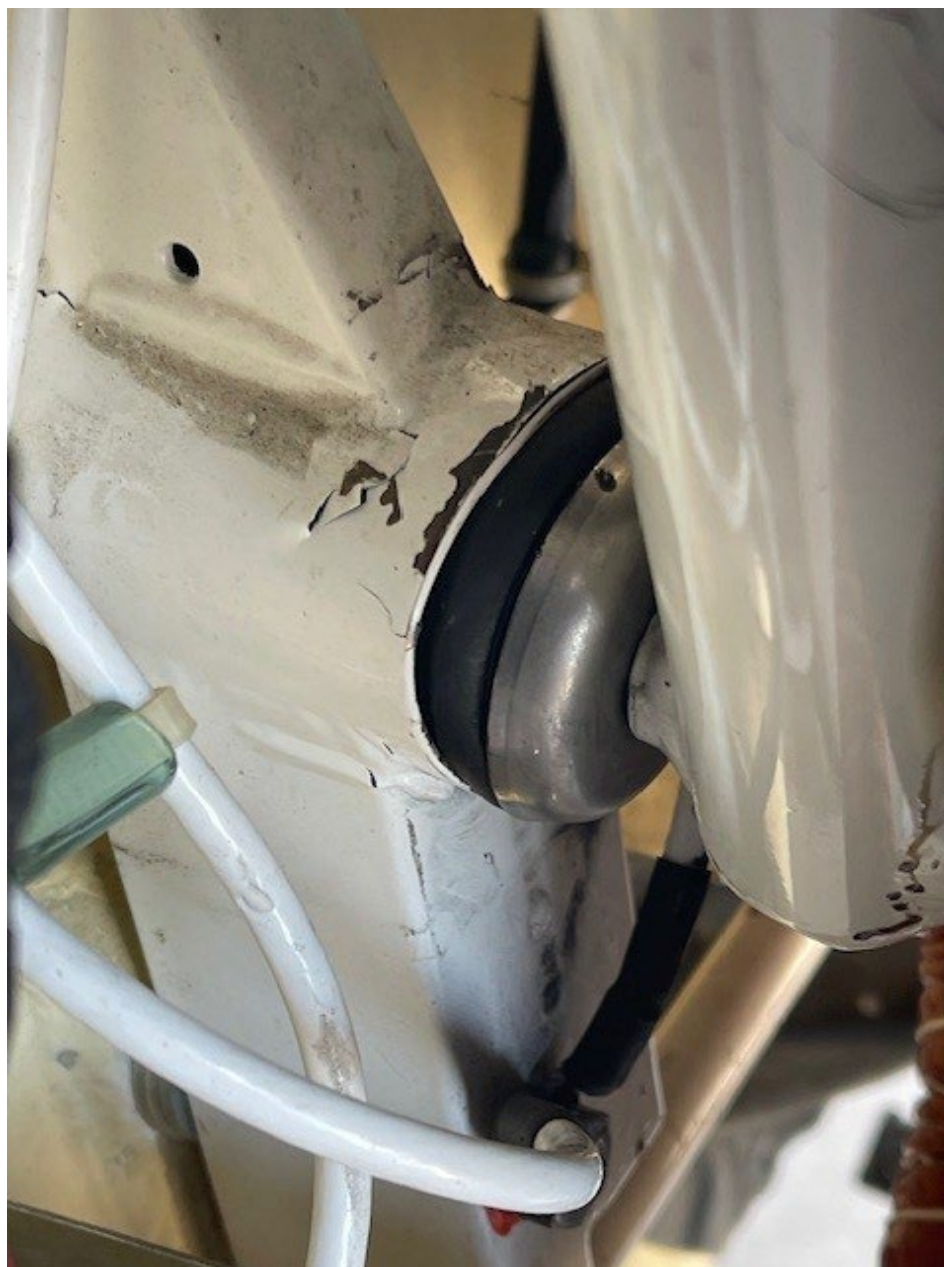
**Photo 3 – Substantial damage to mount. Source owner.**
