WPR24LA306

## INVESTIGATION PHOTOGRAPHS

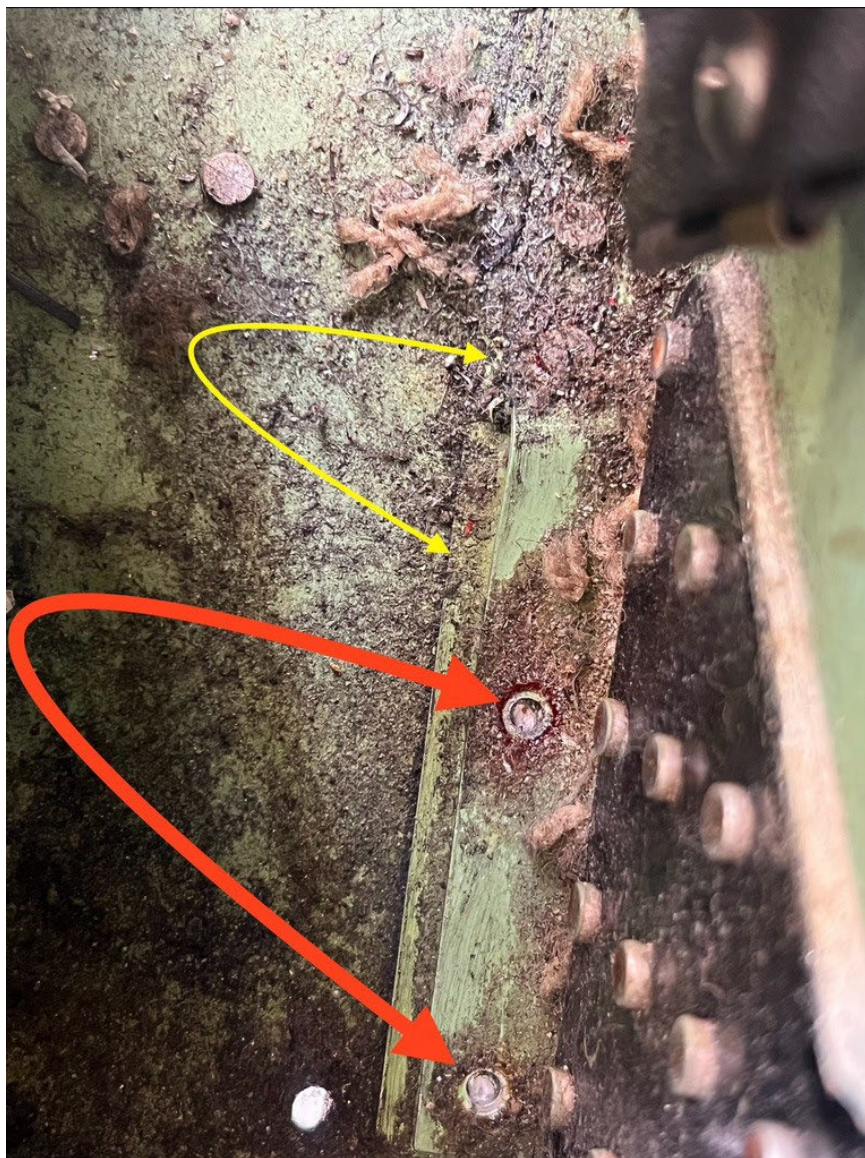
**Photograph 1 - View of the damage to the left wing spar (Courtesy of operator)**
