# National Transportation Safety Board

WPR24LA307

## **ONBOARD IMAGE RECORDER**

Specialist's Factual Report

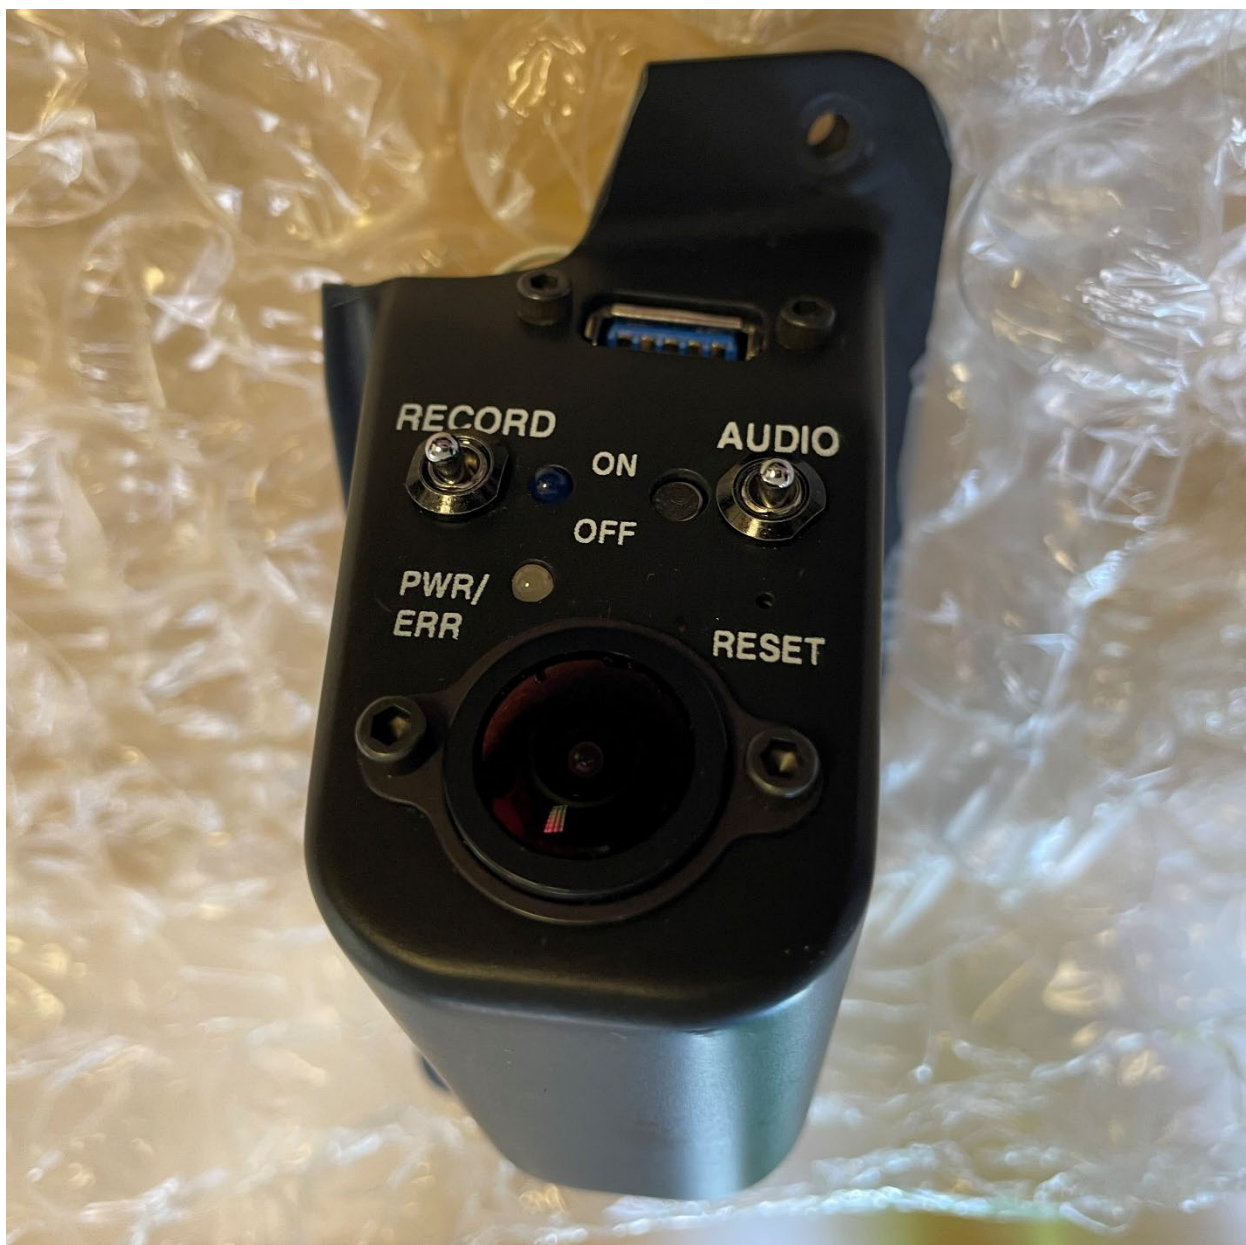
The camera arrived exhibiting signs of mild impact damage (see figure 1). The device contained a microSD card which was in good condition, and the data were downloaded using the manufacturer's procedure.

**Figure 1.** Robinson Cockpit Camera, as received by the Vehicle Recorder Lab.
