WPR24LA312

## INVESTIGATION PHOTOGRAPHS

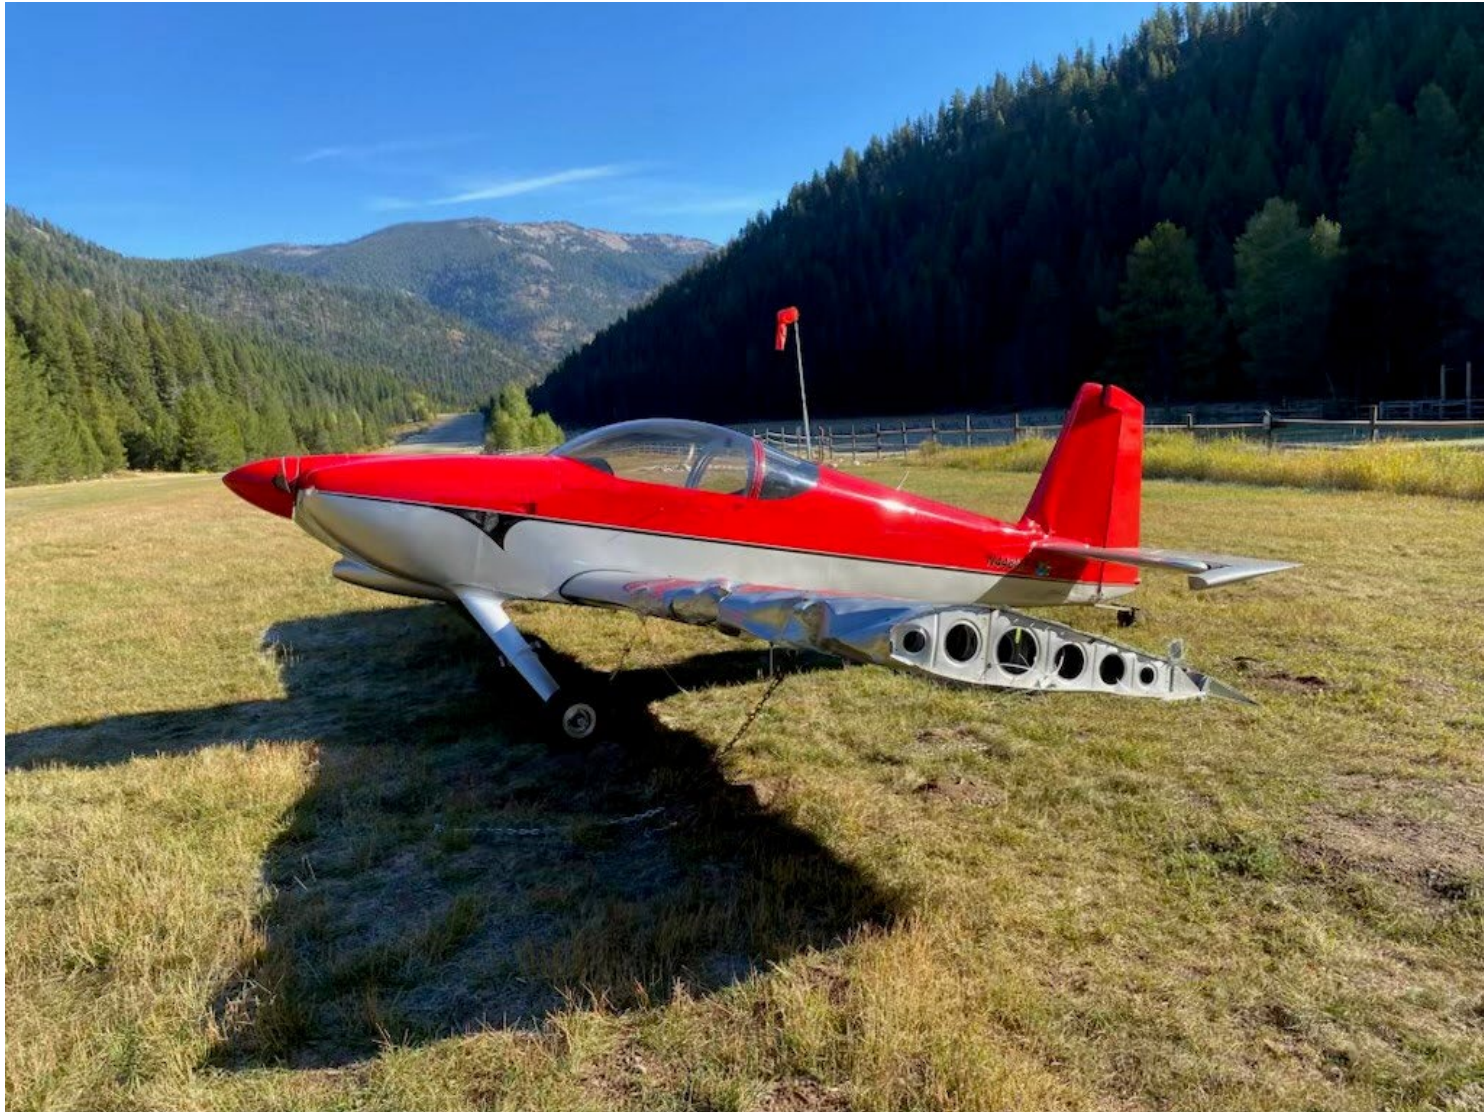
**Photograph 1 - View of left wing and tail damage (Courtesy of pilot)**

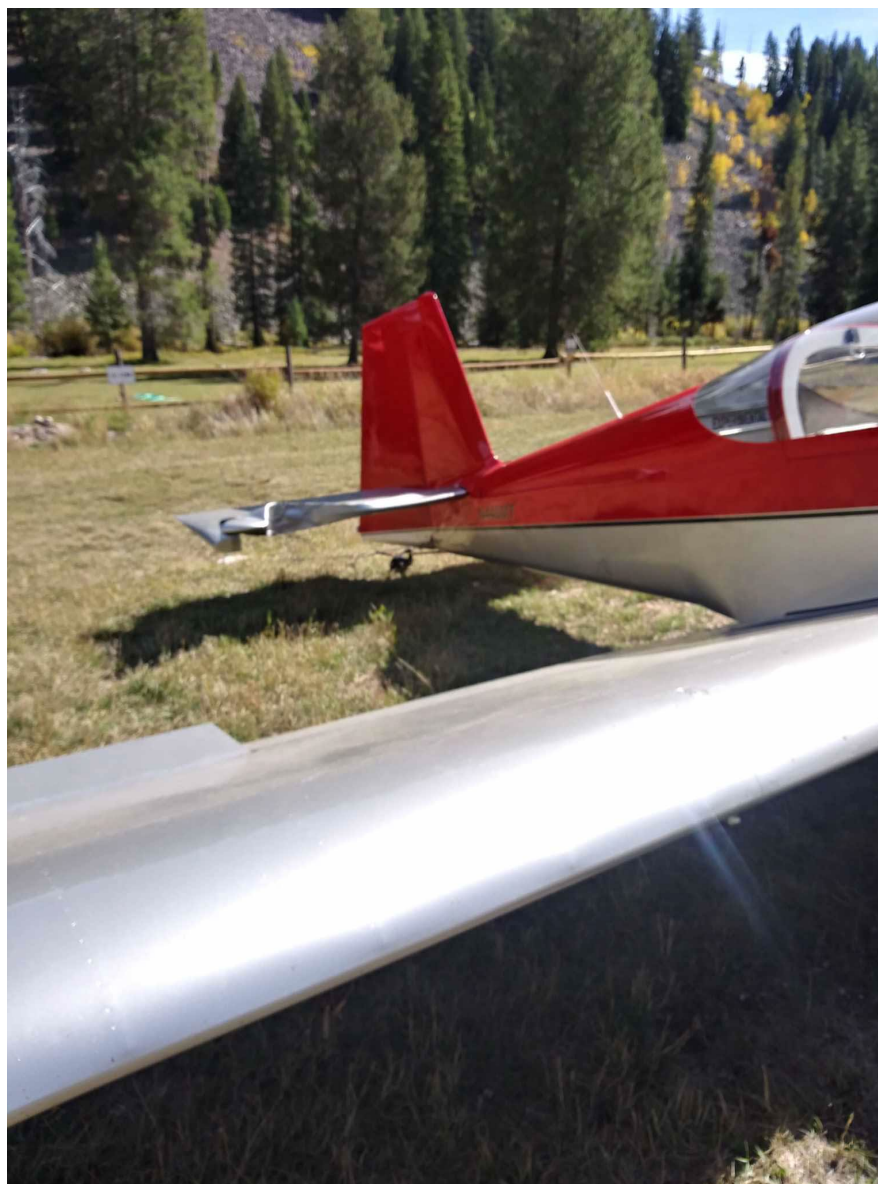
**Photograph 2 - View of right horizontal stabilizer damage (Courtesy of pilot)**
