# National Transportation Safety Board

Office of Research and Engineering

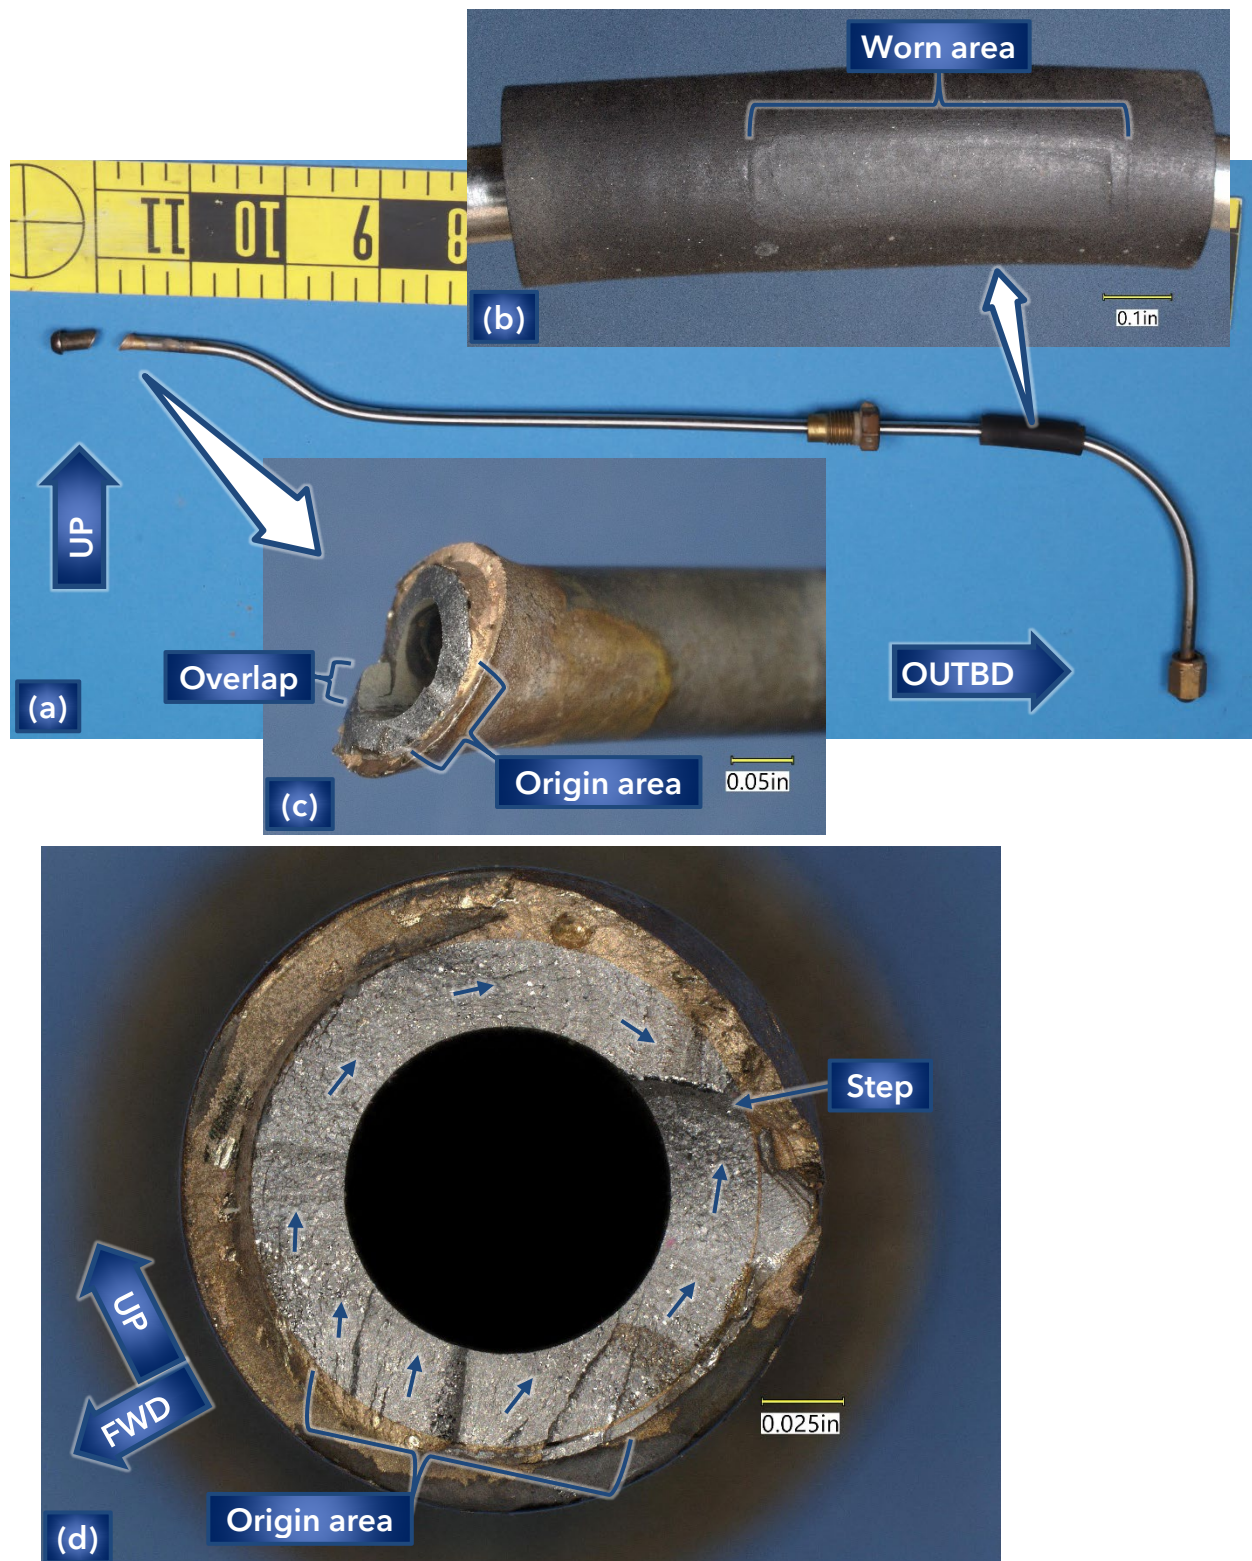
**Figure 1.** (a) Overall view of the forward side of the submitted fuel injector tube assembly as received. (b) Closer view of wear on the elastomer bushing. (c) Oblique view of the tube side of the fracture. (d) Ferrule side of the fracture surface. Unlabeled arrows indicate local fatigue propagation directions.

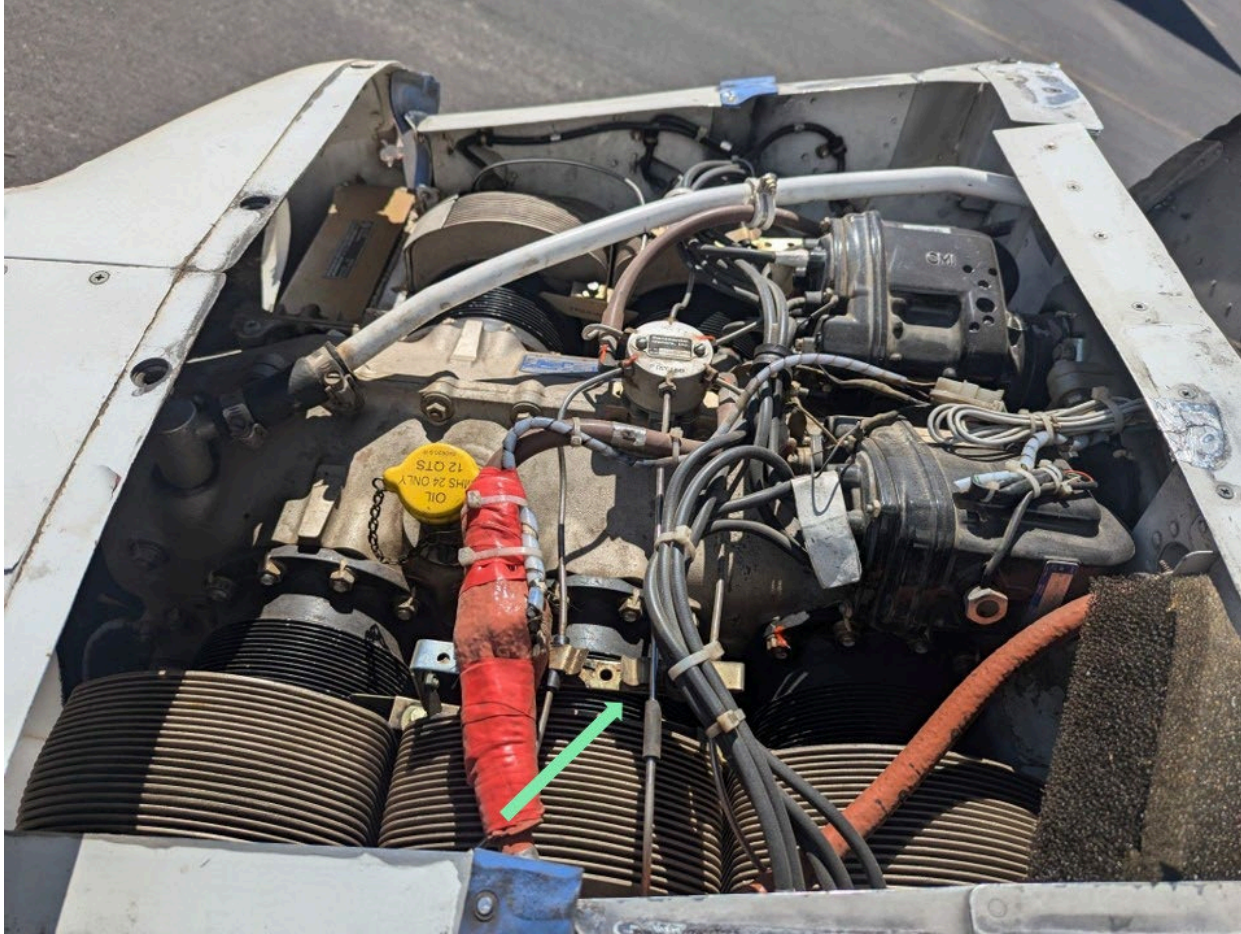
**Figure 2.** Photograph of the engine after it was loaded onto a recovery vehicle. A green arrow points to the clamp location for the number 4 fuel injector tube. (Courtesy of the wreckage recovery team)
