Kristyn Blocher  
Air Safety Investigator  
AS-WPR

**Date:** June 9, 2025  
**Subject:** WPR24LA314, fuel flow bench test  
**Contact:** Aaron Sauer, NTSB

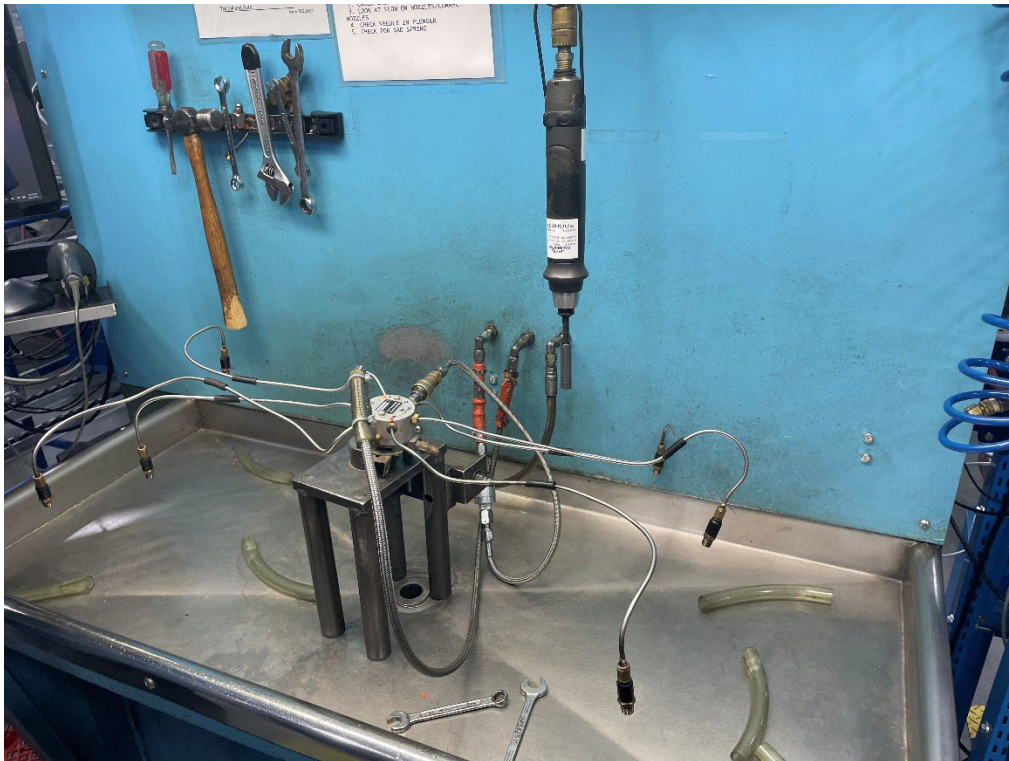
Figure 1. Test bench configuration.

Fuel flow divider body, fuel lines, and nozzles removed from packaging, then reassembled for flow/bench test. Reported as the No. 4 line was fractured and currently in the materials laboratory for failure analysis.

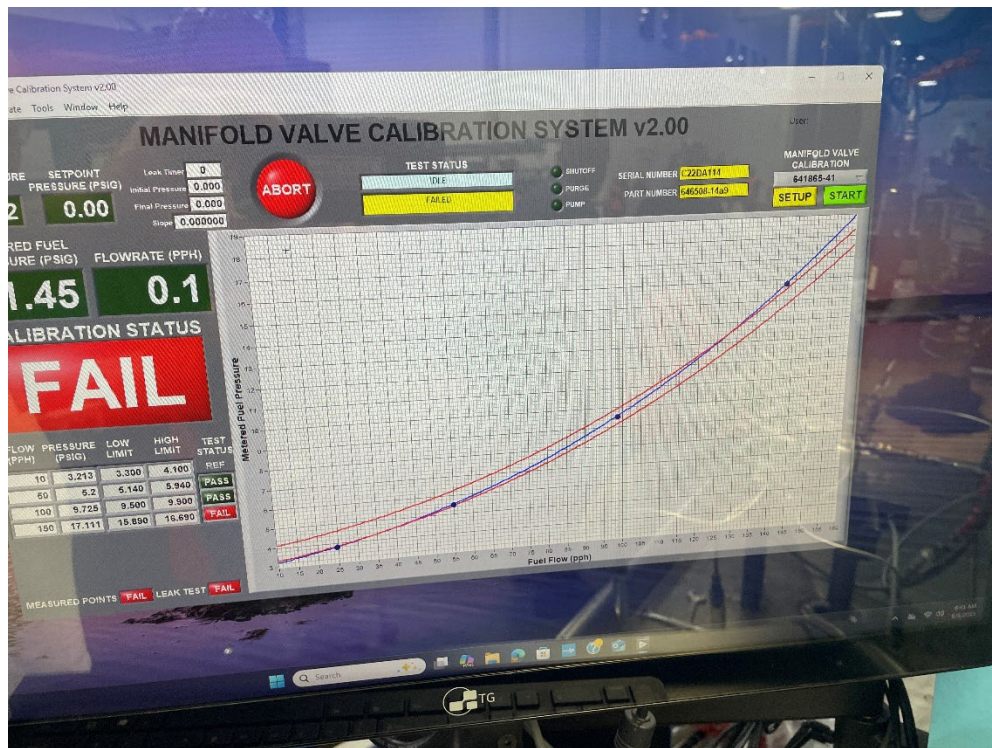
Figure 2. Flow/bench test 1.

Flow/bench test 1: Flow divider tested with all six fuel lines and nozzles connected. Flow pressures were documented (see attached photograph - normal test). Test failed due to high pressure at the 150 PPH test point.

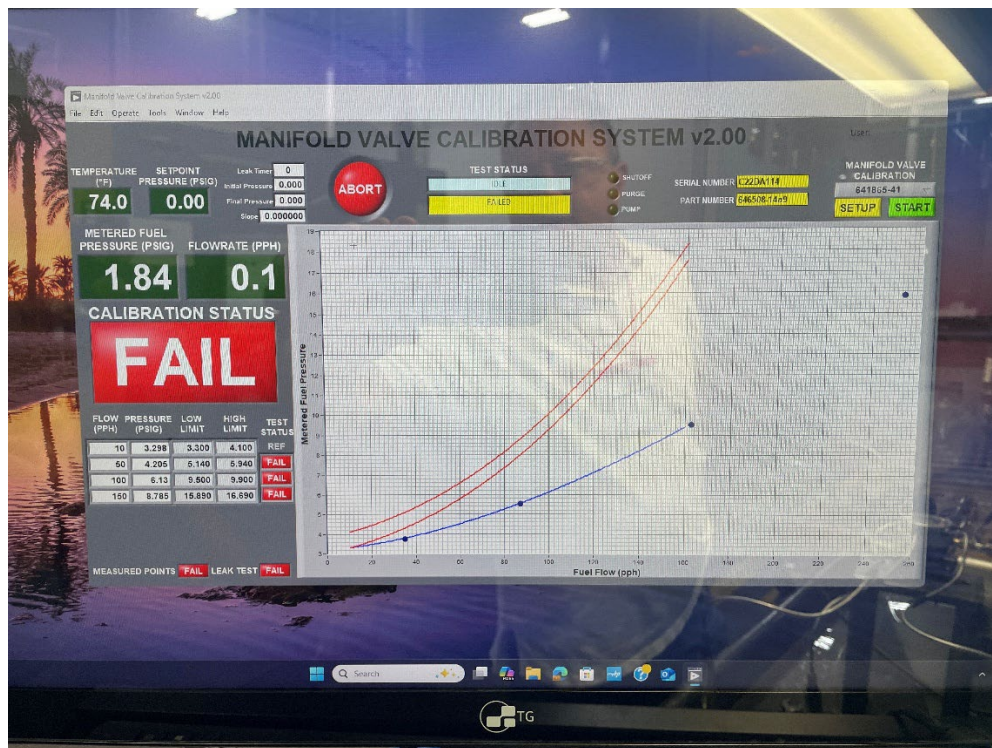
Figure 3. Flow/bench test 2.

Flow/bench test 2: Flow divider tested with the No. 4 nozzle removed and the line open. Flow pressures were documented (see attached photograph - line failure test). Test failed due to low pressures at the 50, 100, and 150 PPH test points.
