WPR24LA314

## INVESTIGATION PHOTOGRAPHS

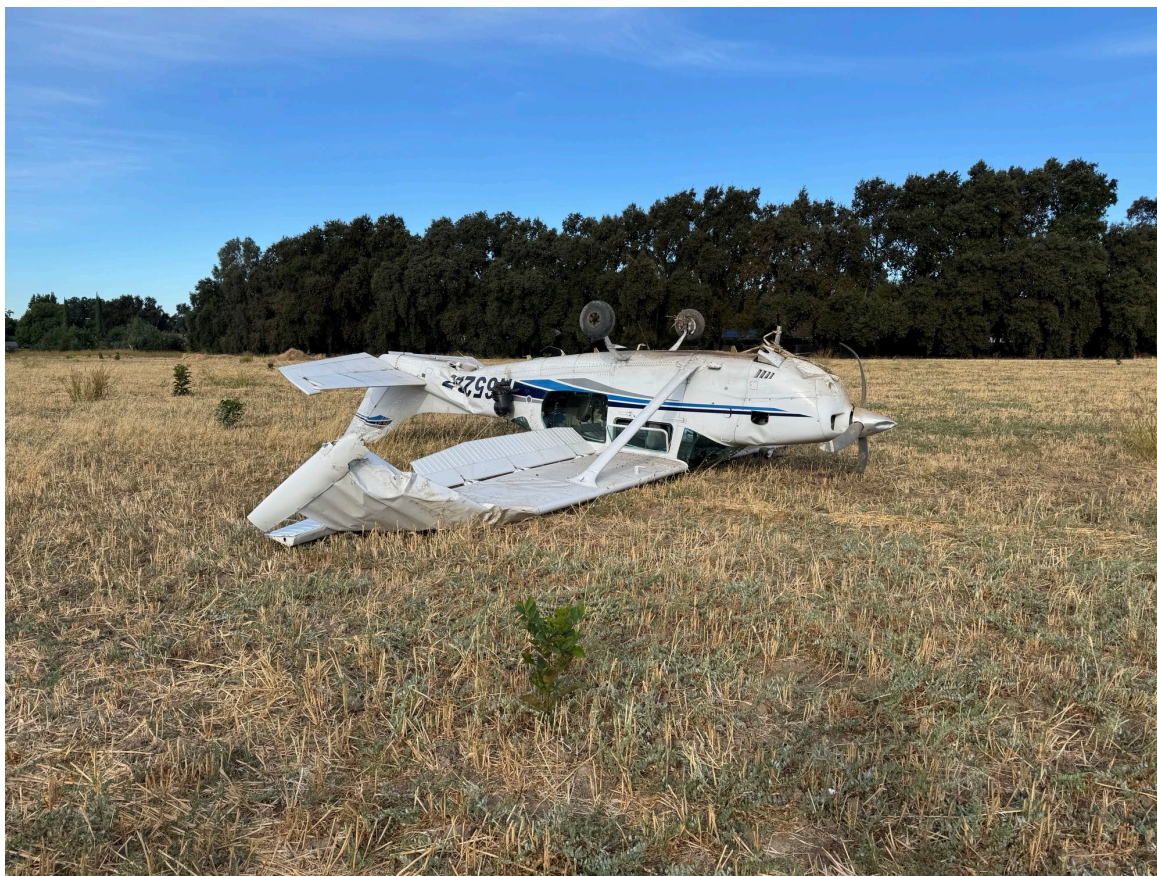
**Photograph 1 - Airplane at accident site. (Courtesy of LEO)**

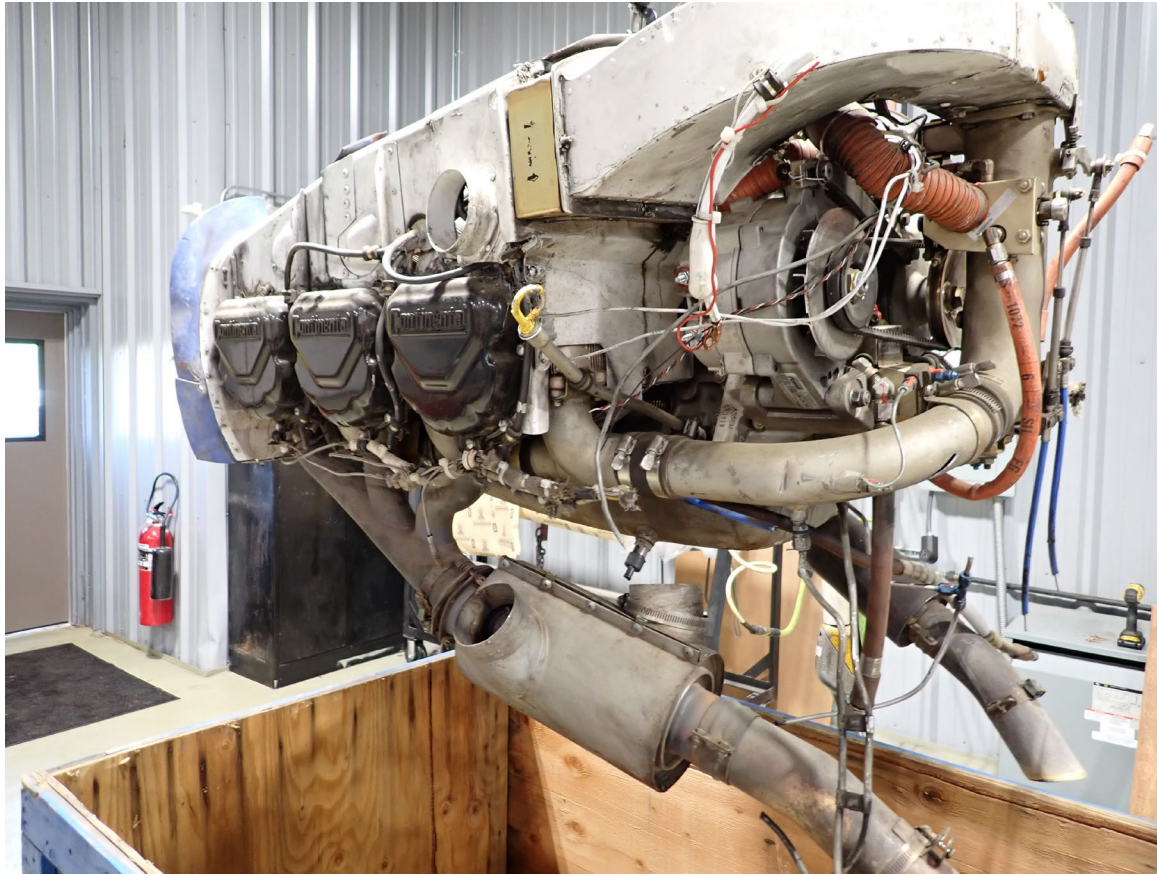
**Photograph 2 - Engine removal from crate.**

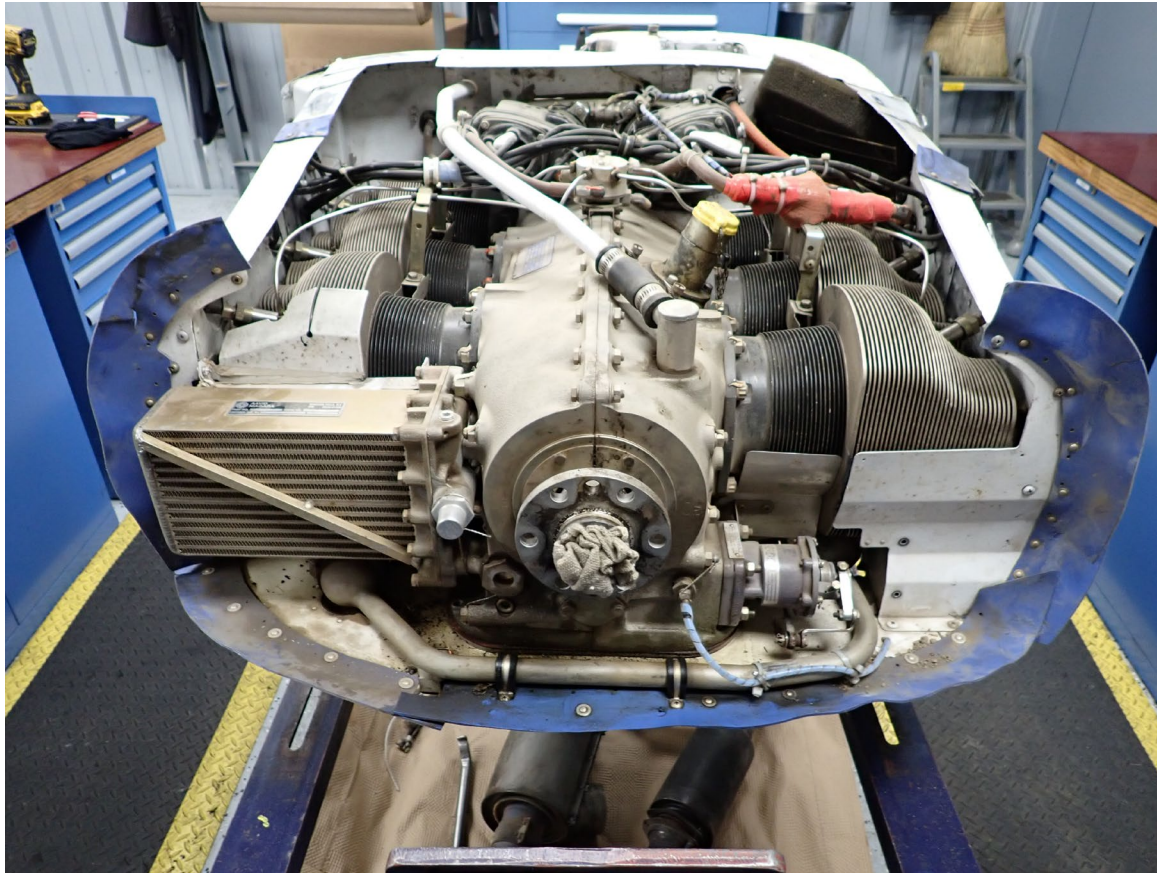
**Photograph 3 - Engine mounted on exam stand.**

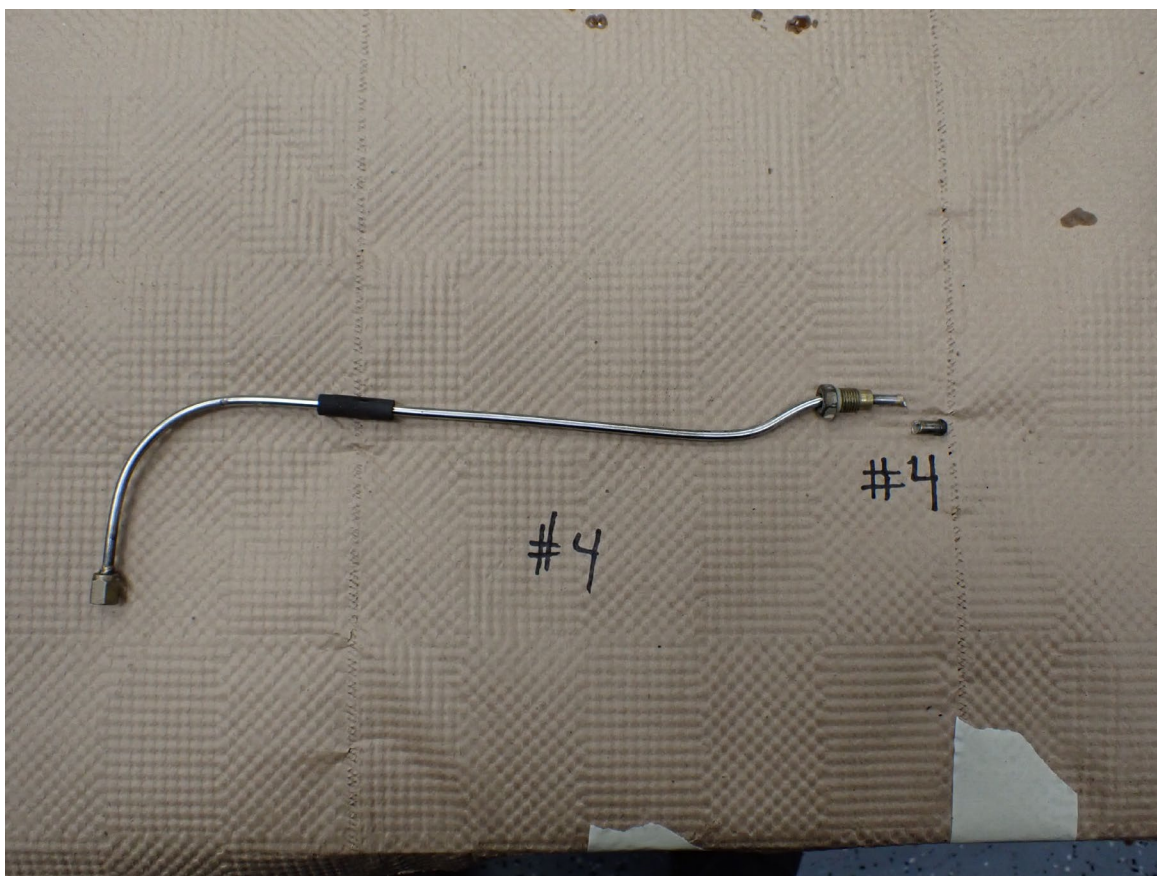
**Photograph 4 - Cylinder number 4 fuel injection assembly tube.**

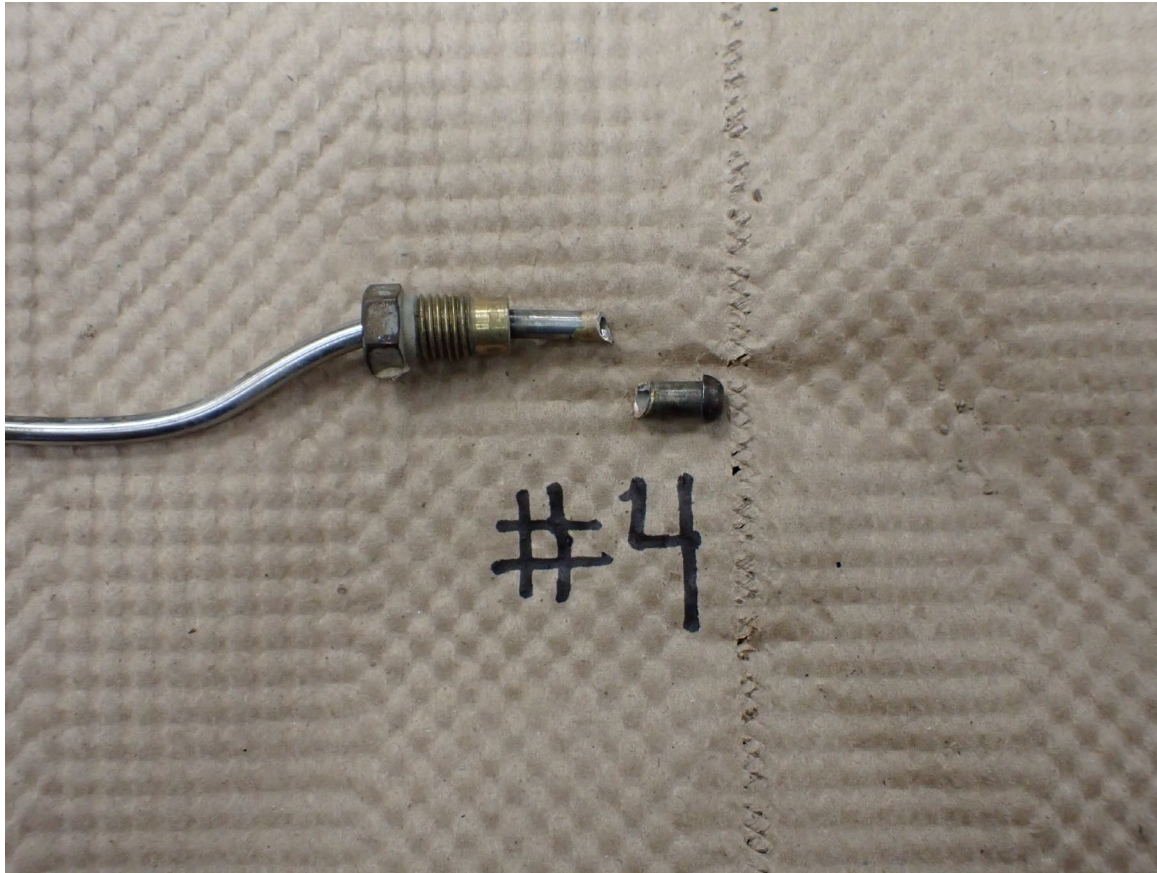
**Photograph 5 - Cylinder number 4 fuel injection assembly tube.**
