# National Transportation Safety Board

WPR24LA314

## **ENGINE EXAMINATION SUMMARY REPORT**

Location: West Sacramento, California  
Date: September 19, 2024  
Time: 0819 Pacific daylight time  
Airplane: Cessna U206G, N6522Z

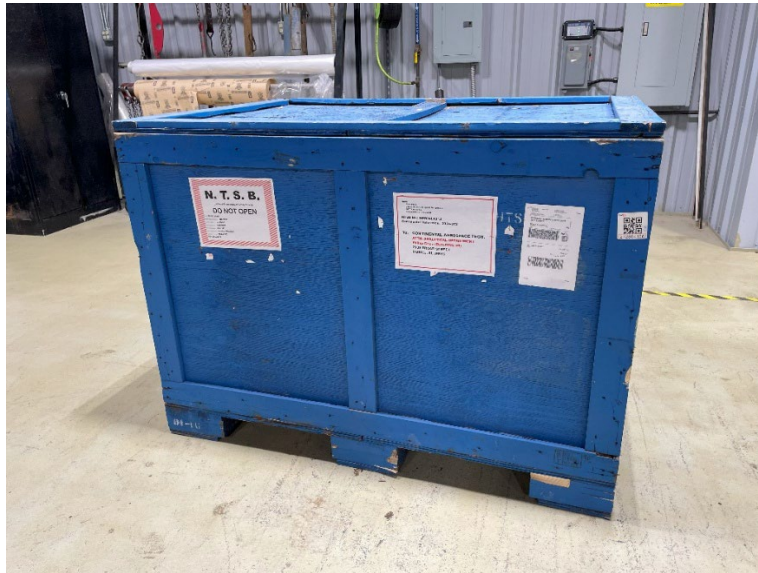
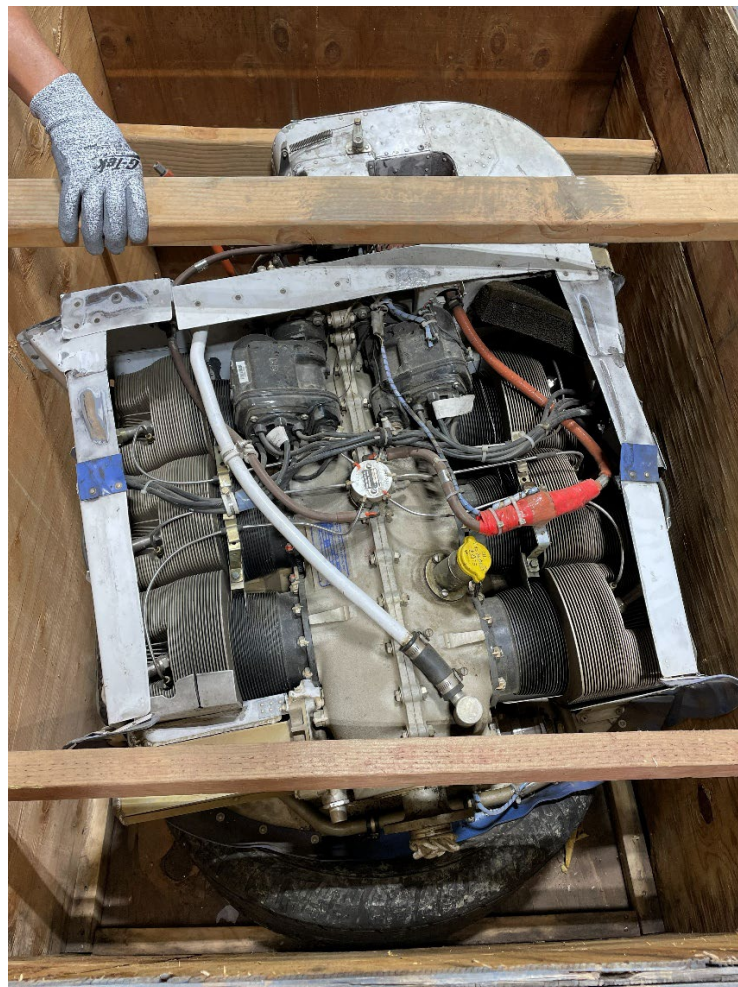
The engine was received crated and sealed. (see figures 1 and 2.) After removal from the crate, the engine was examined. The exhaust remained attached to the engine. The exhaust was removed and visually examined; no blockages were noted.

Figure 1. View of engine crate at examination site.

Figure 2. Engine prior to removal from crate.

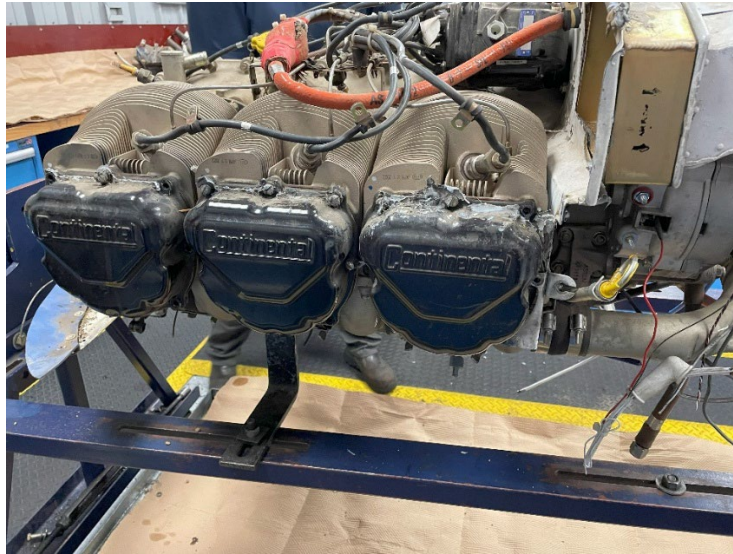
Examination of the recovered engine revealed that all six cylinders and all engine accessories remained attached. No evidence of any external mechanical damage was observed to the engine crankcase. (see figure 3.)

Figure 3. View of engine during examination.

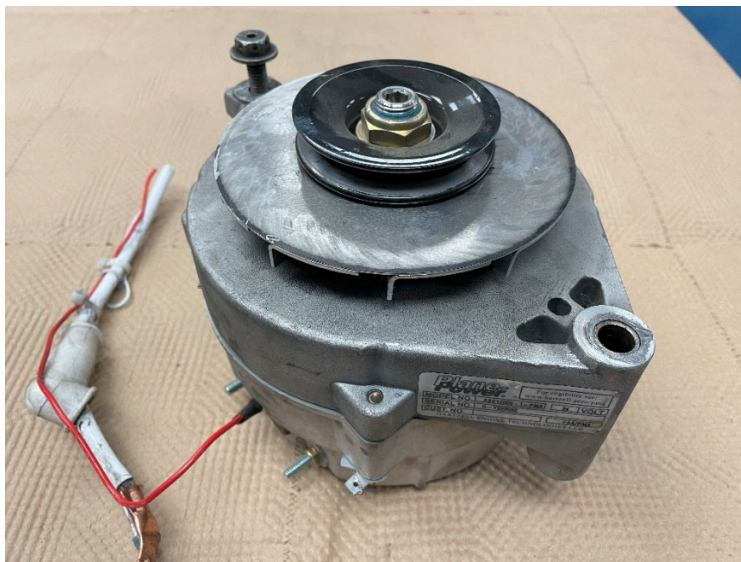
The alternator remained attached to the engine, no apparent damage was noted; it was removed and rotated freely. (see figure 4.)

Figure 4. View of alternator.

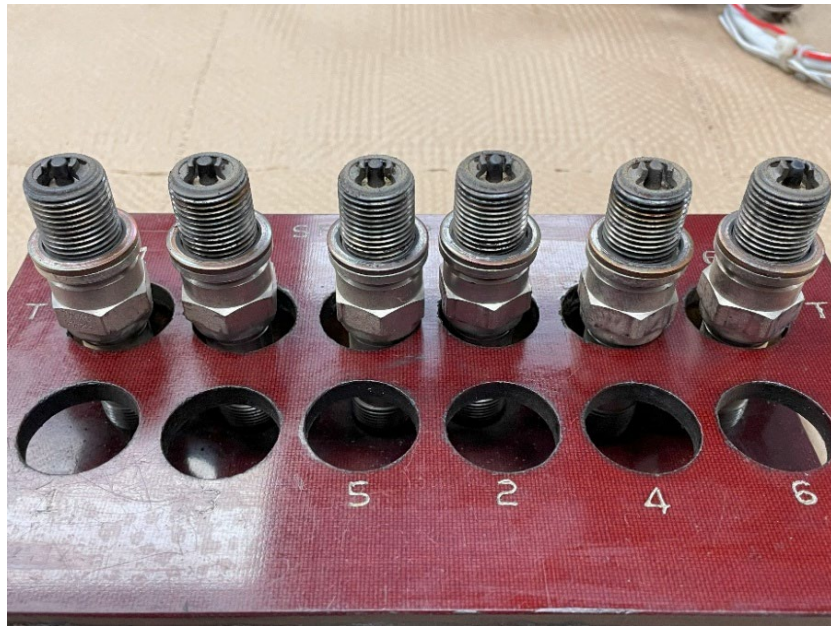
The upper spark plugs were removed from the engine, and they were the massive electrode type. The sparkplugs exhibited black and gray deposits within the electrode area. All of spark plugs exhibited signatures consistent with WORN NORMAL when compared to the Champion Check-A-Plug comparison chart. (see figure 5.)

Figure 5. View of upper spark plugs.

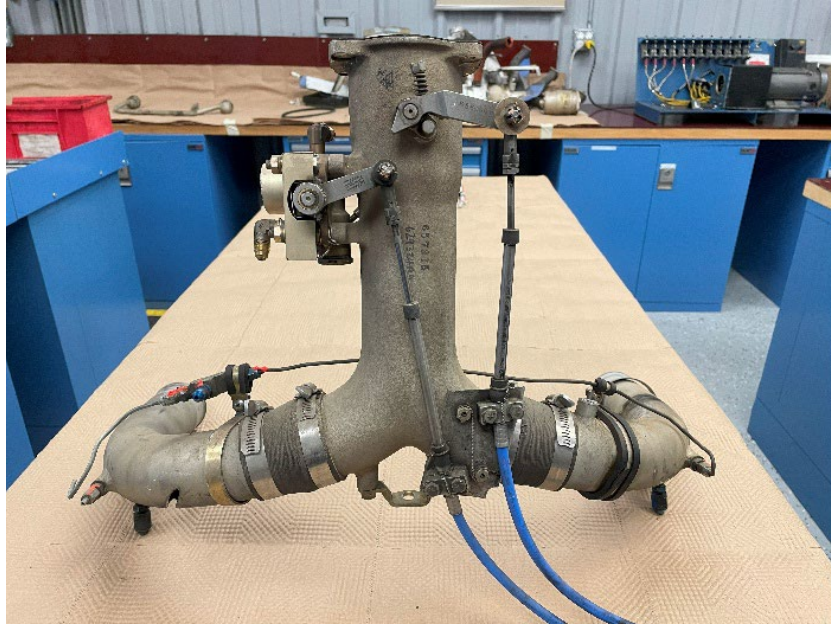
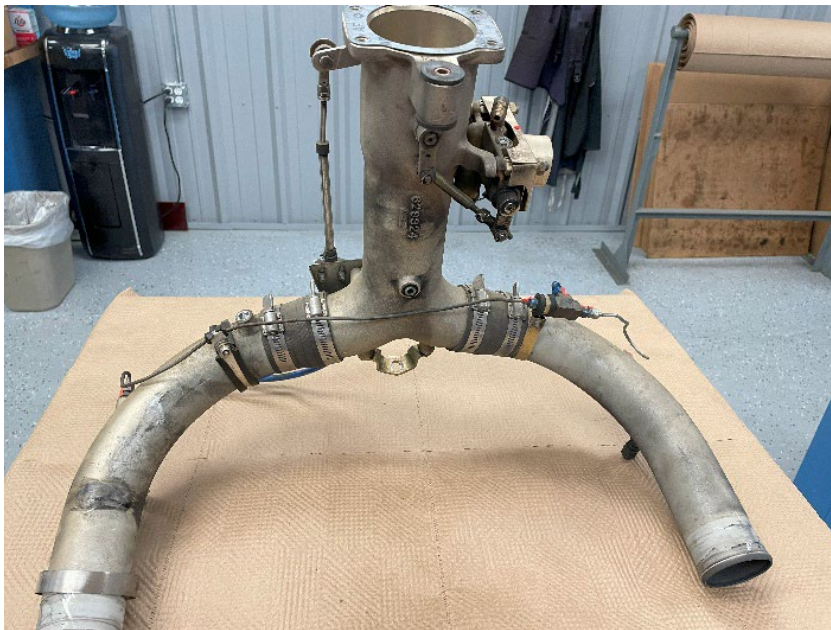
The throttle body was removed from the engine. (see figures 6 and 7.) The throttle lever was intact, moved freely from stop to stop.

Figure 6. View of throttle body.

Figure 7. View of throttle body.

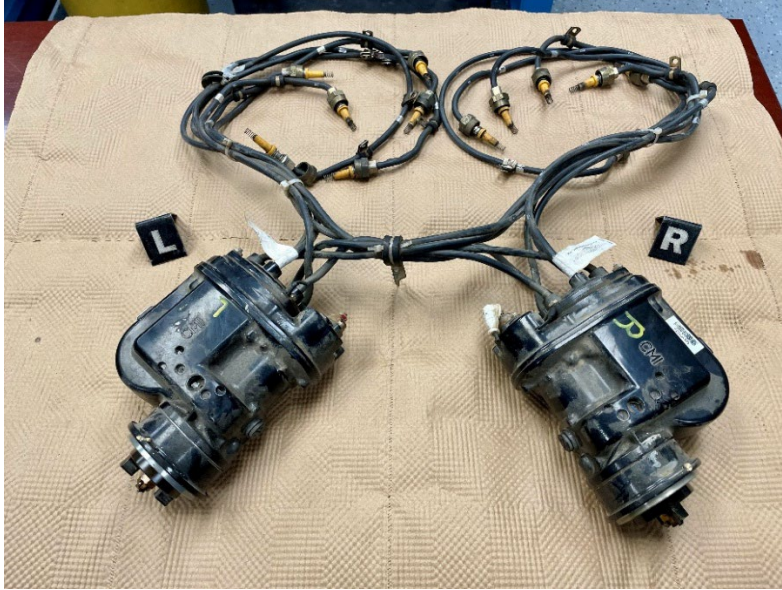
The magnetos remained attached to the engine. Left magneto timing was  $25^{\circ}$ , right magneto timing was  $24^{\circ}$ . The magnetos were removed and mounted to a test stand; spark was produced from both. (see figure 8.)

Figure 8. View of left and right magnetos.

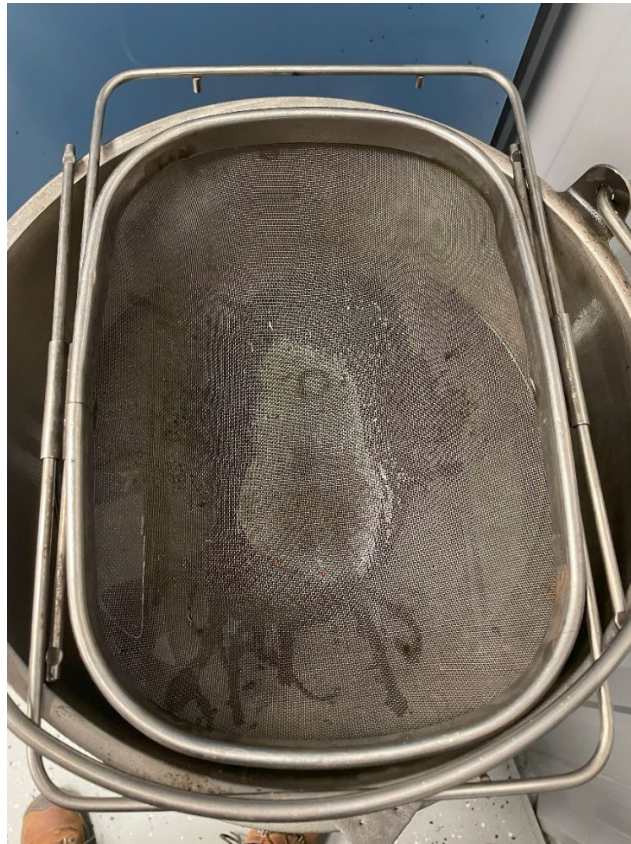
The engine oil dipstick was removed and measured 12 quarts of oil. The oil was drained through a screen. No ferrous debris was observed in the oil. (see figure 9.) The oil filter was opened; no debris was observed in the accordion filter screen.

Figure 9. View of screen oil was drained through.

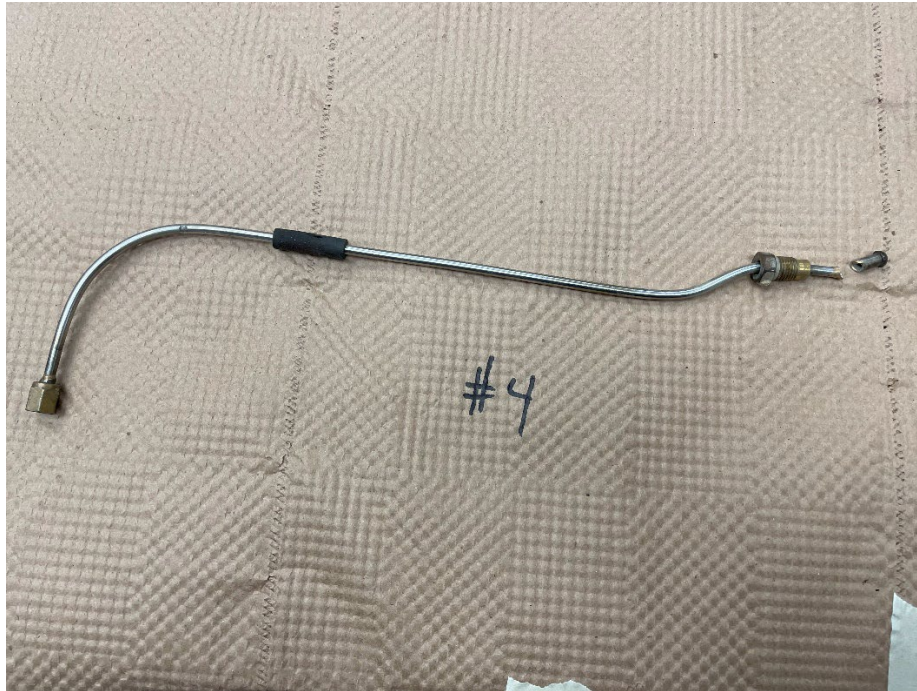
An examination and tear down of the engine was conducted at the facilities of Continental Aerospace Technologies on May 28 and 29, 2025. The examination revealed the number 4 cylinder fuel injection assembly tube was fracture separated at the solder, near the manifold attach point.

The fuel manifold remained attached and secure to the engine. The no. 4 injector assembly tube exhibited a fracture separation at the manifold fitting; all remaining injector assembly tubes remained secure. (see figure 10.) All fuel injectors were unobstructed. The fuel manifold was removed and disassembled; no anomalies were noted and the screen was clear. (see figure 11.)

Figure 10. View of the no. 4 injector assembly tube.

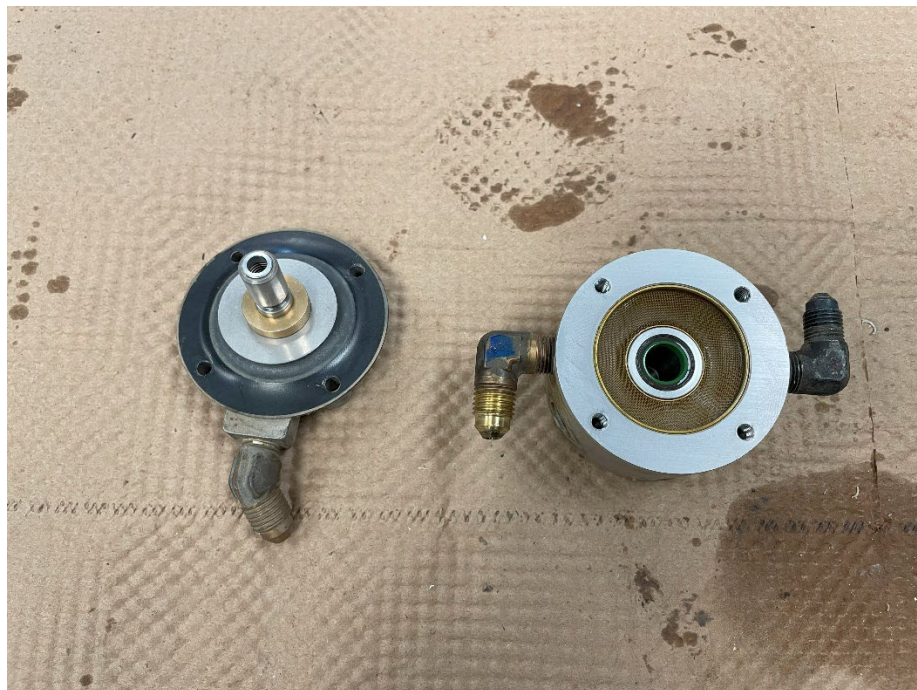
Figure 11. View of disassembled fuel manifold.

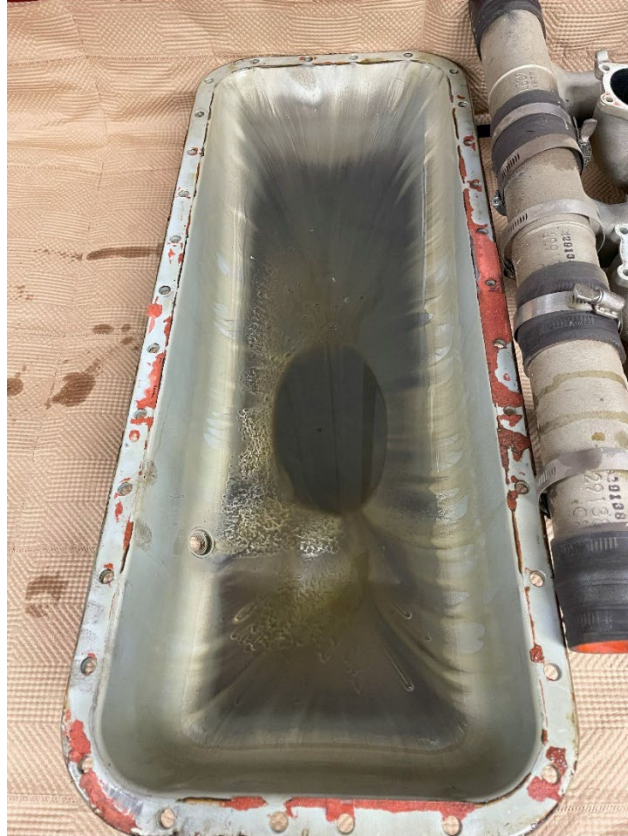
The propeller governor remained attached to the engine, no visible damage was observed. The oil sump remained attached to the engine, no visible damage was observed. The oil sump was removed, and no ferrous debris was observed within. (see figure 12.)

Figure 12. View of the oil sump.

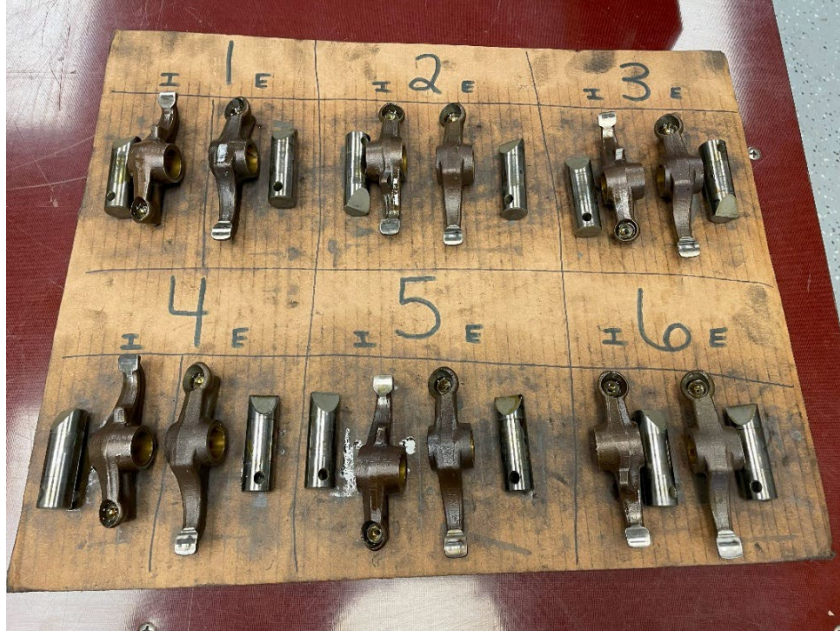
The rocker box covers were removed. The intake and exhaust rocker arms were intact and oil coated on all cylinders. All intake and exhaust valve springs were in place and visually appeared to be undamaged. All rocker arms and push rods were removed, with no visible damage noted. (see figure 13.)

Figure 13. View of rocker arms and push rods.

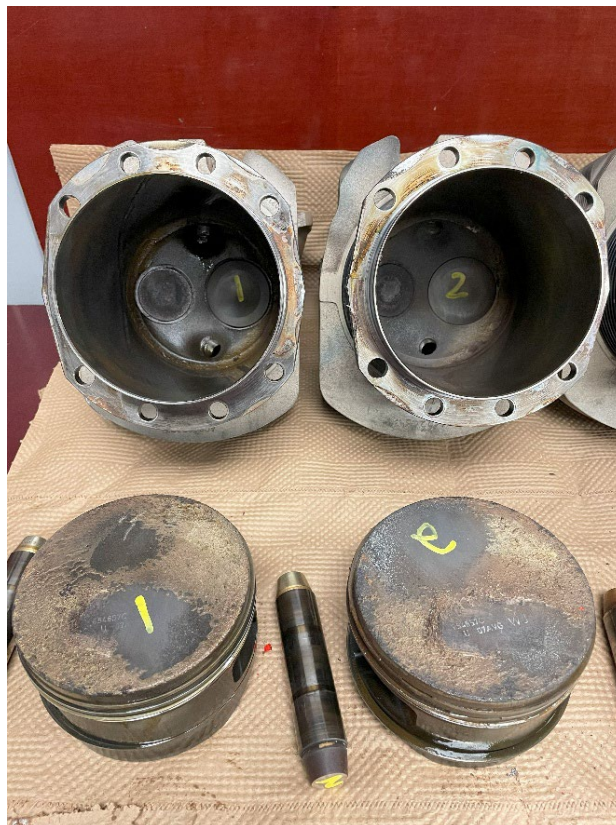
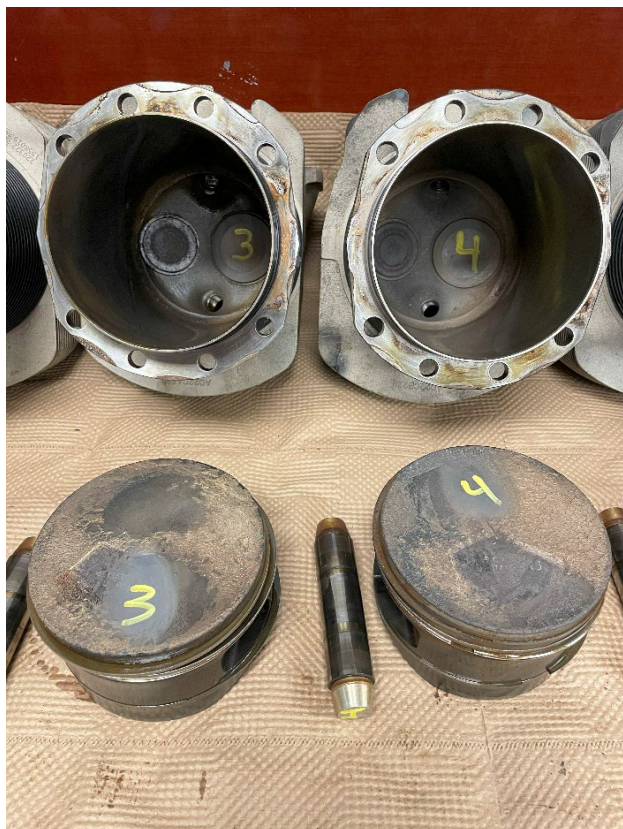
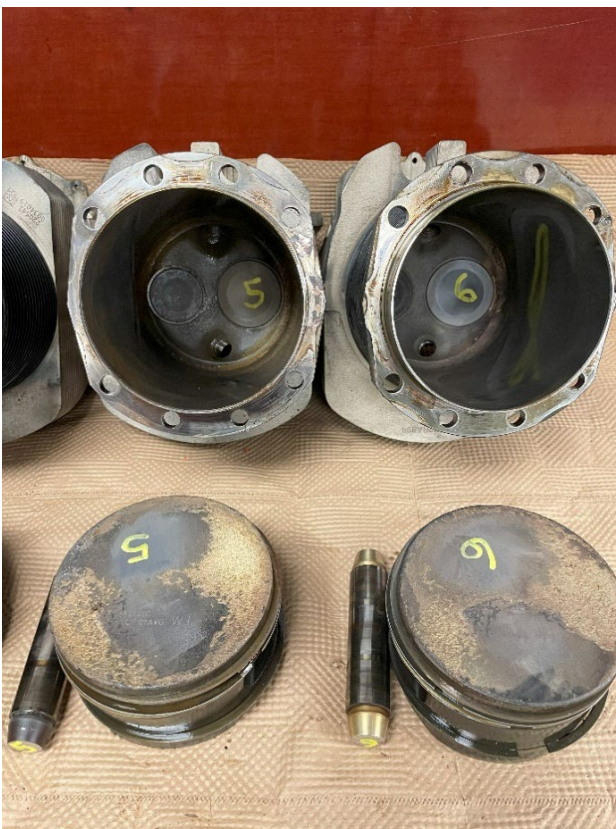
All cylinders remained attached to the engine, no external visible damage was observed. The cylinders and pistons were removed and visually examined. No damage was noted to any of the cylinders or pistons. (see figures 14-16.)

Figure 14. View of cylinders nos. 1 & 2.

Figure 15. View of cylinders nos. 3 & 4.

Figure 16. View of cylinders nos. 5 & 6.

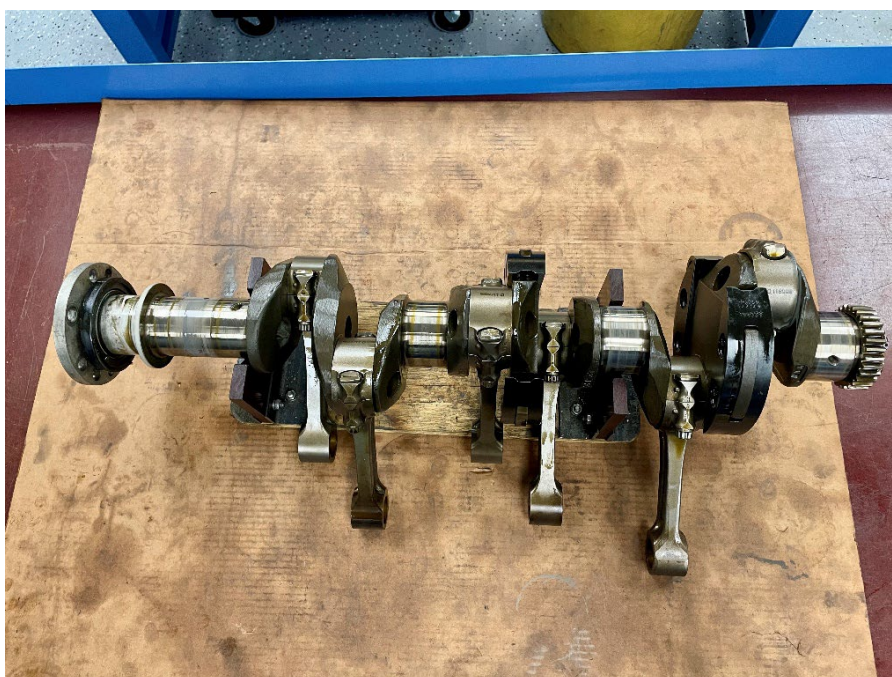
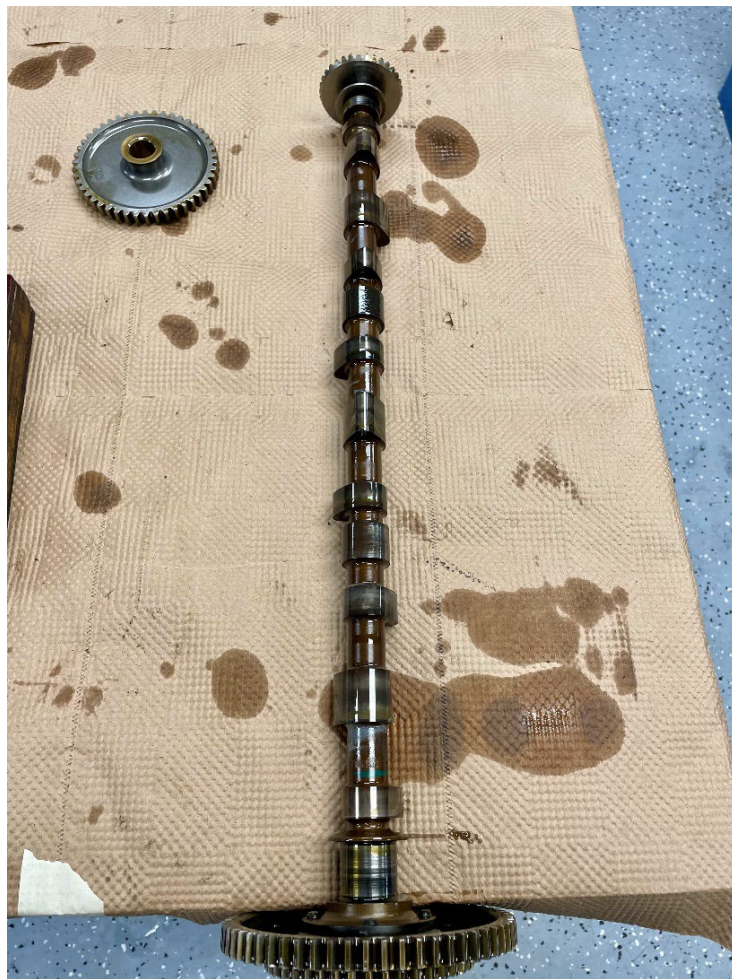
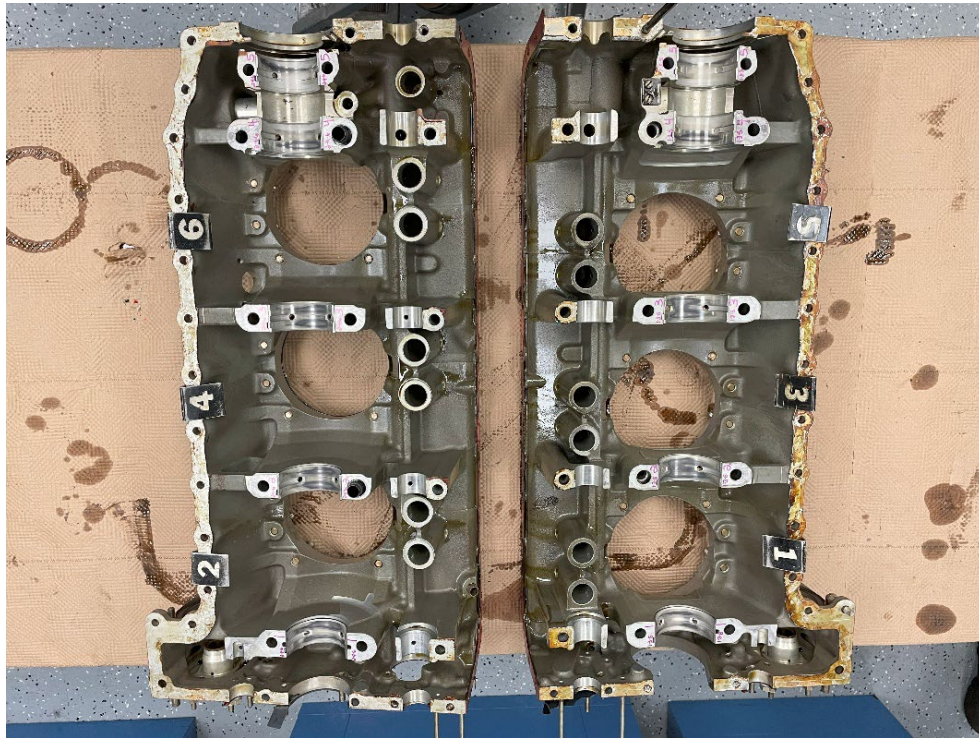
The crankcase was disassembled; the camshaft and crankshaft were removed. No anomalies were noted on the camshaft or crankshaft. (see figures 17-19.)

Figure 17. View of the crankshaft.

Figure 18. View of the camshaft.

Figure 19. View of the crankcase.
