**FLIGHT TEST REPORT No. 206L-MR-FTR-306**

**RISK ASSESSMENT OF LIGHTWEIGHT, HIGH-SPEED,  
VERTICAL VIBRATION**

**MAIN ROTOR BLADE ASSEMBLY 20633000-101**

December 4, 2025

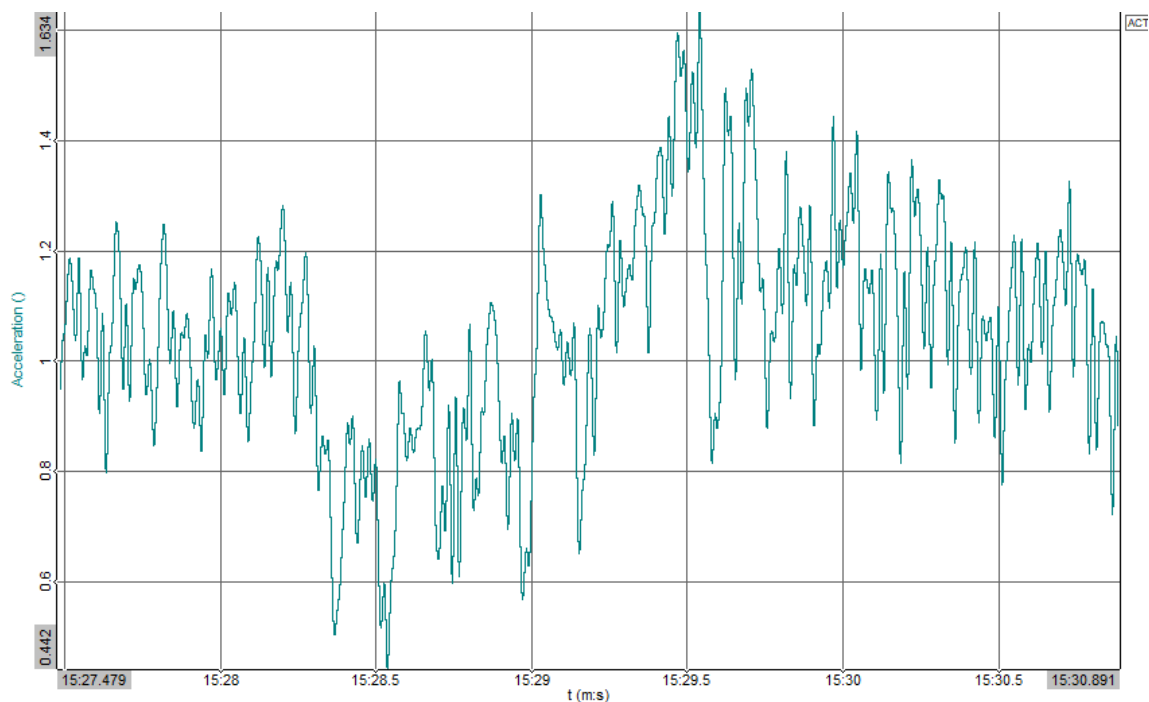
| <p>not reduce collective. The resulting data are therefore considered representative of the onset and expected recovery for real-world vertical vibration occurrences.</p> <p>Cabin vibration was measured using a Shear ICP Accelerometer mounted vertical on the center console. Data acquisition was accomplished using a DEWESoft SIRIUS-R4RT or DEWESoft Krypton 4xACC data acquisition systems at a sample rate of 5000Hz. Due to significant high-frequency signal noise even during level flight, a 100 Hz, Butterworth, low-pass filter was applied to the data to more clearly show the 5Hz frequency content.</p> <p>Figure 1 and Figure 2 show plots of the worst vertical accelerations measured on aircraft N62HP &amp; N393S both of which had previously reported severe vibrations. On N62HP the recovery took about 1.5 seconds for acceleration levels to resume baseline levels, on N393S it took approximately 3 seconds. In both cases, the max G levels only occur for a single cycle with diminishing values immediately before and after.</p> <p>When VHA received N393S for testing, it was configured with nearly 12 pts of forward sweep. No forward sweep is permitted per section 62 of the maintenance manual (Reference 2). The sweep was a result of improper procedure used in string alignment of the rotor head during install. In this forward swept condition, the aircraft was much more prone to the vertical vibration. The minimum and maximum acceleration levels were .41 G and 1.97 G, resulting in a cyclic G level of <math>\pm 0.78</math> G. The 5Hz cycles are approximately <math>\pm 0.5</math> G. This represents the worst-case configuration with a ship well out of published maintenance limits.</p> | | | |

**Figure 1: Unprovoked vertical vibration on N62HP**

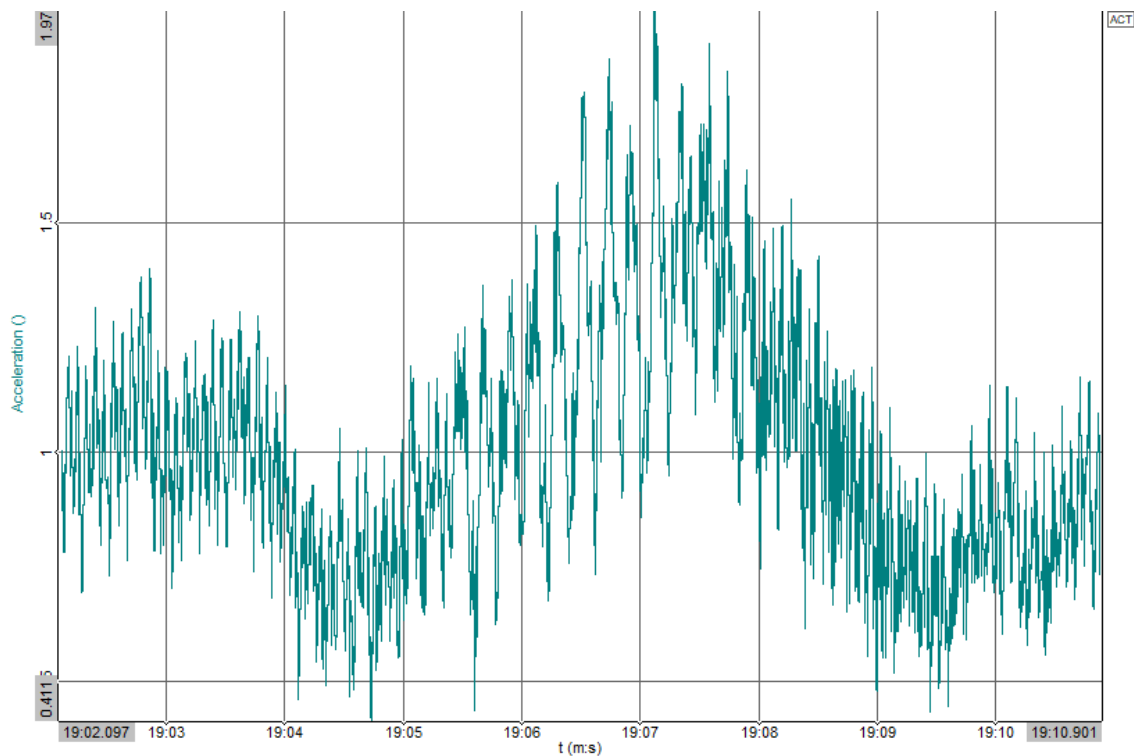
**Figure 2: Unprovoked vertical vibration on N393S**

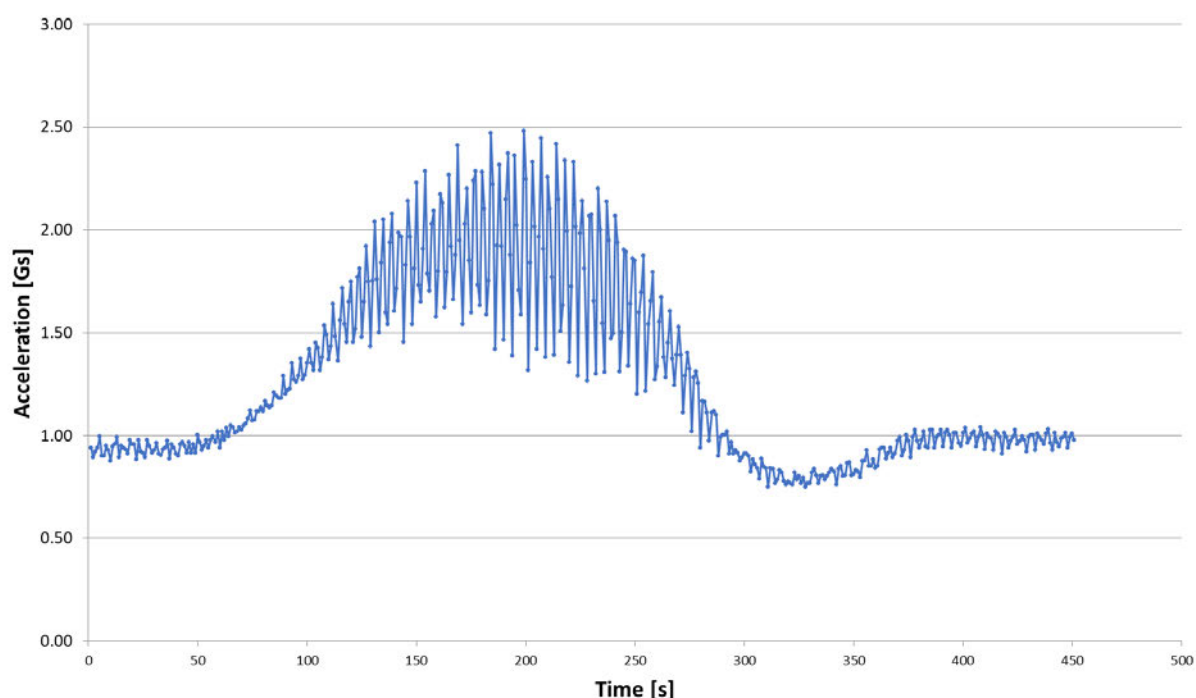
Certification testing for the 20633000-101 main rotor blade (reference 3) documented acceleration levels ranging from 0.4 during a simulated power failure to 2.5 G's during a cyclic pull-up (Figure 3). The worst-case acceleration level measured during a vertical vibration event in which the pilot performed the appropriate recovery method was 1.97 G's. Since the airframe certification testing would have required the demonstration of structural capability and life limits beyond these G levels, there is no impact to the structural integrity of the aircraft. Furthermore, the measured G values are conservative since they were measured on an aircraft with grossly out-of-tolerance maintenance conditions.

**Figure 3: Measured acceleration during a Max G, Cyclic Pull-up**
