## Service Bulletin

### LIGHTWEIGHT, HIGH-SPEED, VERTICAL VIBRATION RECOVERY AND MITIGATION

**HELICOPTER MODELS AFFECTED:** Bell Models 206L, 206L-1, 206L-3, & 206L-4.

**NOTICE No.:** 33000-6R2  
**DATE:** 19 September 2025  
Page **5** of **5**

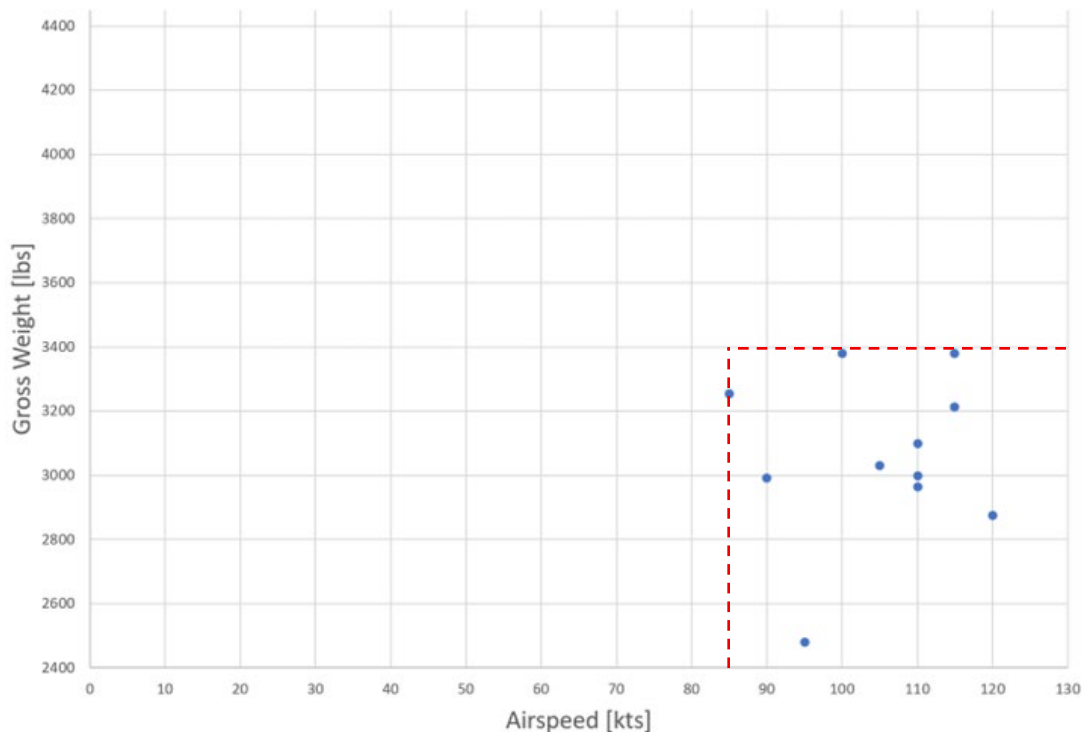
Figure 1. Vertical Hop Flight Envelope

As of the date of publication, this phenomenon has been reported on only 15 aircraft since 2019. All have landed safely. One instance resulted in damage to the aircraft due to the pilot being unaware of the proper recovery resulting in prolonged vibration. All reported instances have been less than 3,400 lbs gross weight, typically with a single pilot and low fuel (see Figure 1). Of the nearly 300 aircraft in service with 20633000-101 main rotor blades, the vast majority (~95%) have never experienced this issue.
