# National Transportation Safety Board

WPR24LA319

## **AIRWORTHINESS**

Location: Fern Prairie, WA  
Date: September 26, 2024  
Time: 1540 Pacific daylight time (PDT)  
Helicopter: Bell Helicopter 206L / N9984K

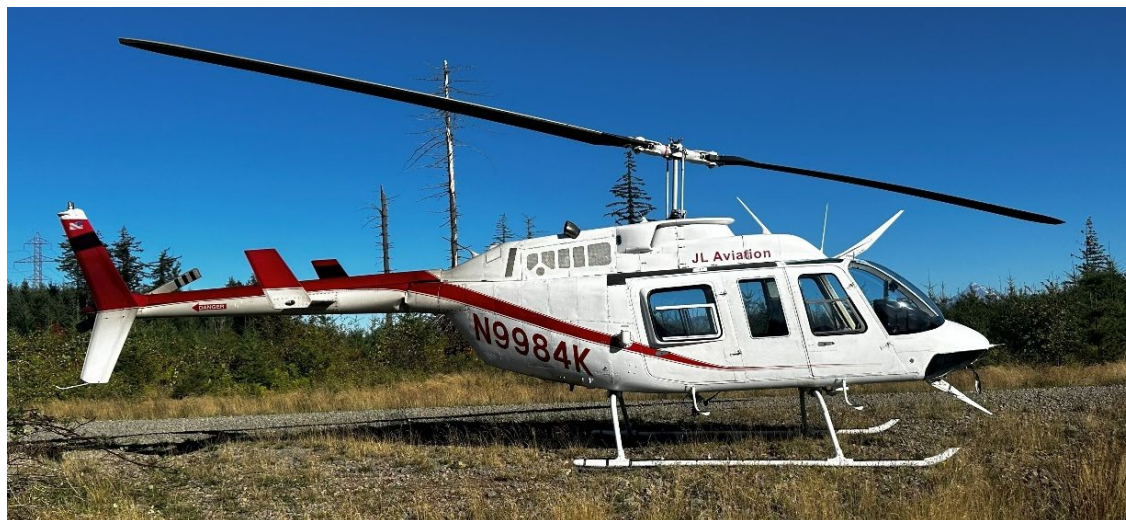
According to the pilot, he had departed a remote landing zone and was enroute to the Fly JLA Airport (OR72), Boring, Oregon. While in cruise flight about 1,000 ft above ground level, the helicopter experienced “a severe vertical hop” and began to shake violently. The pilot initiated an emergency descent, during which time the shaking subsided. The pilot performed a normal landing in an open field. After egressing, the pilot observed substantial damage to the helicopter’s tail boom (Figure 2) .

**Figure 2.** The helicopter immediately after the emergency landing with damage to the tail boom. [Source: JL Aviation]

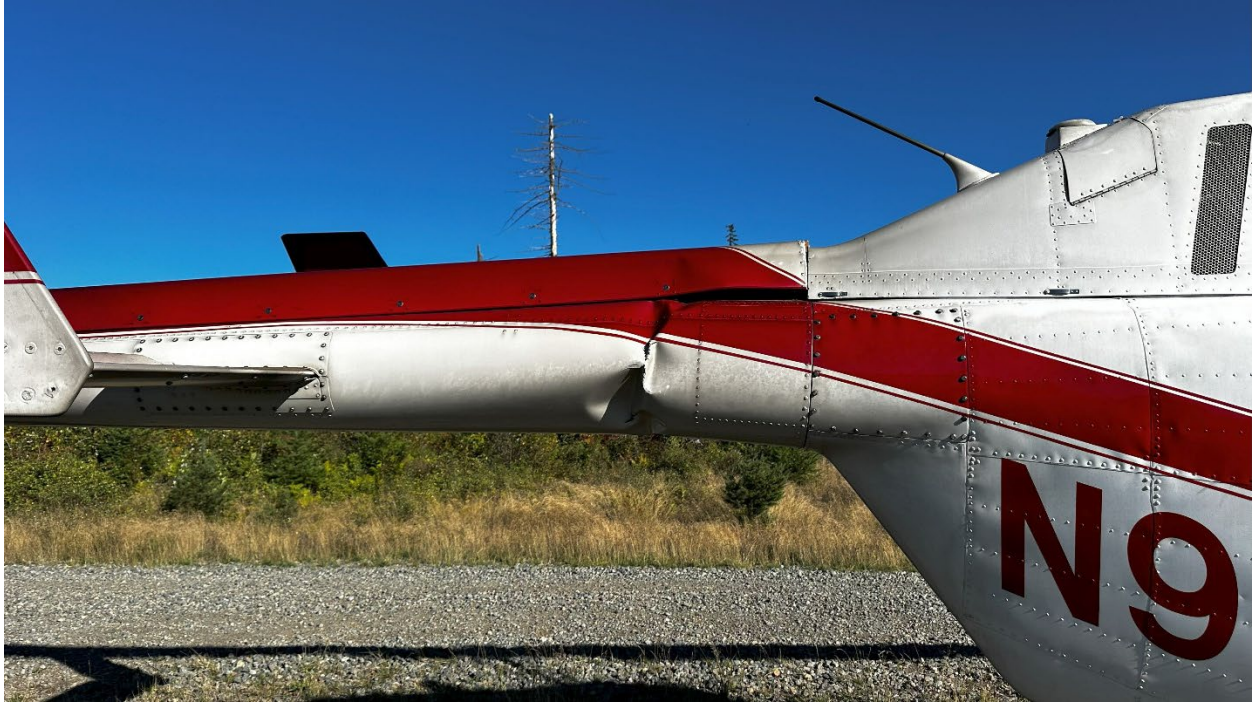
**Figure 3.** Tailboom downward buckle near boom station 42.59. [Source: JL Aviation]

The tail boom displayed buckling around its entire circumference about 13 inches aft of the intercostal support (station 231.486); it was displaced downward and about 15° and to the right. The tail rotor drive shaft could be rotated by hand and appeared undamaged. The elevators moved freely when the control rods were moved by hand.

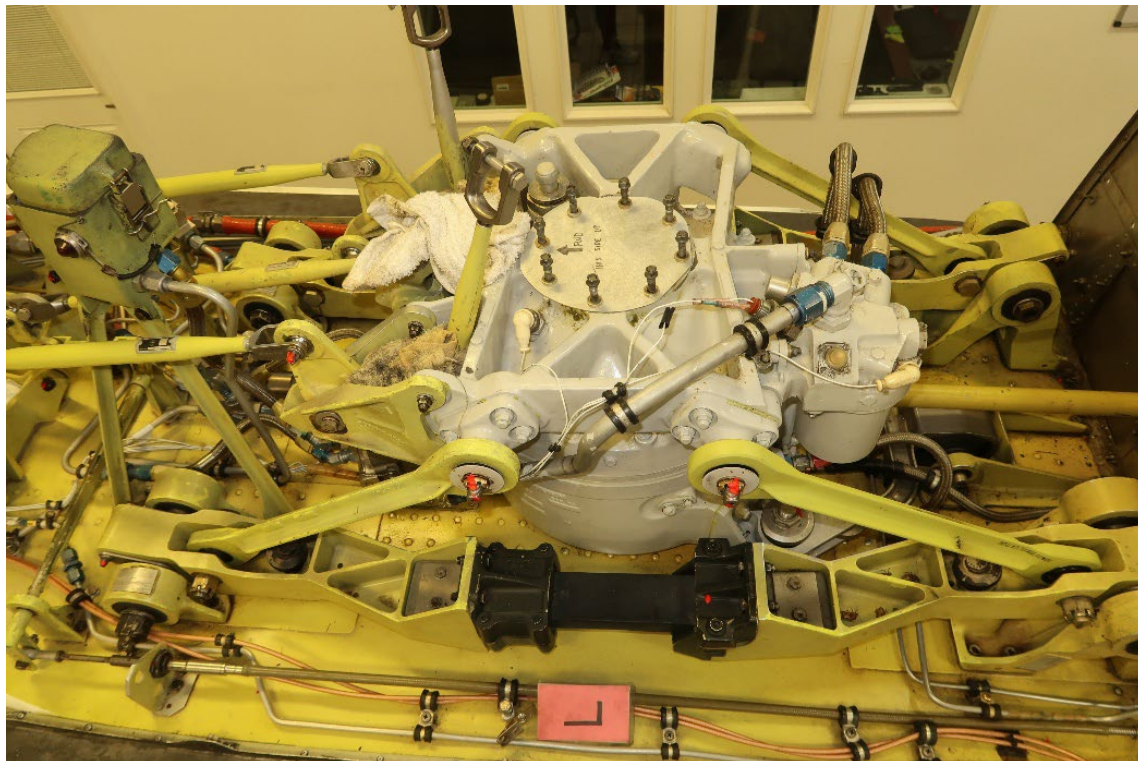
The transmission remained mounted to the nodal beam structure (Figure 4). Visual examination of the nodal beam structure did not reveal any obvious defects. The freewheeling unit functioned as intended when the engine power turbine wheel and transmission main drive shaft were rotated manually.

**Figure 4.** Main rotor transmission and transmission mounts.

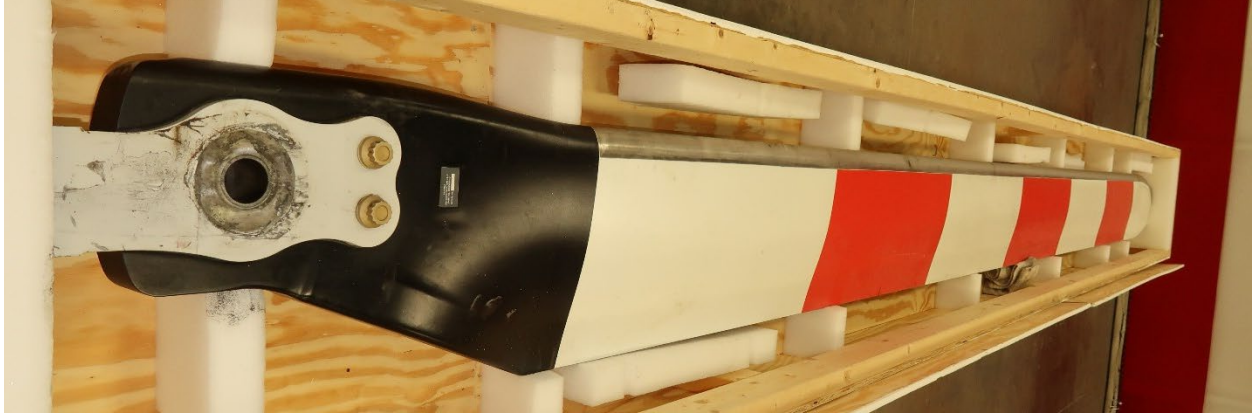
**Figure 5.** Main rotor blade, SN: A453

The main rotor blades were manufactured by Van Horn Aviation LLC. STC No. SR02684LA. Both blades were designated as part number 20633000-101 with individual identifying serial numbers. The blades had been removed from the rotor hub and stored in wood crates. Visual examination and tap testing did not reveal any defects (Figures 5 and 6).

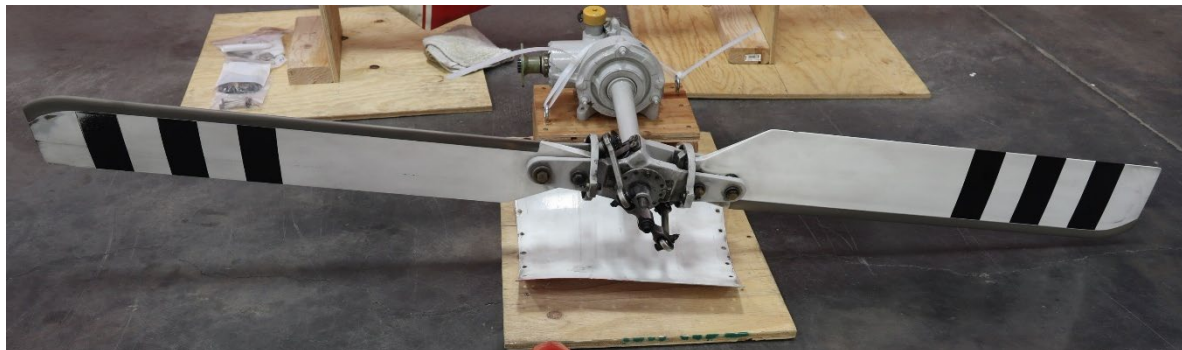
**Figure 7.** Tail rotor assembly attached to the tail rotor gearbox.

The forward short shaft (steel tail rotor driveshaft under the engine) remained connected to the engine gearbox on its forward end and the oil cooler shaft on its aft end. When rotated by hand, free drive movement was observed through the oil cooler shaft. The aft short shaft (first tail rotor driveshaft on the main fuselage) had been removed along with the tail boom from the helicopter during the recovery. The tail rotor drive shaft, Thomas couplings, and hanger bearings on the tailboom were intact. The hanger bearings rotated freely. The tail rotor gearbox exhibited free rotation by hand and corresponding rotation of the attached tail rotor hub and blades was observed. The tail rotor gearbox had been removed from the tailboom during recovery (Figure 7).

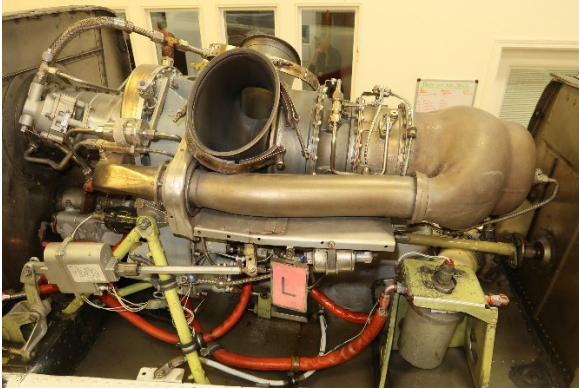
**Figure 8.** View of the left side of the engine.

The engine remained mounted to the helicopter (Figures 8 and 9). External visual examination did not reveal any damage to the engine or engine mount. The engine inlet guide vanes appeared undamaged. The turbine moved freely when rotated by hand.

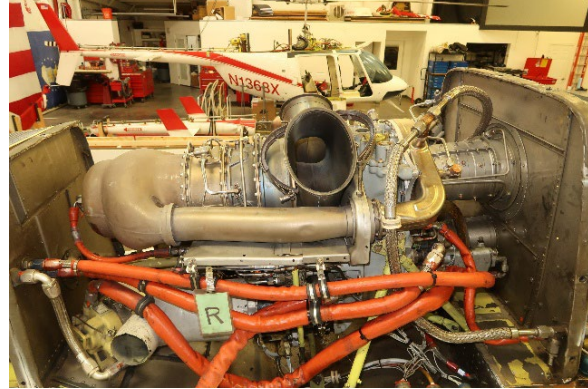
**Figure 9.** View of the right side of the engine.
