# National Transportation Safety Board

WPR25FA020

## **AIRFRAME AND ENGINE EXAM**

Location: Las Cruces, New Mexico  
Date: October 20, 2024  
Time: 0224 MDT  
2024 UTC  
Airplane: Extra Flugzeugbau GmbH EA 300/L, N512DW

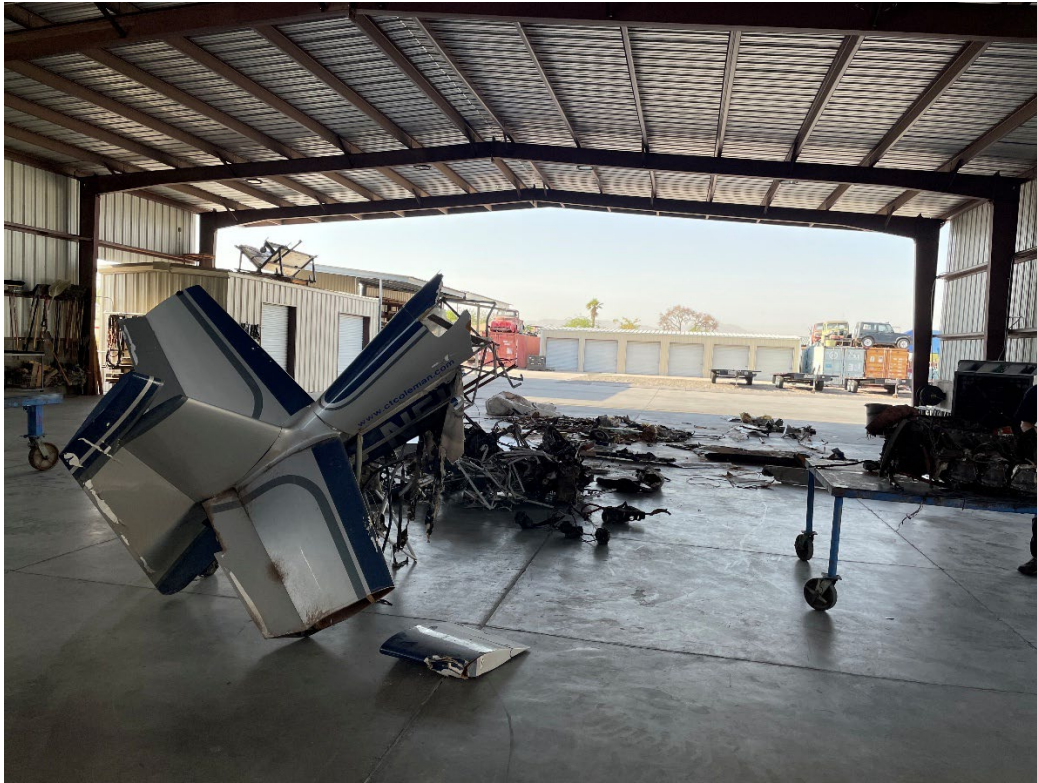
**Figure 1 Airframe and engine exam**

Flight control continuity was established from the cockpit flight controls to the respective flight control surfaces. All areas of separation within the flight control cables were consistent with overload or separation by recovery personnel to facilitate removal from the accident site. There were no anomalies with the engine that precluded normal operation.

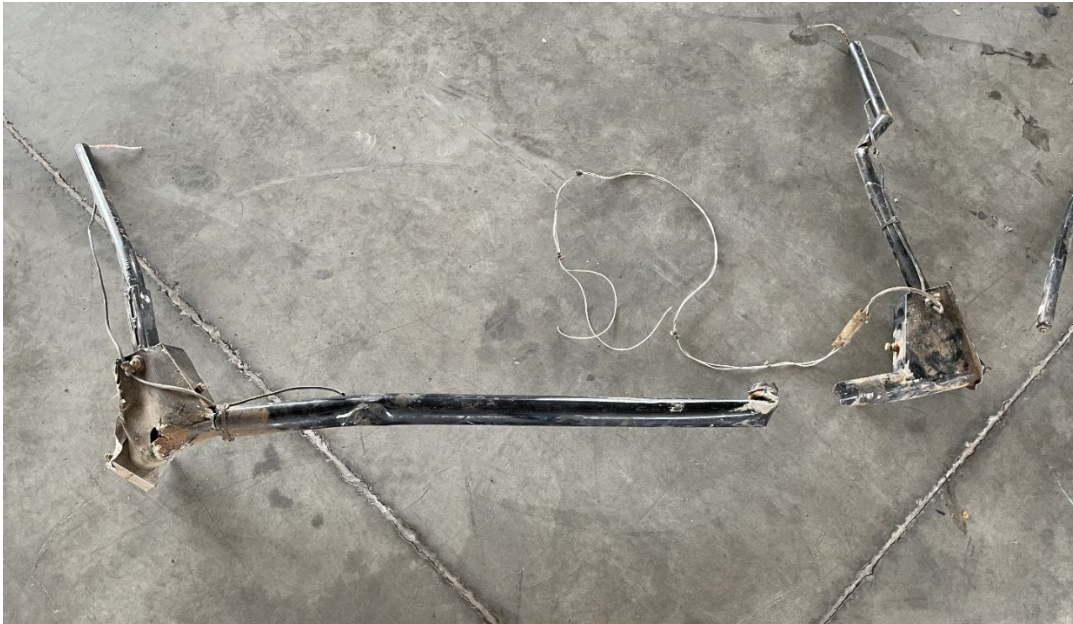
**Figure 2 Forward and aft control stick**

The mass balance remained attached to the elevator control arm. The push-pull tubes forward to the control stick had separated in multiple locations, all separation surfaces exhibited bending and twisting damage consistent with overload. The control sticks remained attached at their bases (figure 2).

The control stick interconnect tube assembly had separated about 9 inches forward of the aft stick (figure 2). The aileron control arm had broken away from the outer tube of the assembly. At the failure point, the weld remained intact, and the arm had torn away in a manner consistent with overload. The aileron interconnect assembly had broken into multiple sections, with all failure features exhibiting bending damage consistent with overload (figures 3, 4, and 5). The wing push-pull tubes on both sides had separated in multiple locations, with similar bending and tear damage as observed in the elevator control system. The left aileron remained attached to the wing. The right wing and aileron had fragmented into multiple pieces. Both the left and right aileron spades remained attached to their respective control surfaces.

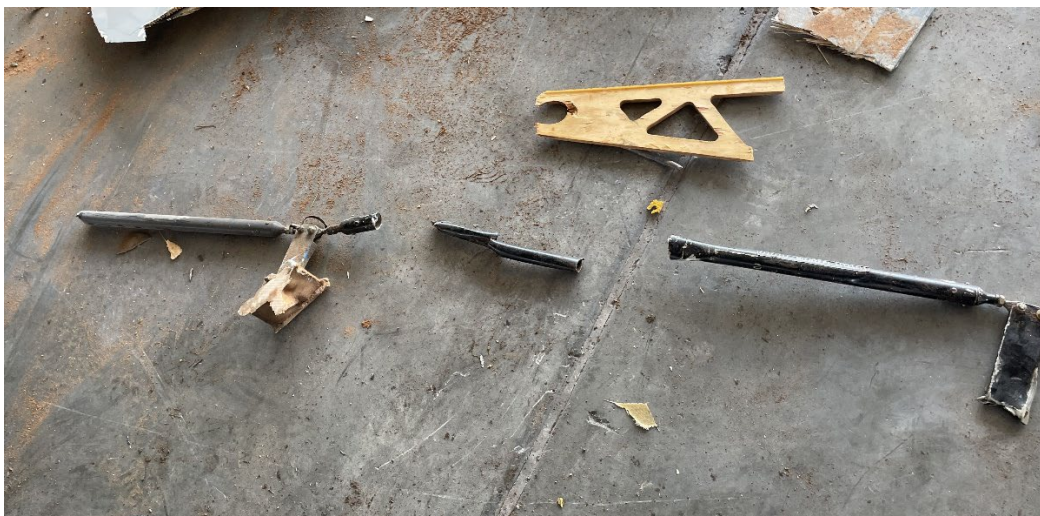
**Figure 3 View of left aileron interconnect tube assembly**

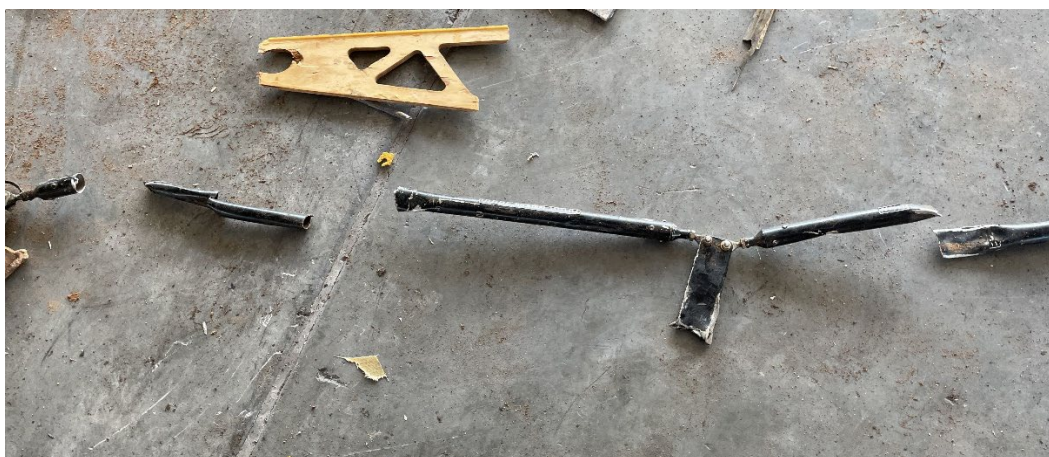
**Figure 4 View of middle aileron interconnect tube assembly**

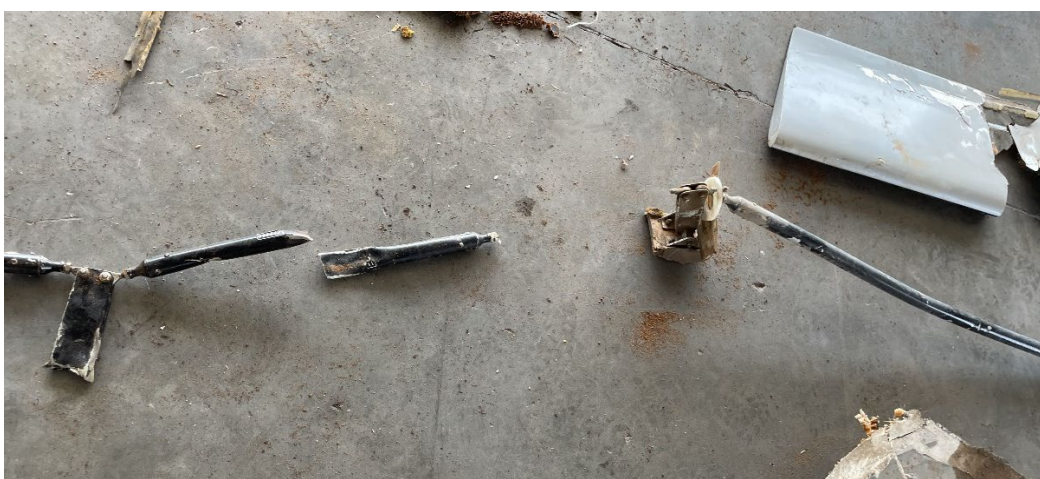
**Figure 5 View of right aileron interconnect tube assembly**

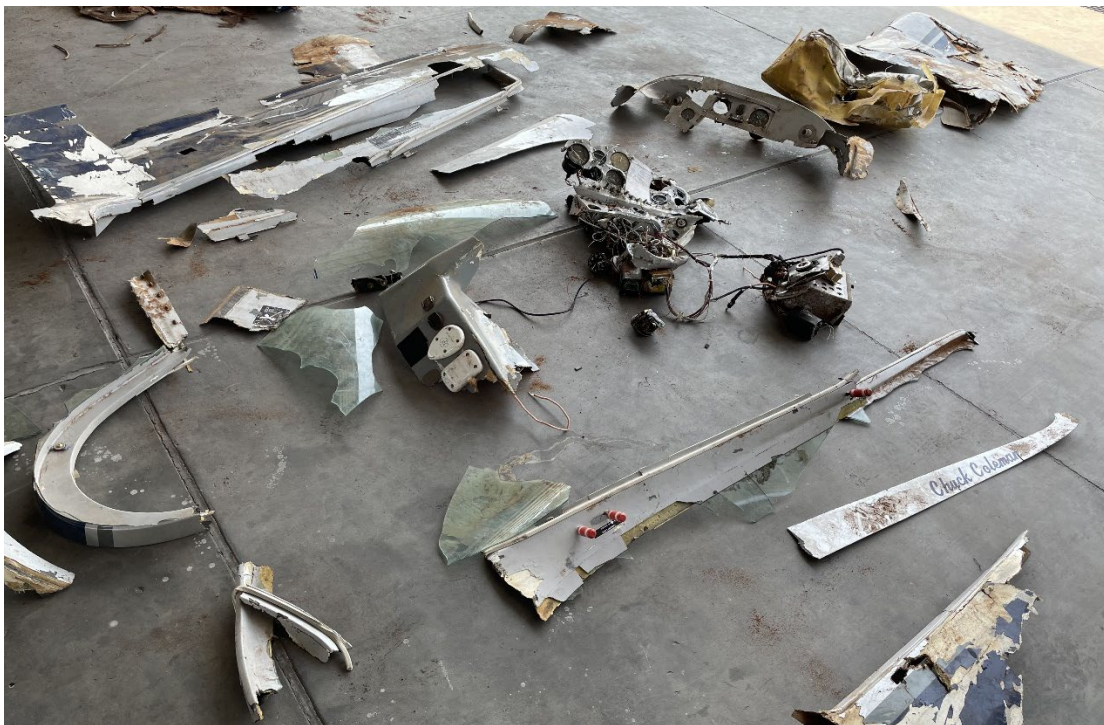
**Figure 6 View of canopy layout**

The canopy (figure 6) and airframe opening had fragmented into multiple pieces. All of the primary components were located. All three canopy hinges remained attached to the canopy frame. The canopy lock shaft had bent about its span, but the aft pin appeared to be in the locked position.

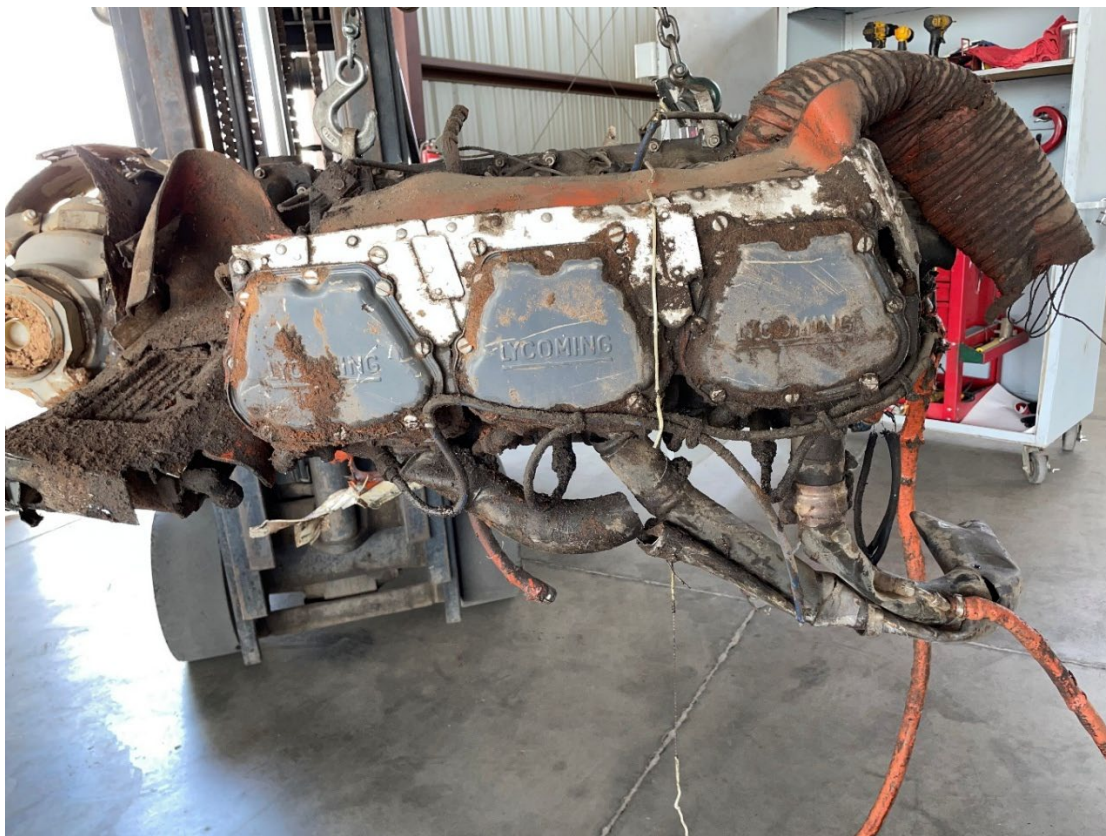
**Figure 7 View of engine exam**

Examination of the engine revealed that it was still attached to the engine mounts, which had been cut by recovery personnel (figure 7). All six cylinder assemblies remained attached to the crankcase and the pushrods all exhibited bending damage consistent with impact. Opposite the number three exhaust valve cam lobe was an inward punched hole on the crankcase. The oil sump was completely shattered. There was a large opening on the left forward side of the crankcase, and the forward crankshaft flange appeared to have been bent to the right.

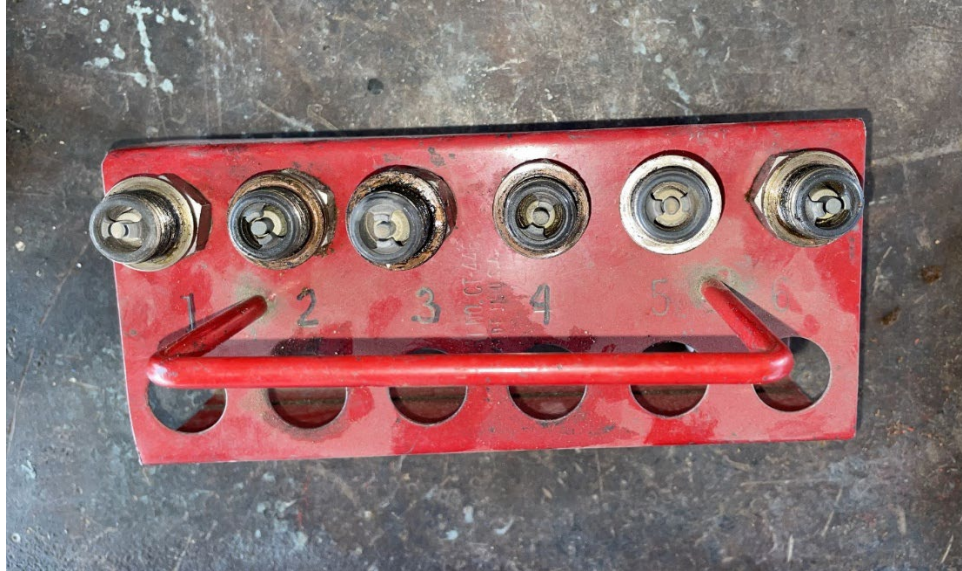
**Figure 8 Removed top spark plugs.**

The spark plugs were the massive electrode type, and all exhibited black and gray deposits within the electrode area (figure 8). The spark plugs exhibited signatures consistent with WORN OUT - NORMAL when compared to the Champion Check-A-Plug comparison chart.
