# National Transportation Safety Board

WPR25FA020

## **ACCIDENT SITE EXAMINATION**

Location: Las Cruces, New Mexico  
Date: October 20, 2024  
Time: 0224 MDT  
2024 UTC  
Airplane: Extra Flugzeugbau GmbH 300/L, N512DW

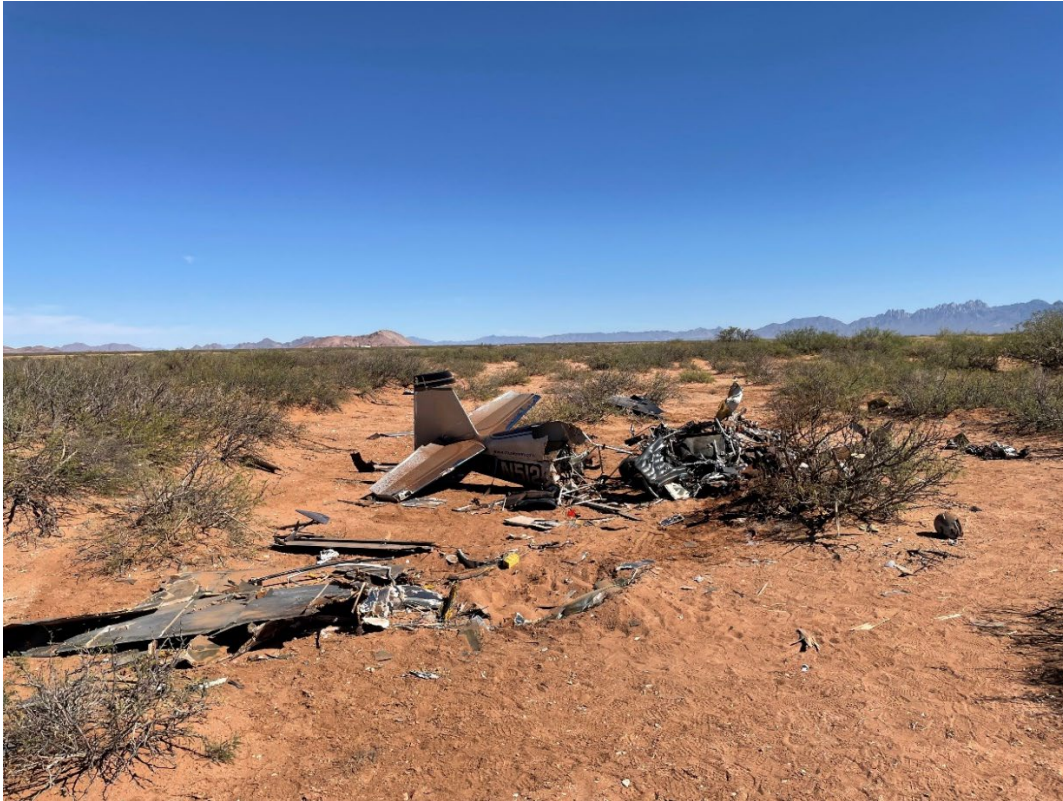
**Figure 2 Wreckage site northeast view**

Examination of the accident site revealed that the airplane impacted desert terrain approximately 200 ft northwest of Runway 4/22 at Las Cruces International Airport (LRU). The airplane came to rest on its right side on a magnetic heading of approximately 130° at an elevation of 4,434 ft mean sea level (msl).

The first identified point of contact (FIPC) was a ground scar consistent with impact by the right wingtip. The right wing was separated from the fuselage and located adjacent to the initial ground scar.

A crater approximately 6 ft in diameter and 1 ft deep was observed at the right-wing root. The main wreckage came to rest about 20 ft beyond the crater. It had a berm on its southwest edge rising approximately 1 ft above the terrain which appeared to be mounding created by the impact force in the direction of the main wreckage. The left

wing, with the aileron attached, was found inverted approximately 50 ft from the FIPC.

The main wreckage was located 20 ft from the larger impact crater along a 070° magnetic heading. The aft tail section was oriented upright, attached and angled 40° left of the main fuselage centerline on a 170° magnetic heading. All four corners of the airplane were identified within 200 ft of the initial impact.

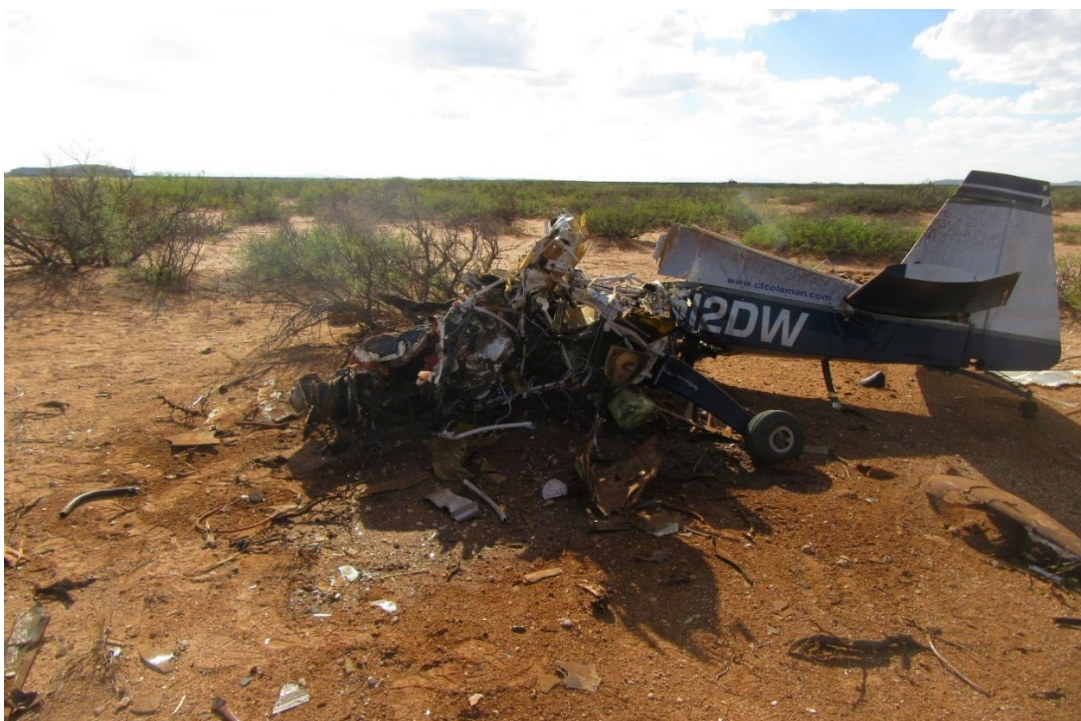
**Figure 3 Wreckage site southwest view (Courtesy of FAA)**

The forward fuselage underwent a large amount of compression and clockwise twisting moment during the impact. The flight cockpit rolled upside down at the nose of the airplane where the airplane came to rest.

Most of the tail was intact. The ELT was functioning and immobilized by FAA personnel. Both rudder cables were attached to the rudder and functioned normally when each was actuated. The horizontal stabilizer was actuated and found functional to the point of separation from the forward fuselage.

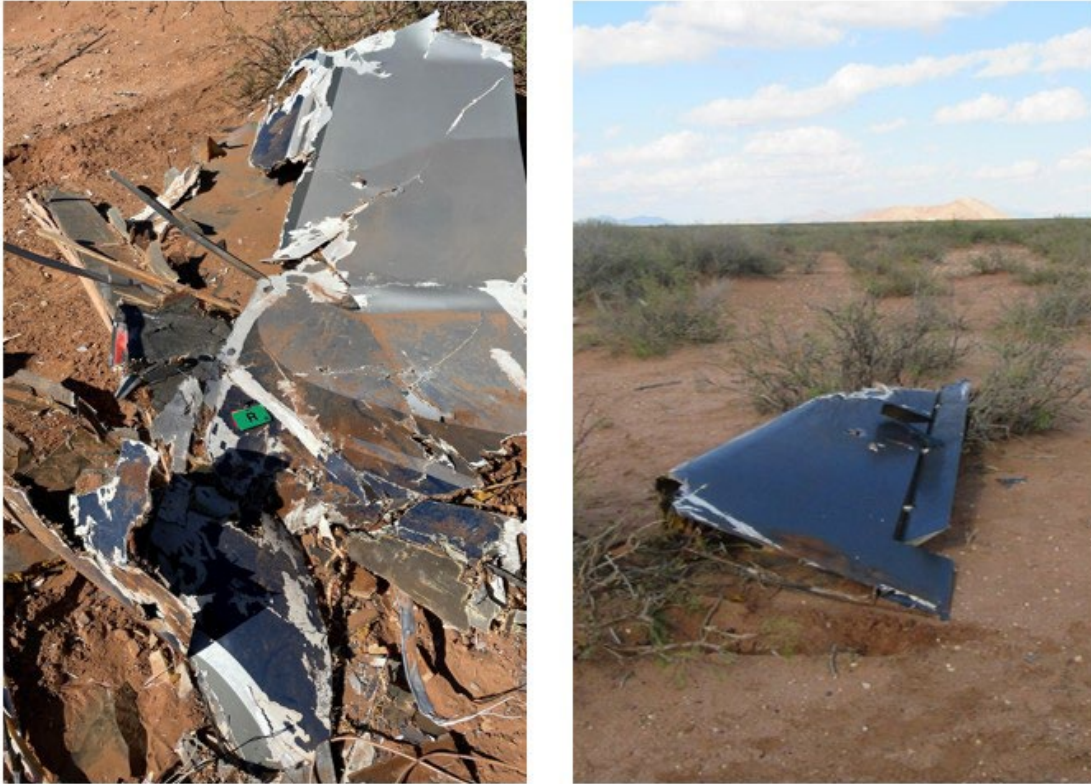
**Figure 4 Right and left wings**

Both wings and ailerons were found near the fuselage. The right wing was shattered close to the point of impact upright, under and on top of where the main wing spar was found and extended to the 6-foot main crater. The right fuel tank was distinguishable and was thrown about 50 feet from the airplane. The right aileron was separated and adjacent to the shattered wing. The left wing and aileron were found inverted about 50 feet from the main crater impact wreckage together.

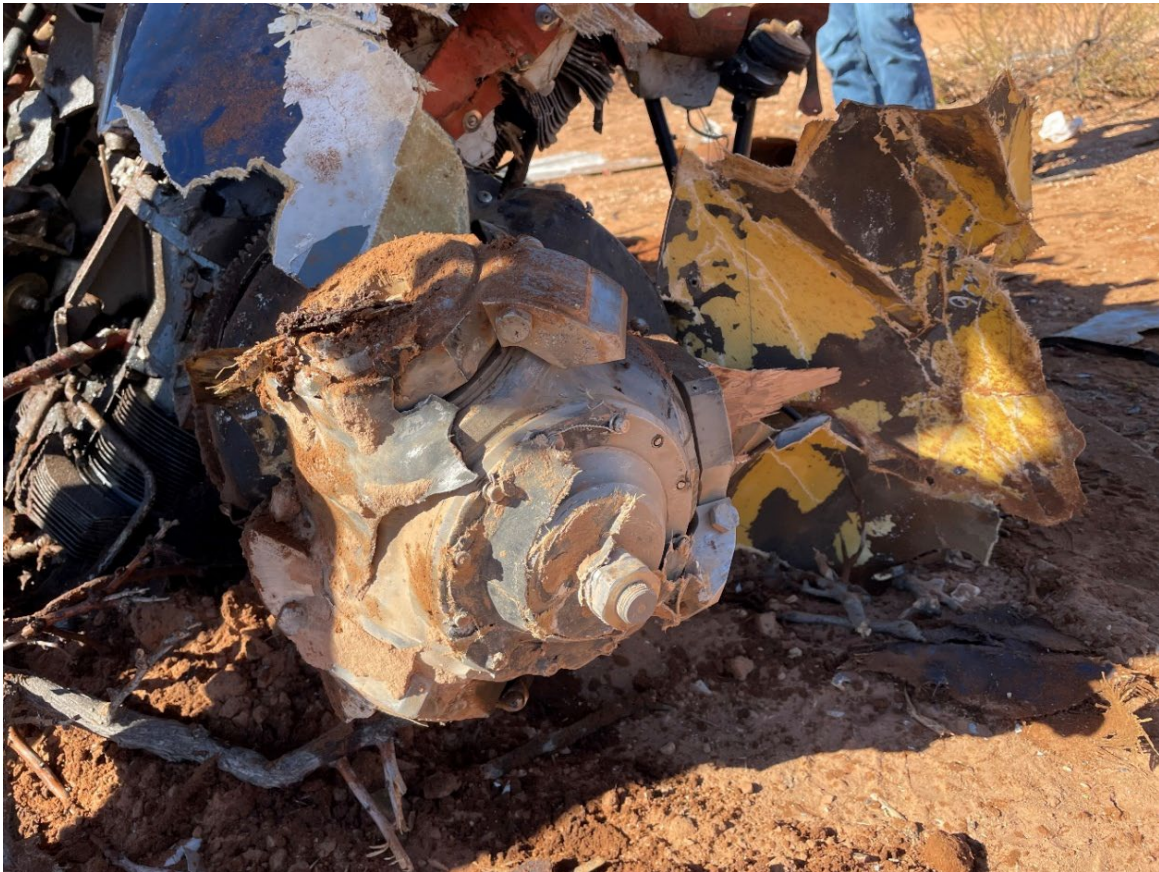
**Figure 5 Engine and Propeller hub**

The engine remained attached to the engine mount attached points twisted clockwise resting on its right side. The engine cowling was fracture separated. The engine and forward portion of the fuselage was impact damaged and displaced to the right. The engine mount had several fractures, consistent with impact damage. All four cylinders remained attached and exhibited impact damage. Impact had torn most all the exhaust, oil sump and intake manifold from the engine. Most engine accessories were torn from the engine and were heavily crushed found near the engine. No engine data instruments evidence was found. The absence of gauges in the engine instrument panel doesn't preclude the possibility of engine data monitoring. No EGT probe lines were found going into the cylinders. Instruments found did not match mounting holes available.

A few years earlier the pilot had replaced the propellor with a three-blade wood prop. Only one blade was partially distinguishable with the remaining blades existing as wood chips. From what was observed the engine was making power when it impacted terrain. Three FAA inspectors observing the event all stated they heard the engine developing power to the ground.
