# National Transportation Safety Board

WPR25FA145

## **ACIDENT SITE EXAMINATION**

Location: Cottonwood, California  
Date: April 29, 2025  
Time: 15:34 Pacific daylight time  
Airplane: N6310N, Champion, 7ECA

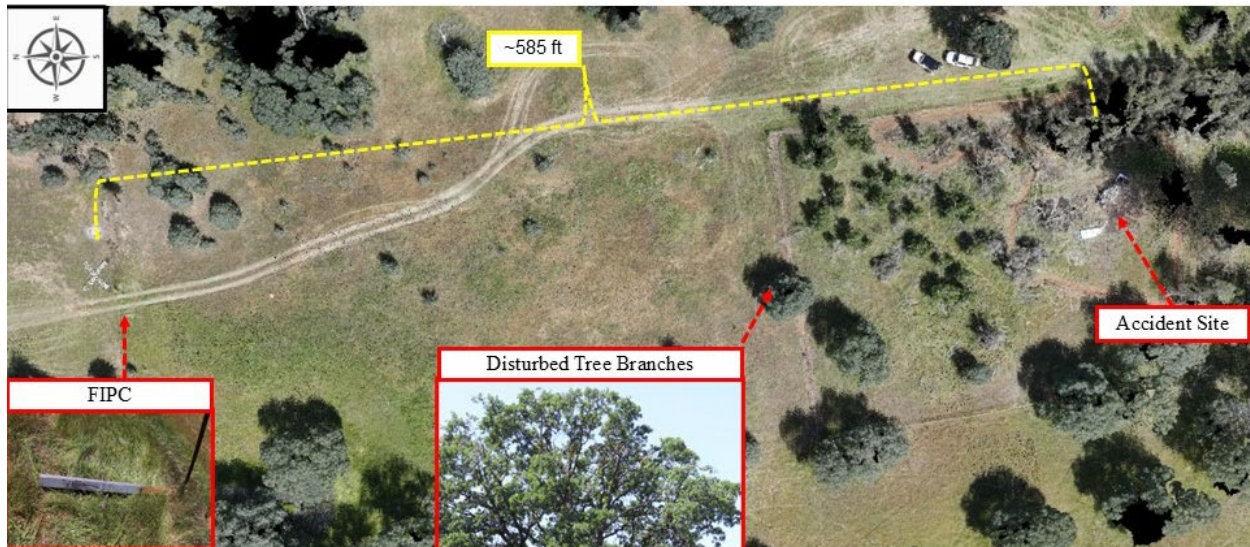
Examination of the accident site revealed that the airplane impacted several trees and came to rest at a base of a tree about 585 ft south of the departure end of runway 16 at the Flying N Ranch Airport (CA04), Cottonwood, California. The first identified point of contact (FIPC) was a downed fence post located about 40 ft south of the departure end of the runway, aligned on an extended centerline. The downed fence post was about 5 ft in height and was separated at the base. The 5 ft tall downed fence post was separated at the base and exhibited a black transfer mark near the top of the post. The tree limbs of a 40 ft tree were damaged and about 380 ft south of the FIPC. The debris path was oriented along a heading of about 185° magnetic and was about 585 ft in length from the FIPC to the main wreckage. The fuselage came to rest on its left side in an approximate 10° nose low attitude, on a heading of about 310°

magnetic, at an elevation of 538 ft mean sea level (msl). The right wing and left main landing gear were separated from the fuselage and located about 5 to 10 ft. north of the main wreckage.

**Figure 1: View of accident site diagram.**

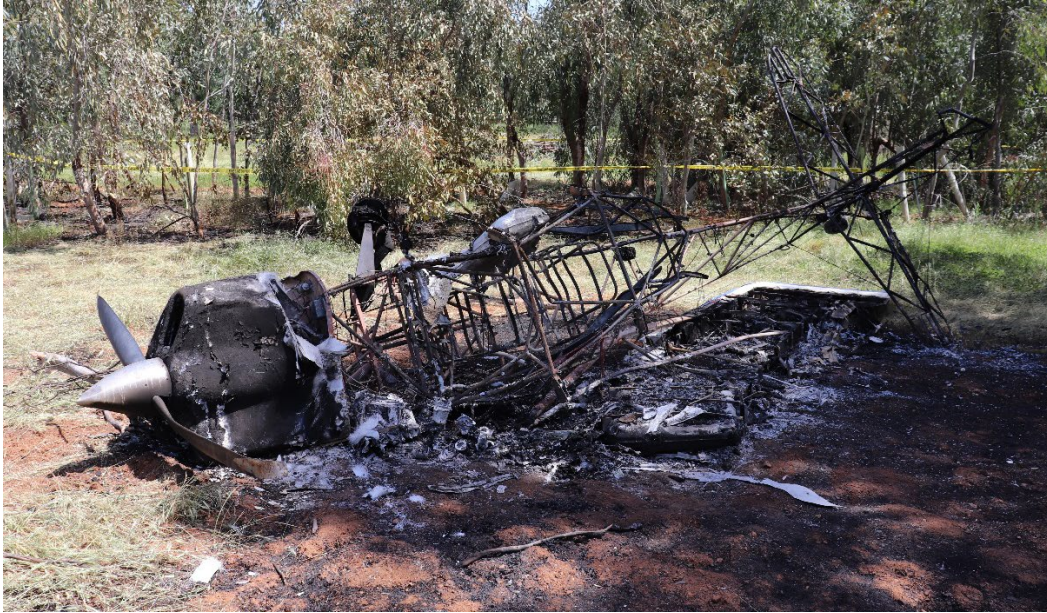
Visual examination of the fuselage revealed that it had come to rest on its left side and sustained thermal and impact damage. The instrument panel was thermal and impact damaged with instruments separated. The left main landing gear was separated from the fuselage and located in the debris path. Damage to the left brake rotor, consistent with impact damage, was observed. The right main landing gear remained attached to the fuselage, was bent aft and thermally damaged.

The instrument panel was thermal damaged with multiple instruments displaced. Flight controls were observed in both the forward and rear seat positions. The forward flight control had fracture separated at the torque tube attachment point. The rudder pedals were observed in the cockpit area with thermal damage. Flight control continuity was established from the cockpit controls to their respective flight control surfaces; separations of the flight control cables were consistent with overload.

**Figure 2: Side view of accident airplane.**

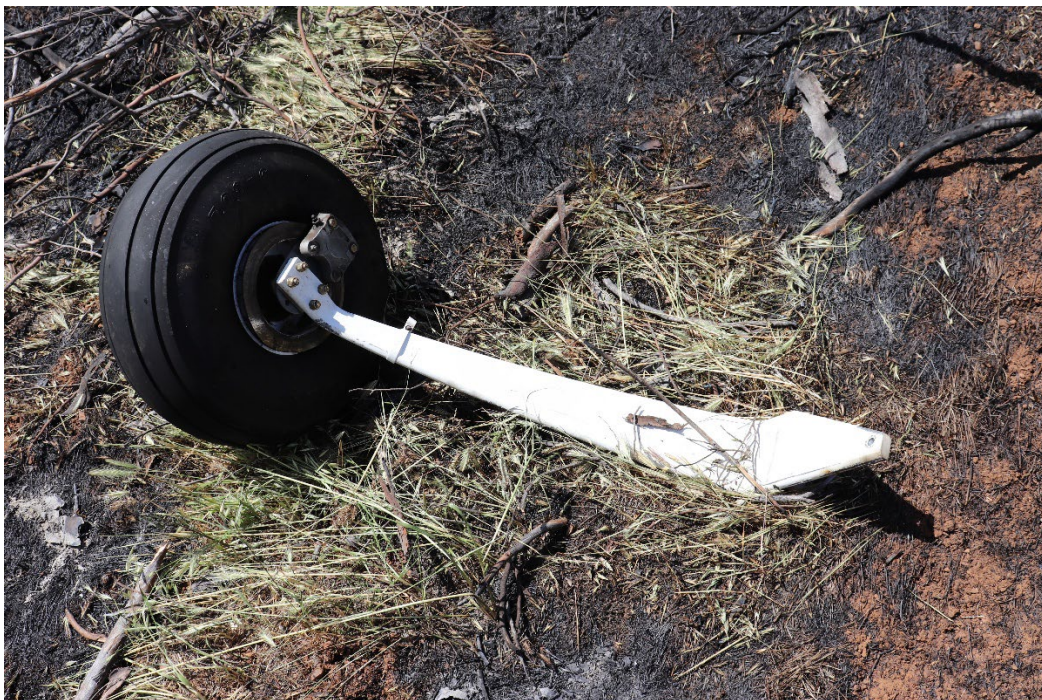
**Figure 3: View of left main landing gear.**

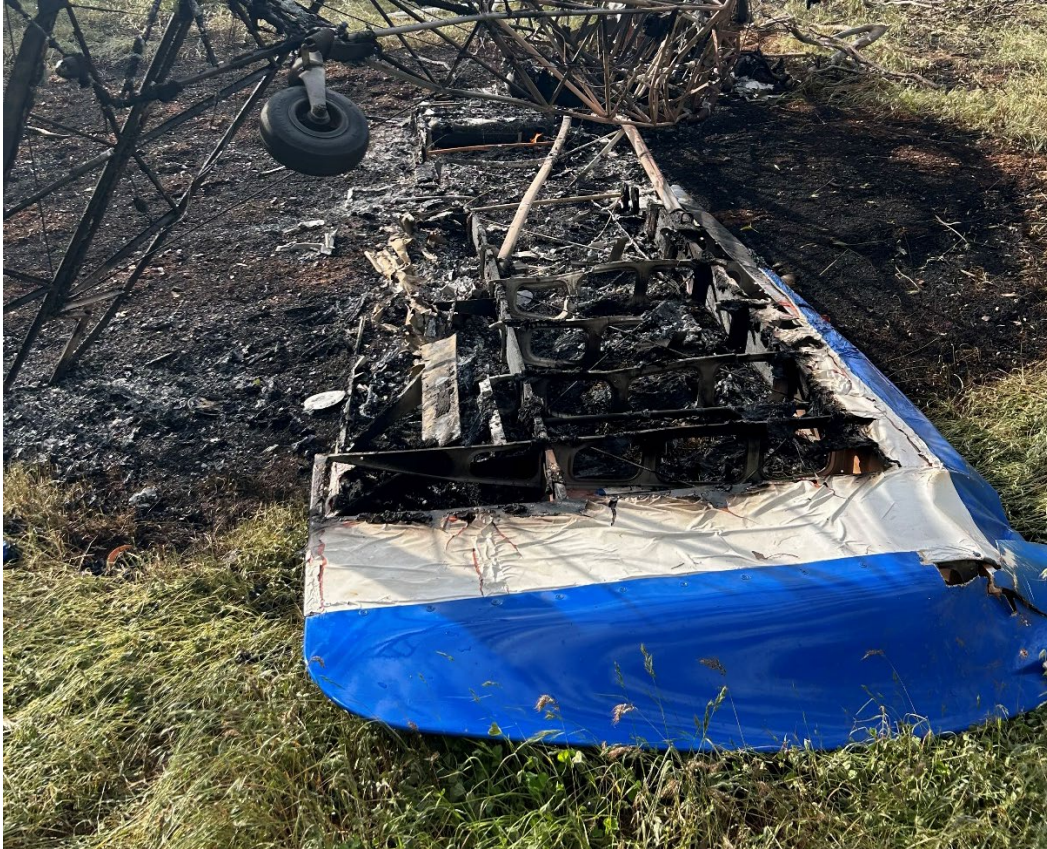
The left wing separated from the fuselage near the wing root and came to rest under the fuselage. The left wing and aileron were mostly destroyed by fire. The flight control cables remained within the left-wing structure and were traced from the aileron attach points to the center fuselage. The left-wing aluminum fuel tank was mostly destroyed by fire. Aluminum pooling was observed throughout the entire left-wing structure.

**Figure 4: View of left wing.**

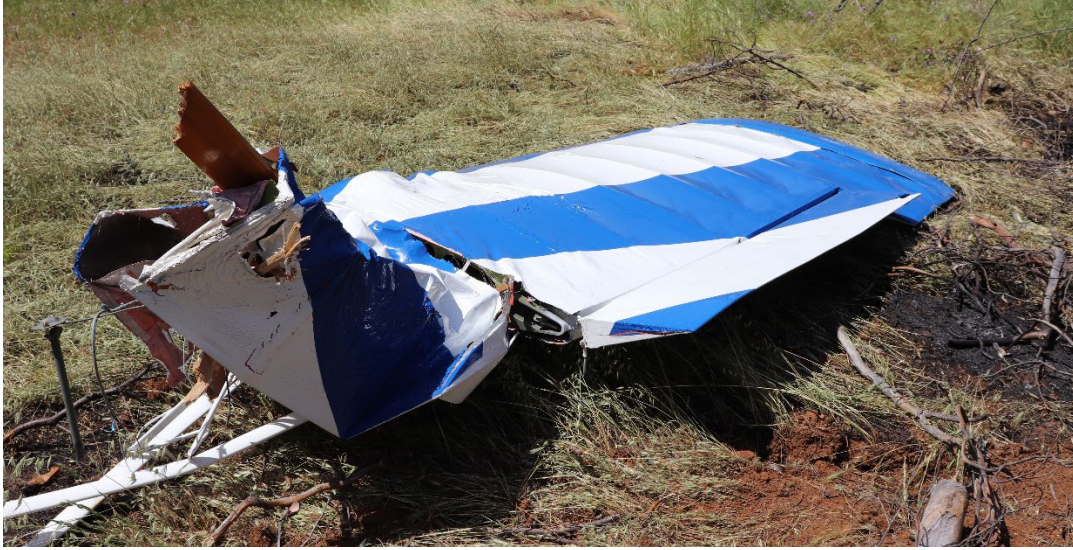
The right wing separated from the fuselage near the wing root and was located about 5 to 10 ft north of the main wreckage. The right-wing aileron remained attached to the wing, via its attach points. The flight control cables separated from their attachment points and were located with the main wreckage, the separation in the flight control cables were consistent with overload. The right-wing aluminum fuel tank separated from the wing and was mostly destroyed by fire.

**Figure 5: View of right wing.**

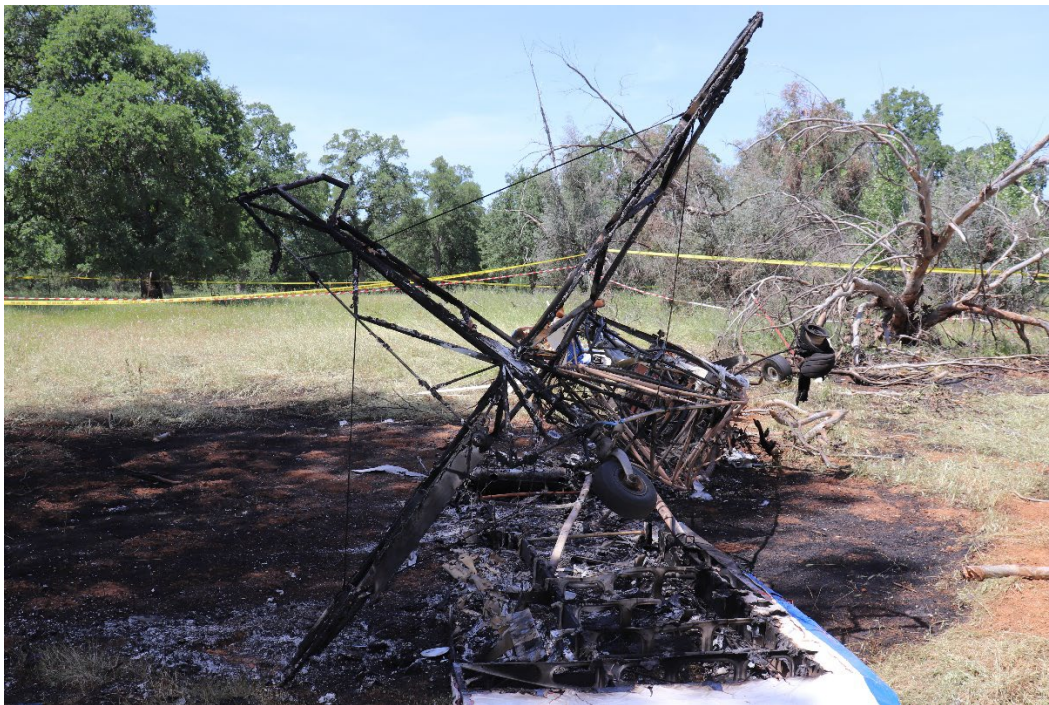
The empennage remained attached to the fuselage and was thermal damaged throughout. The elevator and rudder remained attached to their respective attachment points. The elevator flight control cables remained attached to their respective mounts, the control cables were traced to the cockpit and were attached to the flight control torque tube. The rudder flight control cables remained attached to their respective mounts, the control cables were traced to cockpit, where they remained attached to the rudder pedals.

**Figure 6: View of airplane empennage.**

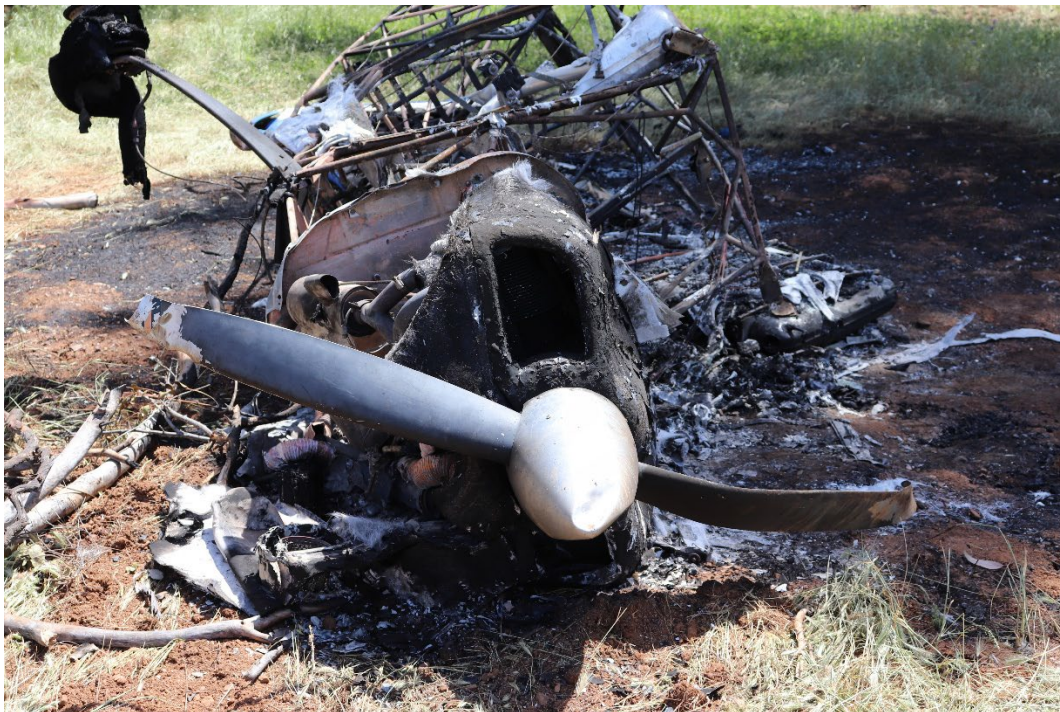
The engine remained attached to the engine mount and fuselage. No damage was noted to the steel engine mount tubes. Thermal damage was observed throughout the engine from post impact fire. The engine was covered in burned fiberglass cowl remains which appeared to be draped over the engine area only.

**Figure 7: Front view of airplane engine and propeller.**

The airplane was equipped with a fixed pitch propeller. The propeller remained attached the crankshaft. One propeller blade exhibited damage to the propeller tip. The other propeller blade exhibited aft bending about mid span and the leading edge exhibited chipping, polishing, and chordwise striations.
