**From:** [Adrienne Lamm](#)  
**To:** [Eric Gutierrez](#)  
**Subject:** WPR25FA145 - Cottonwood CA - Materials Laboratory Assessment  
**Date:** Monday, September 8, 2025 8:47:53 AM  
**Attachments:** [8T7A6040.JPG](#)  
[8T7A6042.JPG](#)  
[8T7A6052.JPG](#)  
[8T7A6057.JPG](#)

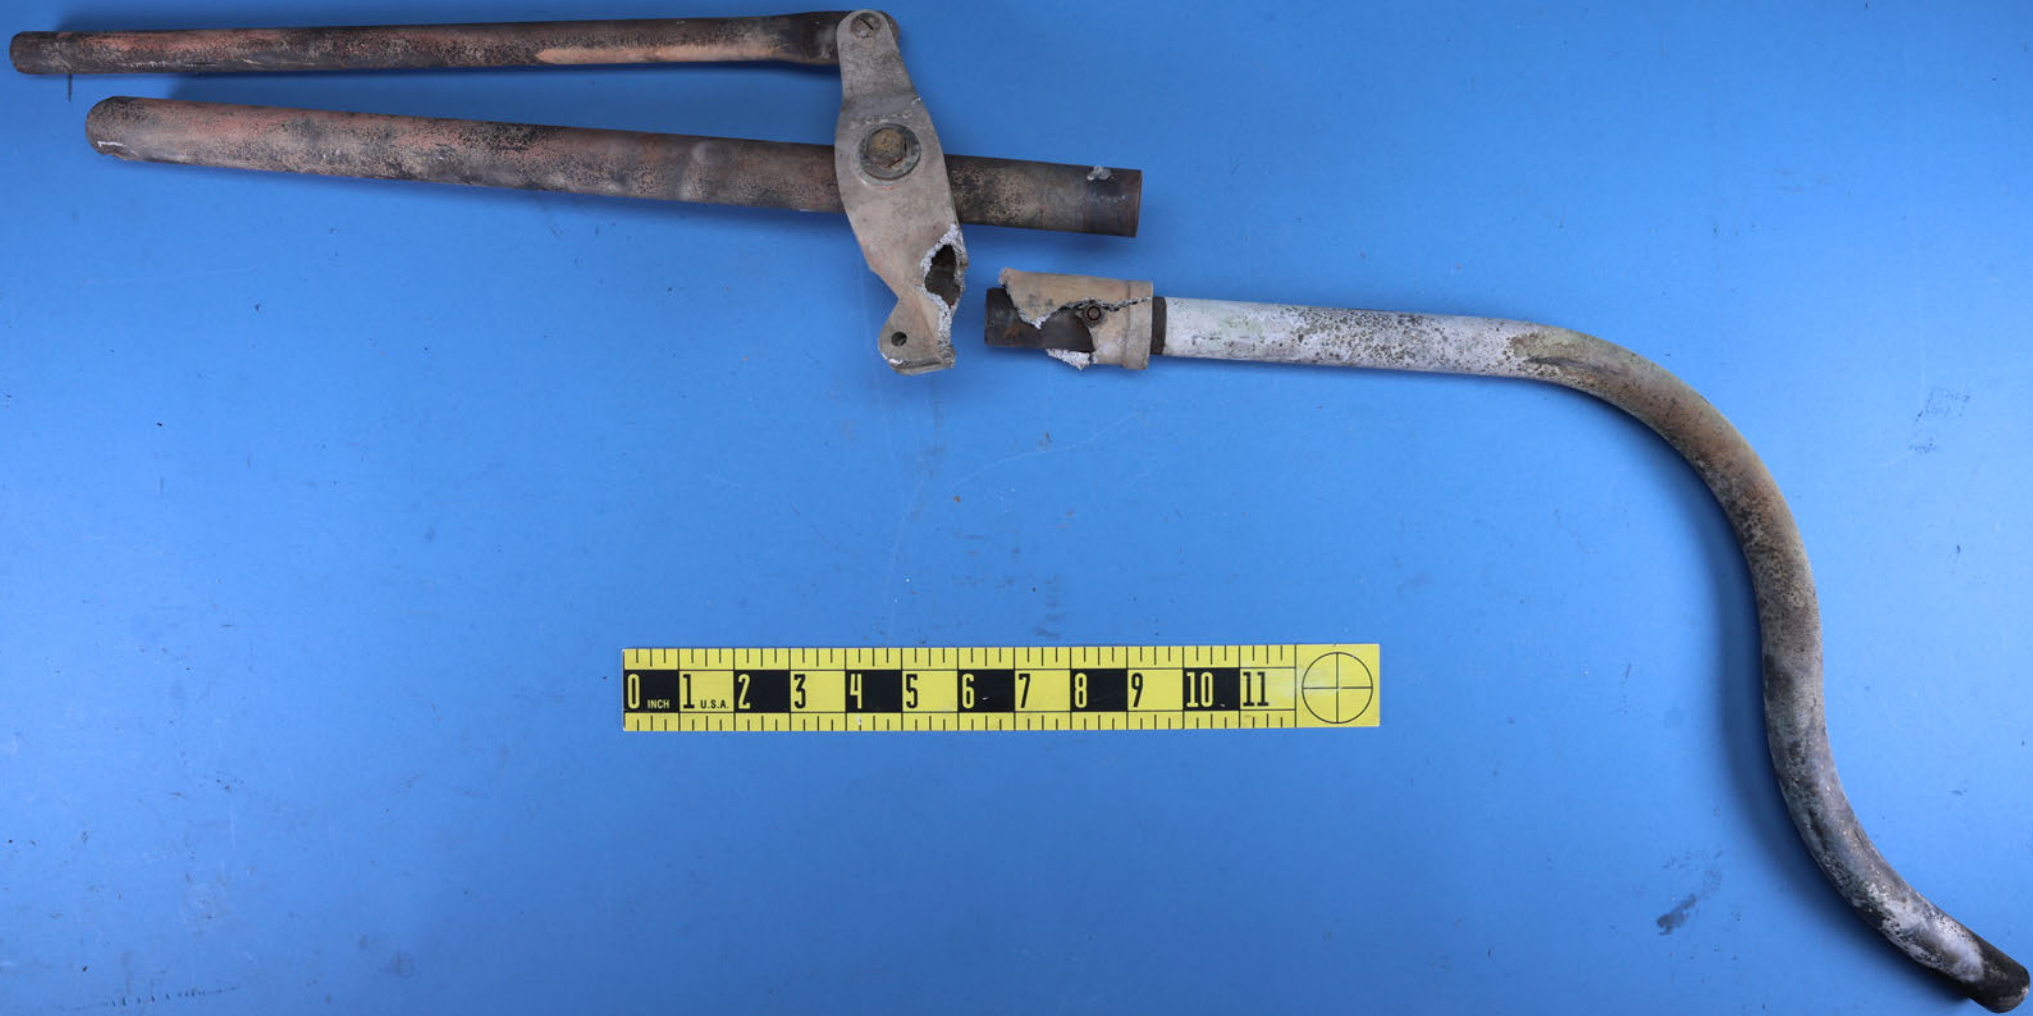
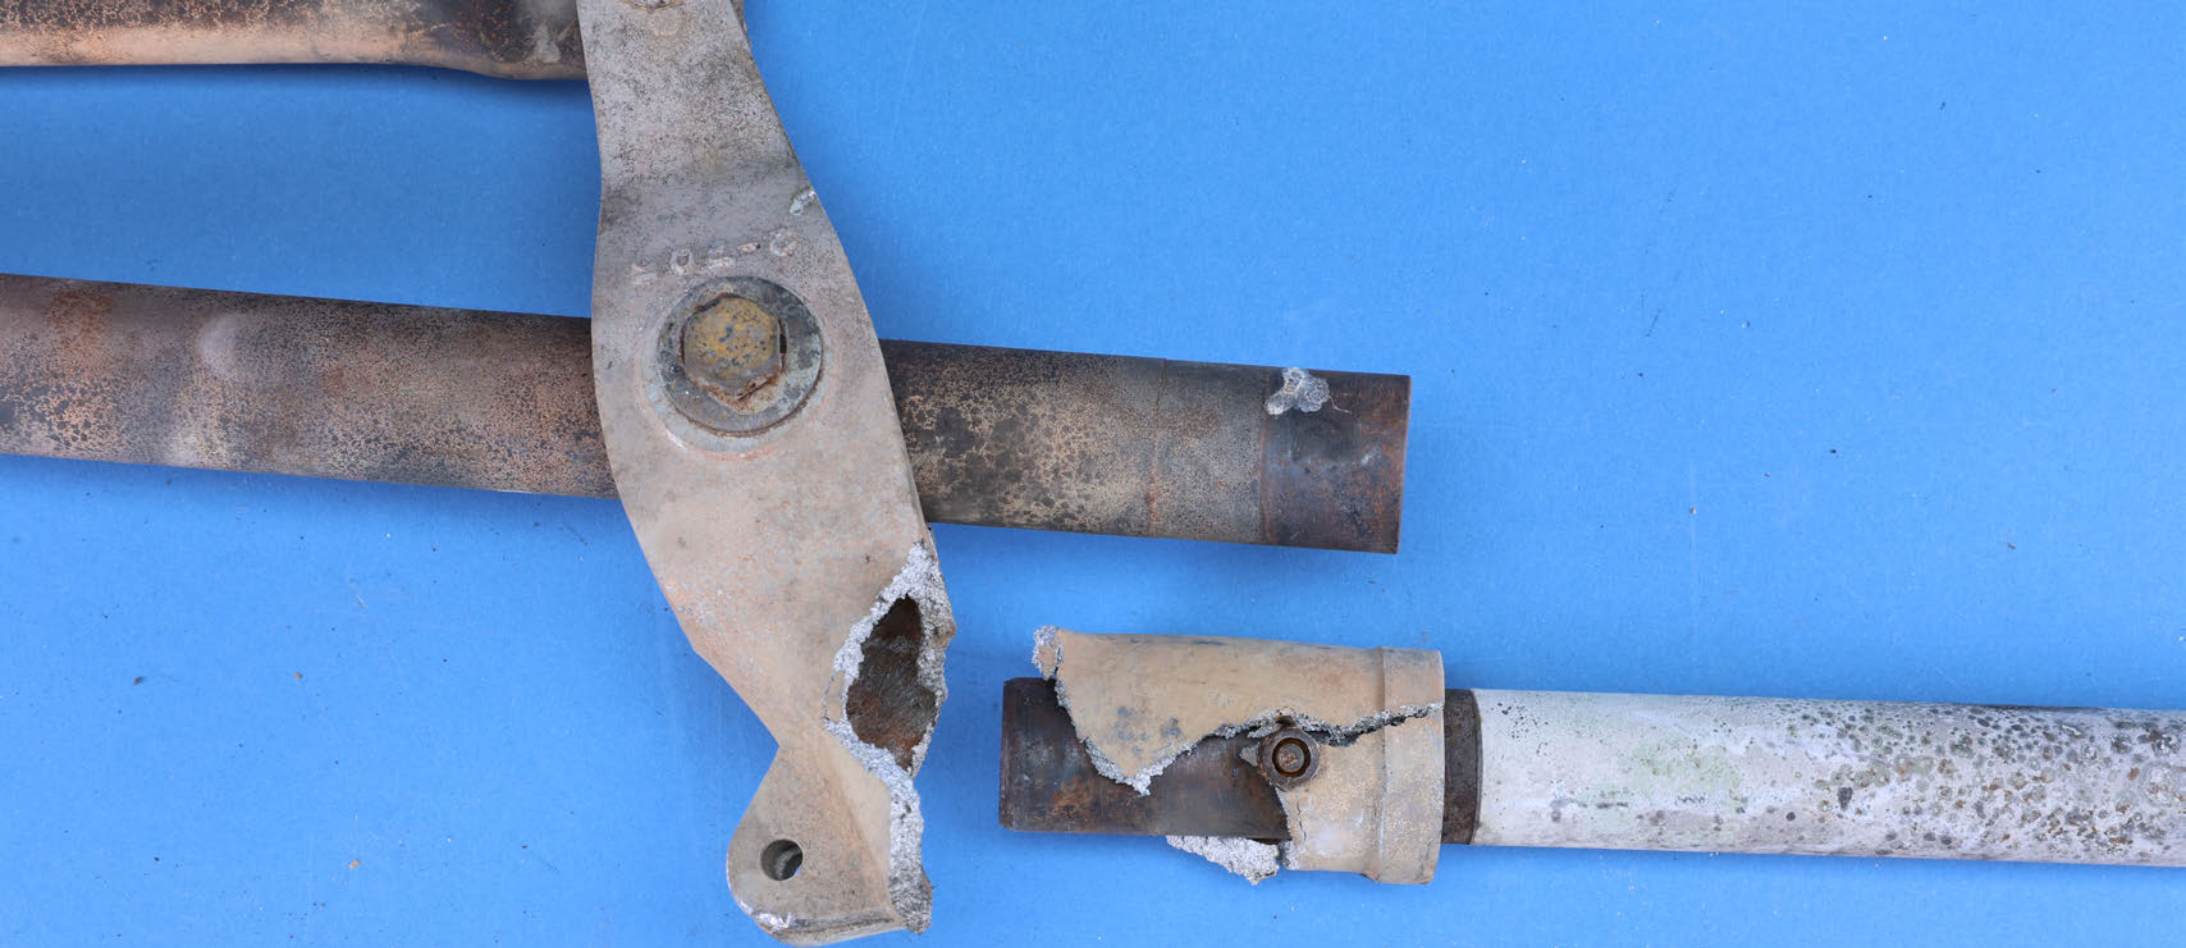
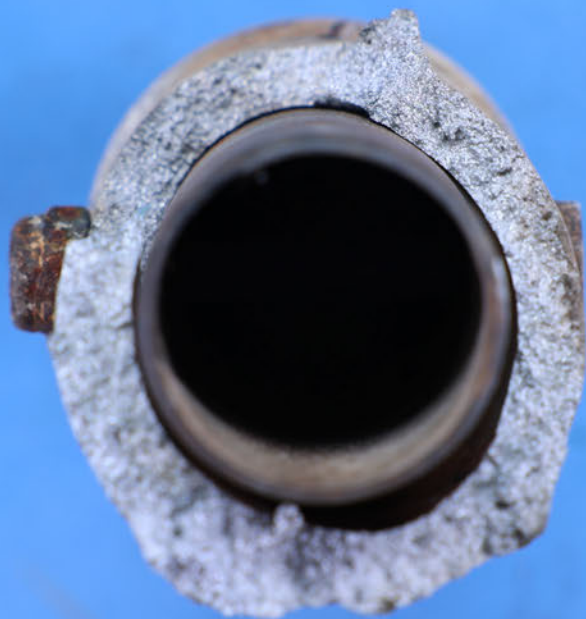
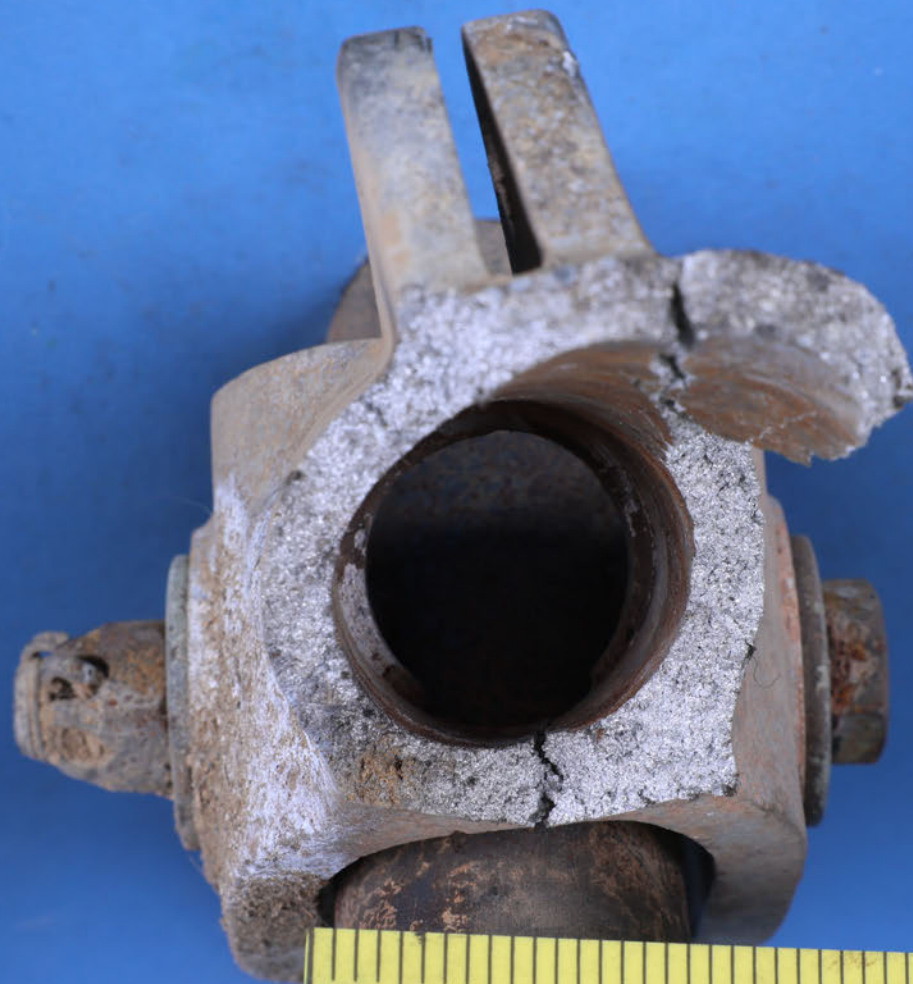
The flight control and attachment point from the subject aircraft were examined. The surfaces of all the components had deposits and damage consistent with fire. The attachment point bracket separated below the attachment lugs on the unconnected side, and that half of the bracket was also bent backwards. The mating collar piece was still attached to the control rod and had the pin still assembled. The fracture surfaces were examined using a 5x-to-50x stereo microscope. The fracture surfaces were rough with features consistent with overstress. Several secondary cracks branched off the fracture surface that were irregular and consistent with overstress due to deformation.

"The fracture and deformation of the flight control attachment point were consistent with overstress separation during the crash, and the heat-related damage to the components was due to exposure to the post-crash fire."
