# National Transportation Safety Board

WPR25FA145

## **AIRFRAME AND ENGINE EXAM**

Location: Cottonwood, California  
Date: April 29, 2025  
Time: 1534 Pacific daylight time  
Airplane: Champion, 7ECA, N6310N

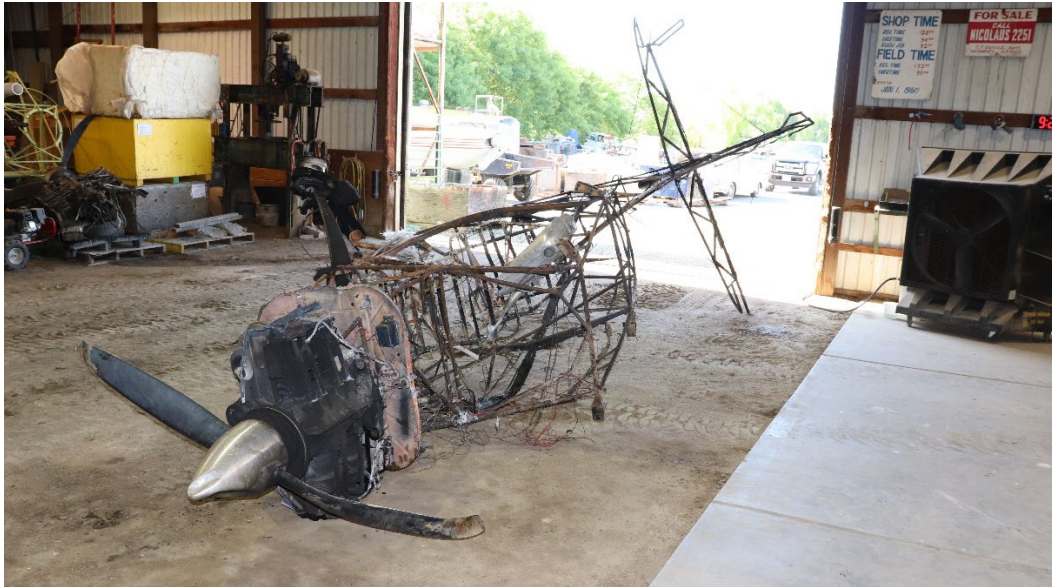
Examination of the fuselage revealed that it was thermal and impact damaged. The instrument panel was thermal and impact damaged with instruments separated. Flight controls were observed in both the forward and rear seat station. The forward flight control was fracture separated at the torque tube attachment point. The left main landing gear was separated from the fuselage. Damage to the left brake rotor, consistent with impact damage, was observed. The right main landing gear remained attached to the fuselage, was bent aft and thermally damaged.

**Figure 1: Front view of accident airplane during examination.**

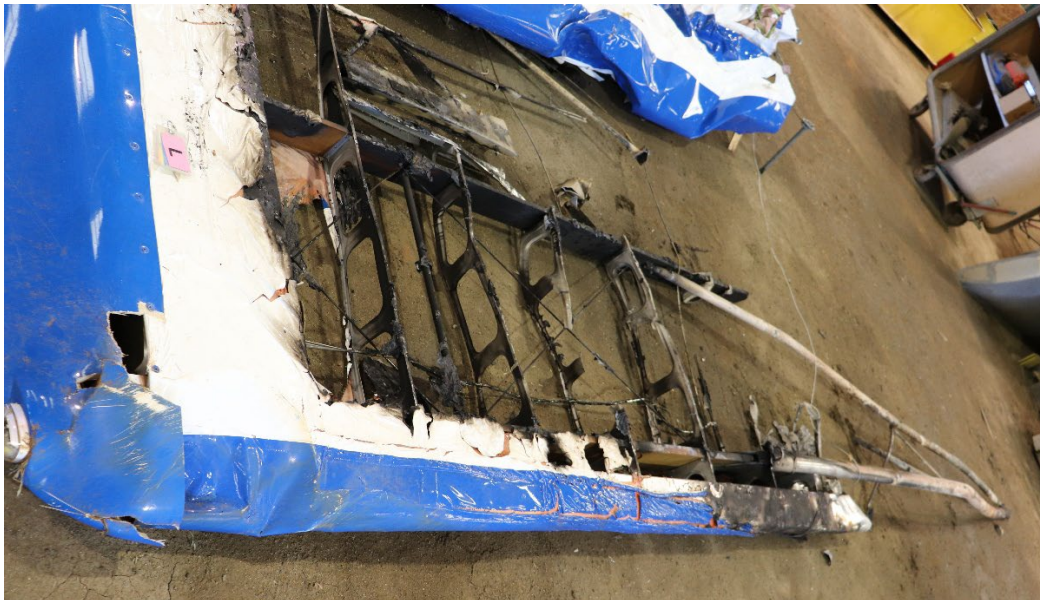
The left wing separated from the fuselage near the wing root and was mostly destroyed by fire. The left wing aileron was mostly destroyed by fire. The flight control cables remained within the fragmented left wing and traced from the aileron attached points to the center fuselage. The left wing aluminum fuel tank was mostly destroyed by fire.

**Figure 2: View of left wing during examination.**

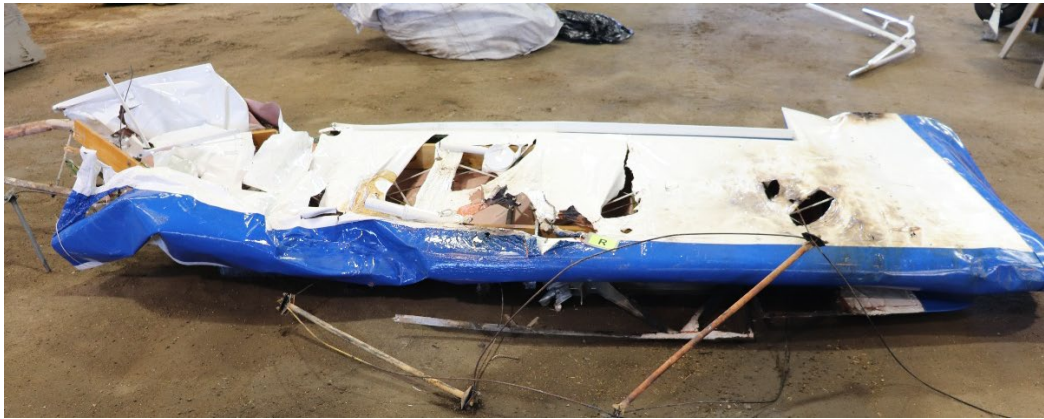
The right wing was separated from the fuselage near the wing root. Thermal and impact damage was observed throughout the wing. The right wing aileron remained attached to the wing, via its attached points. The right wing aluminum fuel tank separated from the wing and was mostly destroyed by fire.

**Figure 3: View of right wing during examination.**

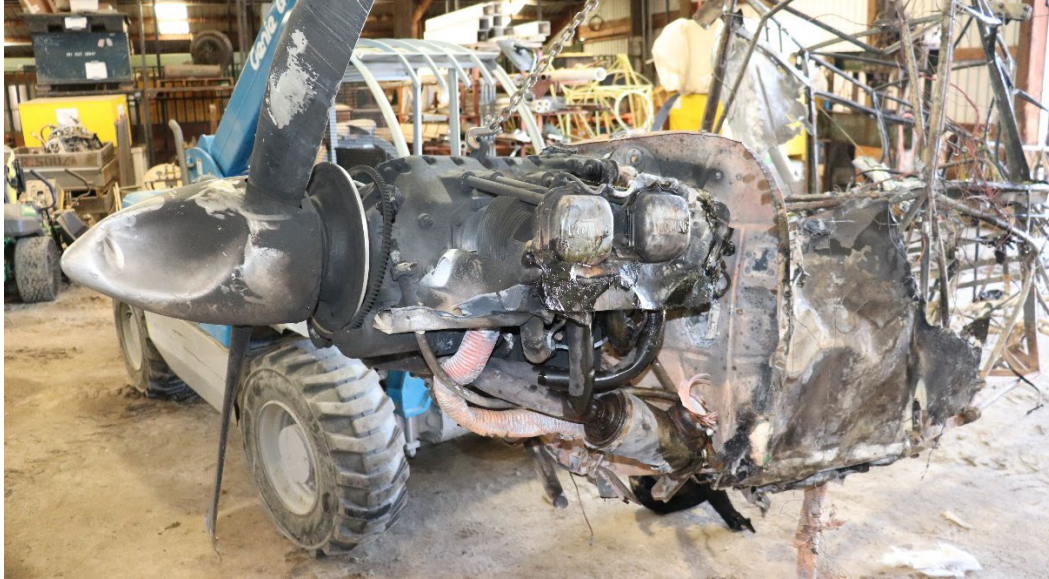
The engine remained attached to the engine mount and fuselage. No damage was noted to the steel engine mount tubes. Thermal damage was observed throughout the engine from post impact fire.

**Figure 4: Side view of engine during examination.**

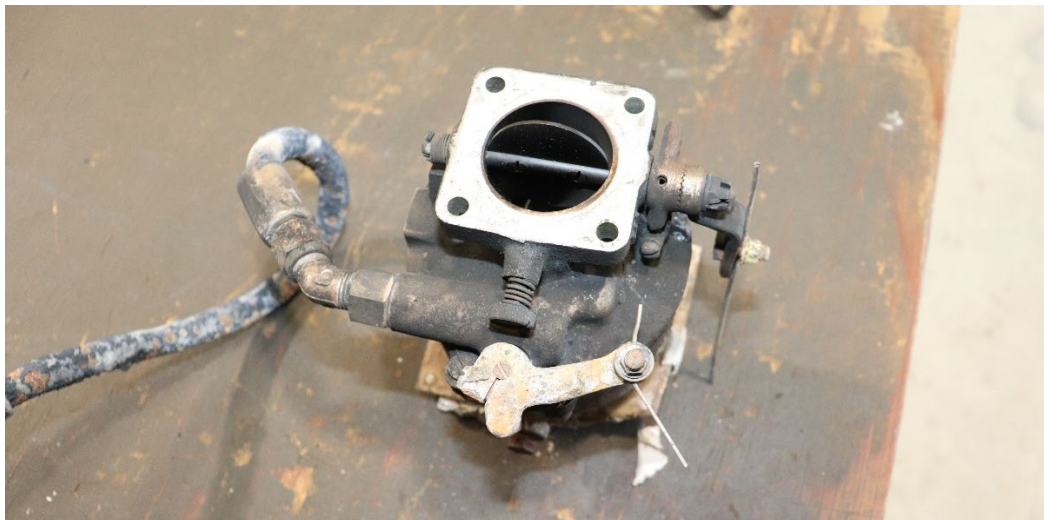
The carburetor was removed from the engine and the mixture and throttle arms moved the available length. The carburetor was disassembled, no visible contamination was observed in the carburetor bowl and no anomalies were observed in the carburetor floats.

**Figure 5: Side view of carburetor during examination.**

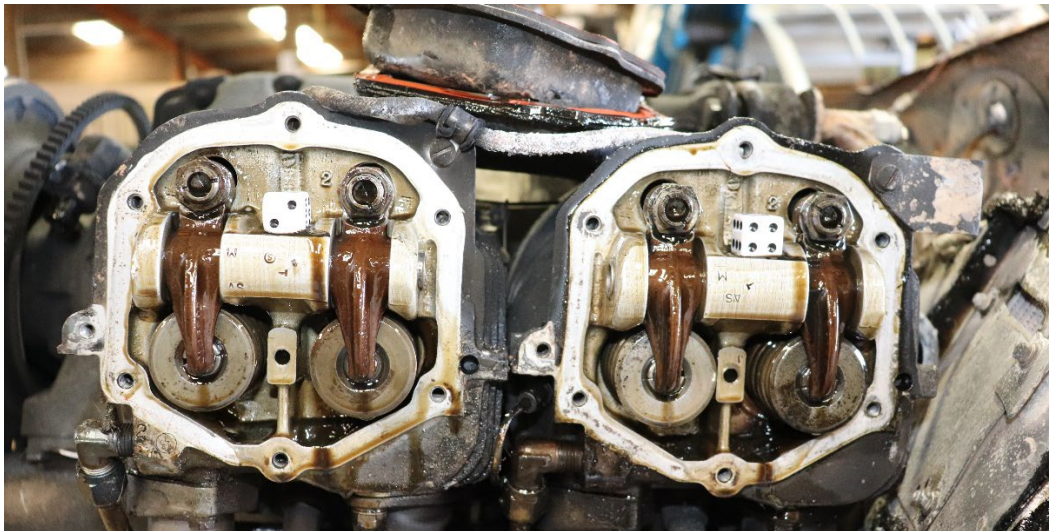
The rocker box covers were removed. The intake and exhaust rocker arms were intact, and oil coated on all cylinders. All intake and exhaust valve springs were in place and visually appeared to be undamaged. The upper spark plugs were removed, and all four cylinders were examined internally using a lighted borescope. A normal amount of combustion deposits was observed within the combustion dome of each cylinder and piston face. All of the intake and exhaust valves were unremarkable. The crankshaft was rotated by hand using the propeller. Rotational continuity was established throughout the engine and valve train. Thumb compression and suction was obtained in proper order on all four cylinders.

**Figure 6: View of the No. 2 and 4 cylinder intake and exhaust valve springs.**

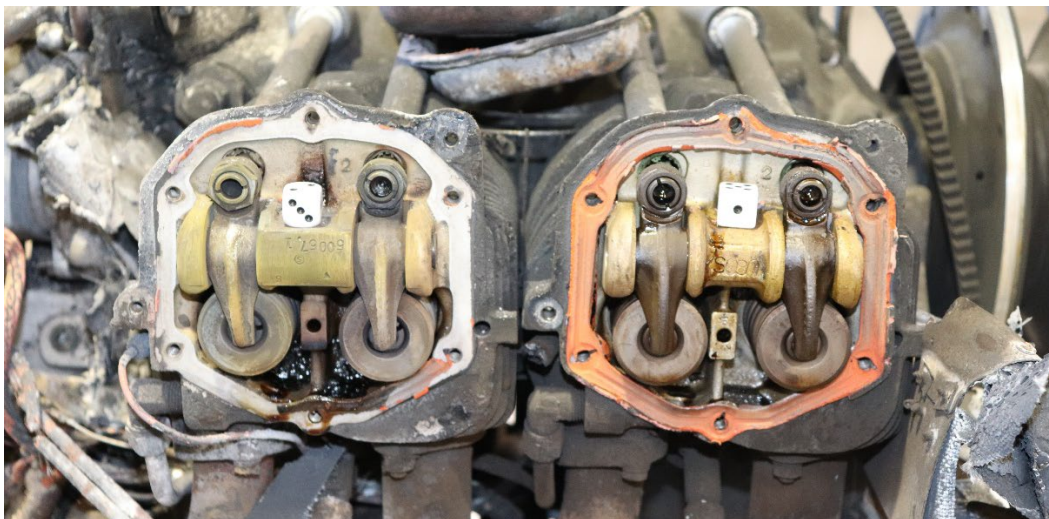
**Figure 7: View of the No. 1 and 3 cylinder intake and exhaust valve springs.**

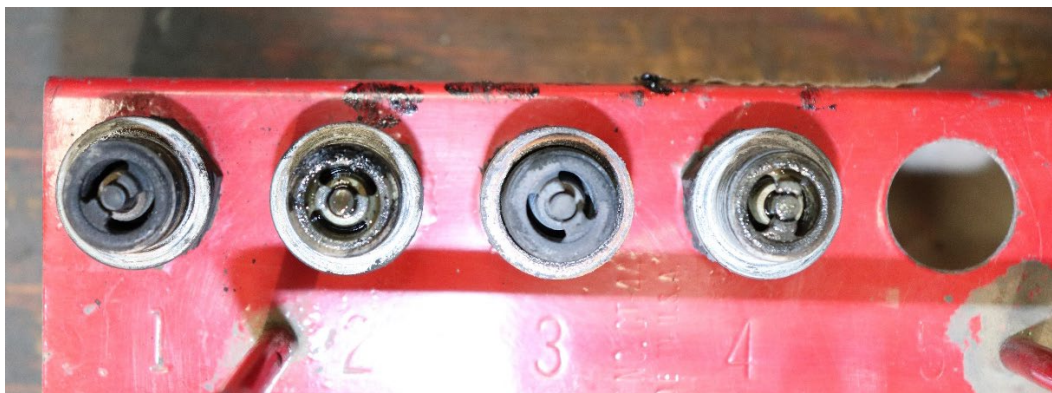
The top engine spark plugs were removed from the engine, and they were the massive electrode type. The sparkplugs exhibited gray deposits within the electrode area. All of spark plugs exhibited signatures consistent with WORN NORMAL when compared to the Champion Check-A-Plug chart. The No. 2 and 4 spark plugs were oil soaked, consistent with engine position at the accident location and post-accident recovery.

**Figure 8: View of top engine spark plugs.**
