WPR25FA145

## INVESTIGATION PHOTOGRAPHS

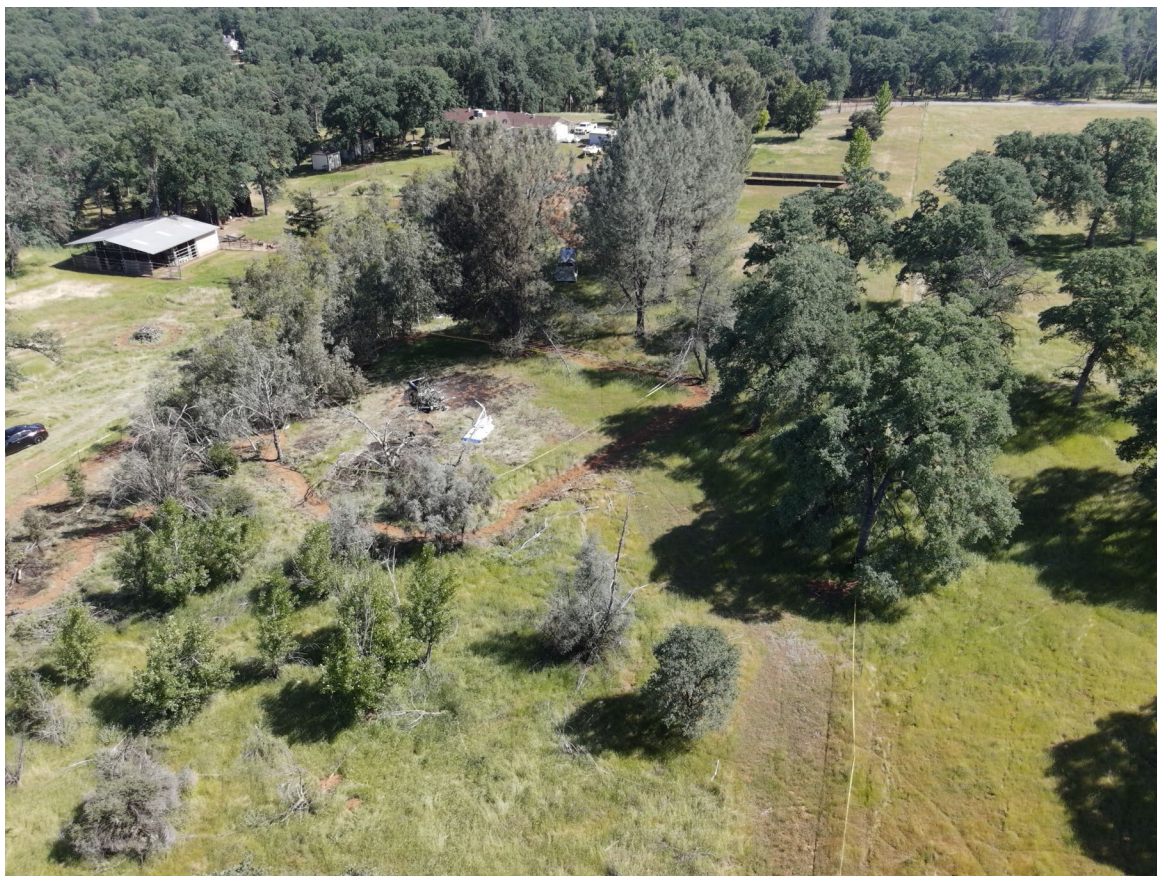
**Photograph 1 - View of accident site from above.**

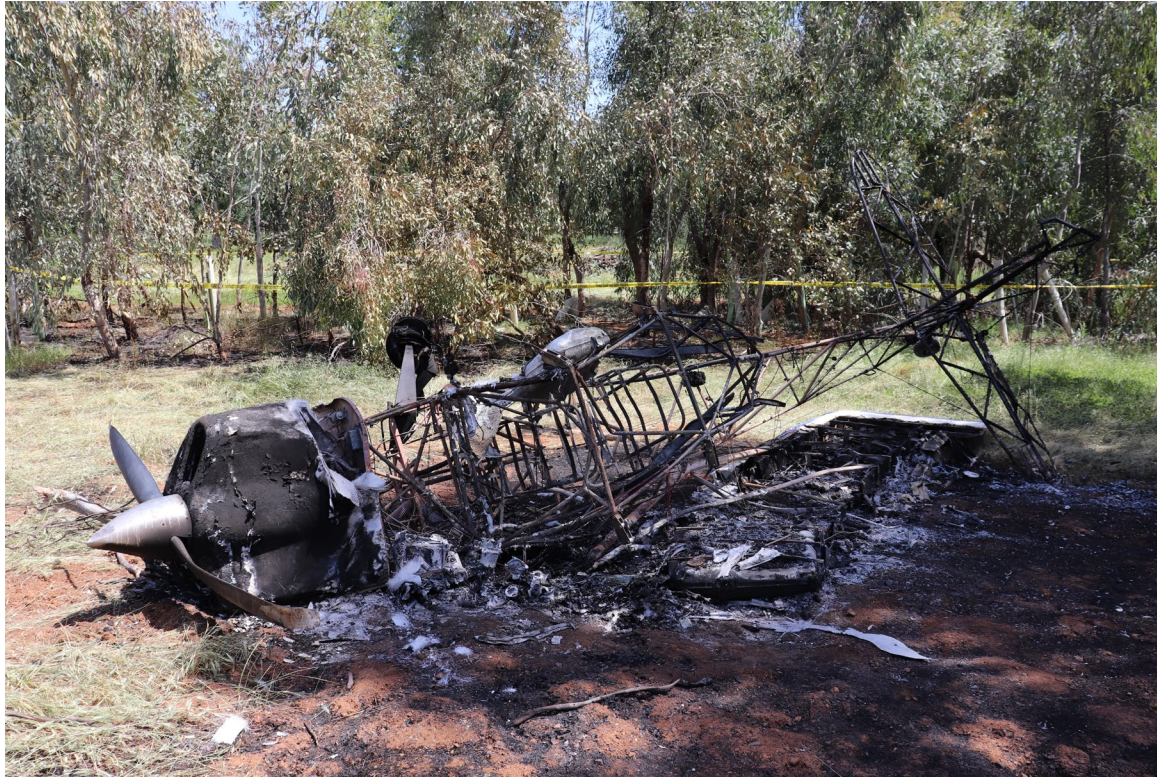
**Photograph 2 - Front view of accident airplane.**

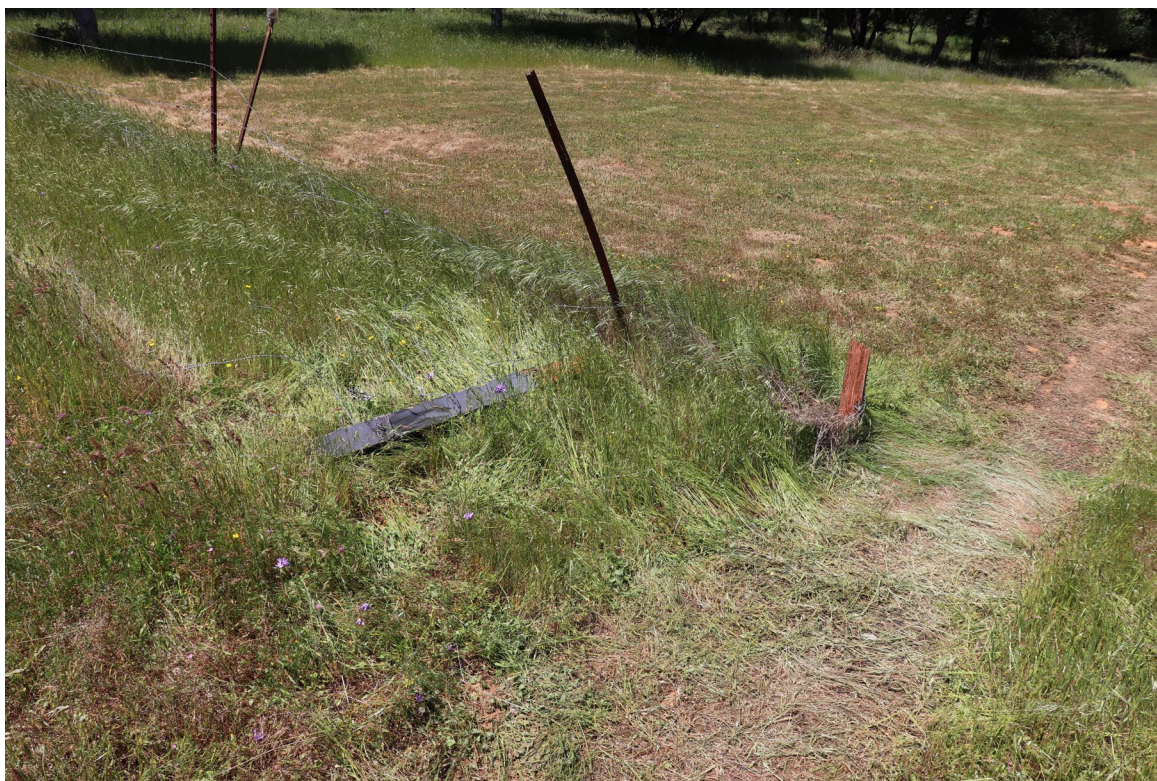
**Photograph 3 - View of downed airport perimeter fence post.**

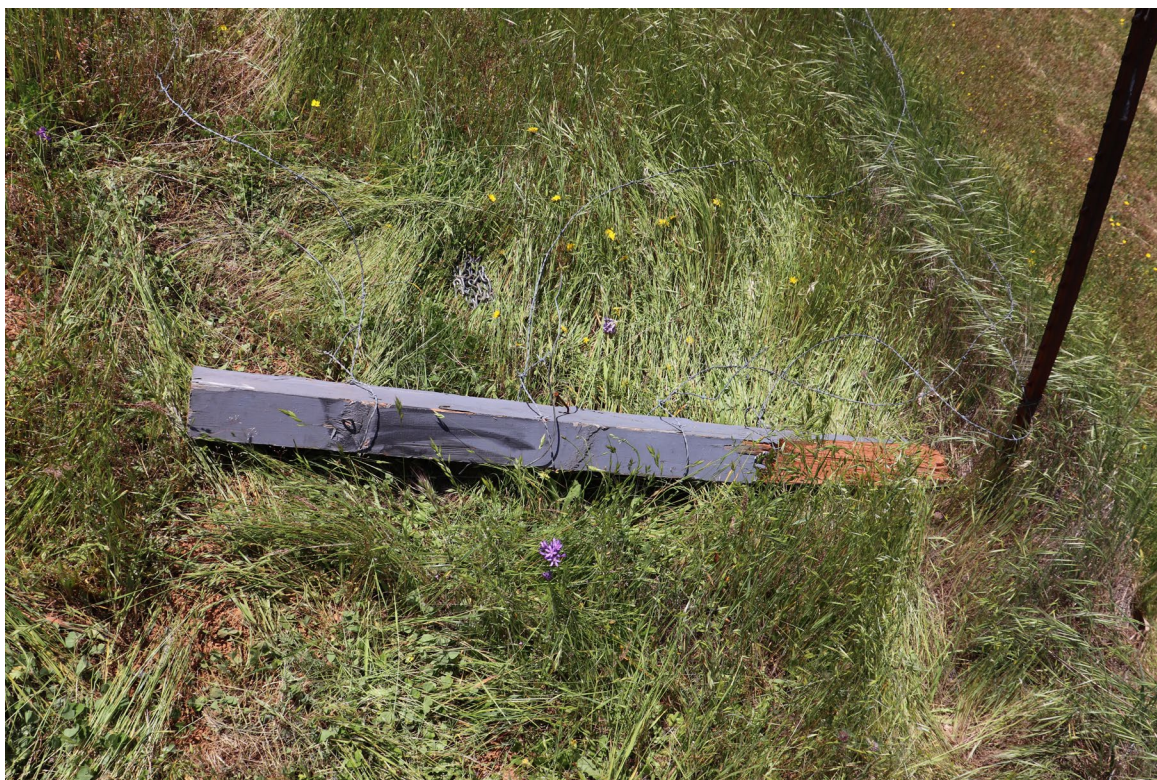
**Photograph 4 - View of downed airport perimeter fence post with black transfer mark.**

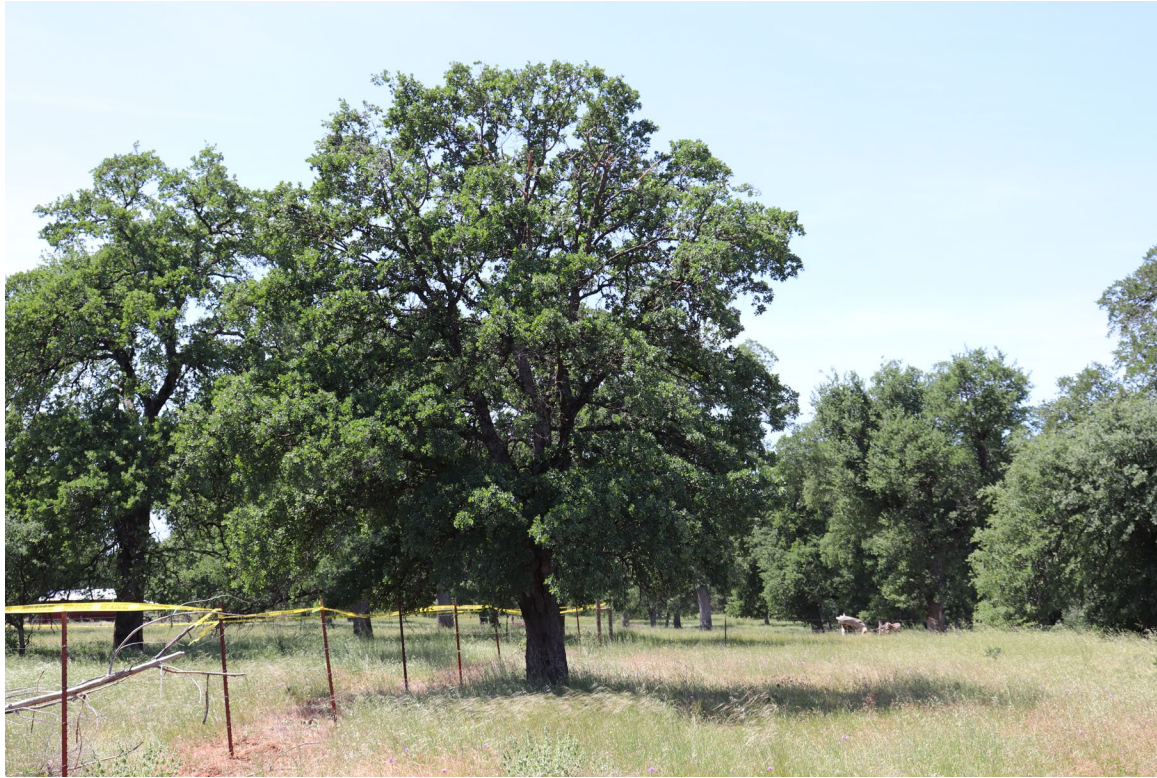
**Photograph 5 - View of tree with damaged limbs along extended runway center line.**

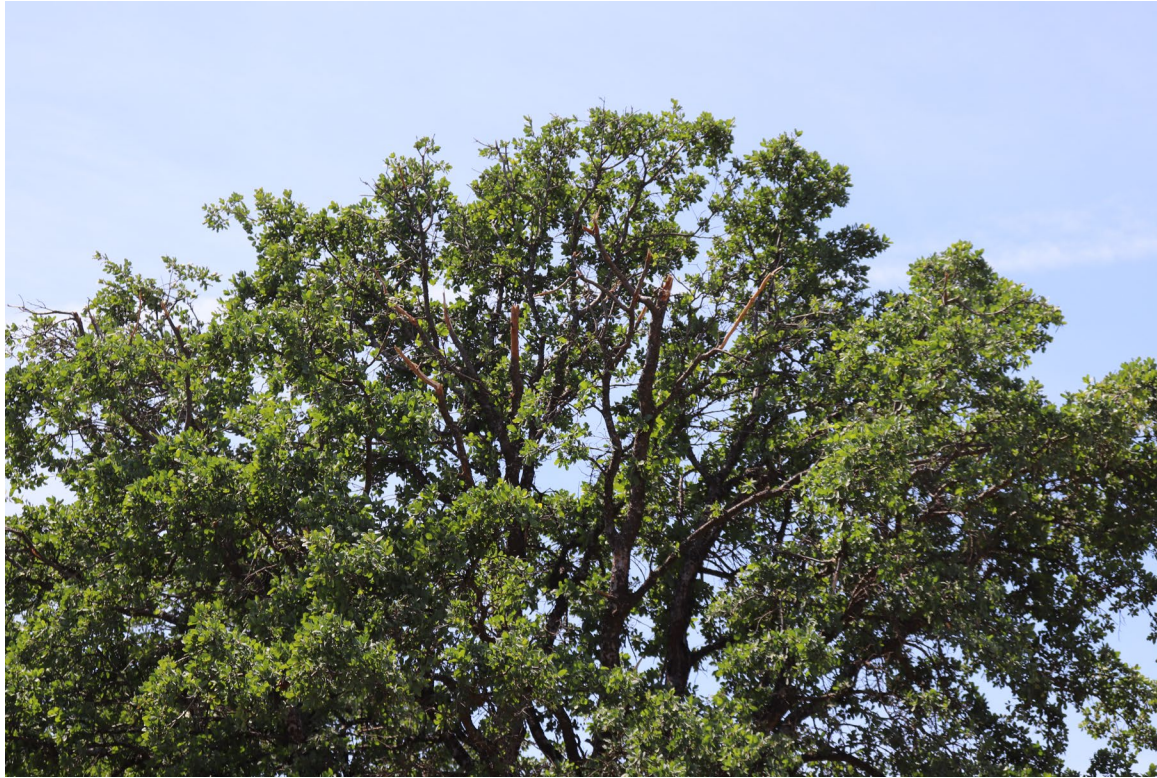
**Photograph 6 - View of damaged limbs along extended runway center line.**
