# National Transportation Safety Board

WPR25FA146

## **WRECKAGE EXAMINATION**

Location: Grass Valley, California  
Date: May 1, 2025  
Time: 08:15 Local  
1:15 Zulu  
Airplane: Cessna 177RG

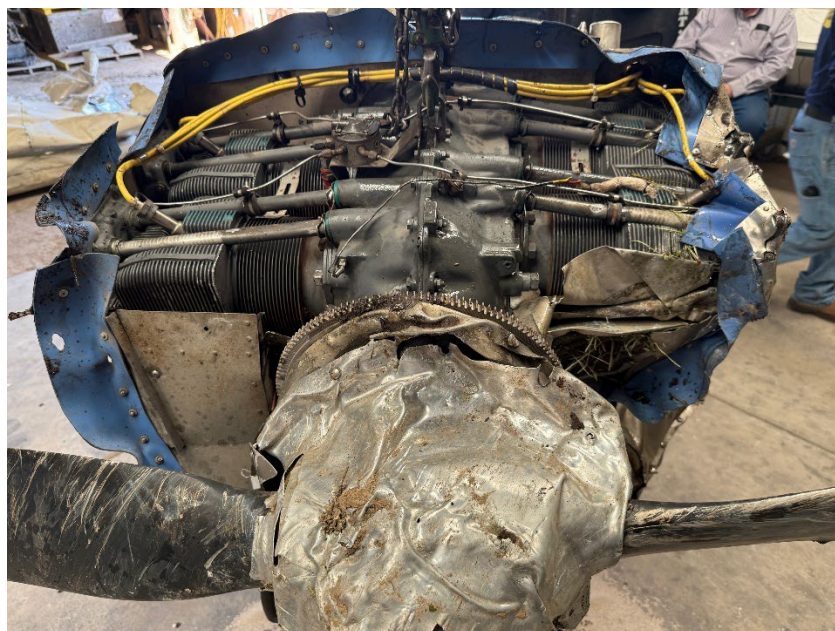
Lycoming IO-360-A1B6D, serial number L-1999-51E was installed on the airplane (Figure 1). Examination of the engine revealed that the engine was separated from the airframe during the accident sequence. All four cylinders and all engine accessories remained attached. The No. 4 cylinder rocker box cover and cylinder head were impact damaged. No evidence of any mechanical damage was observed to the engine crankcase. The oil suction screen was free of visible contamination.

**Figure 1 Engine from accident airplane**

The rocker box covers were removed. The intake and exhaust rocker arms were intact, and oil coated on all cylinders. The No. 4 cylinder, intake rocker arm and valve spring was fracture separated. The remaining intake and exhaust valve springs were in place and visually appeared to be undamaged. The upper spark plugs were removed, and all four cylinders were examined internally using a lighted borescope. A

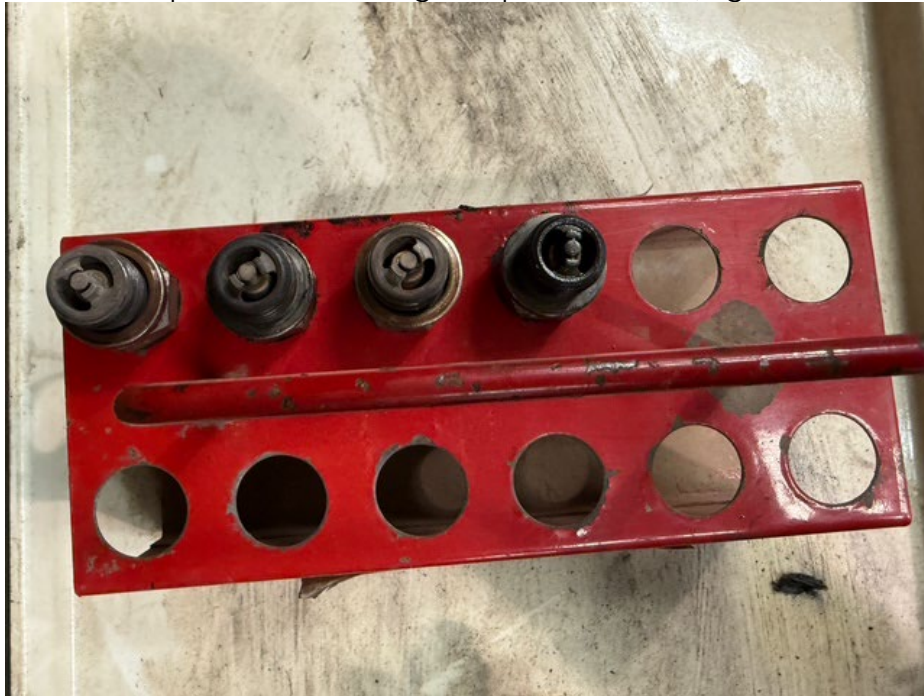
The top engine spark plugs were the massive electrode type. The No. 4 cylinder spark plug was oil coated. The spark plugs exhibited gray deposits within the electrode area. The spark plugs exhibited signatures consistent with WORN NORMAL when compared to the Champion Check-A-Plug comparison chart (Figure 2).

**Figure 2 Top spark plugs from each cylinder**

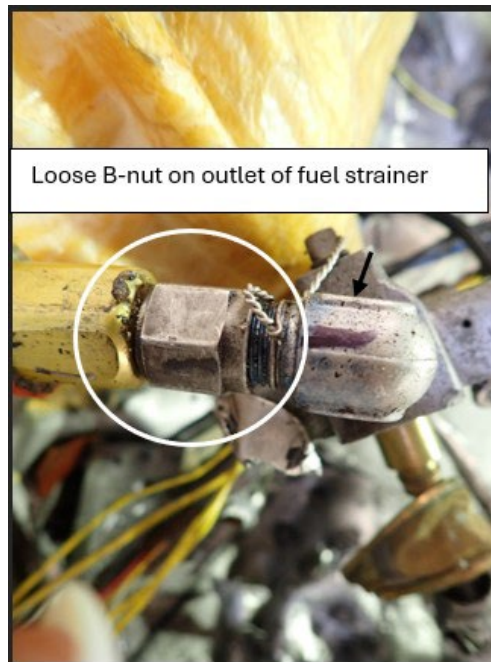
The B-nut attached to the outlet of the fuel strainer was finger tight. A wrench was used to turn the nut and it moved more than half a flat to tighten (Figure 3).

**Figure 3 Loose B-nut fitting on outlet line from fuel strainer**

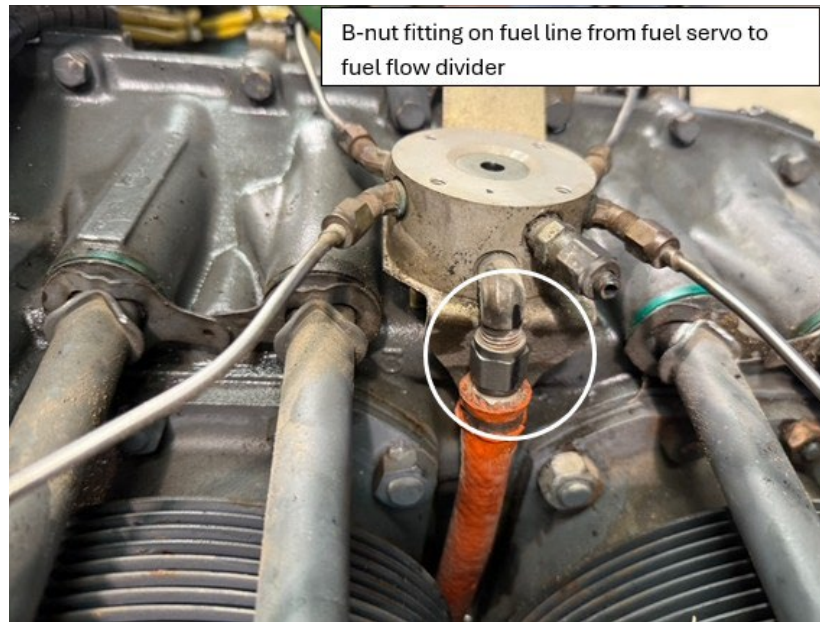
The fuel flow divider remained attached to the engine (Figure 4). The fuel flow gage line was fractured and separated from the flow divider. The remaining fuel lines remained attached to their respective fuel flow nozzles. The fuel line from the fuel servo to the fuel flow divider was approximately ½ turn loose at the fuel flow divider fitting. Blue fuel staining was observed in the area surrounding the loose fitting (figure 5). No damage was observed to the surrounding area near the attachment point. All the fuel nozzles were removed; no obstructions were observed.

**Figure 4 Fuel flow divider with B-nut fitting**

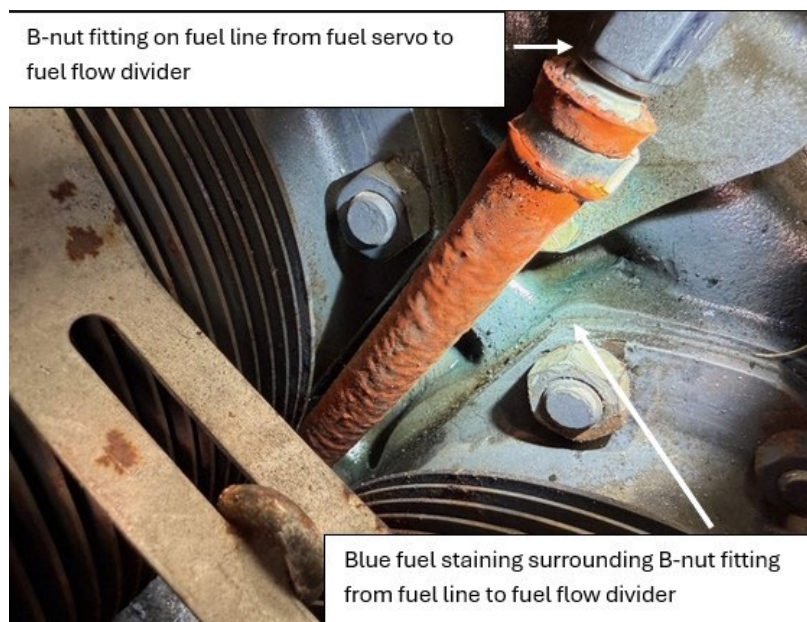
**Figure 5 Blue dye staining surrounding B-nut fitting into fuel flow divider**

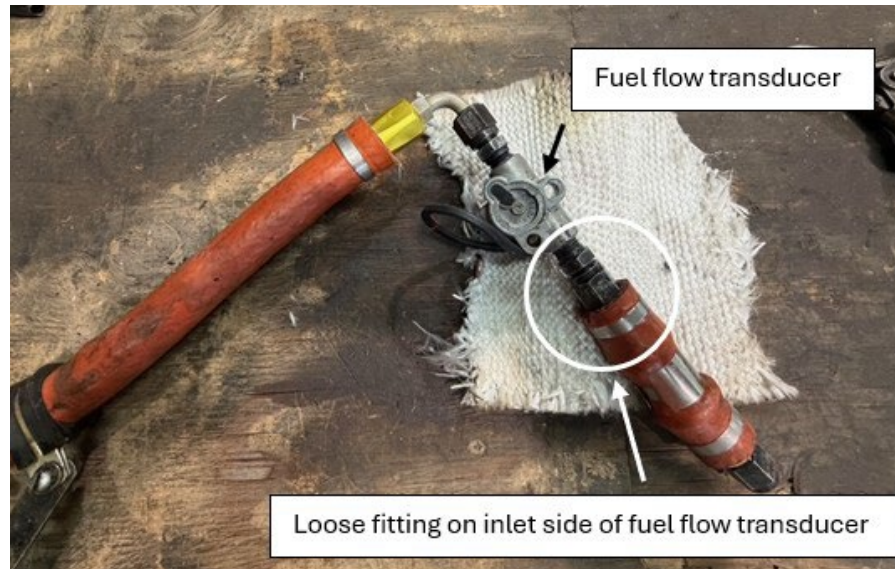
The fuel pump outlet line, fuel flow transducer and fuel control inlet line were removed from the engine. The fitting on the inlet side of the fuel flow transducer was loose and rotated freely (Figure 6). The fitting was tightened with a wrench and rotated

half a turn before the fitting was tight to the transducer housing. The B-nut attached to the fitting was tight.

**Figure 6 Loose fitting on inlet side of fuel flow transducer**

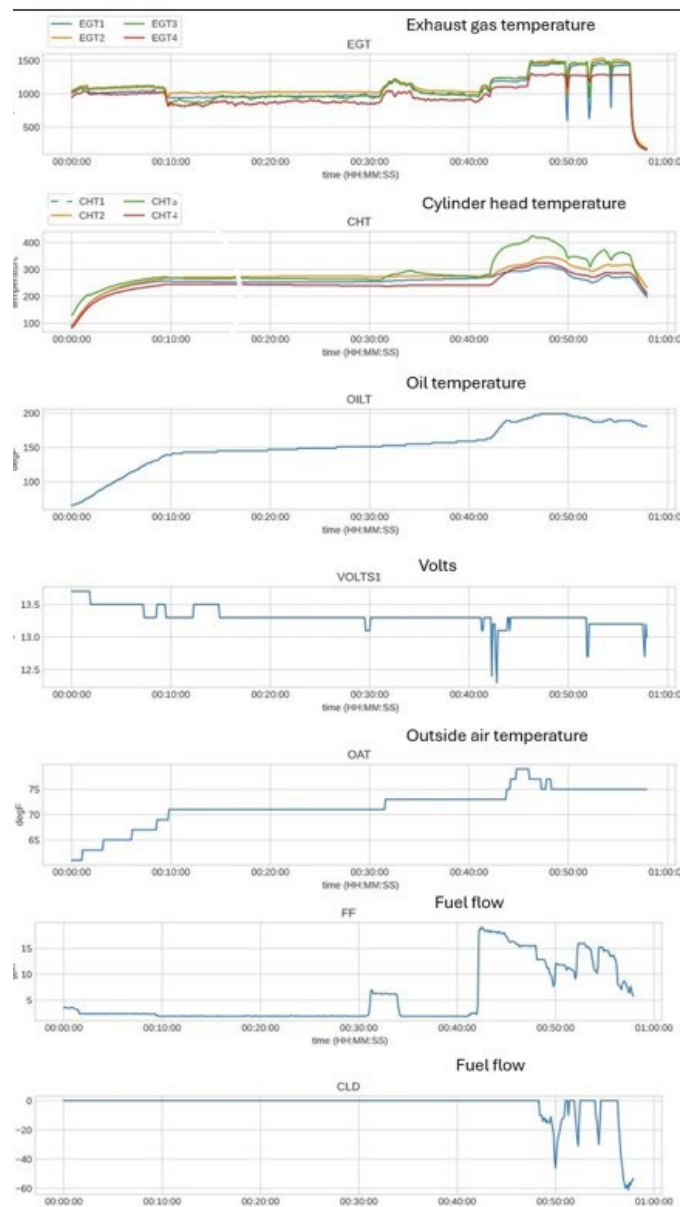
The data reflected a normal takeoff and cruise until the last few seconds of flight when the EGTs briefly spiked and then began to drop along with the CHTs. Engine RPM decreased to 0 RPM.

Data is measured in seconds, 1200 seconds=20 minutes

Figure 7 Engine data from engine monitoring instrument
