# National Transportation Safety Board

WPR25LA004

## **AIRFRAME AND ENGINE EXAMINATION**

Location: El Monte, California  
Date: October 6, 2024  
Time: 2039 Pacific daylight time  
Airplane: Cessna 172L, N7869G

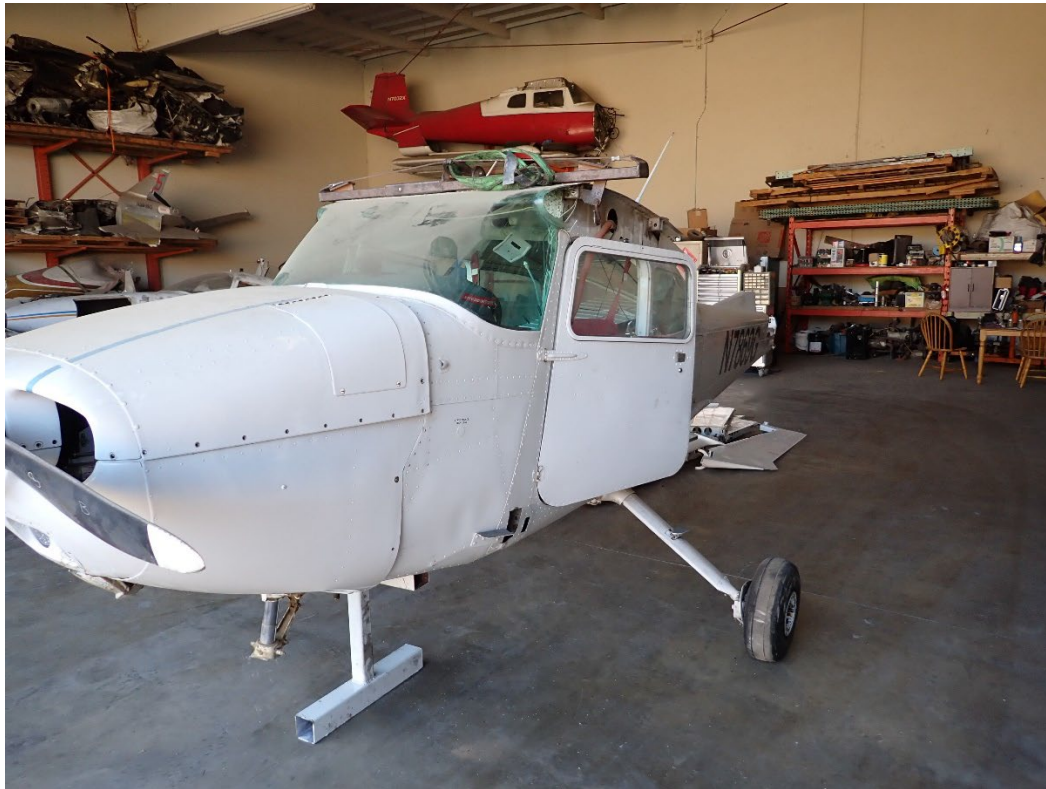
Examination of the recovered wreckage revealed that the nose landing gear was impact damaged, and buckling on the undercarriage near the firewall was observed.

The firewall exhibited crushing and bending aft. Both wings, horizontal stabilizer, vertical stabilizer, rudder and elevator were removed by recovery personnel.

**Figure 1: Front view of accident airplane during examination.**

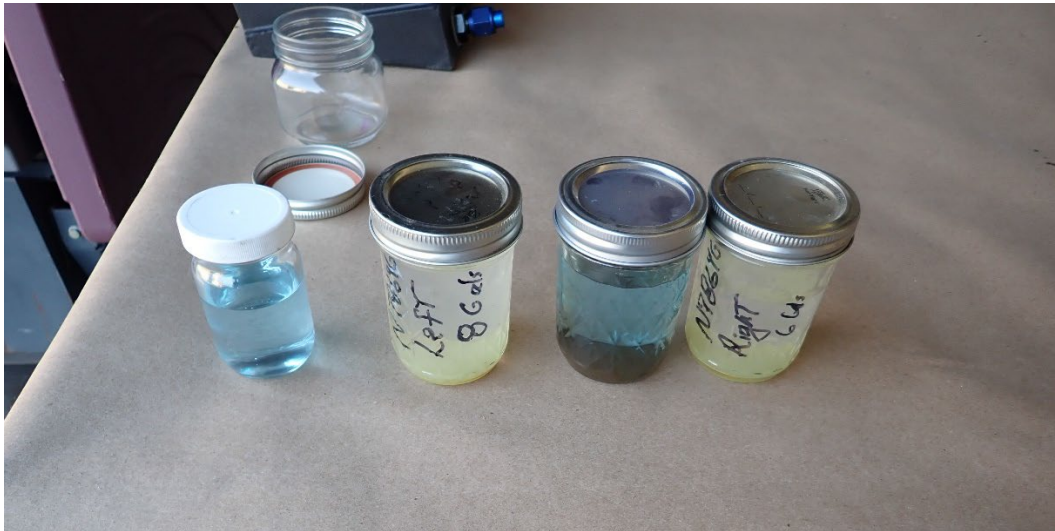
According to the recovery company, about 8 gal of fuel was recovered from the airplane's left wing and about 6 gal of fuel was recovered from the right wing. A yellow in color fuel sample was collected from each wing.

**Figure 2: View of the fuel samples.**

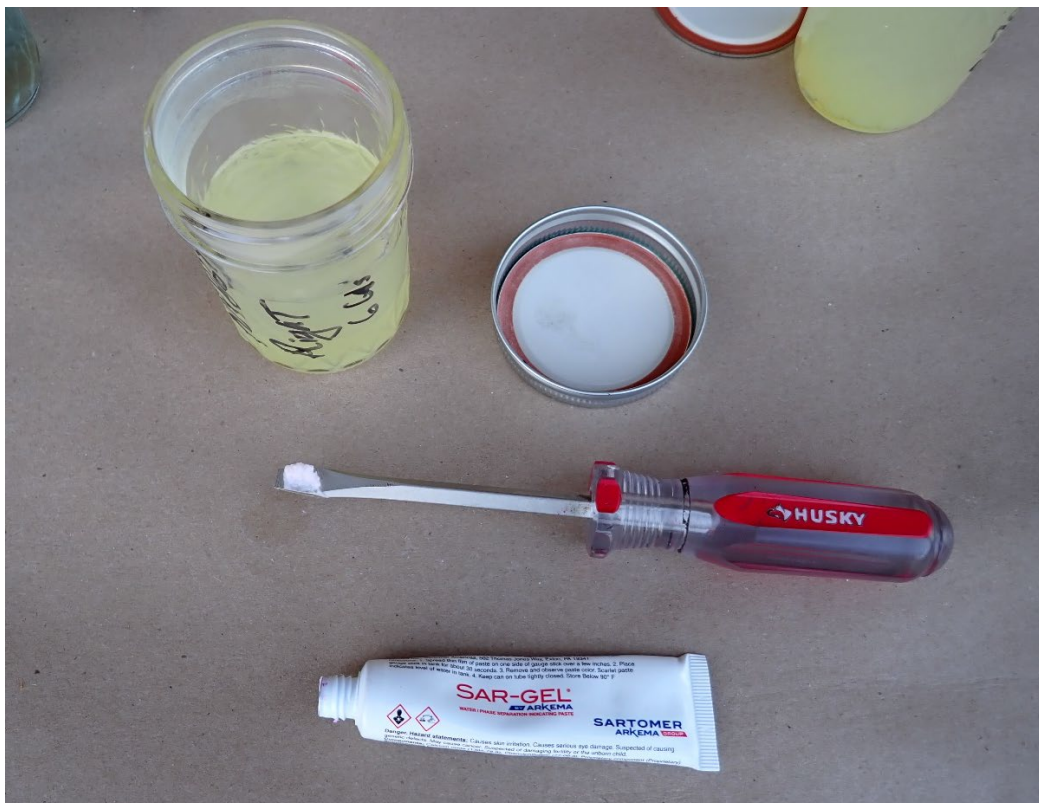
color liquid, constant with 100 LL was observed coming from the airframe fuel strainer. The fuel selector lever was then moved to the right fuel tank position and blue in color liquid, constant with 100 LL was observed coming from the airframe fuel strainer. The fuel was tested for water using SAR-GEL water finding paste, with negative results. An external fuel tank was attached to the left-wing fuel line. When the fuel selector lever was moved to the left tank position, fuel expelled from the airframe fuel strainer.

**Figure 3: View of the right wing fuel sample water test.**

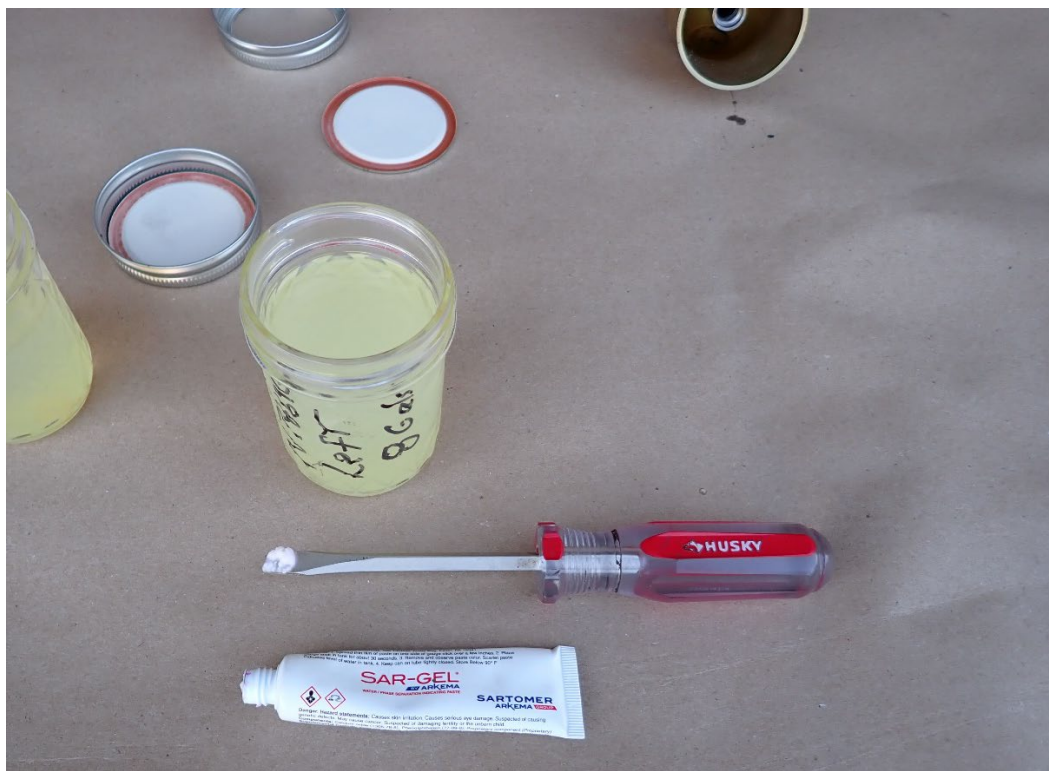
**Figure 4: View of the left wing fuel sample water test.**

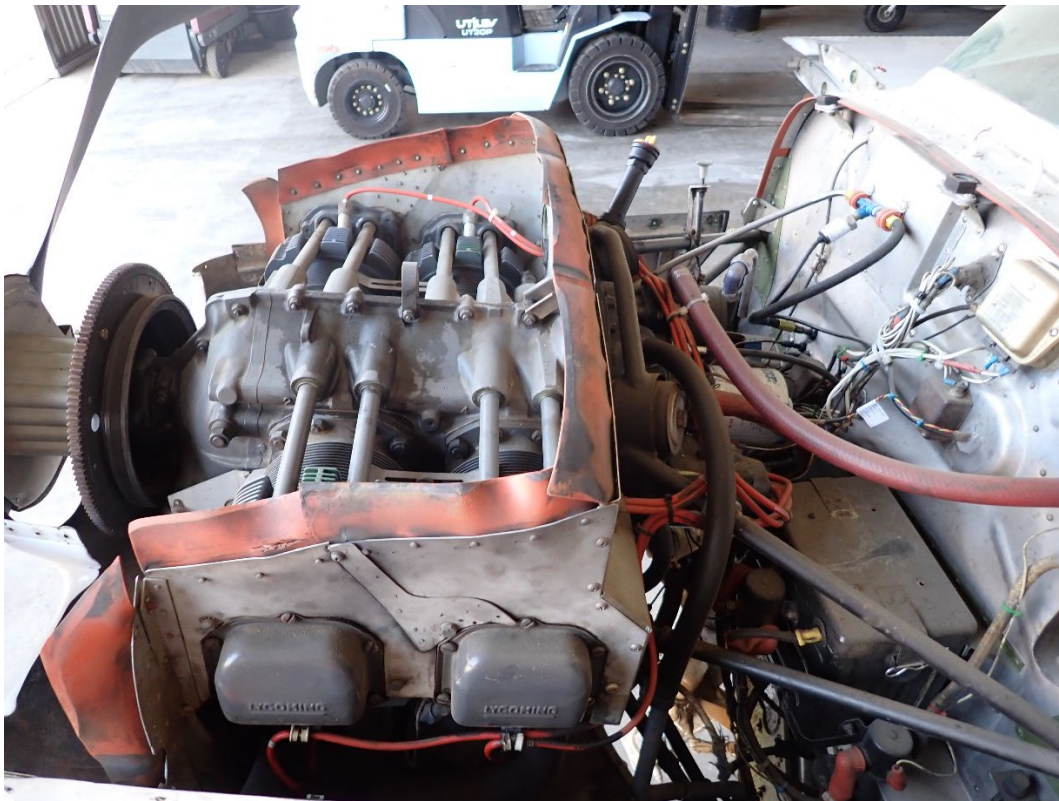
Examination of the recovered engine revealed that it remained attached to the engine mounts. All four cylinders and all engine accessories remained attached. All fuel and oil lines appeared attached to their respective fittings and were tight. No evidence of any mechanical damage was observed to the engine crankcase.

**Figure 5: View of the engine during exam.**

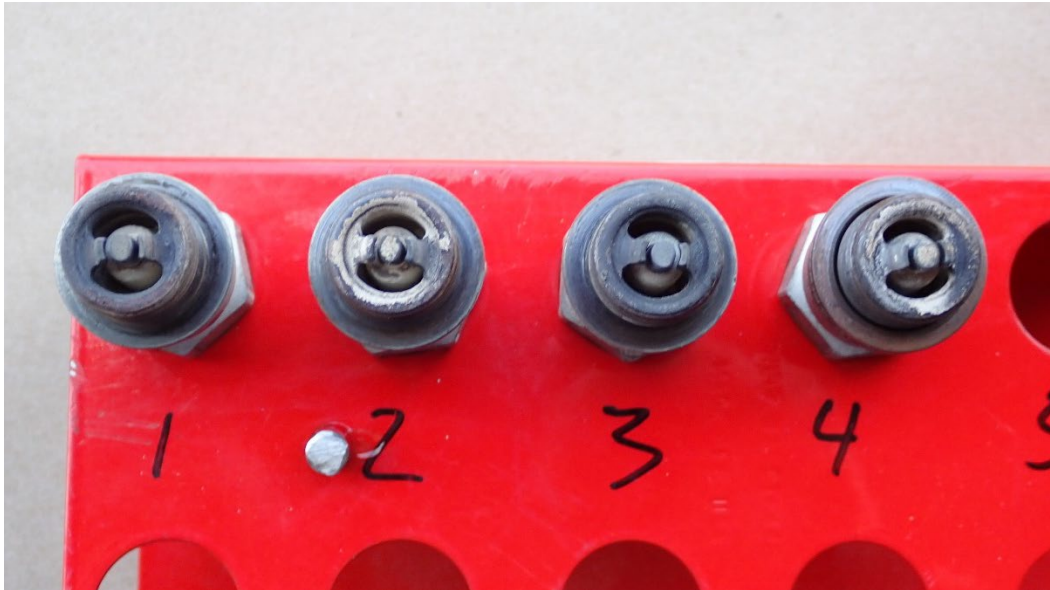
The top spark plugs were removed from the engine and they were the massive electrode type. Light gray coloration within the electrode areas was observed. When compared to the Champion Check-A-Plug chart, the sparkplugs exhibited NORMAL use signatures.

**Figure 6: View of the top spark plugs.**

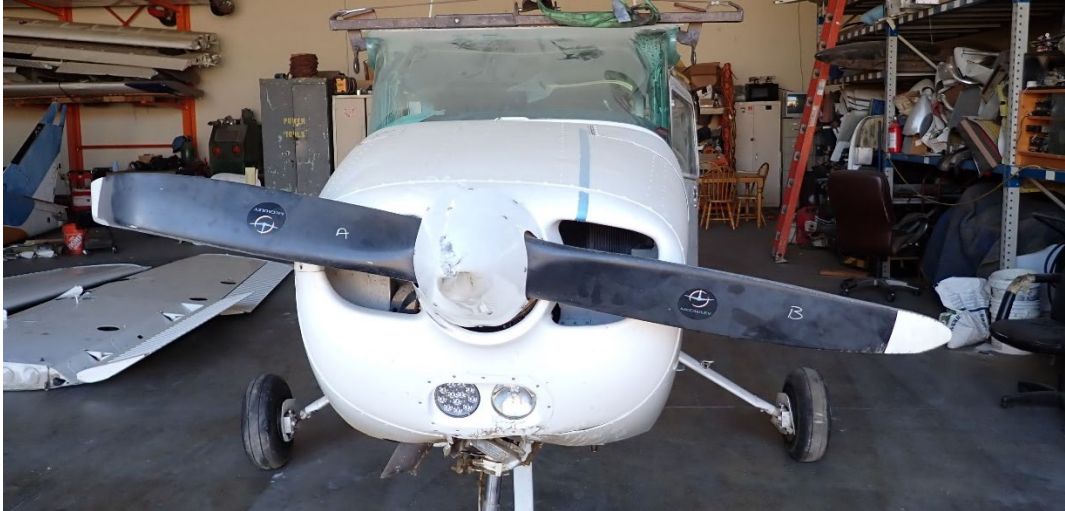
The airplane was equipped with a two blade McCauley Propeller; for the purposes of this report the propeller blades were labeled A and B. The propeller remained attached to the engine crank shaft. Propeller blade A exhibited aft bending about midspan with various striations on the cambered side of the blade. Propeller blade B exhibited aft bending near the propeller tip with various striations on the cambered side of the blade.

**Figure 7: Front view of propeller.**
