WPR25LA004

## INVESTIGATION PHOTOGRAPHS

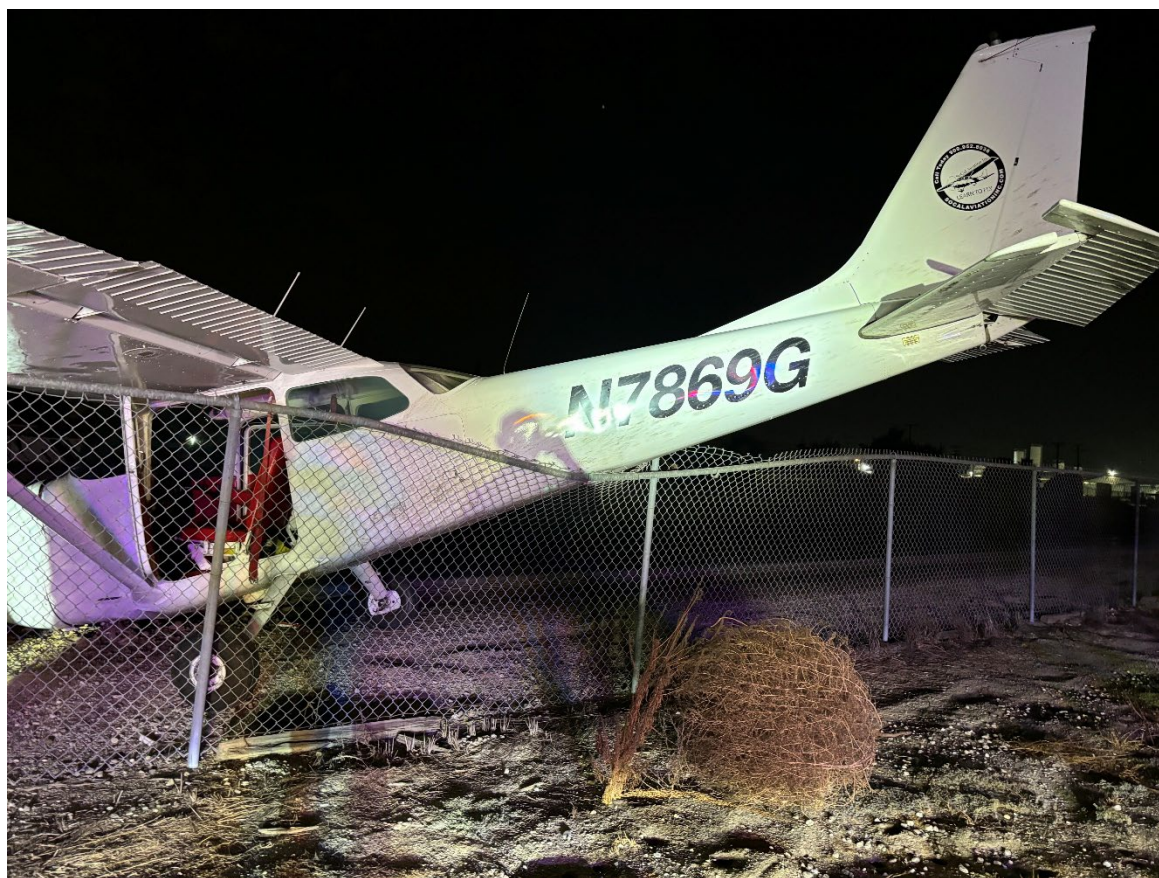
**Photograph 1 - N7869G at accident site (Courtesy of airport manager)**

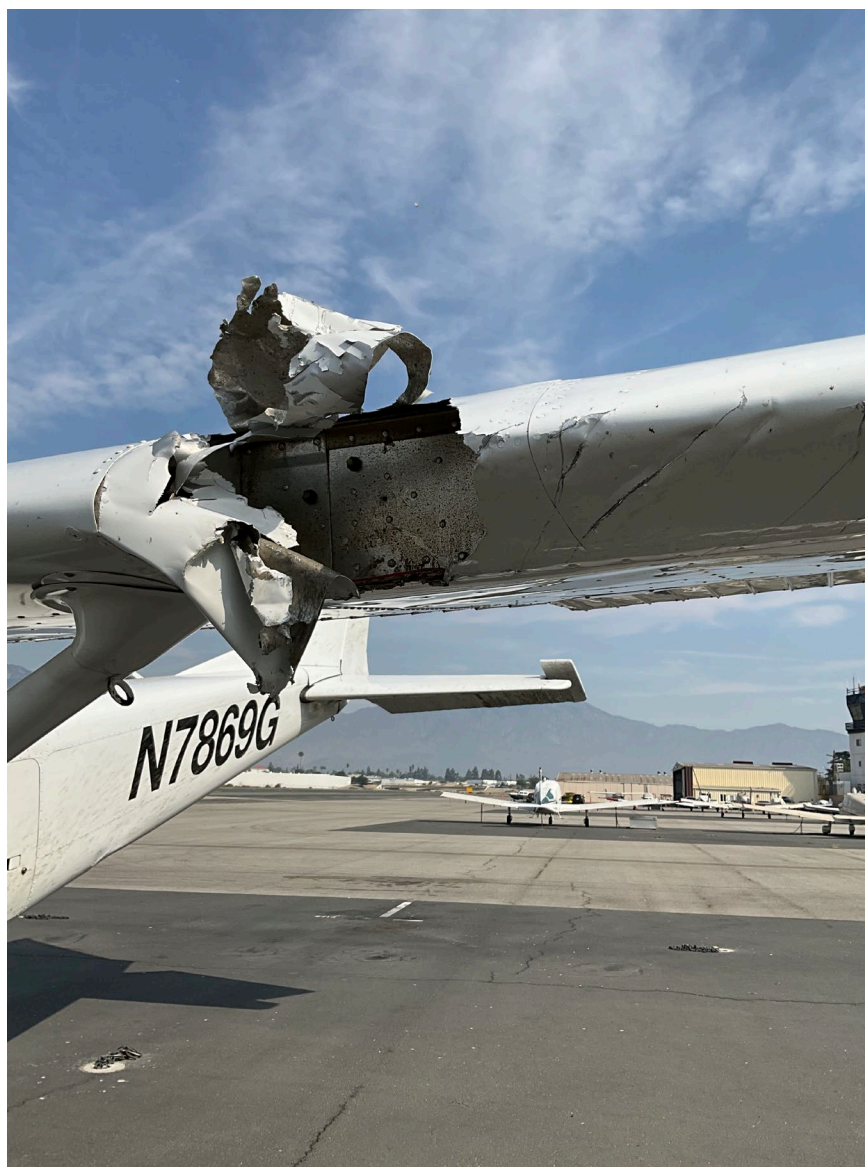
**Photograph 2 - Substantial damage to the left-wing spar (Courtesy of airport manager)**

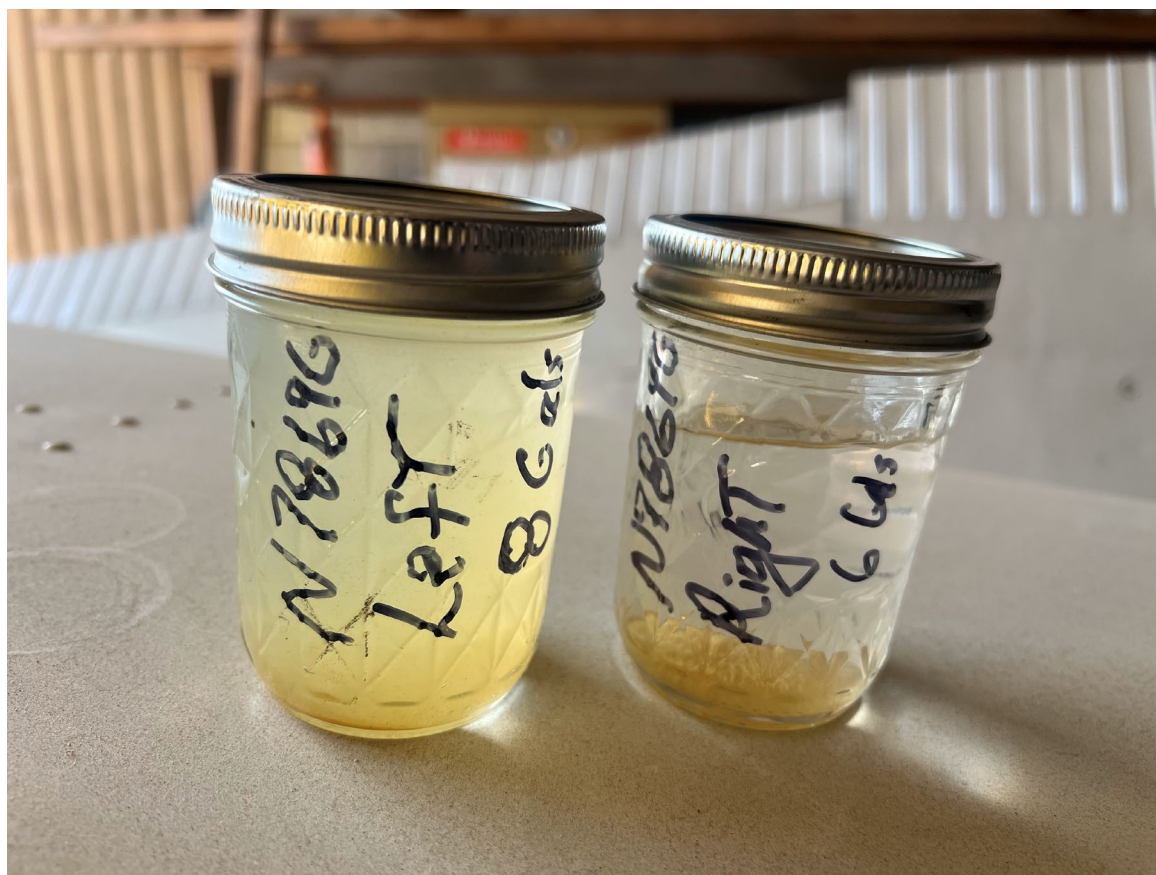
**Photograph 3 - Left- and right-wing fuel samples showing contamination (Courtesy of Recovery agent)**
