WPR25LA006

**INVESTIGATION PHOTOGRAPH**

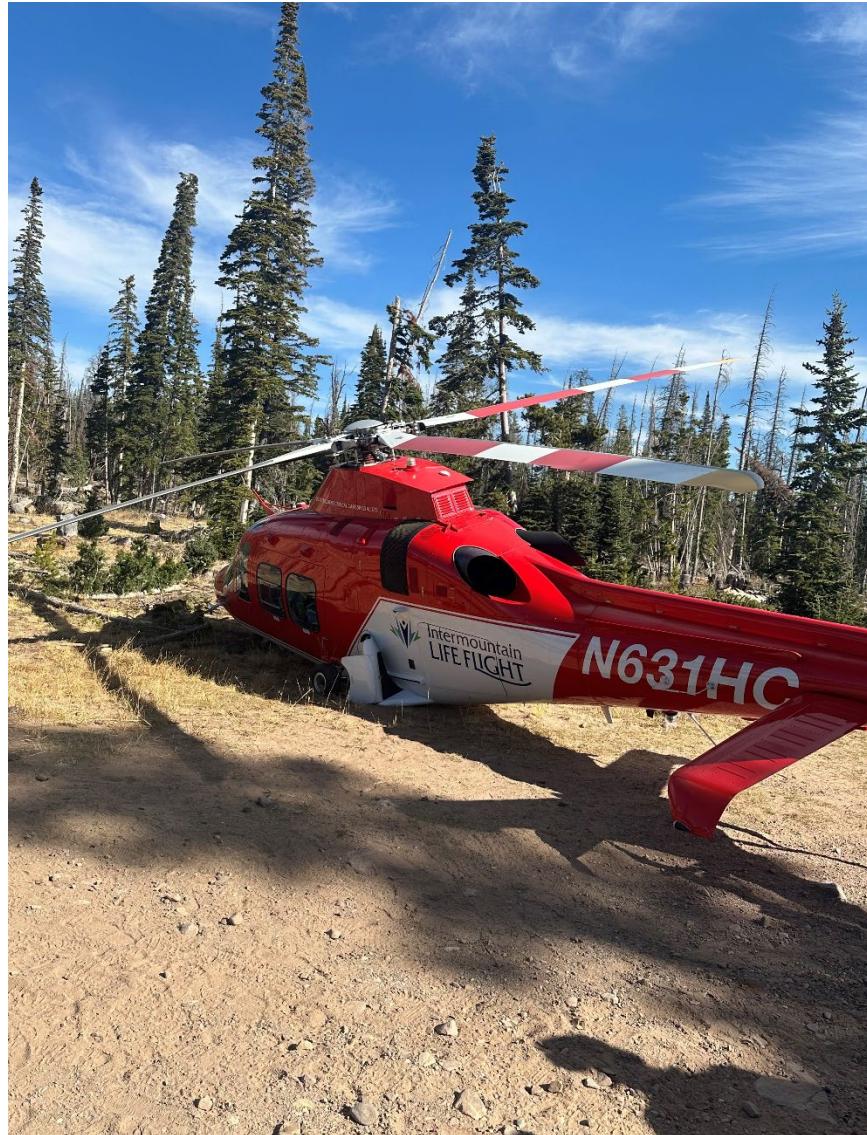
**Photograph 1 - View of damage to the helicopter's left main landing gear strut and lower fuselage (Courtesy of operator)**
