WPR25LA011

## INVESTIGATION PHOTOGRAPHS

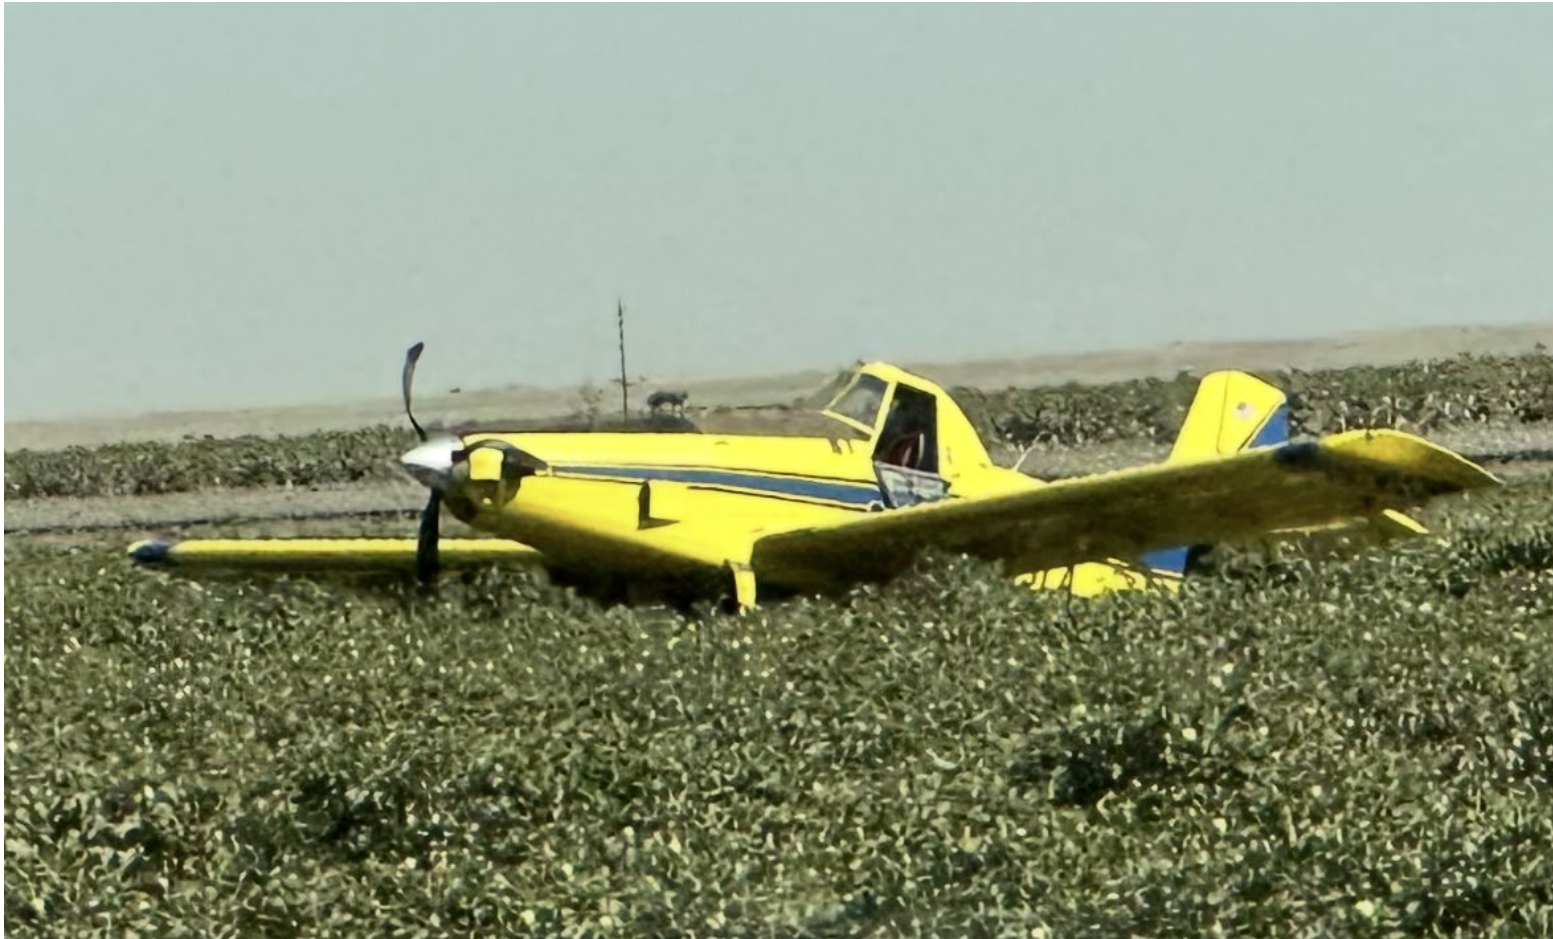
**Photograph 1 -Accident Airplane (Courtesy of Pilot)**

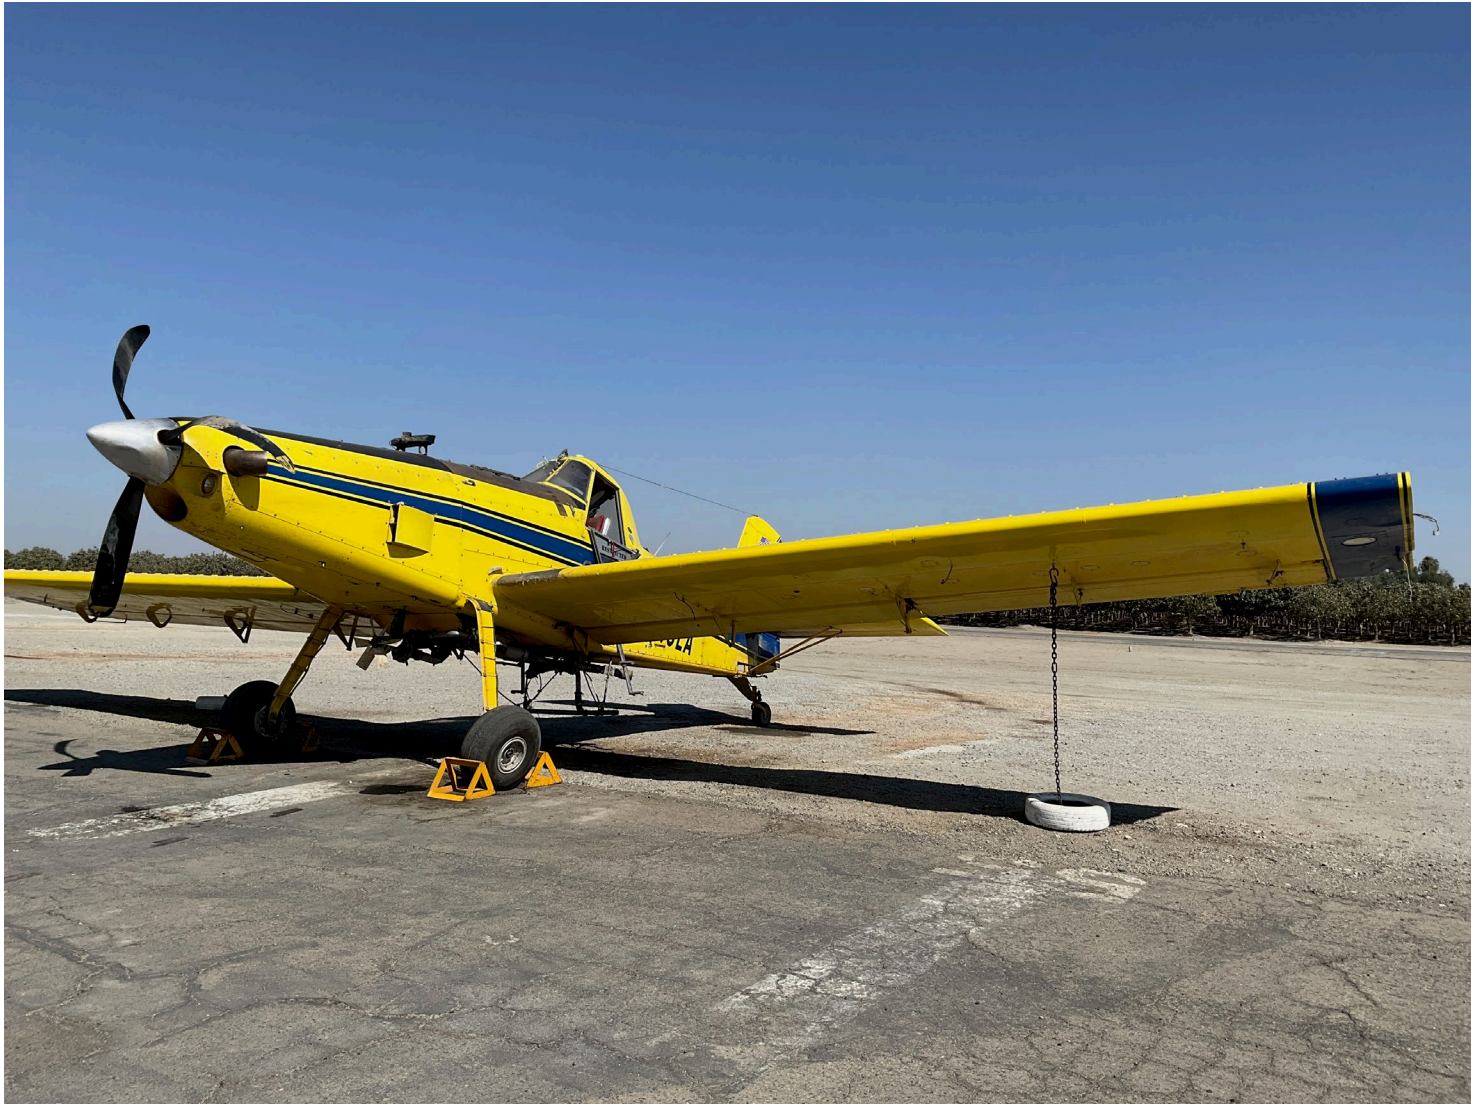
**Photograph 2 - Accident Airplane (Courtesy of FAA)**

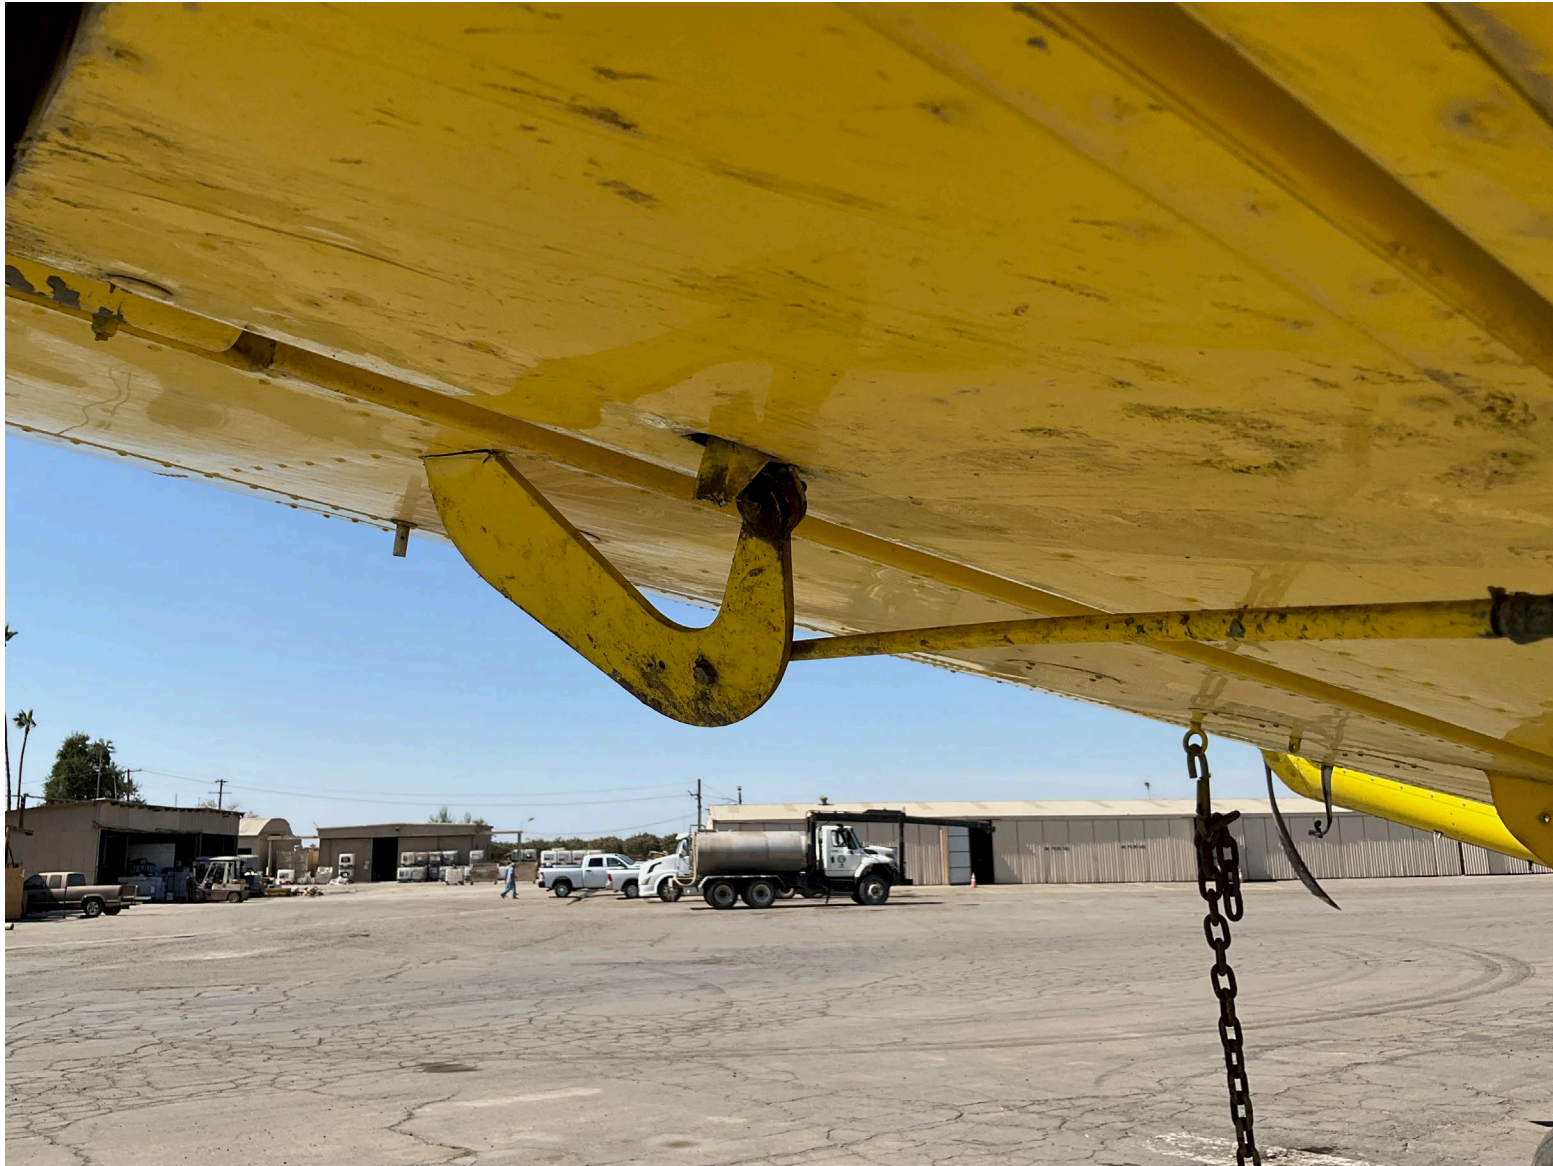
**Photograph 3 - Damaged aileron hinge and boost tab control rod (Courtesy of FAA)**
