WPR25LA015

## INVESTIGATION PHOTOGRAPHS

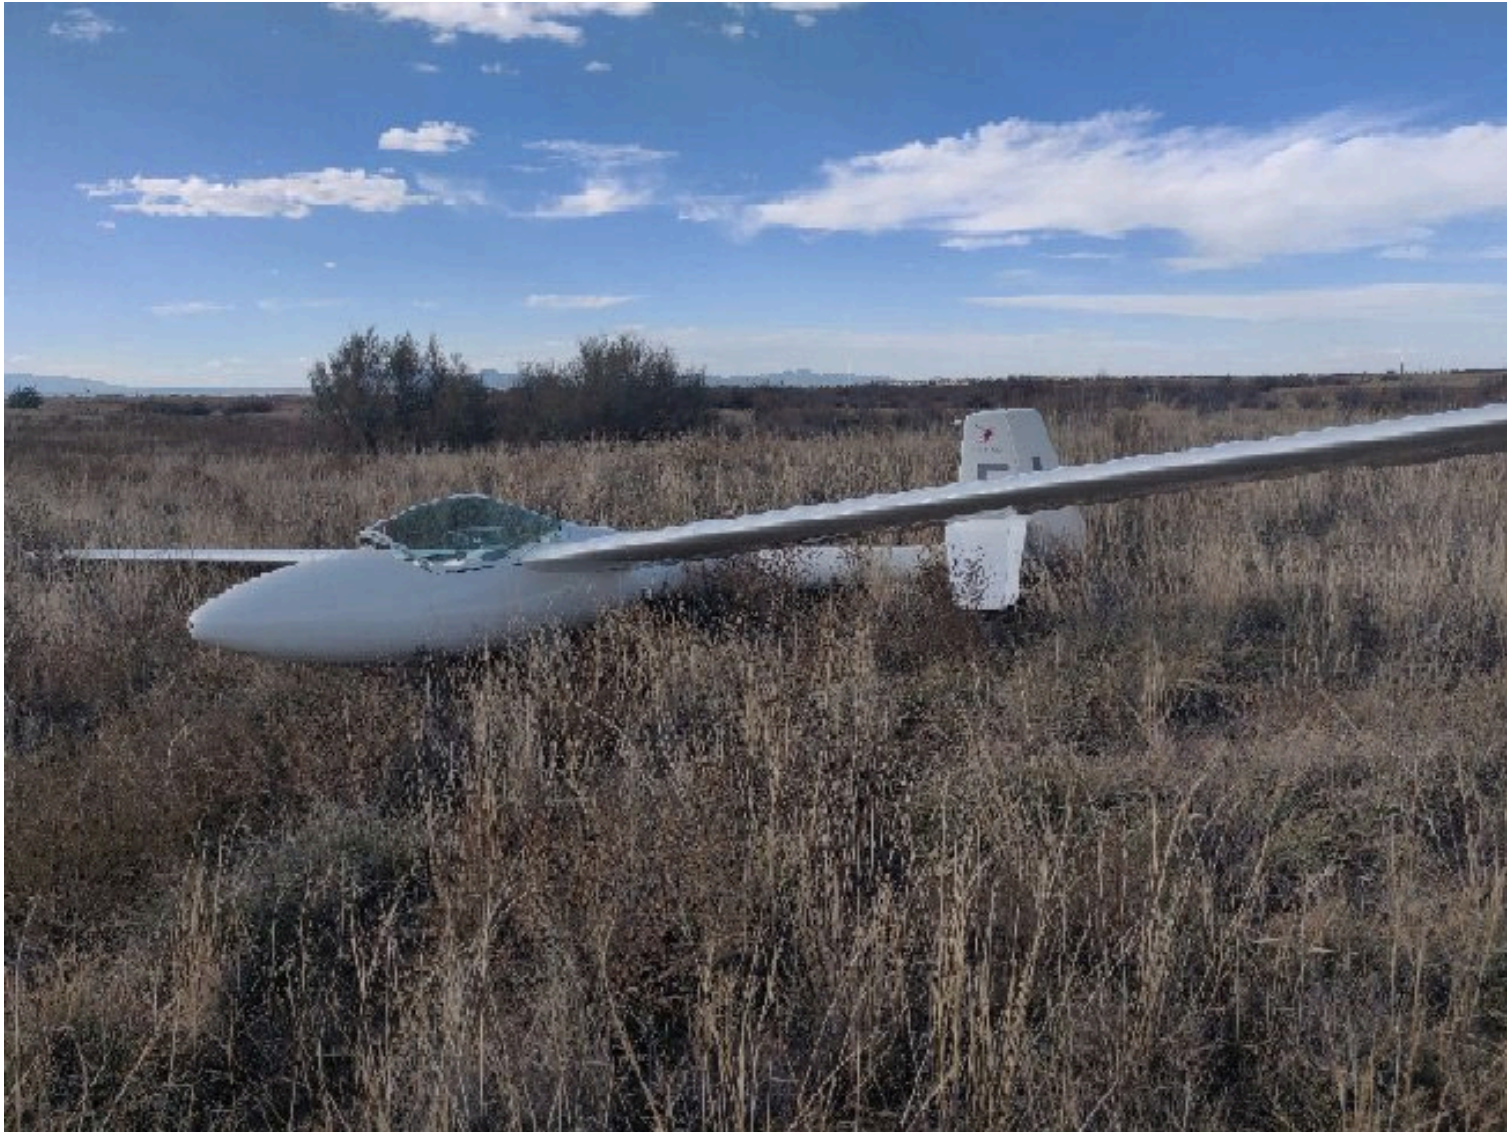
**Photograph 1 - View of the glider from the front left. (Courtesy of airport operations.)**

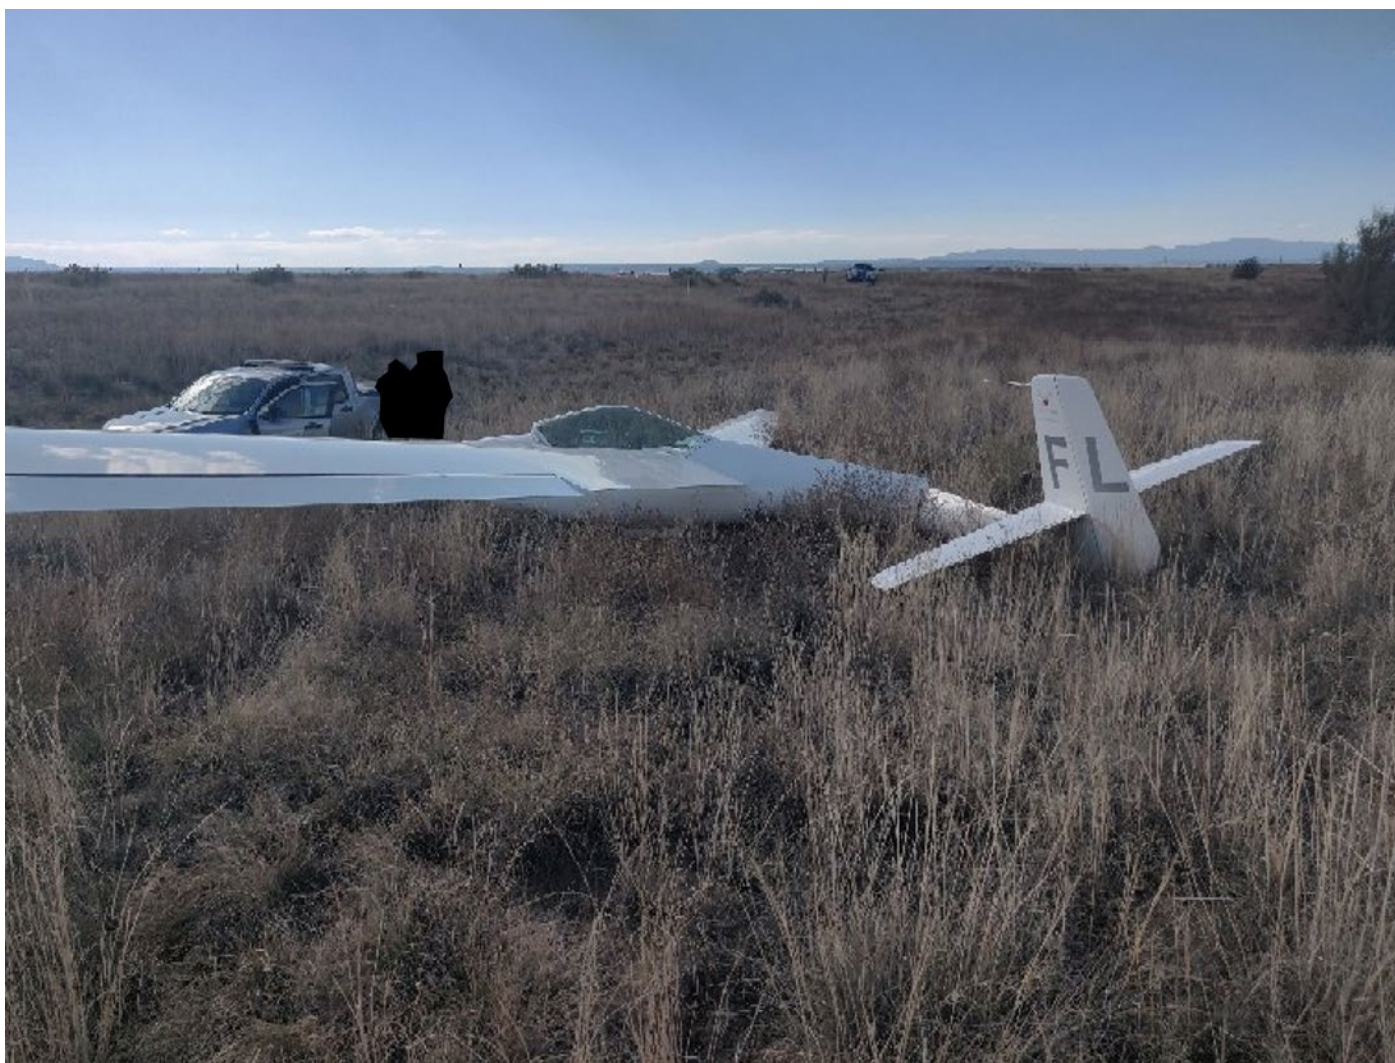
**Photograph 2 - View of the glider from aft left. (Courtesy of airport operations.)**

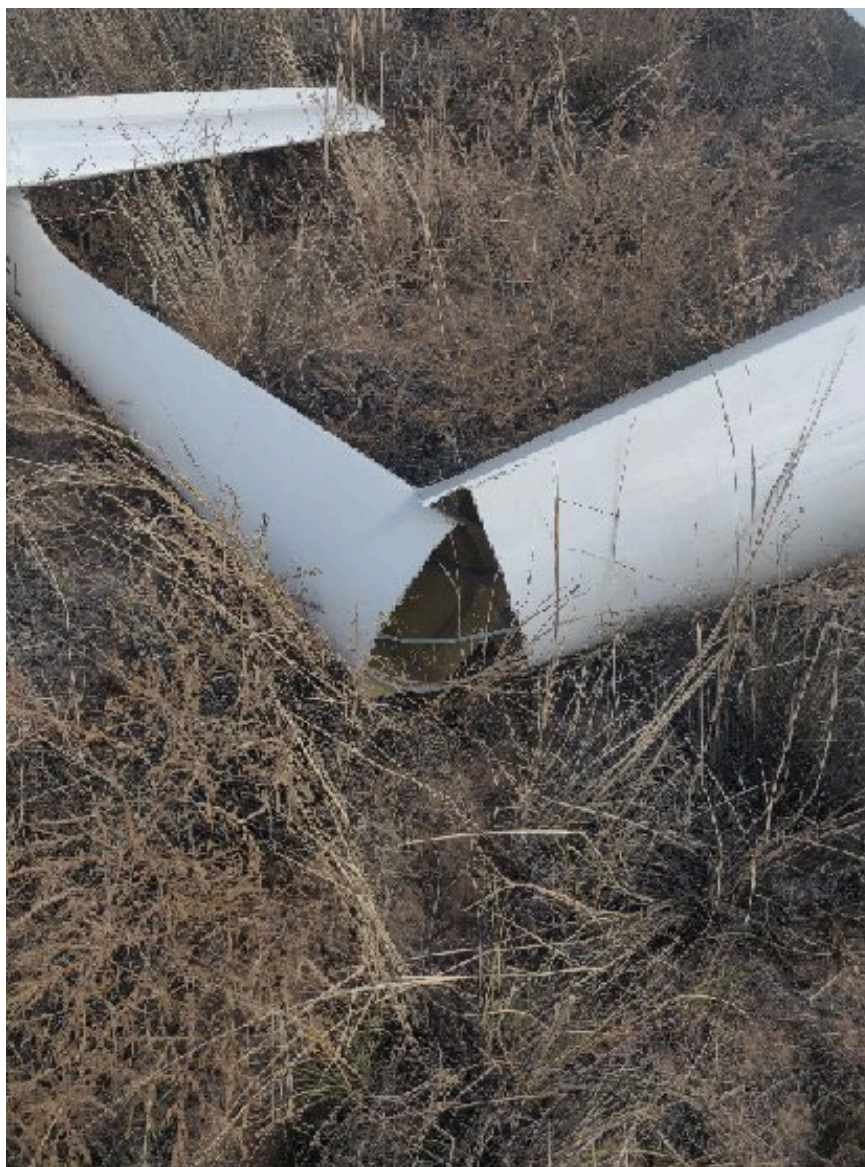
**Photograph 3 - View of substantial damage to empennage. (Courtesy of airport operations.)**
