WPR25LA026

**INVESTIGATION PHOTOGRAPH**

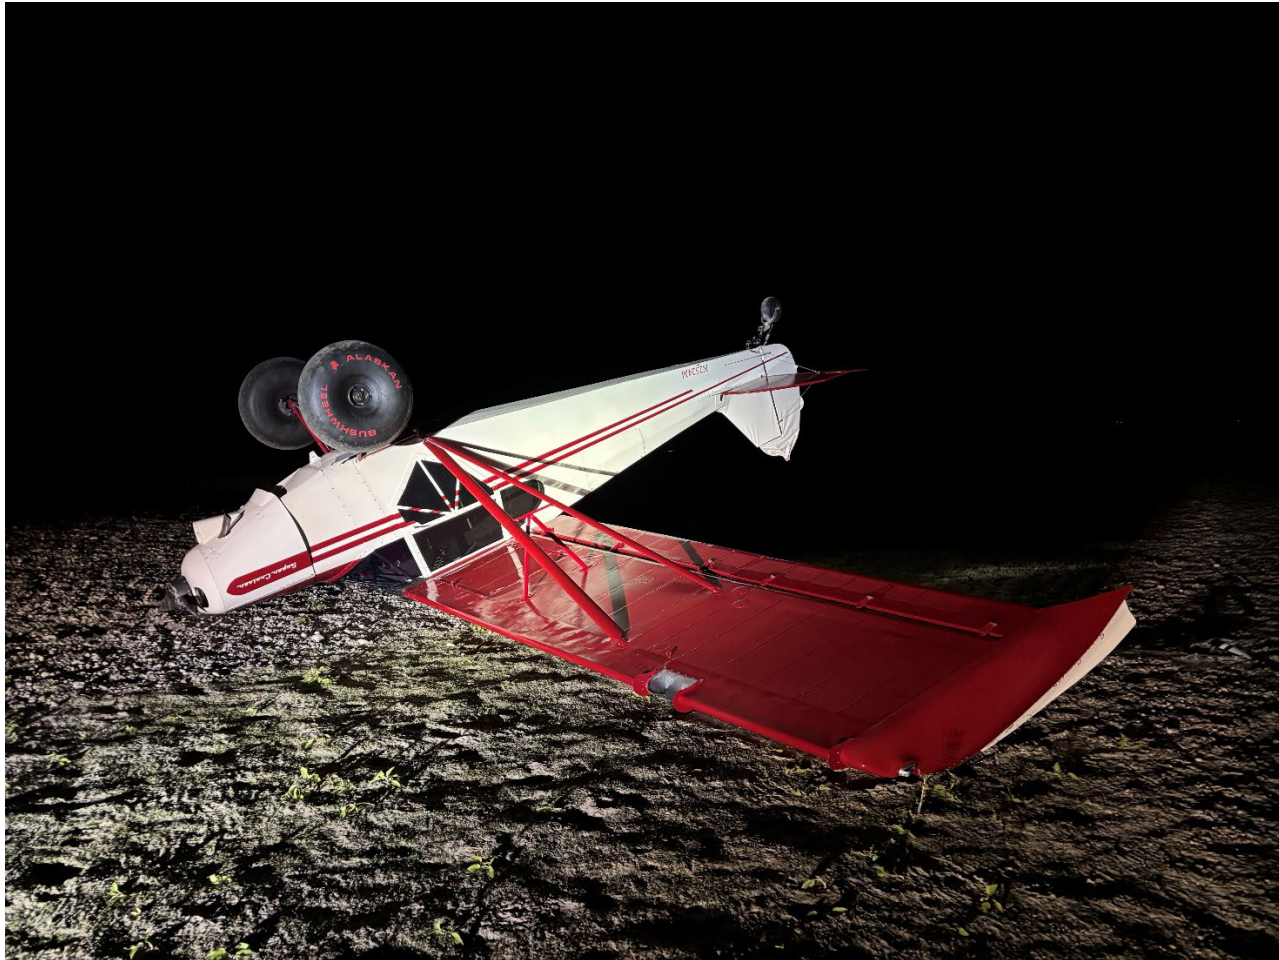
**Photograph 1 - View of substantial damage to the rudder (Courtesy of operator)**
