# National Transportation Safety Board

WPR25LA030

## **WRECKAGE EXAMINATION REPORT**

On October 31, 2024, at 1620 mountain standard time, a Piper PA-32-300, N154DC, was substantially damaged when it was involved in an accident near Prescott Valley, Arizona. The pilot was not injured. The airplane was operated as a Title 14 *Code of Federal Regulations* Part 91 personal flight.

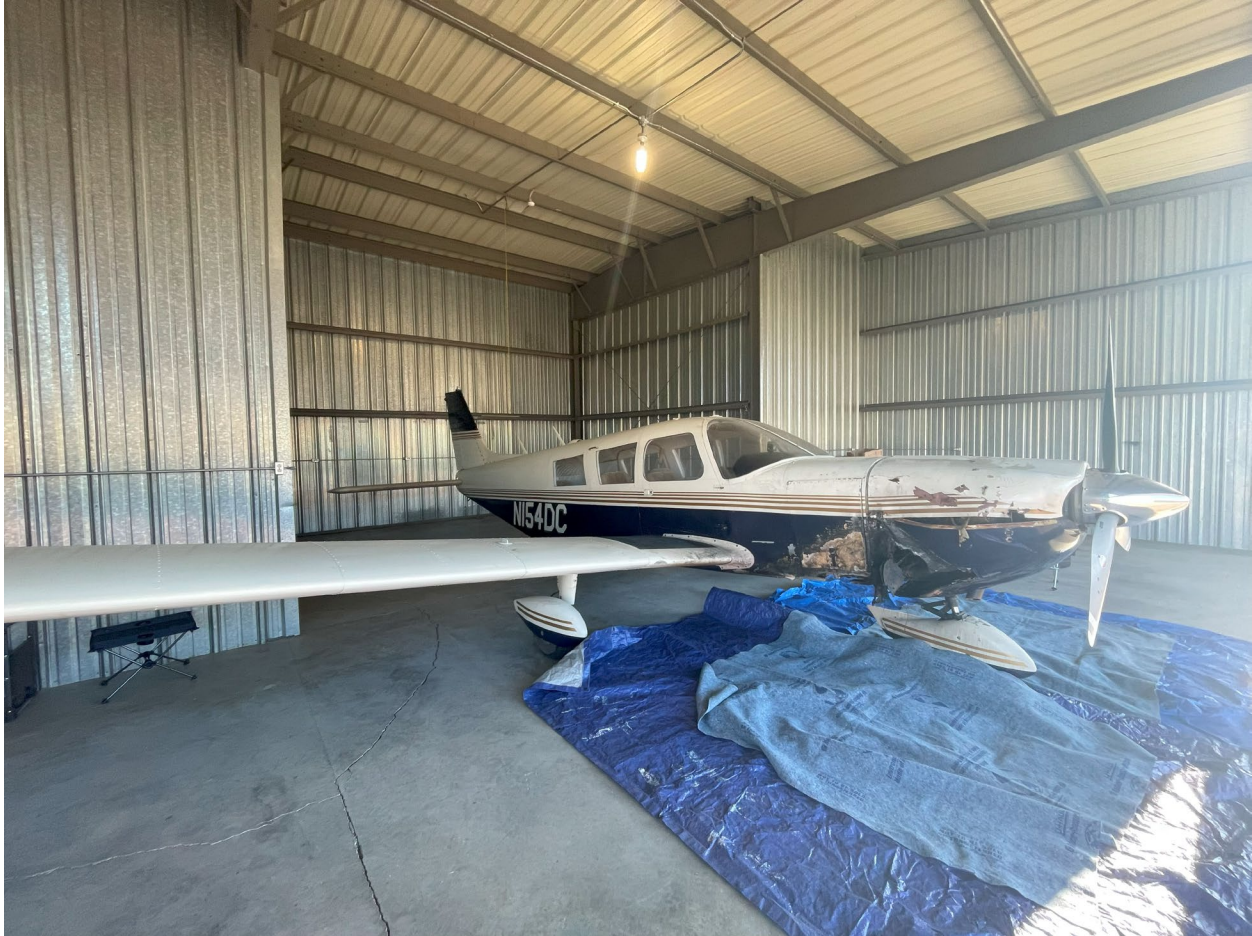
The airplane was removed from the site and transported to Prescott Municipal Airport, where a subsequent examination was conducted in a secured hangar on January 13-20, 2025 (figure 1).

**Figure 1. View of accident airplane in secured hangar.**

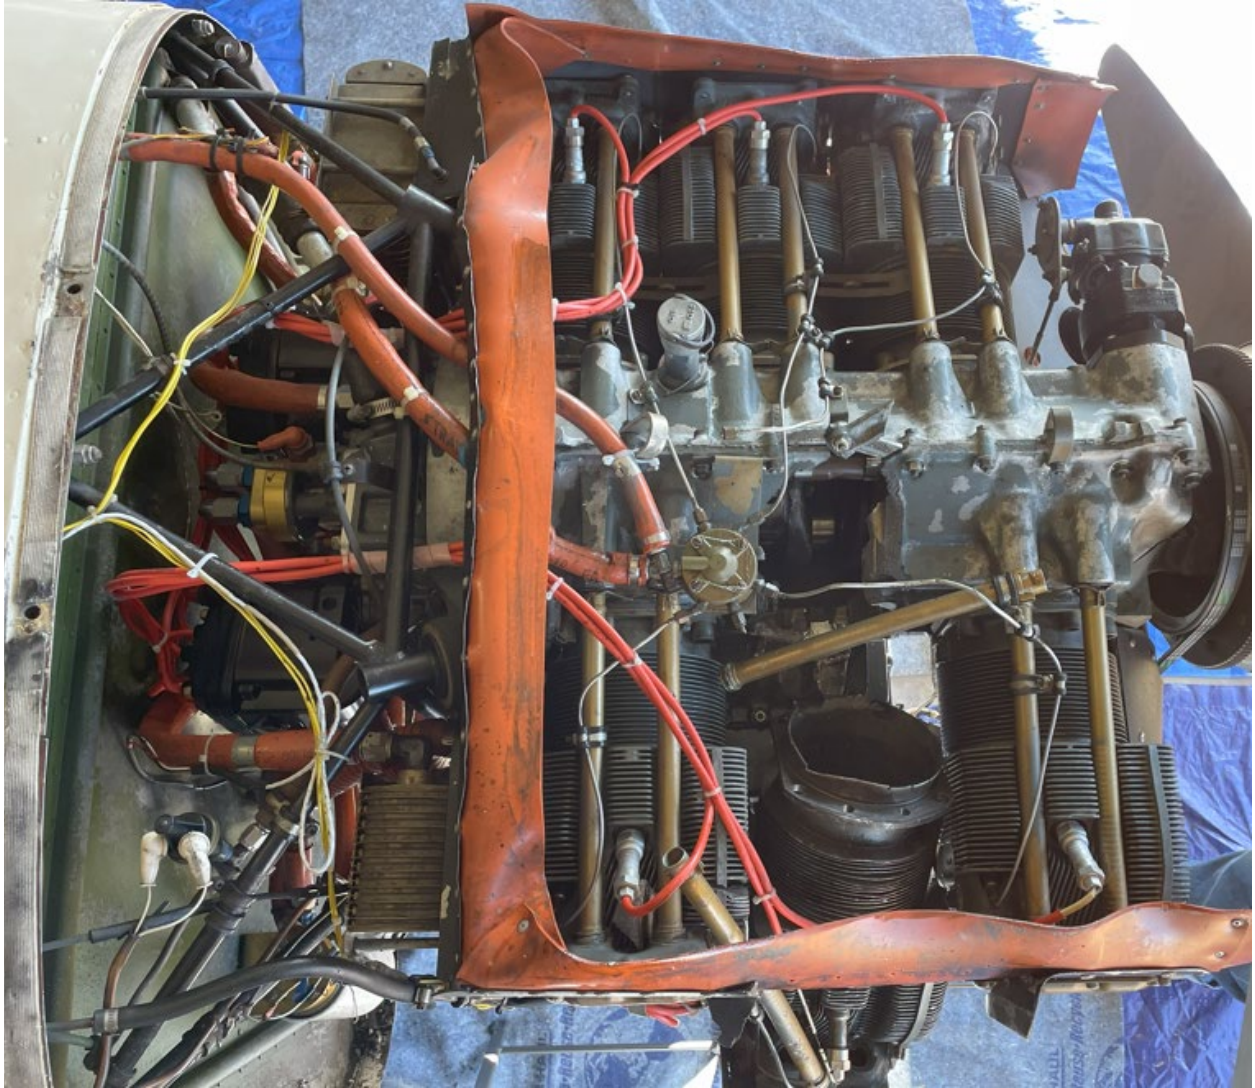
**Figure 2. Top view of accident engine.**

The engine remained attached to the airframe via the engine mounts (figure 2). The three-bladed propeller remained attached to the propeller hub and flange, which remained connected to the crankshaft; all were found unremarkable. The accessory case was unremarkable, and each accessory remained secured to its respective mounting pad.

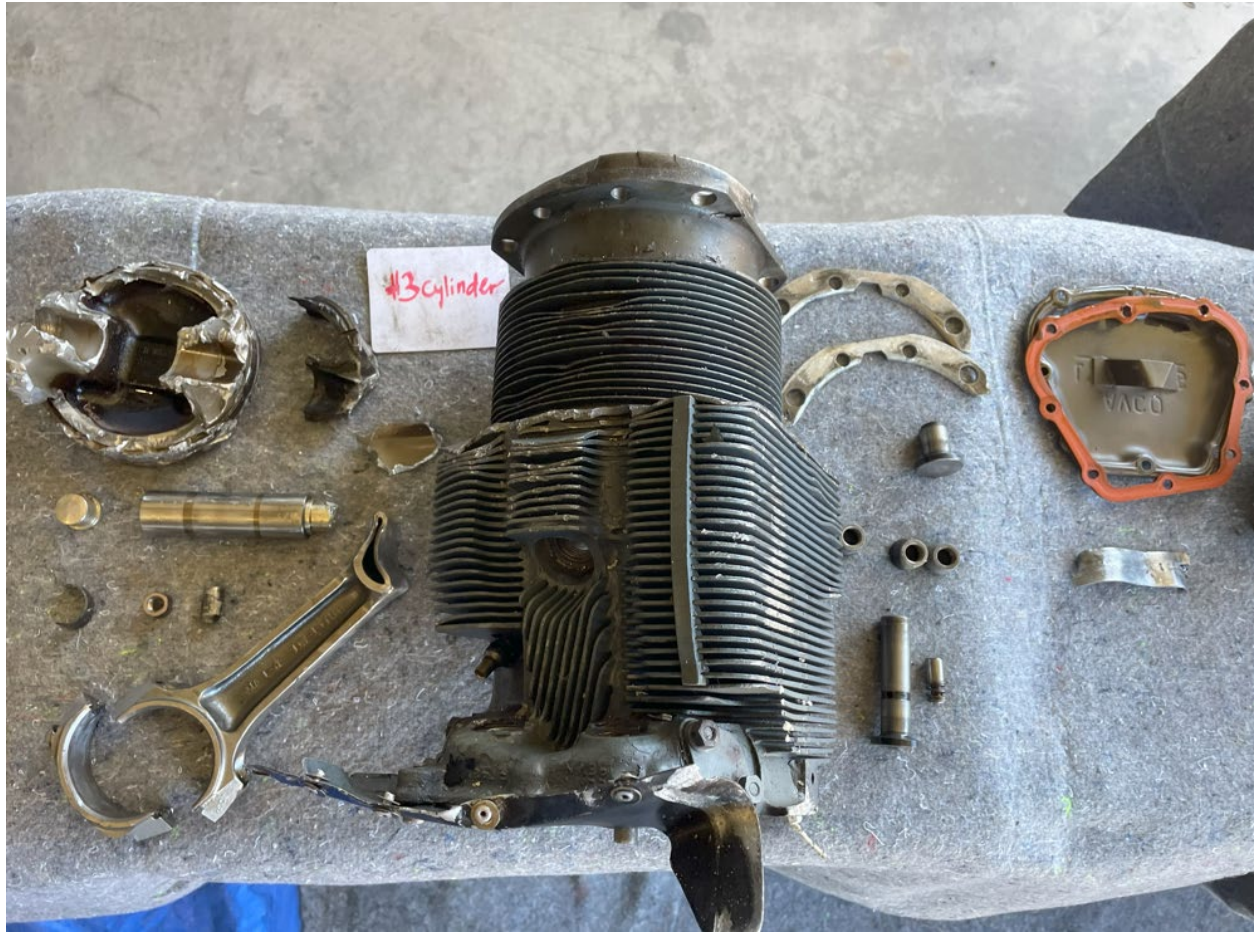
All cylinders, except no. 3 cylinder, remained attached to the engine case. The no. 3 cylinder was found liberated from the engine case and resting against the engine cowling. The cylinder was retrieved to include the following liberated parts: connecting rod, connecting rod cap, a connecting rod nut, a connecting rod bearing, the no. 3 piston, the no. 3 wrist pin, and various pieces of the engine case (figure3).

**Figure 3. View of No. 3 cylinder and recovered parts.**

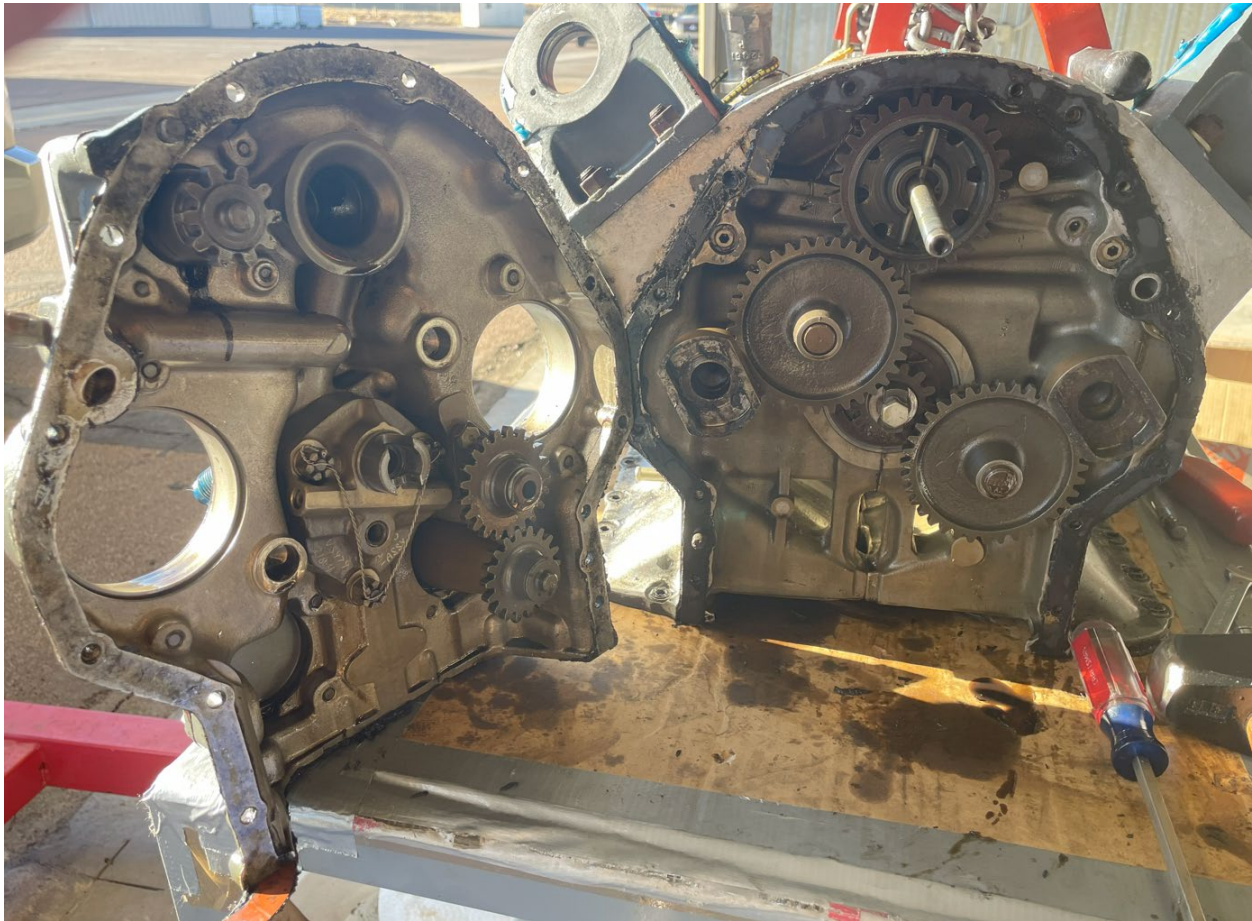
The accessory case was unremarkable (figure 4). All accessories remained secured to its mounting pad. The accessory case was disassembled; all internal gears were unremarkable and was manually rotated by hand, which revealed movement that was smooth with no binding.

**Figure 4. Internal view of accessory gearbox.**

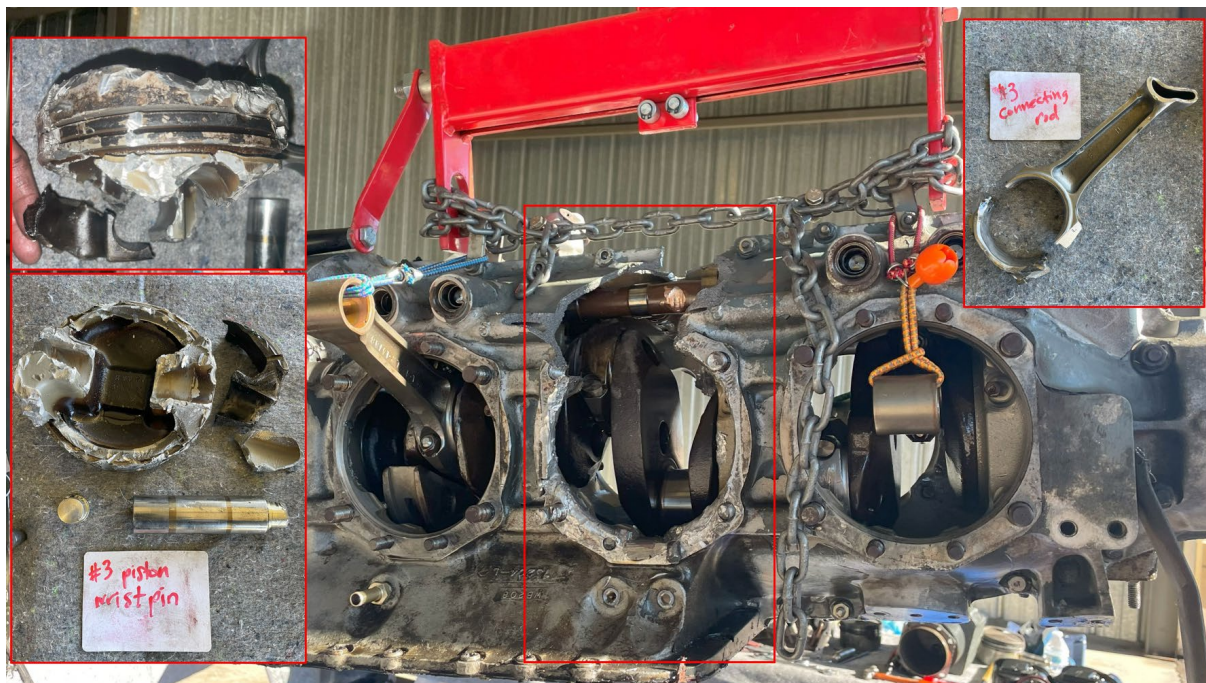
The engine case was then removed from the engine truss and disassembled. The mating surface of the engine case with no. 3 cylinder collar showed mechanical damage consistent with the no. 3 piston head articulating up and down as the crankshaft rotated, followed by a subsequent secondary failure of the connecting rod (figure 5). Internal scoring marks within the engine case were consistent with the no. 3 connecting rod end cap separating from the connecting rod. The crankshaft surface with which the connecting rod mated was found with minimal mechanical damage. The bearing saddles did not display any signs of thermal damage. The crankshaft oil galleries remained free of obstructions.

**Figure 5. View of engine case highlighting damage to No. 3 cylinder mating surface and studs. Upper left and lower left photo: view of damage to No. 3 piston; Upper right photo: view of damaged connecting rod.**

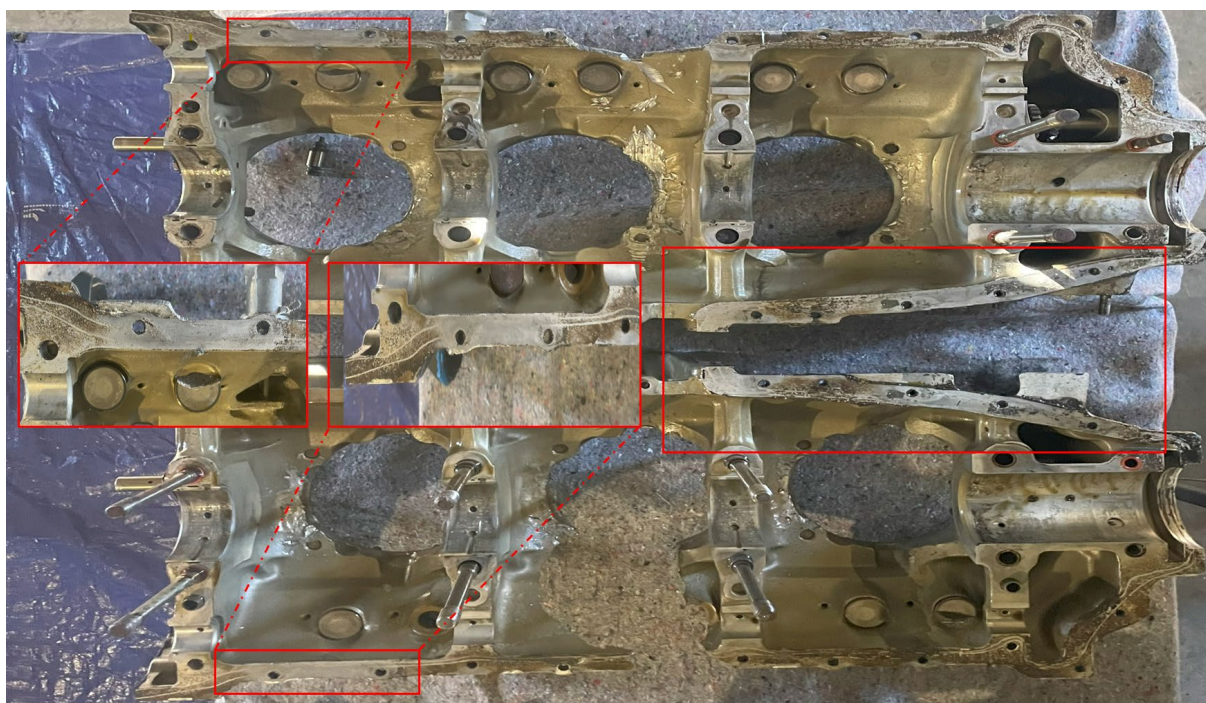
The mating surfaces of each left and right engine case revealed signs of fretting (figure 6). There were no signs of oil deprivation or main bearing shift.

**Figure 6. Main photo: internal view of left and right engine case halves, highlighting fretting to forward section of each case half; left photo: view of fretting to upper surface of left case half; center photo: view of fretting to upper surface to right case half.**

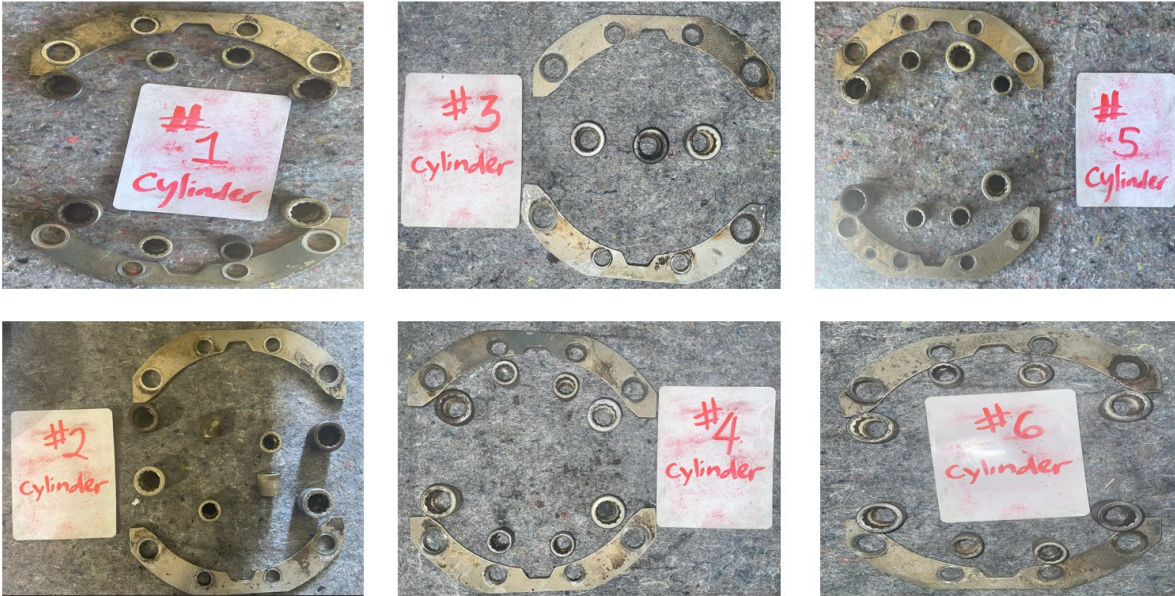
The no. 3 cylinder had separated from the engine case; the no. 3 connecting rod had fractured and mechanical damage was found to the engine case, camshaft, and crankshaft. Five of the eight no. 3 cylinder base nuts were not located. The examination revealed signs of engine case fretting and fretting on each of the six cylinder's hold down plates, consistent with a loss of torque of engine case nuts/bolts and cylinder base nuts.

Further examination of each cylinder hold down plate (both top and bottom for each cylinder) revealed signs of fretting on the mating surface where they interfaced with the cylinder base nuts (figure 7).

**Figure 7. Six photos showing fretting to each cylinder hold down plate.**

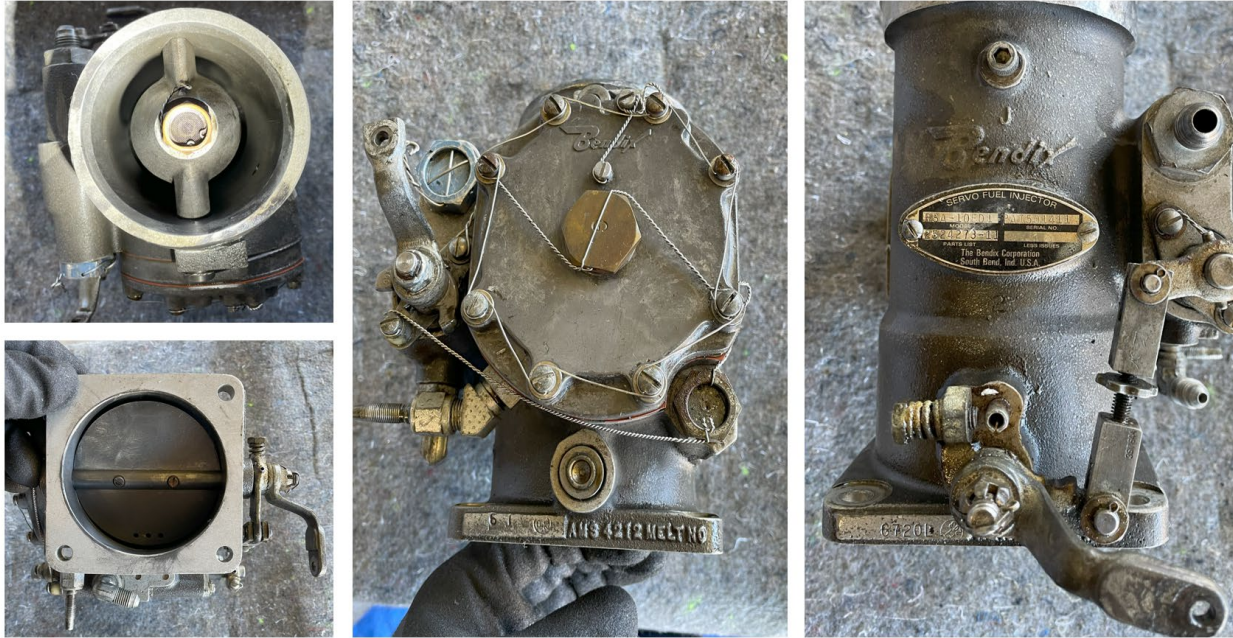
The fuel servo remained secured to its mounting. When removed from its mounting pad (figure 8), fluid consistent with aviation gas was observed in both the input and output fuel lines. About 5 oz of fuel was recovered from the fuel servo and tested for water contamination using Sargel; testing revealed that water was not present in the tested fuel.

**Figure 8. Multiple views of removed fuel servo.**

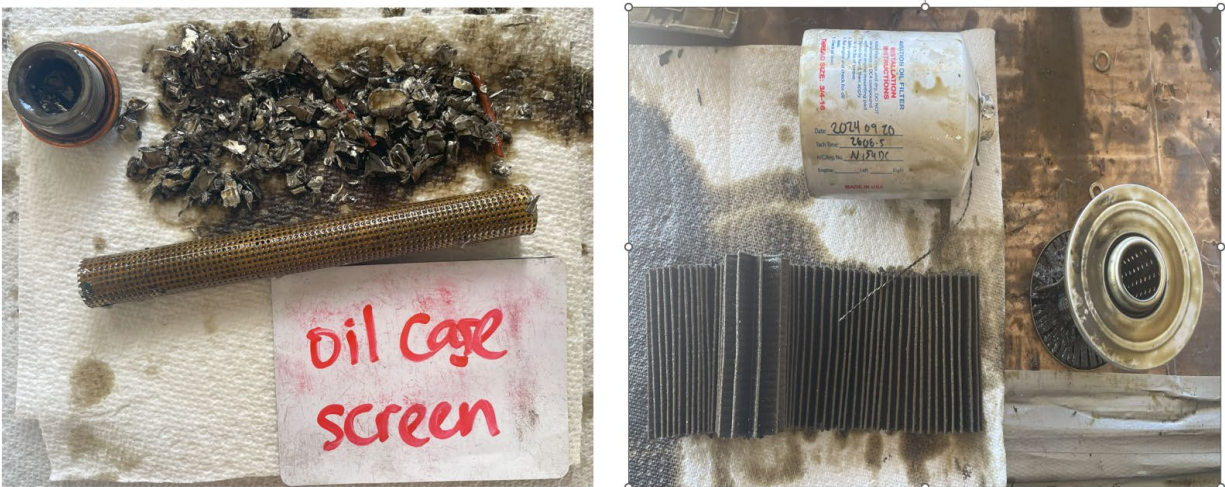
The oil sump was removed and metal particulates from the oil pan were recovered. Metal particulates were consistent with metal from the engine case. The oil screen was also removed and found to be filled with metal particulates (figure 9). The oil filter was removed and opened. A fine mist of metal shavings was found throughout the folds of the oil filter paper element (figure 9).

**Figure 9. Left photo: view of oil case screen; right photo: view of removed oil filter.**

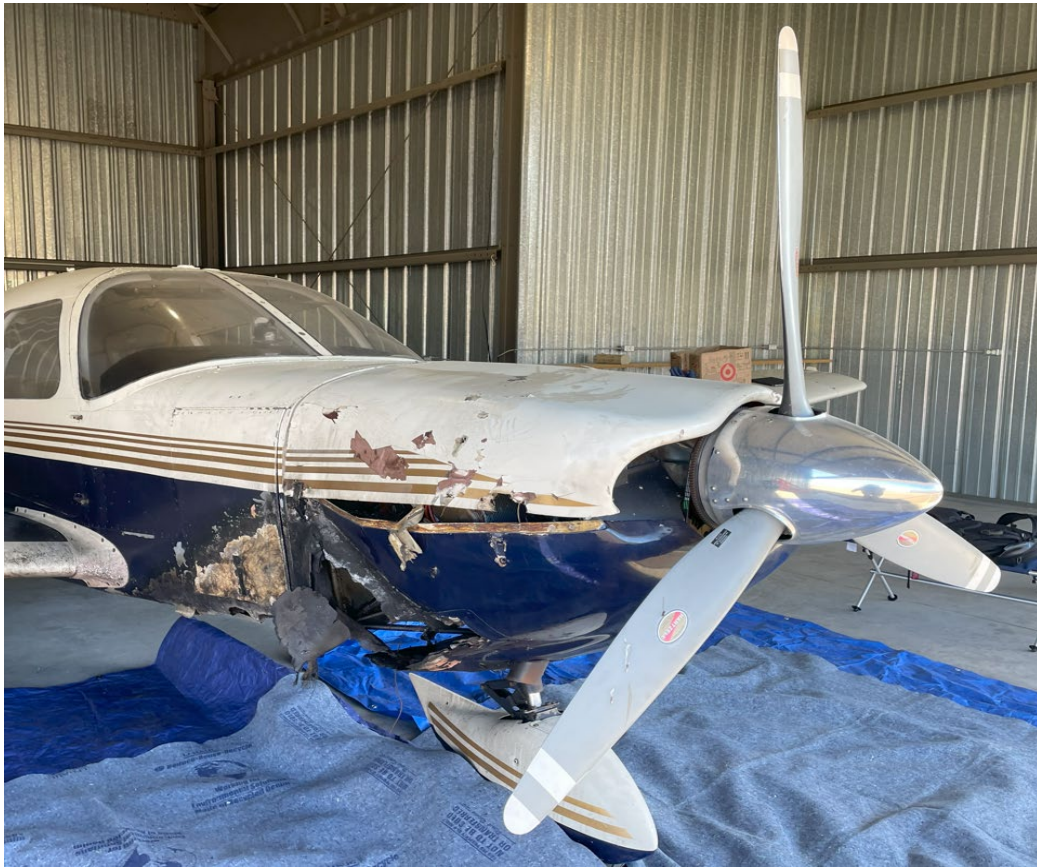
The three bladed constant speed propeller remained attached at the crankshaft flange (figure 10). The spinner remained attached and was unremarkable. The propeller governor remained secure at its respective mounting pad and was unremarkable. The governor control arm was secured and unremarkable.

**Figure 10. View of propeller mounted to accident engine.**

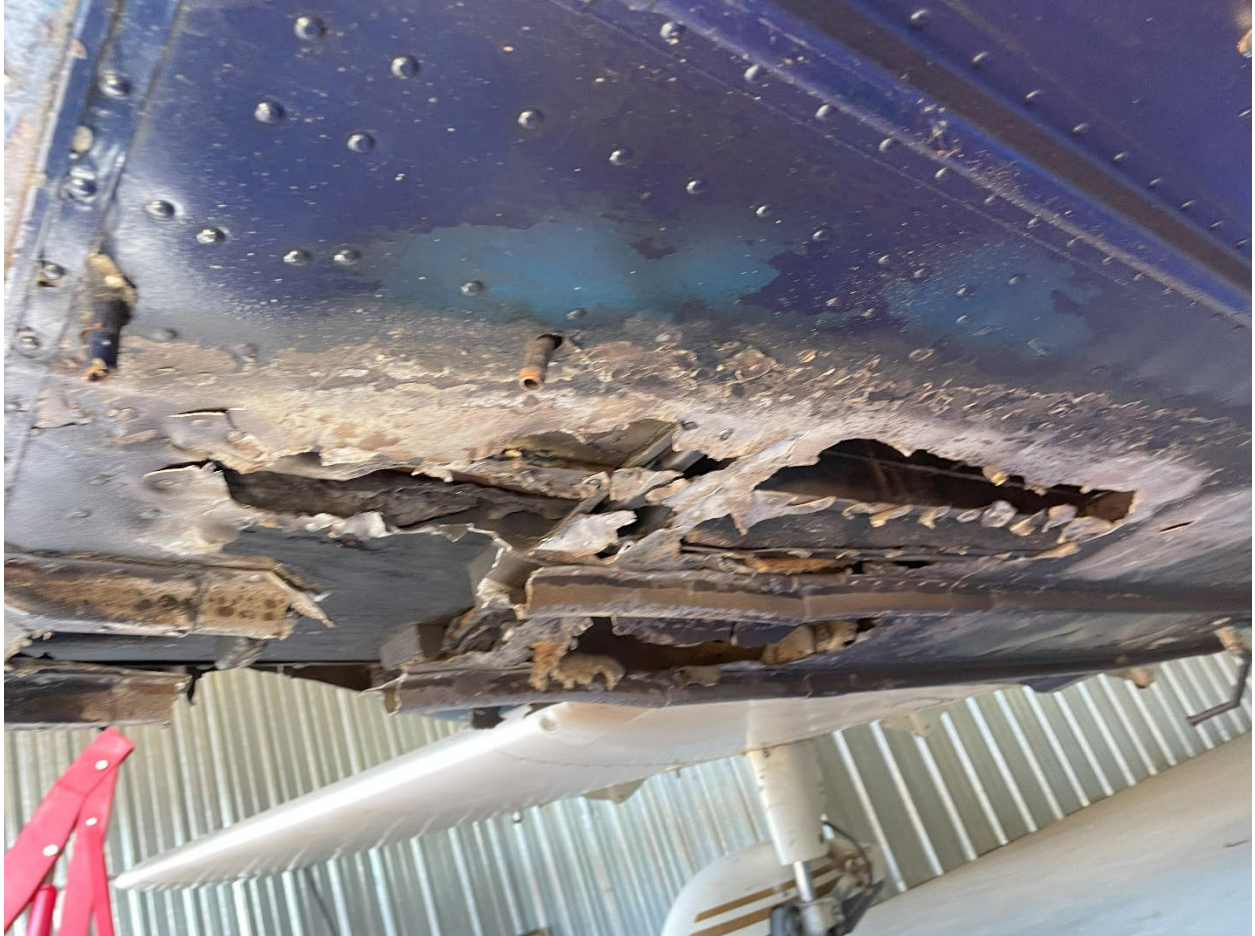
Outward deformation of both the upper and lower right side engine cowlings was evident, consistent with impact from the separated no. 3 engine cylinder. Fire and heat damage was visible to the lower, right side engine cowling, forward right-side fuselage, and the underside of the forward fuselage (figures 1 and 12).

**Figure 12 - View of underside fuselage fire and heat damage**
