WPR25LA030

## INVESTIGATION PHOTOGRAPHS

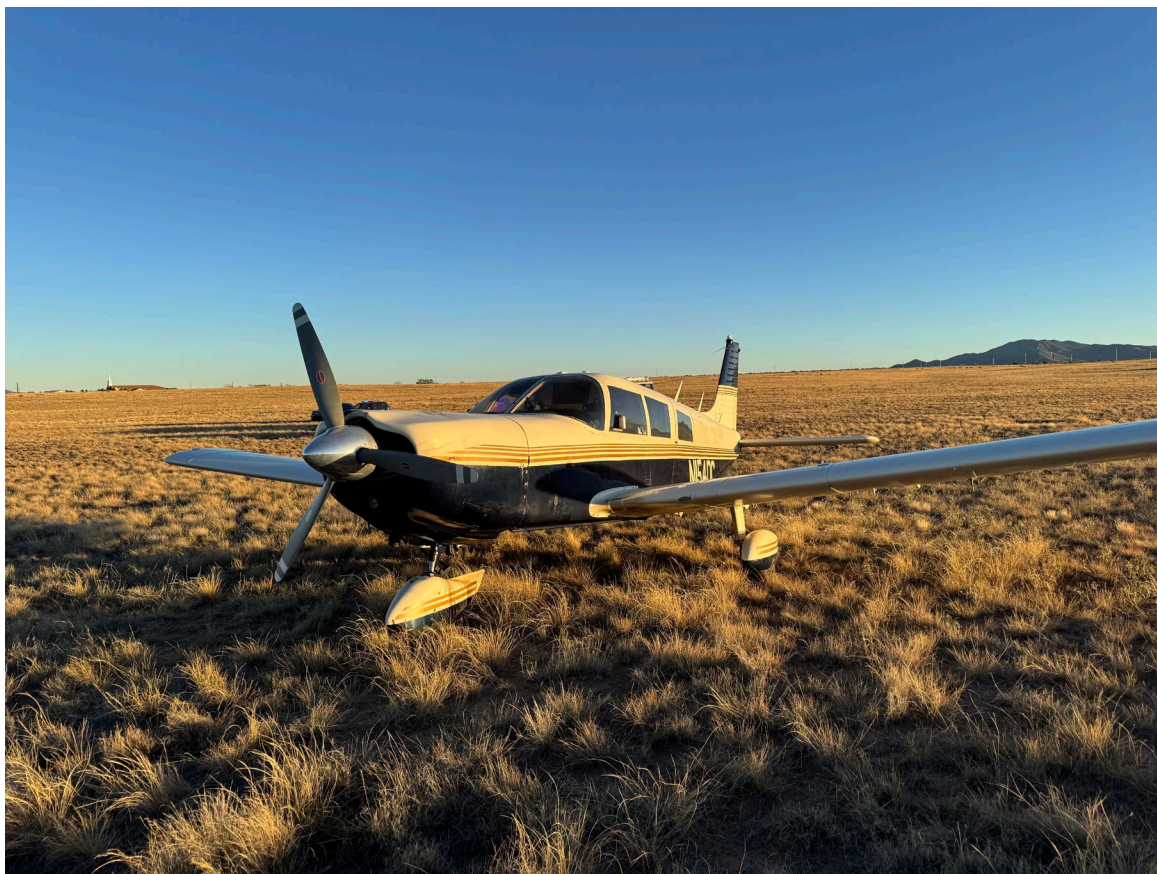
**Photograph 1 - Airplane Wreckage on Scene (Courtesy of Pilot)**

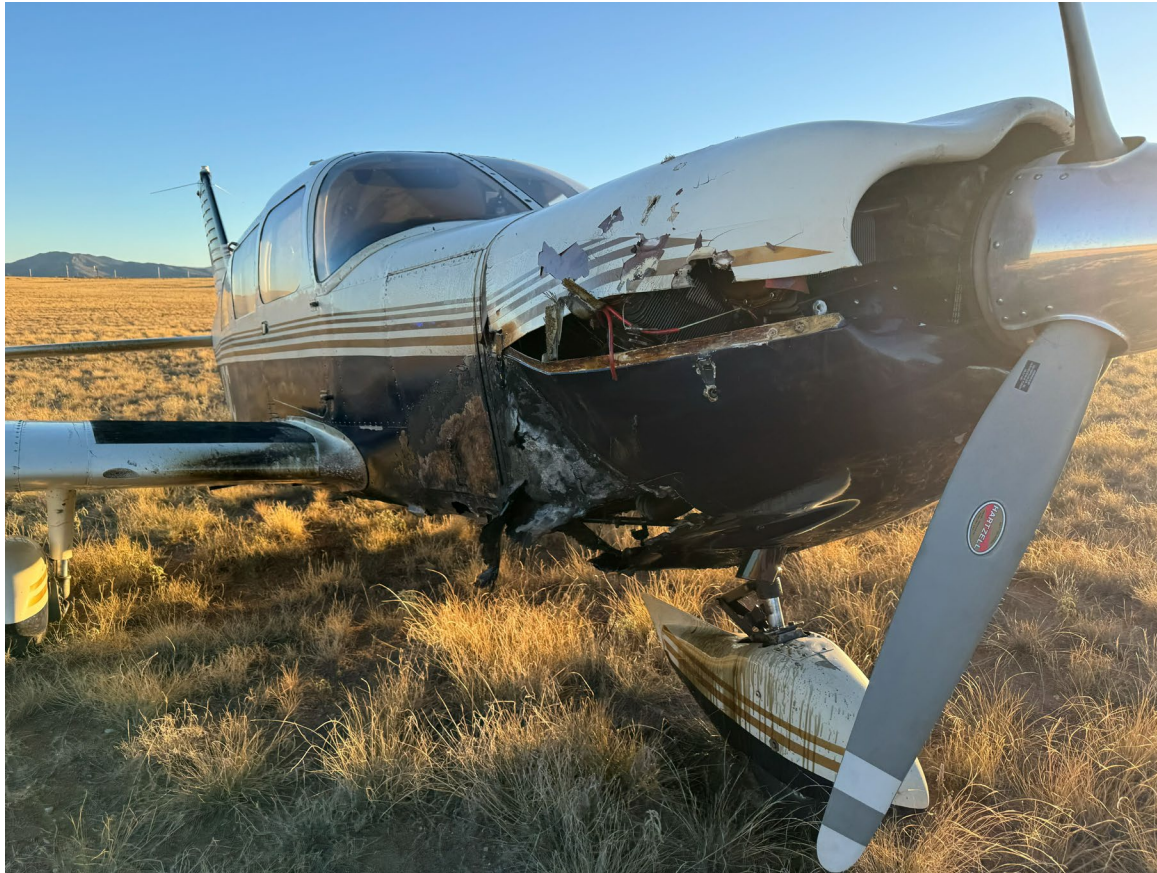
**Photograph 2 - Damage to Airplane (Courtesy of Pilot)**

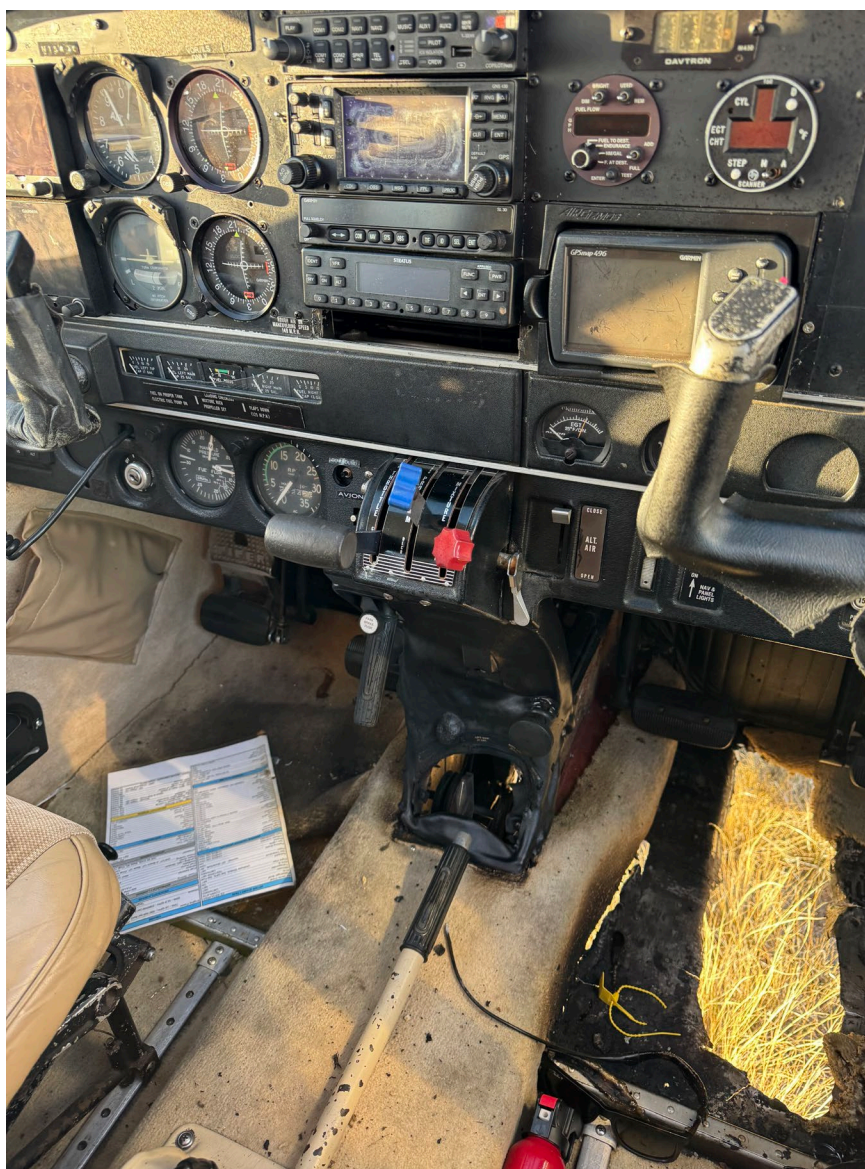
**Photograph 3 - Cockpit Damage (Courtesy of Pilot)**

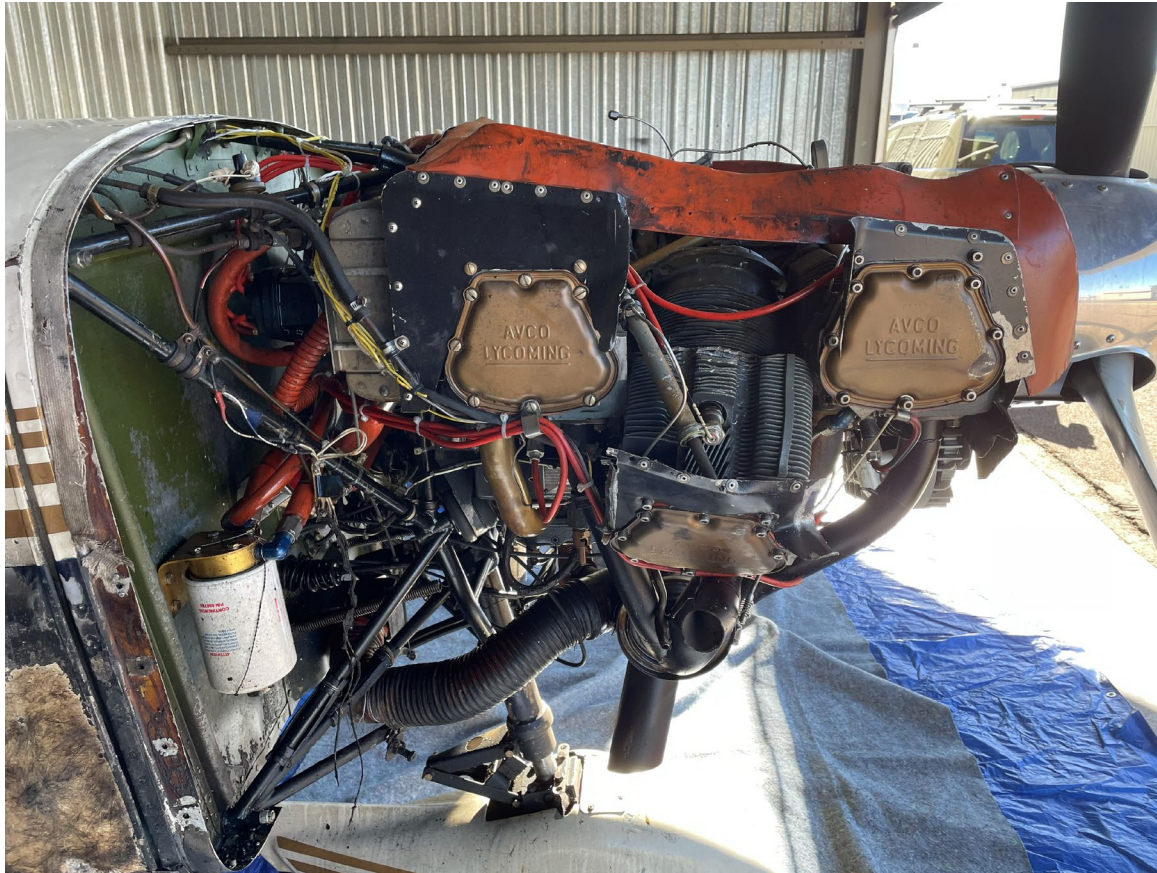
**Photograph 4 - Engine Damage (Courtesy of NTSB)**

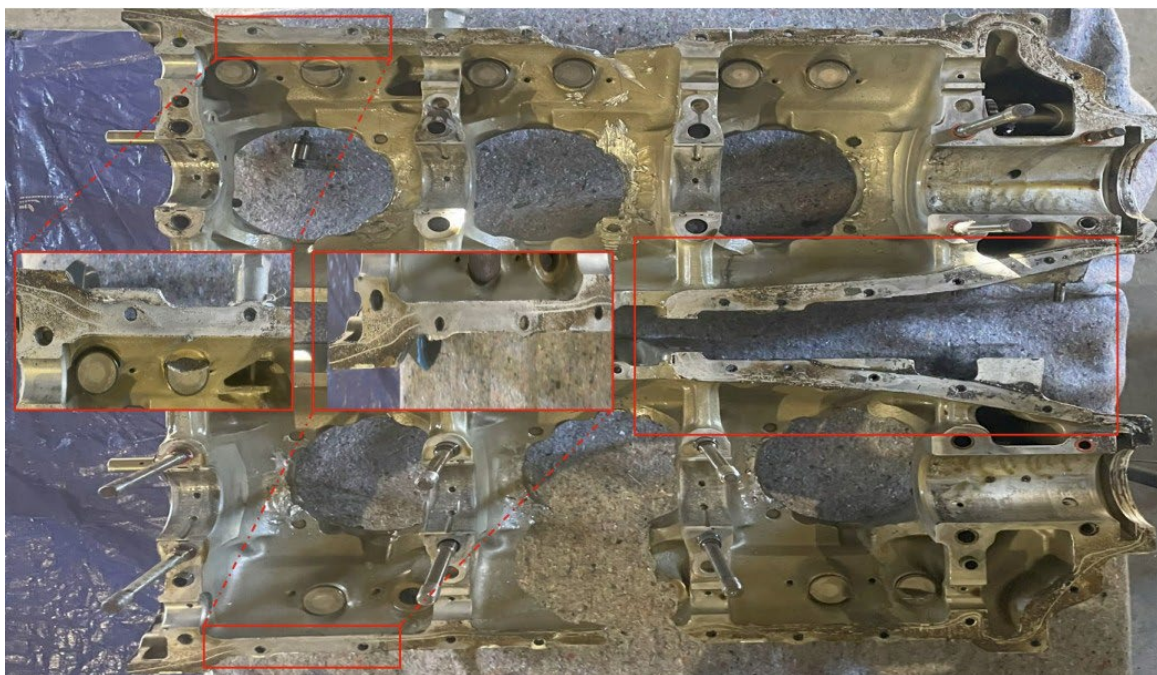
**Photograph 5 - Internal view of left and right engine case halves, highlighting fretting to forward section of each case half (Courtesy of NTSB)**

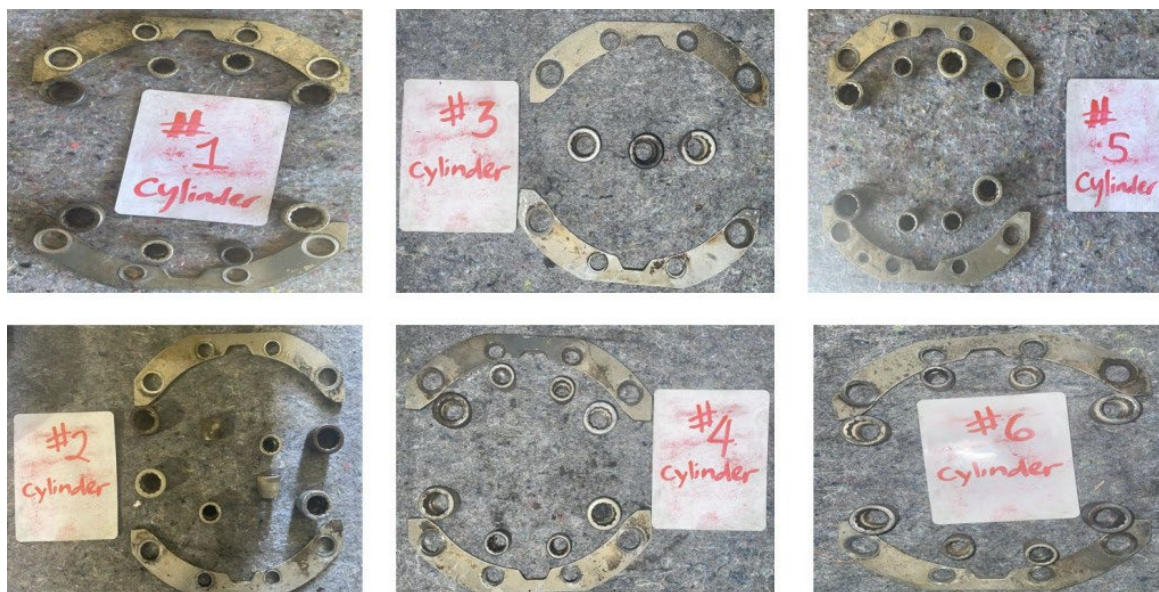
**Photograph 6 - Photos showing fretting to each cylinder hold down plate (Courtesy of NTSB)**
