WPR25LA032

## INVESTIGATION PHOTOGRAPHS

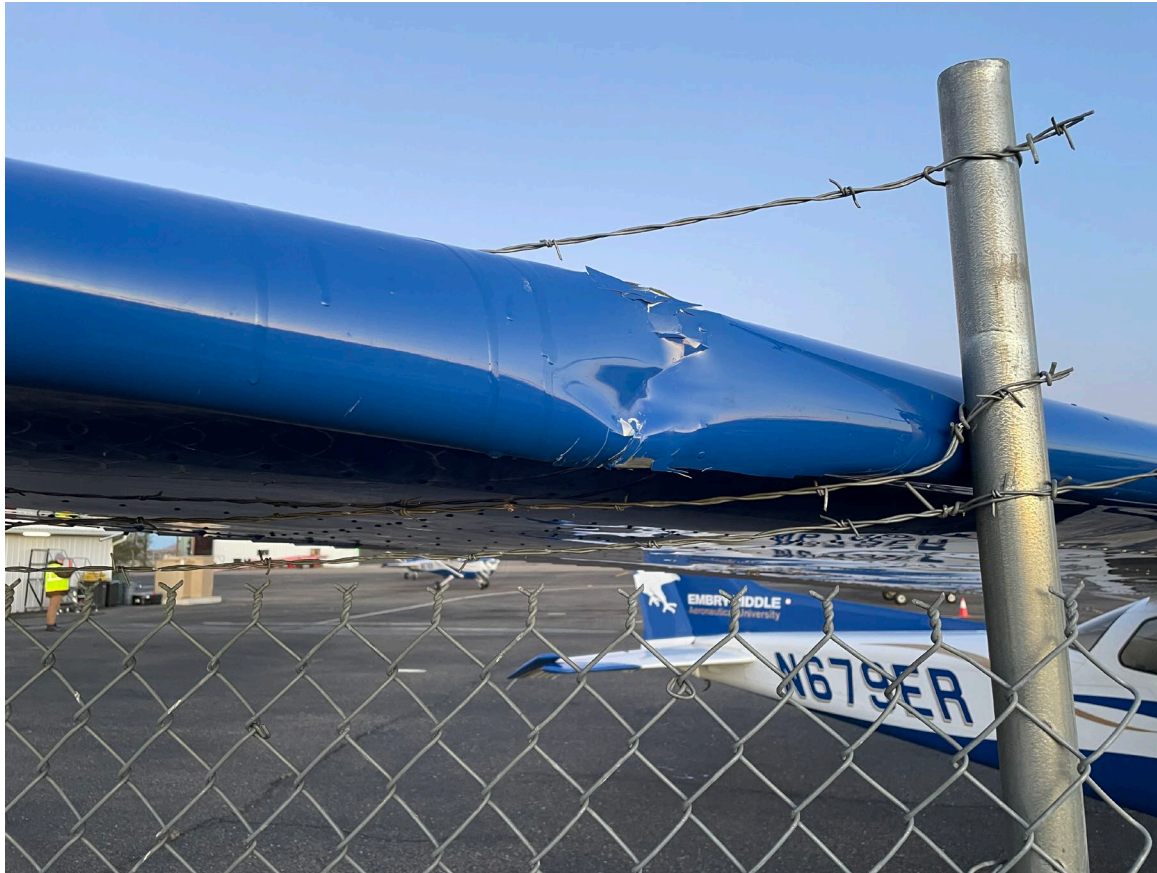
**Photograph 1 - View of damage to right wing. (Courtesy of operator.)**

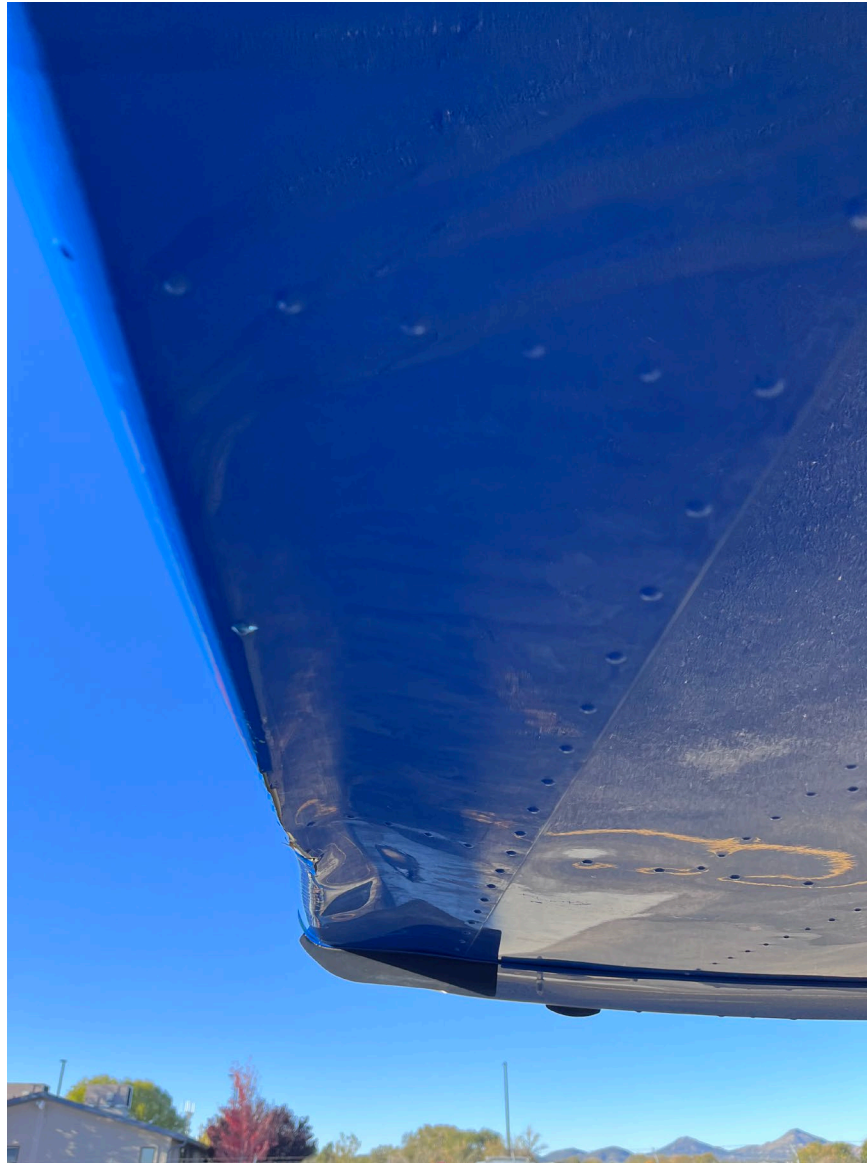
**Photograph 2 - View of damage to right wing. (Courtesy of operator.)**
