# National Transportation Safety Board

WPR25LA034

## **AIRFRAME AND ENGINE EXAMINATION REPORT**

Location: Durkee, Oregon  
Date: November 7, 2024  
Time: 0837 Pacific standard time  
Helicopter: Robinson R-44 II / N4361R

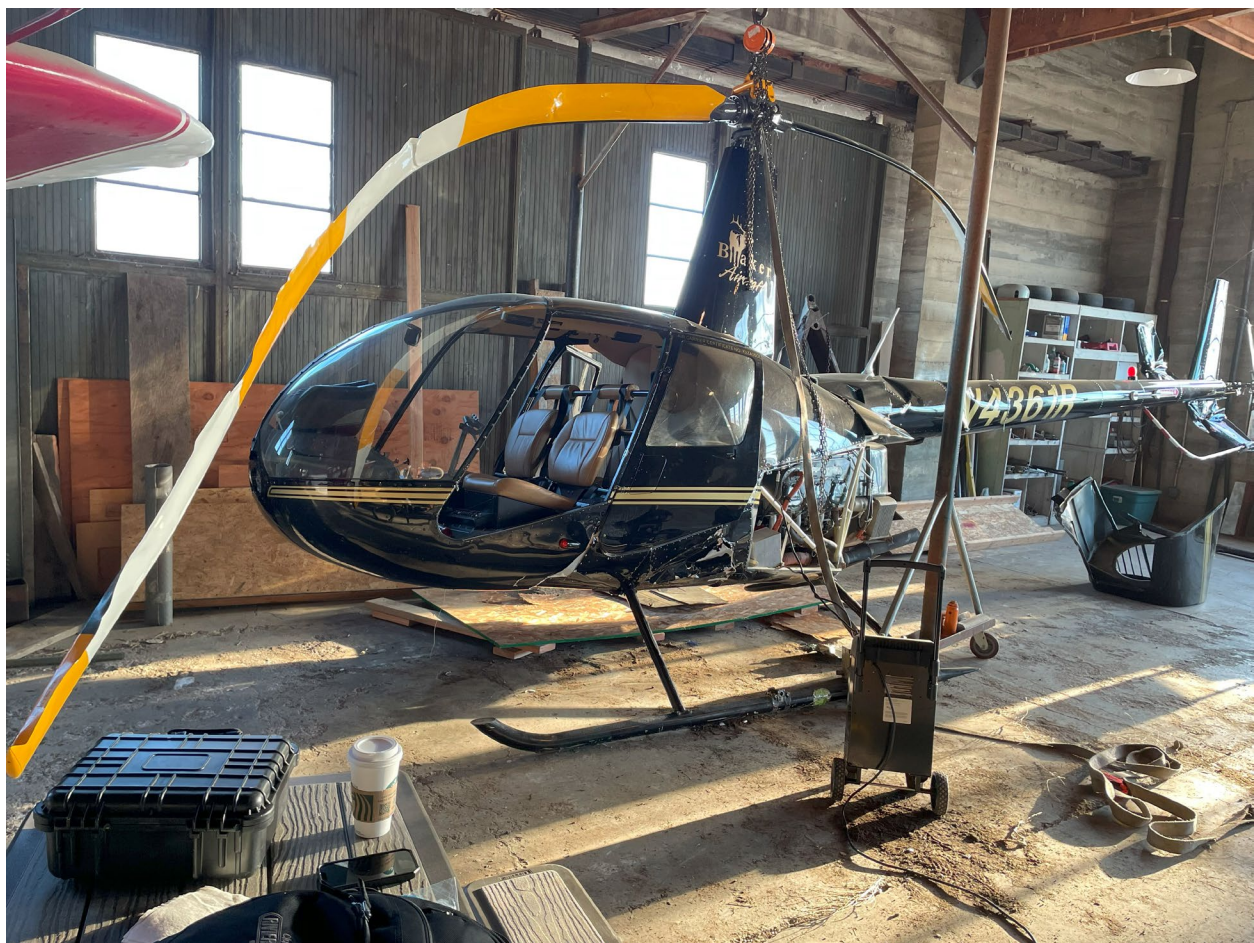
The fuselage was substantially damaged and exhibited a fractured windscreen, damage to the left side, left door, and large dents and tears to the sheet metal underneath the left-side rear door, and bent framework. The tail cone exhibited large dents to the sheet metal and bent structural metal under the skin, along with bending of the tail cone.

Figure 1. N4361R at the recovery facility.

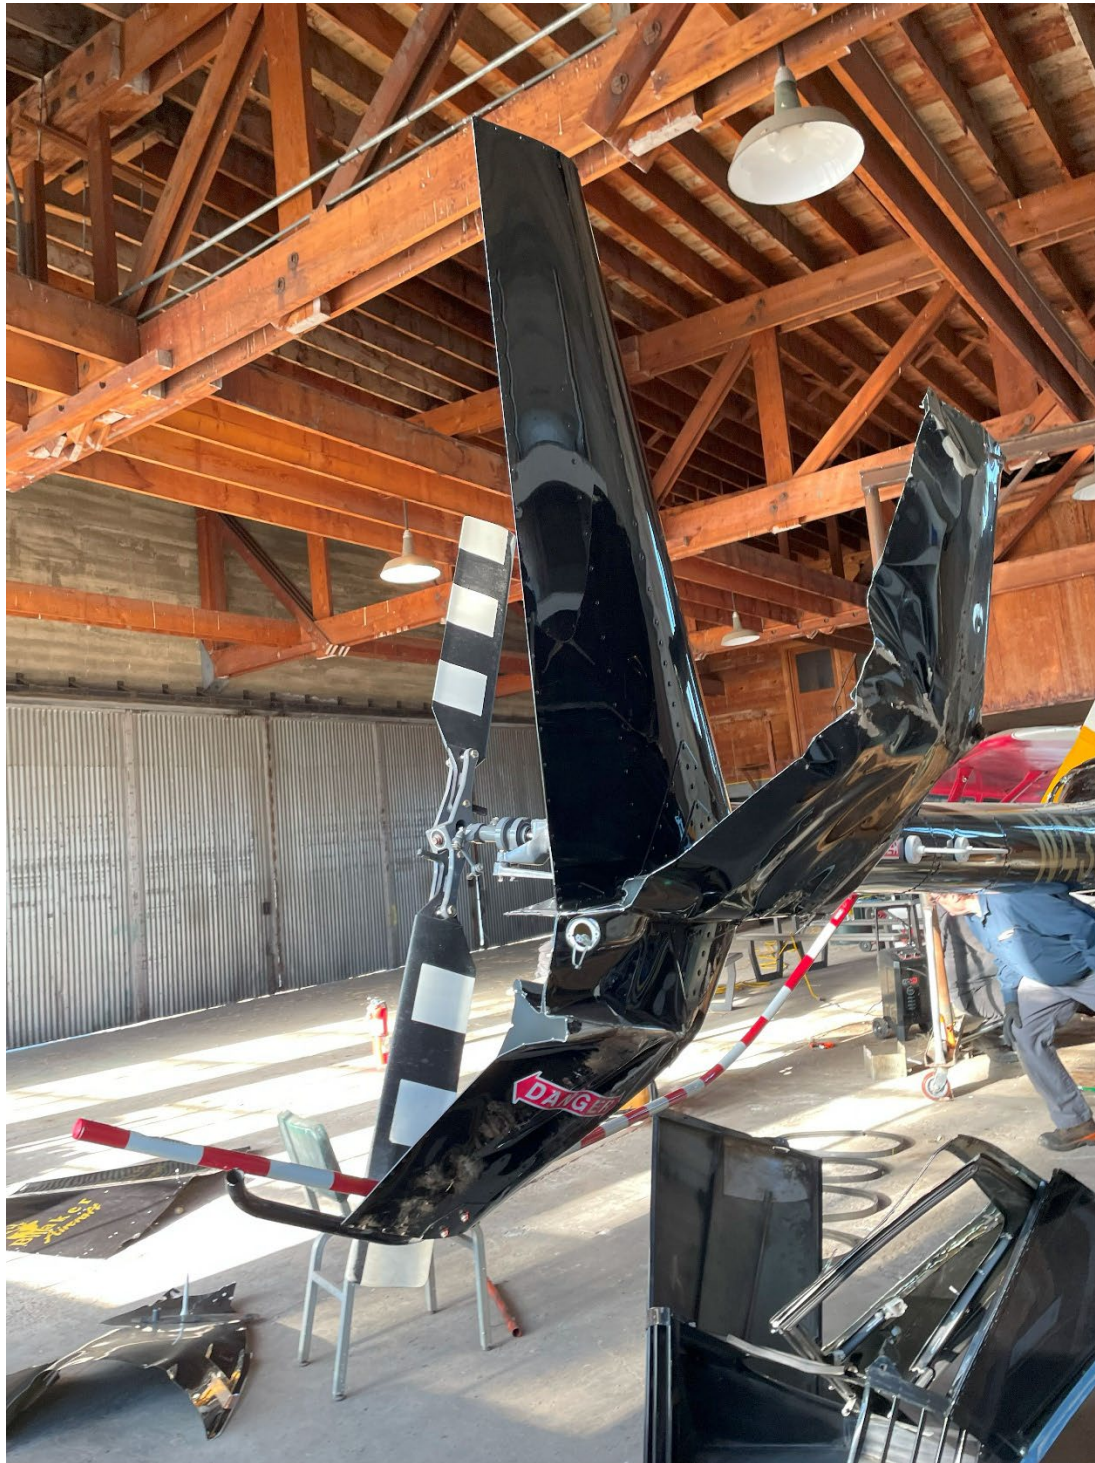
The empennage exhibited substantial damage to the lower vertical, and horizontal stabilizers. The tail rotor blades remained wholly attached to the hub. One blade exhibited dents to the leading edge. The other blade exhibited only minor damage.

The tail rotor gearbox remained attached to the end of the tail cone and contained oil.

Figure 2. Empennage.

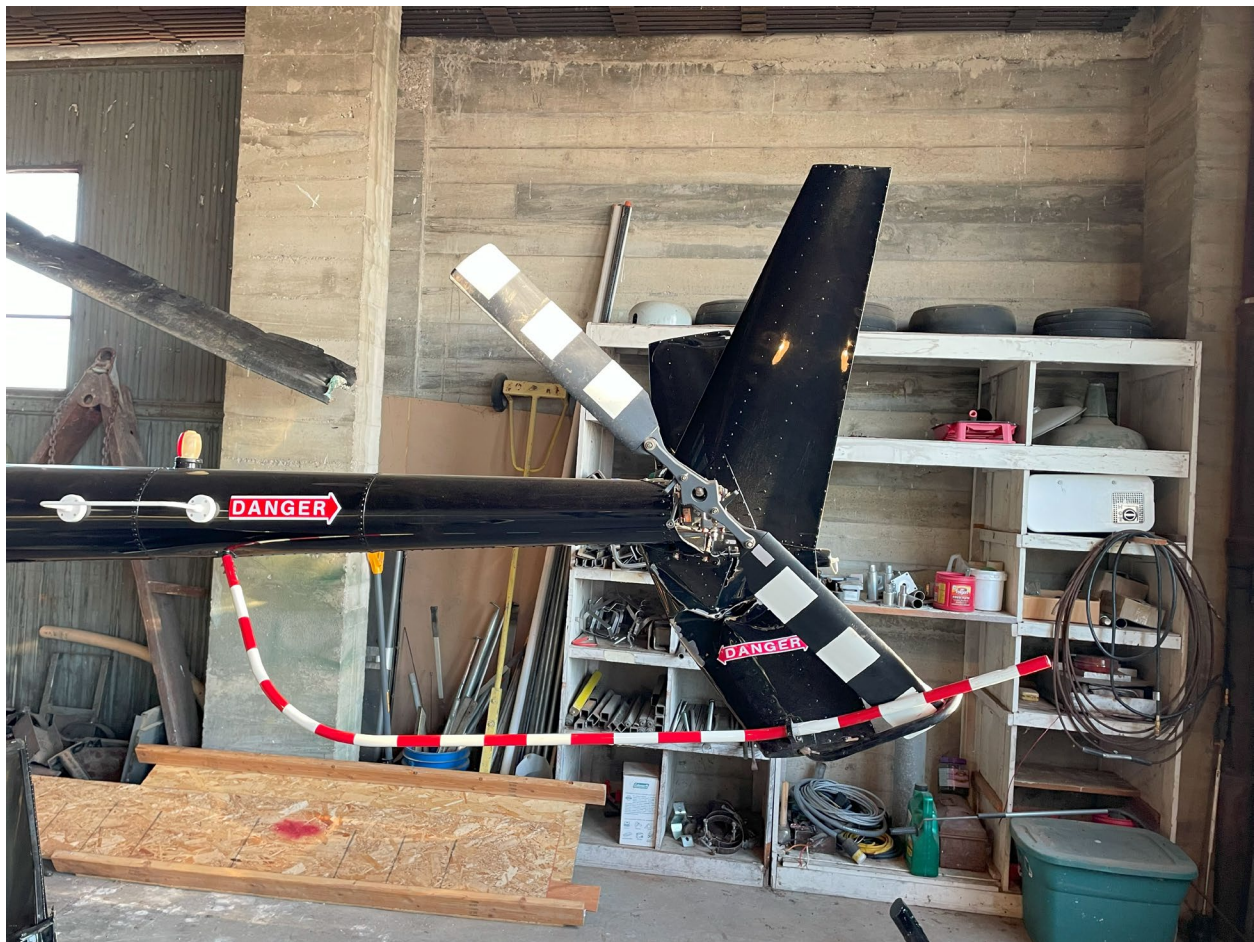
Figure 3. Tail rotor assembly, and Main rotor blade B.

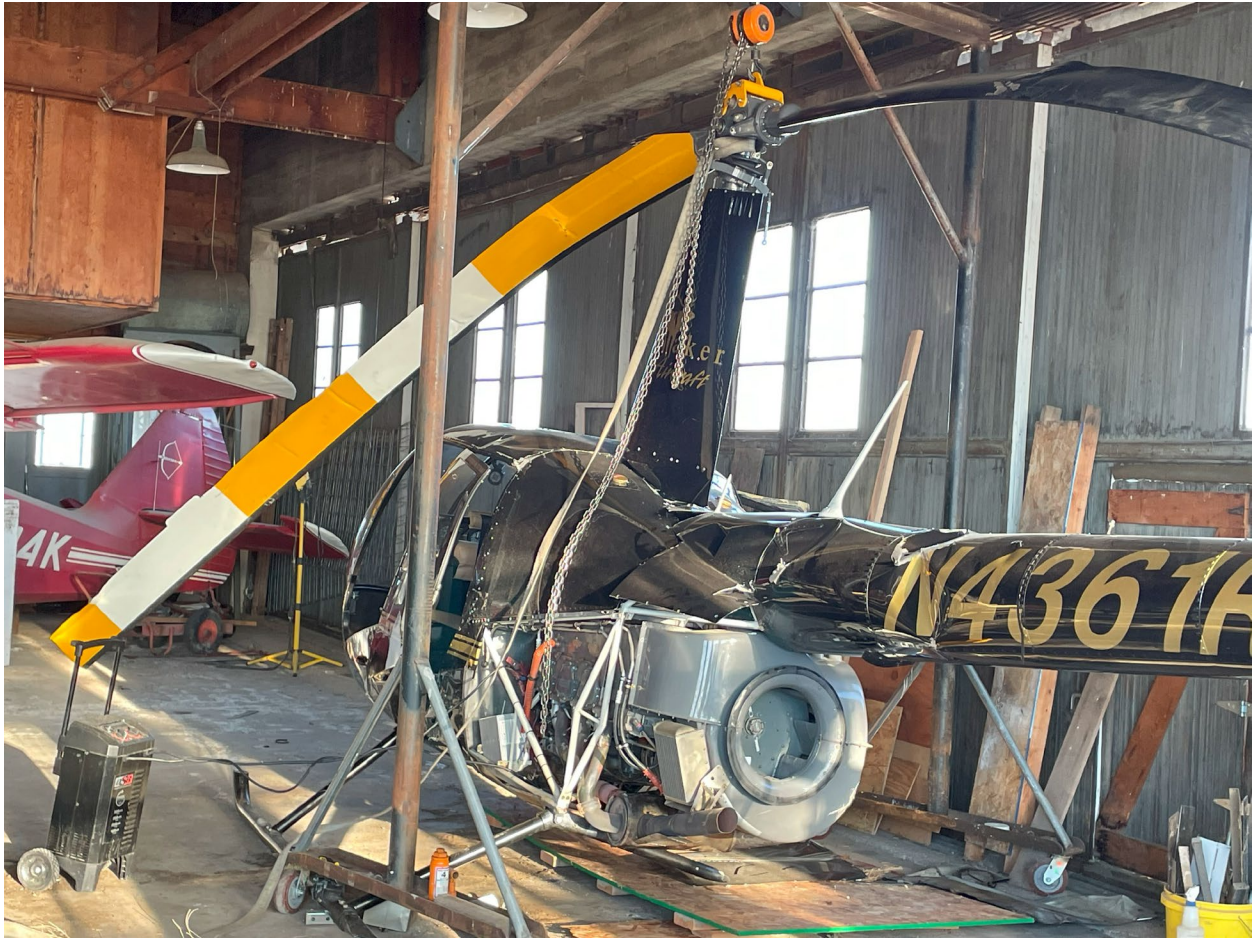
The main rotor assembly remained attached to the mast. The blades, arbitrarily identified as A and B, exhibited large upward bending along with chordwise creases along the span, consistent with excessive upward coning.

Blade A remained wholly intact with no obvious impact marks along the leading edge. The pitch change link from the pitch horn of blade A to the rotating swashplate was removed during recovery. The bushings for the teetering hinge were removed during recovery. The pitch horn remained attached to the blade grip.

Figure 4. Top view of Blade A (over the cockpit) and the root end of Blade B.

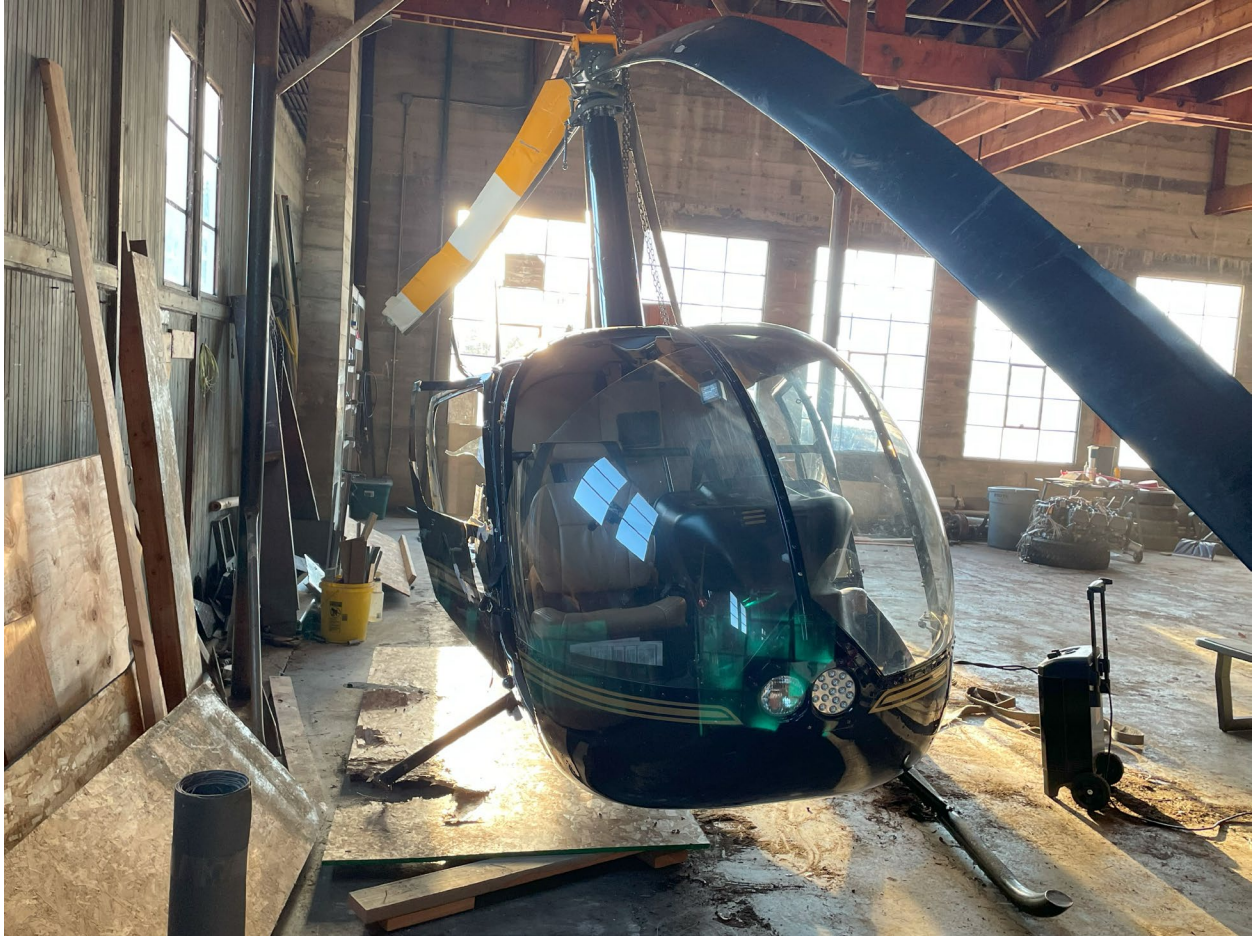
Blade B remained mostly intact, except for a 2 ft section of the outboard blade that was fracture separated from the rest of the blade. The main section of the blade remained attached to the blade grip. The pitch change link from the pitch horn to the rotating swashplate, and the bushings for the teetering bearings were removed for recovery.

Figure 5. Top view of blade B and bottom view of blade A.

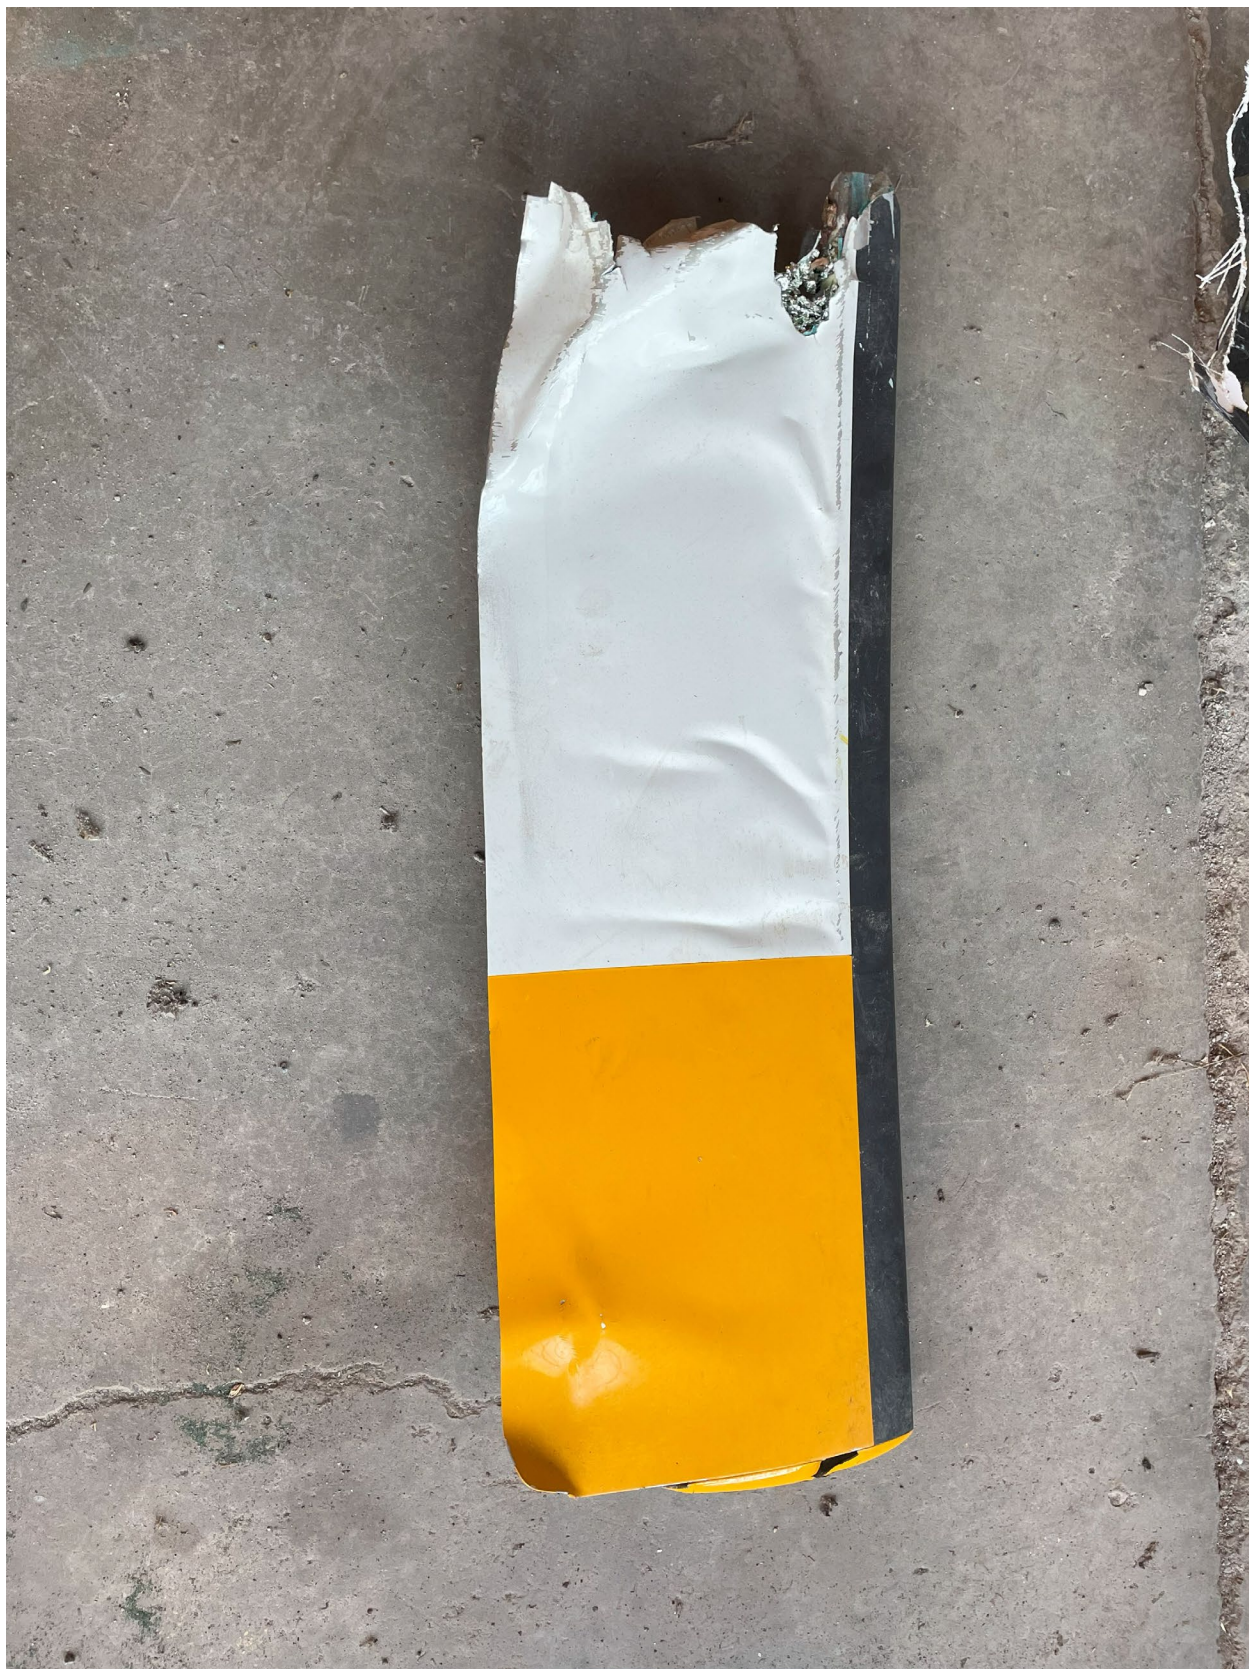
Figure 6. Top view of Blade B tip.

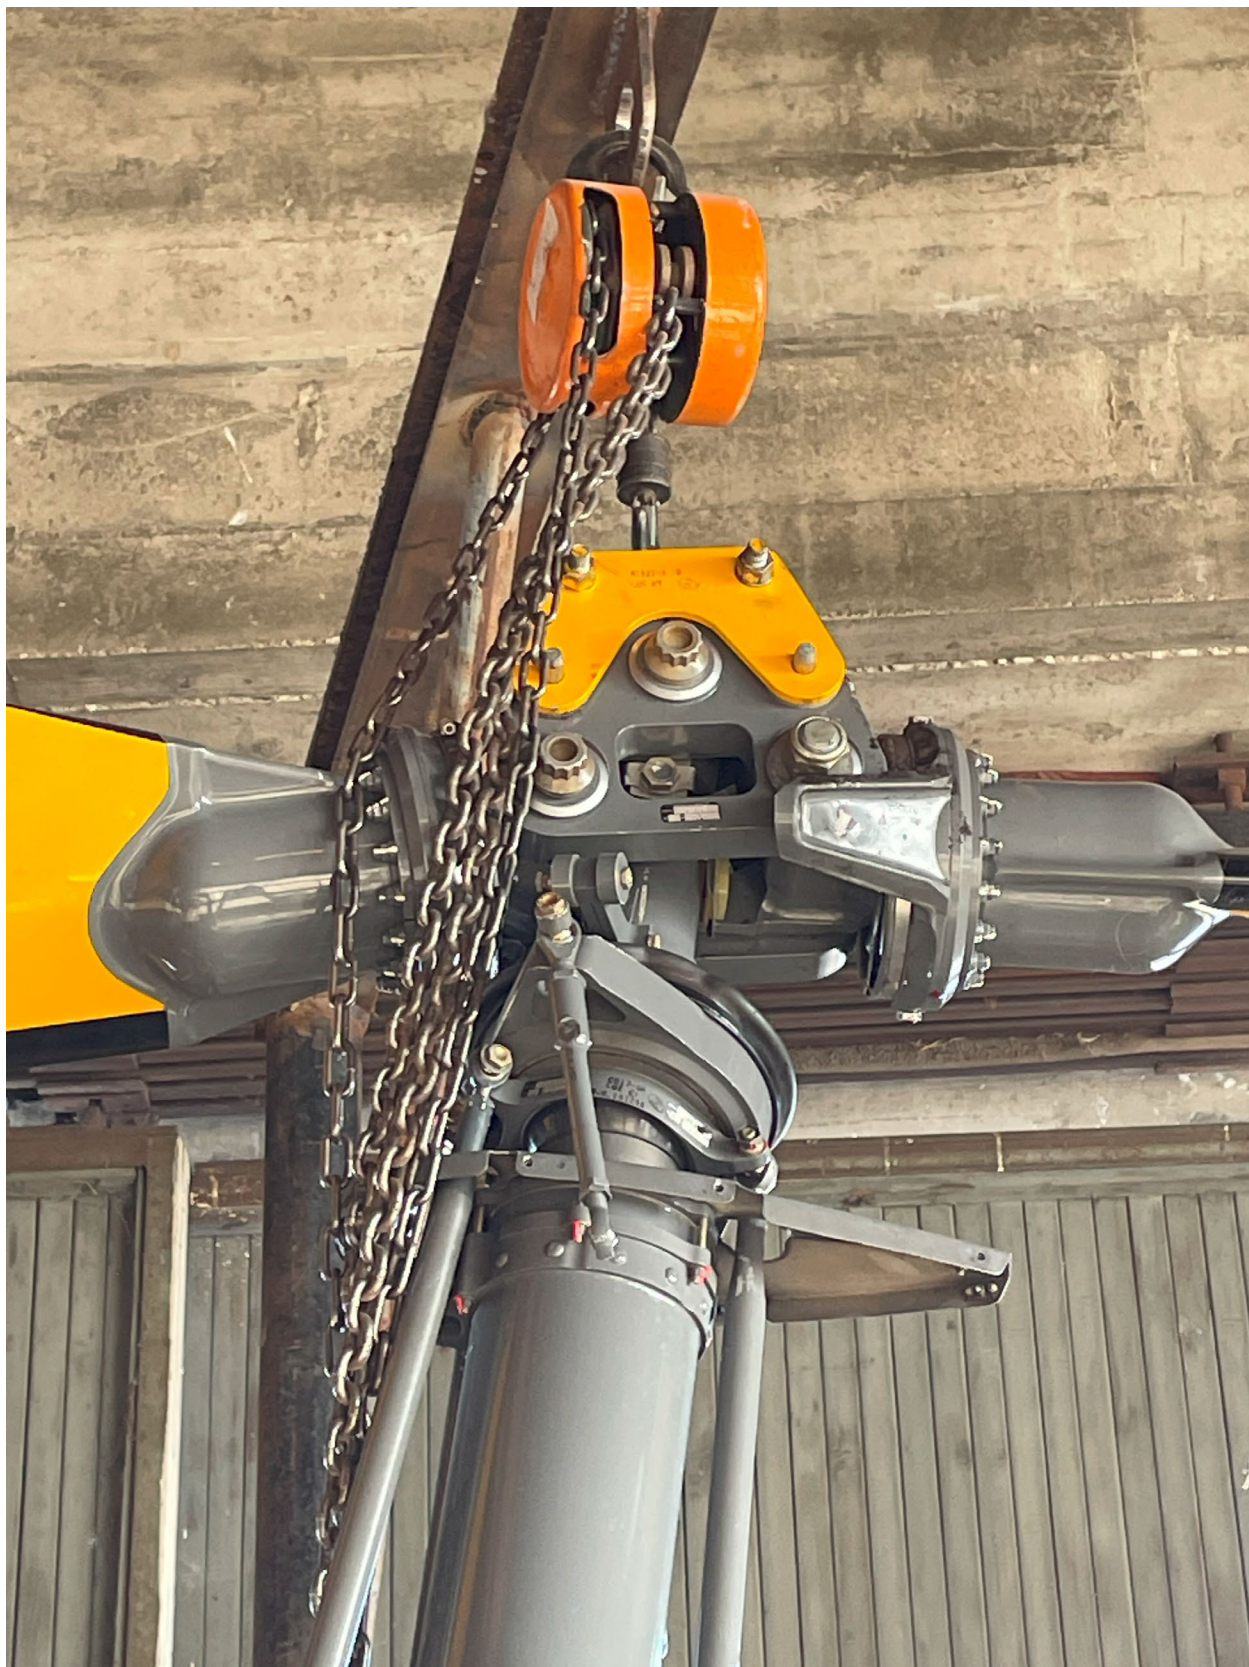
Figure 7. View of main rotor hub assembly and swashplate assembly.

The swashplate assembly remained secured to the top of the mast and functioned normally. The control rods from the rotating swashplate to the pitch horns exhibited minor damage. The control rods from the hydraulic servos to the non-rotating swashplate exhibited bending but remained intact.

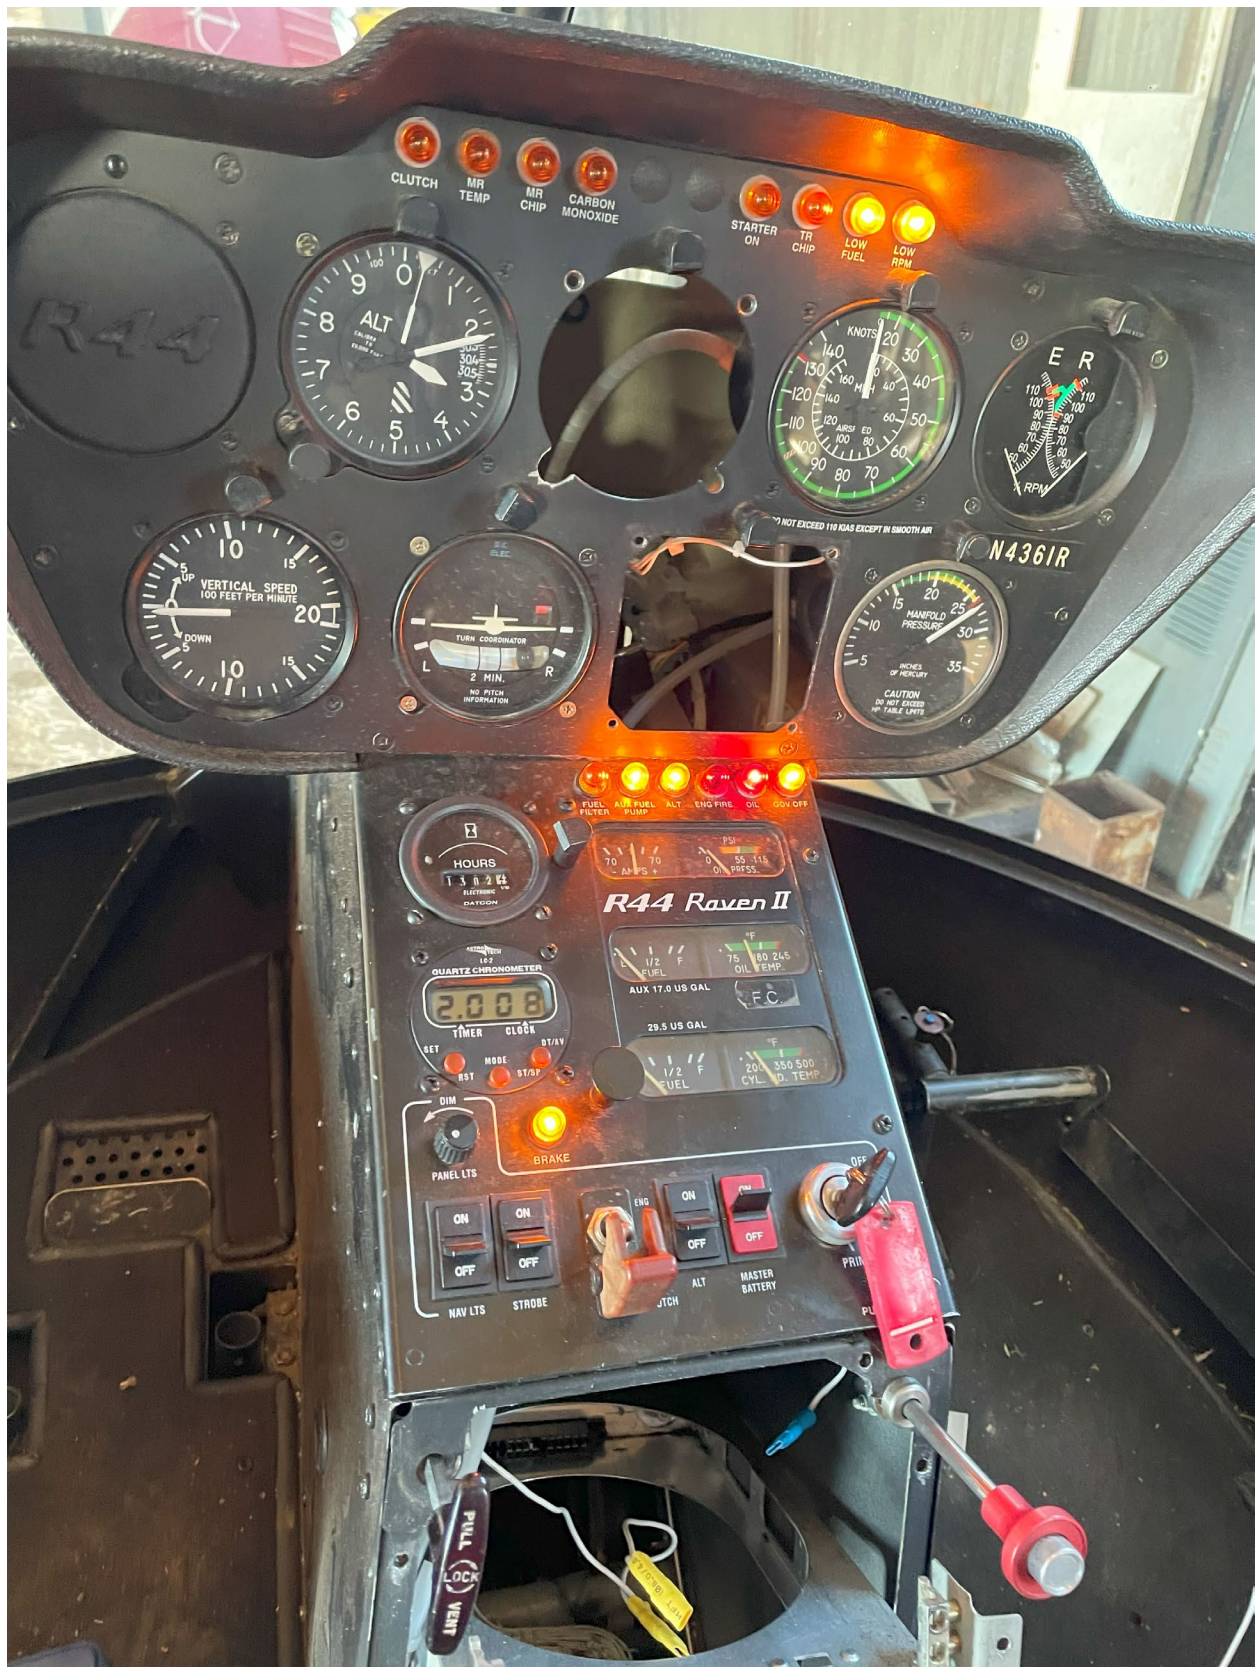
The cockpit exhibited minor damage, except for the right-side windscreen which was fractured. With approval from the IIC, the helicopter's radios were removed and not available for examination. The flight and engine instruments remained secured in the instrument panel. The dual tachometer was inoperative. The low rotor horn was tested and functioned normally.

Figure 8. Instrument panel with power applied.

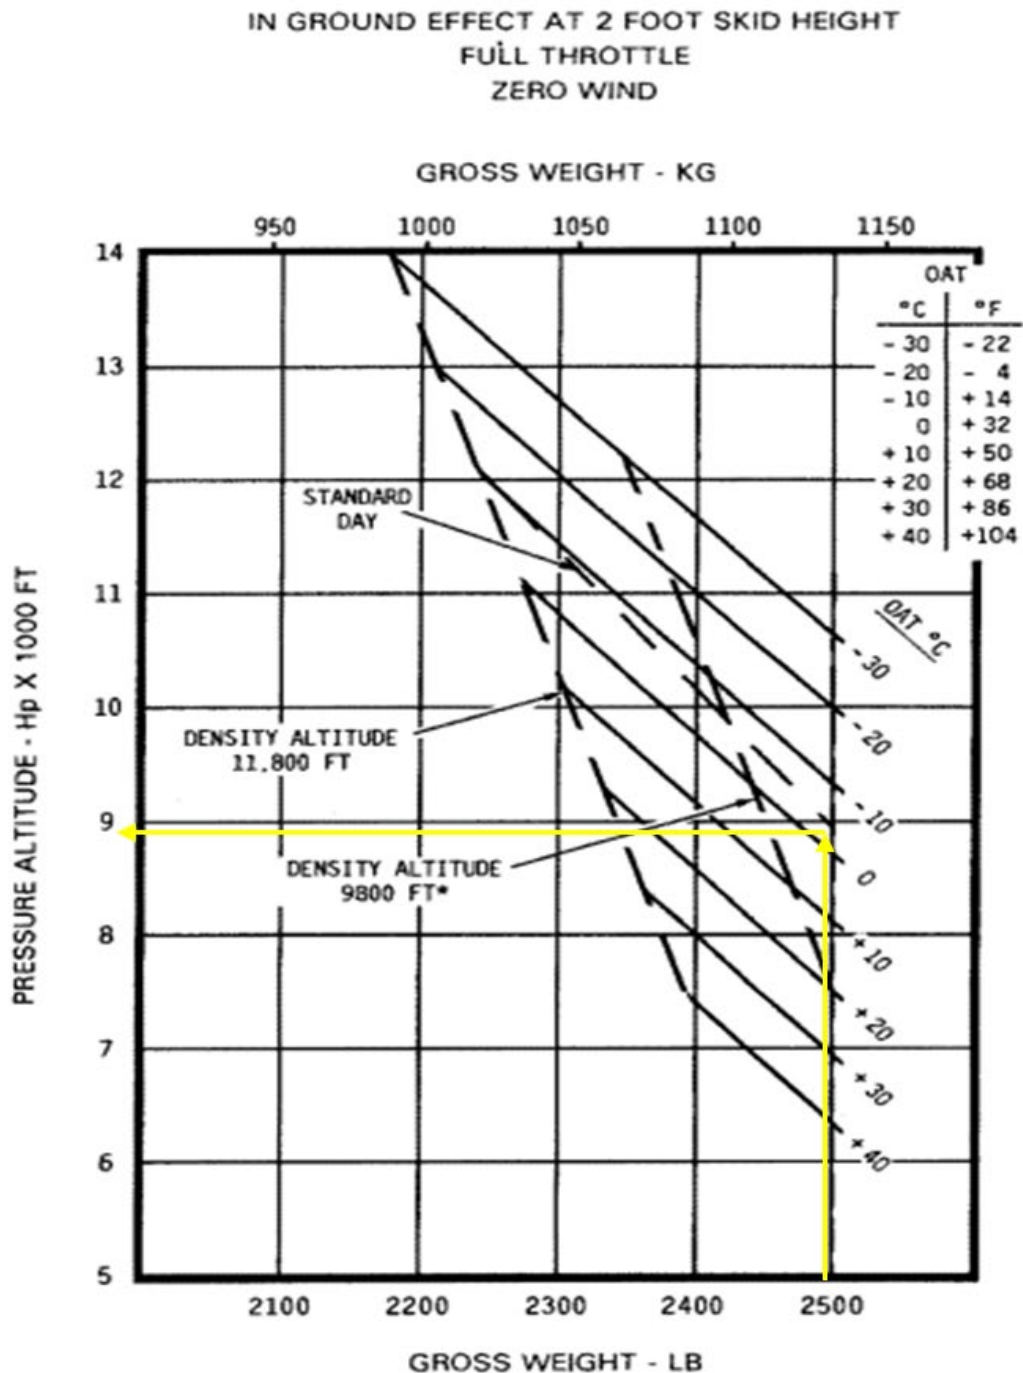
The pilot estimated the altitude of the drop off site to be about 5,300 ft mean sea level (msl) and the temperature to be about -1°C. A review of the performance charts for the accident helicopter revealed that at the estimated environmental conditions, the helicopter was capable of hovering in ground effect at 2,500 pounds, up to 8,900 ft msl.

Figure 9. Hover in ground effect chart. Courtesy of Robinson Helicopters.

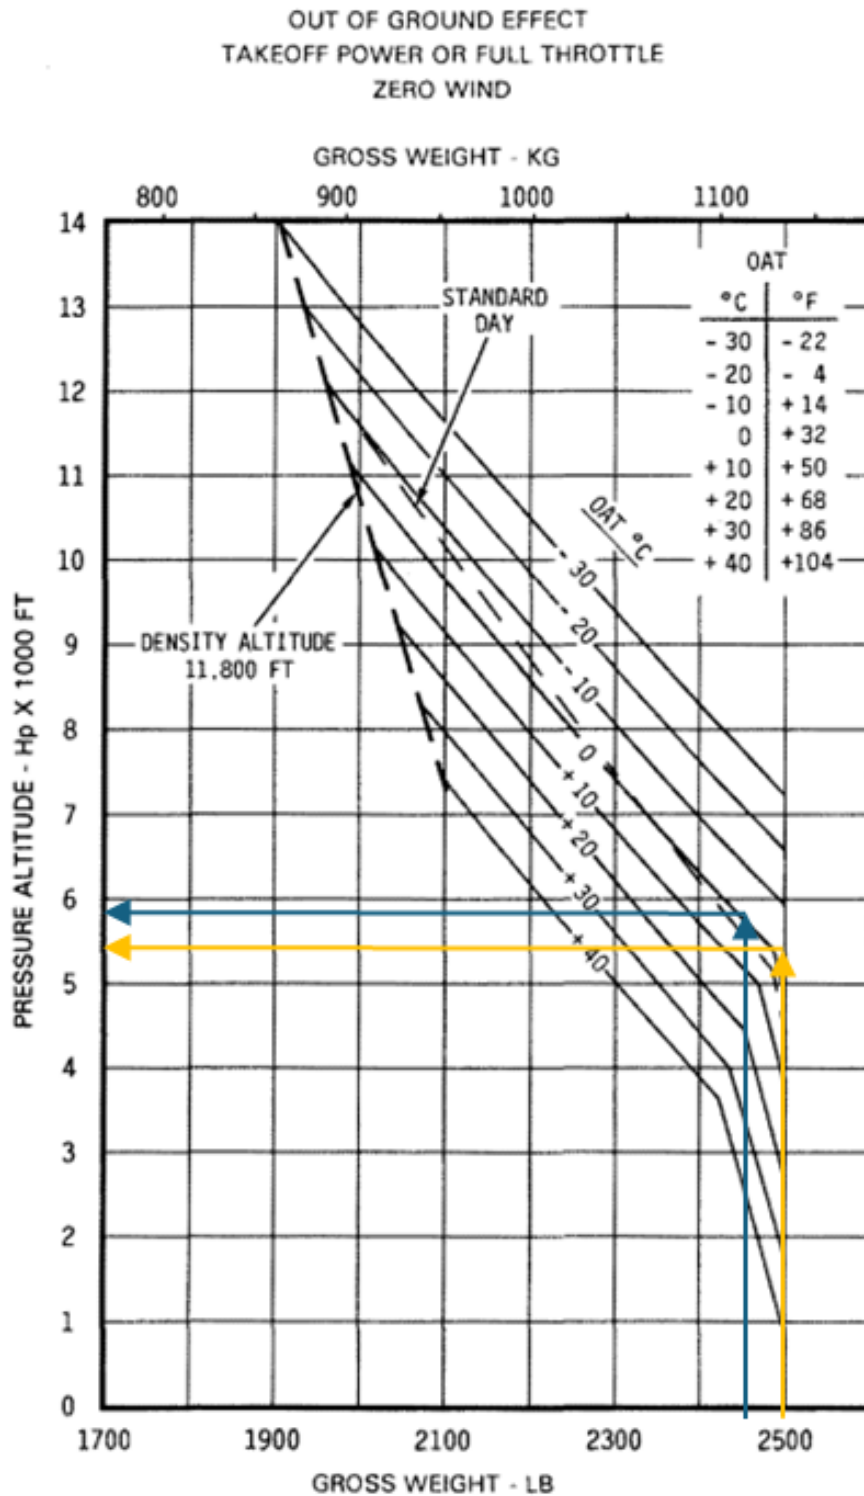
At the estimated environmental conditions of the accident site, the helicopter was capable of an out of an OGE hover, at the maximum gross weight, up to 5,300 ft msl. At the estimated gross weight of 2,450 pounds, the helicopter was capable of an OGE hover, up to 5,800 ft msl (figure 10).

Figure 10. Hover out of ground effect chart. Courtesy of Robinson Helicopters. Blue arrows show performance at 2,450 pounds. The yellow arrows show performance at 2,500 pounds.
