WPR25LA035

## INVESTIGATION PHOTOGRAPHS

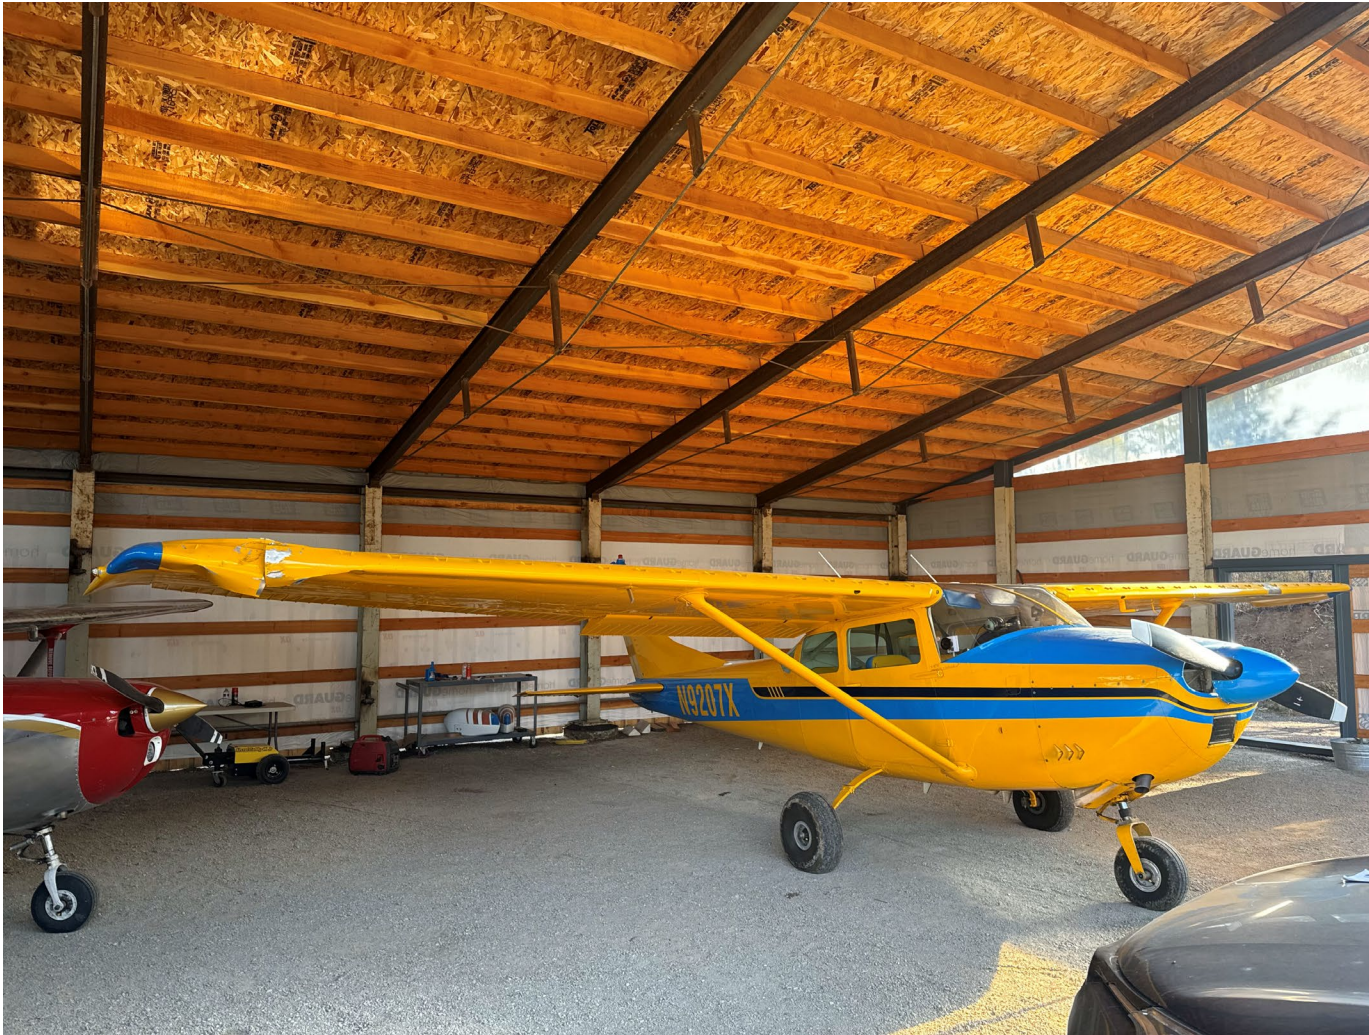
**Photograph 1 - View of right wing damage (Courtesy of Pilot)**

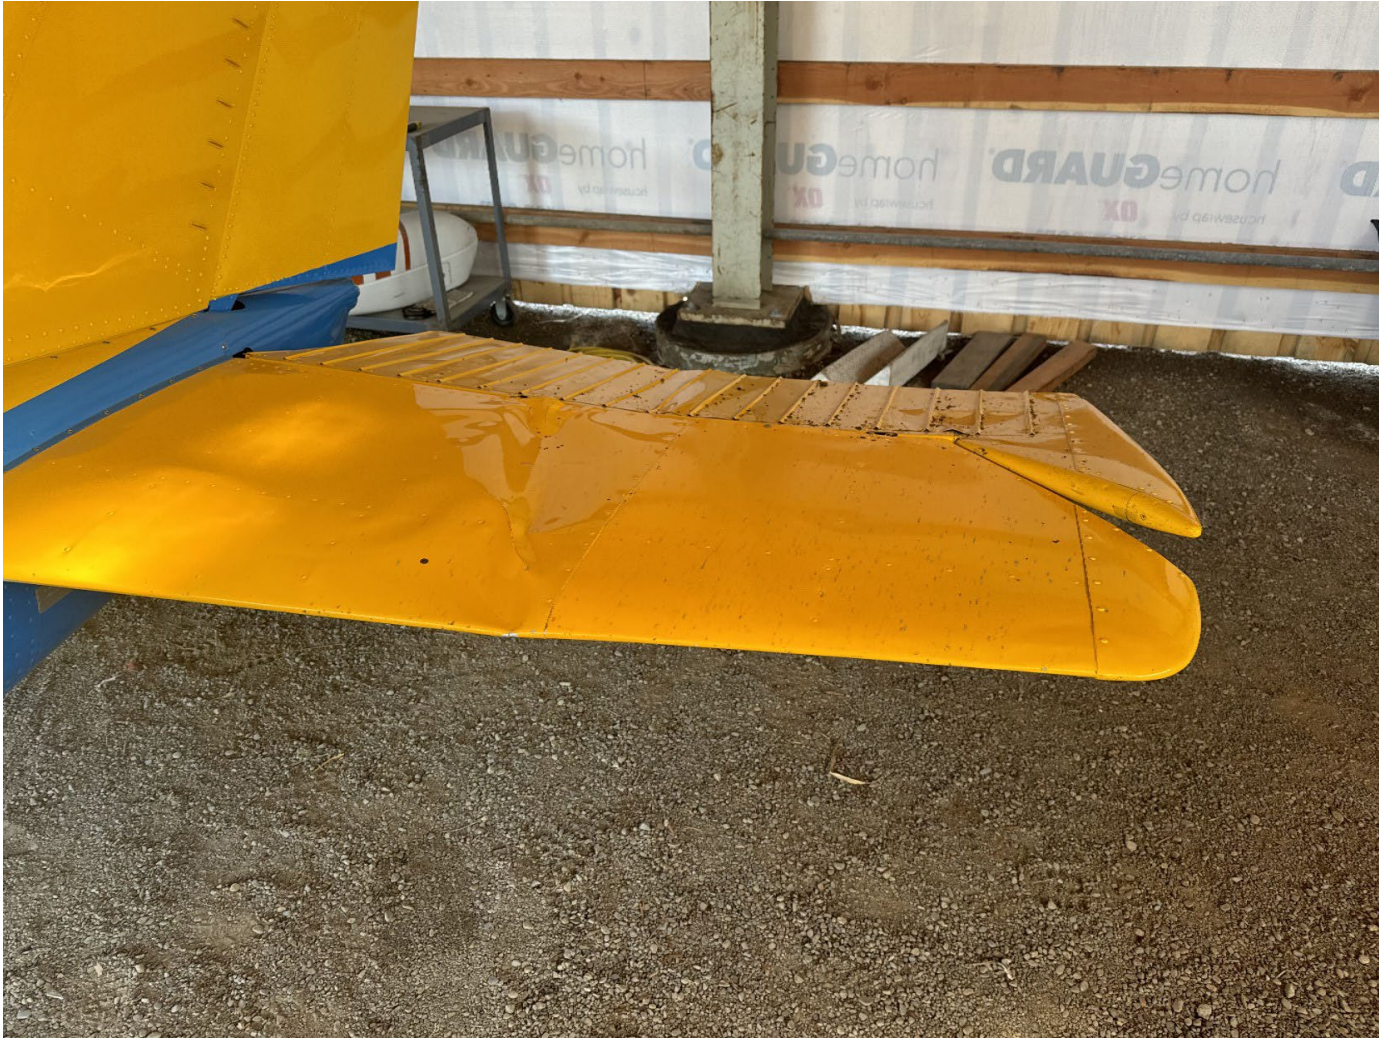
**Photograph 2 - View of left horizontal Stabilizer damage (Courtesy of Pilot)**
