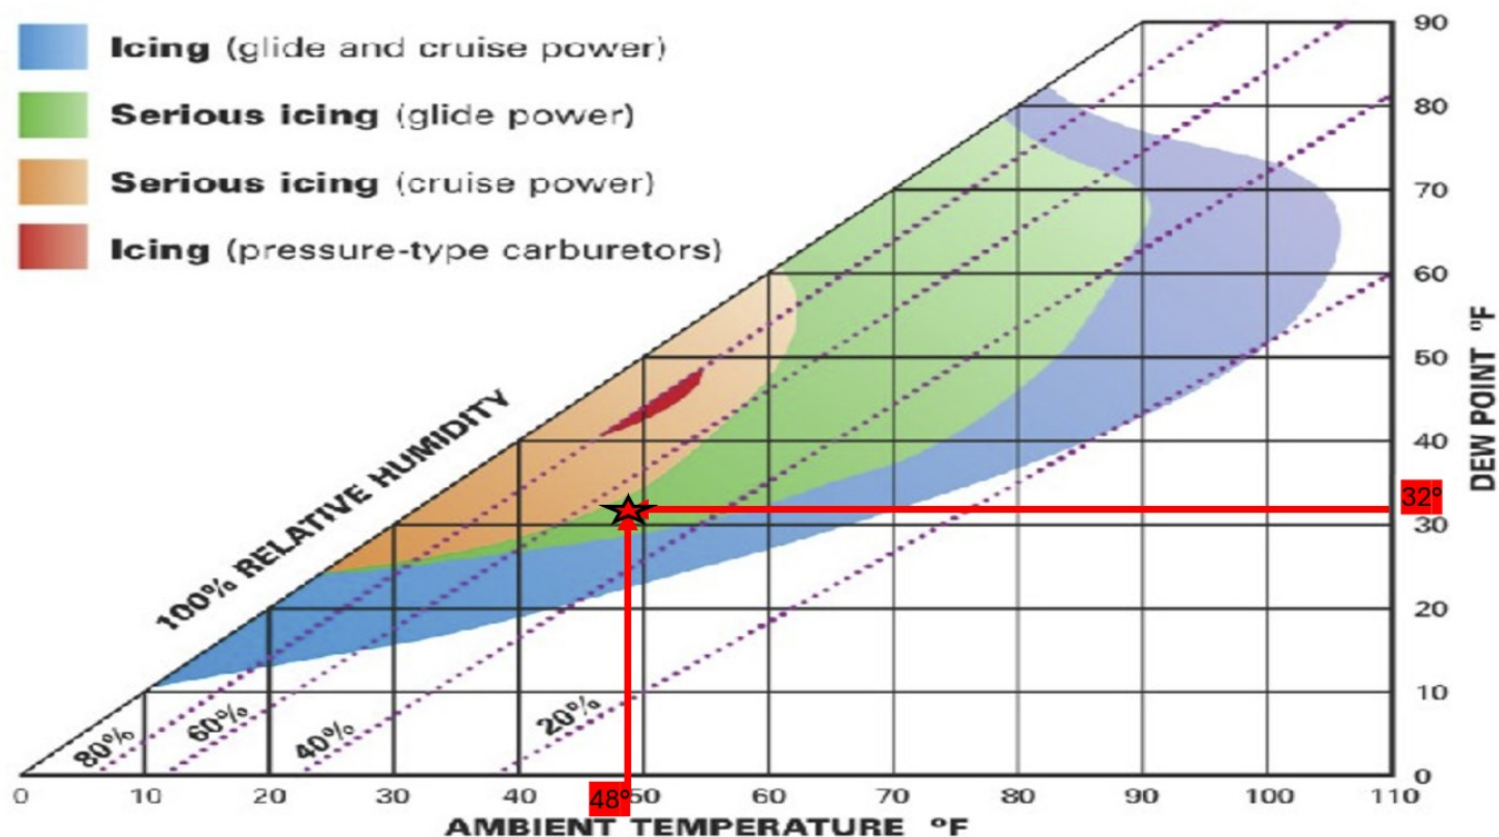
- The Special Airworthiness Information Bulletin (SAIB CE-09-35) Carburetor Icing Prevention chart indicated Serious Icing conditions during the initial climb temperature of 48°F and dew point of 32° F.
