WPR25LA037

## INVESTIGATION PHOTOGRAPHS

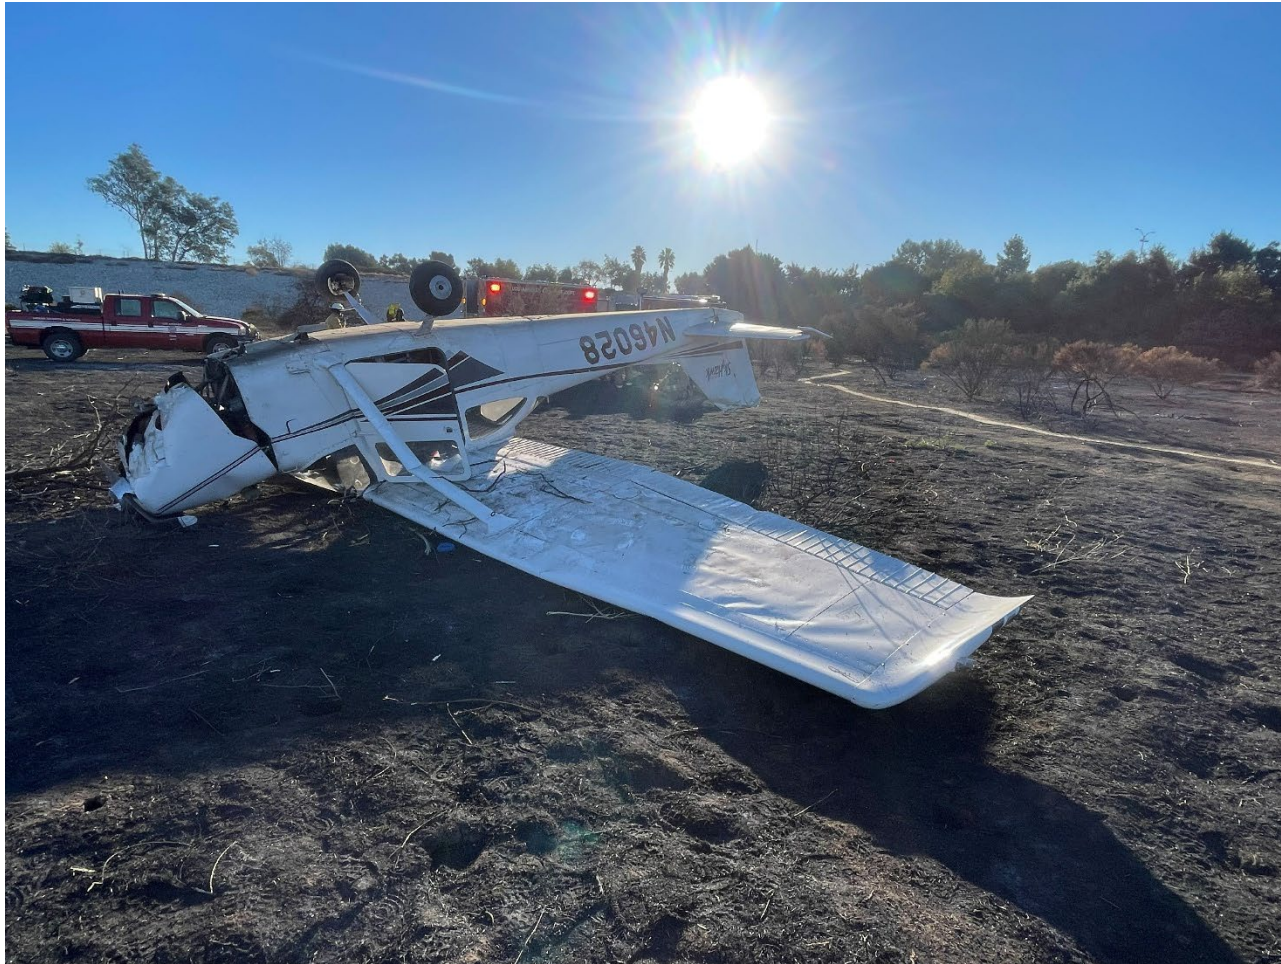
**Photograph 1 - View of inverted airplane and substantial damage to the right wing lift strut, vertical stabilizer and rudder (Courtesy of FAA)**

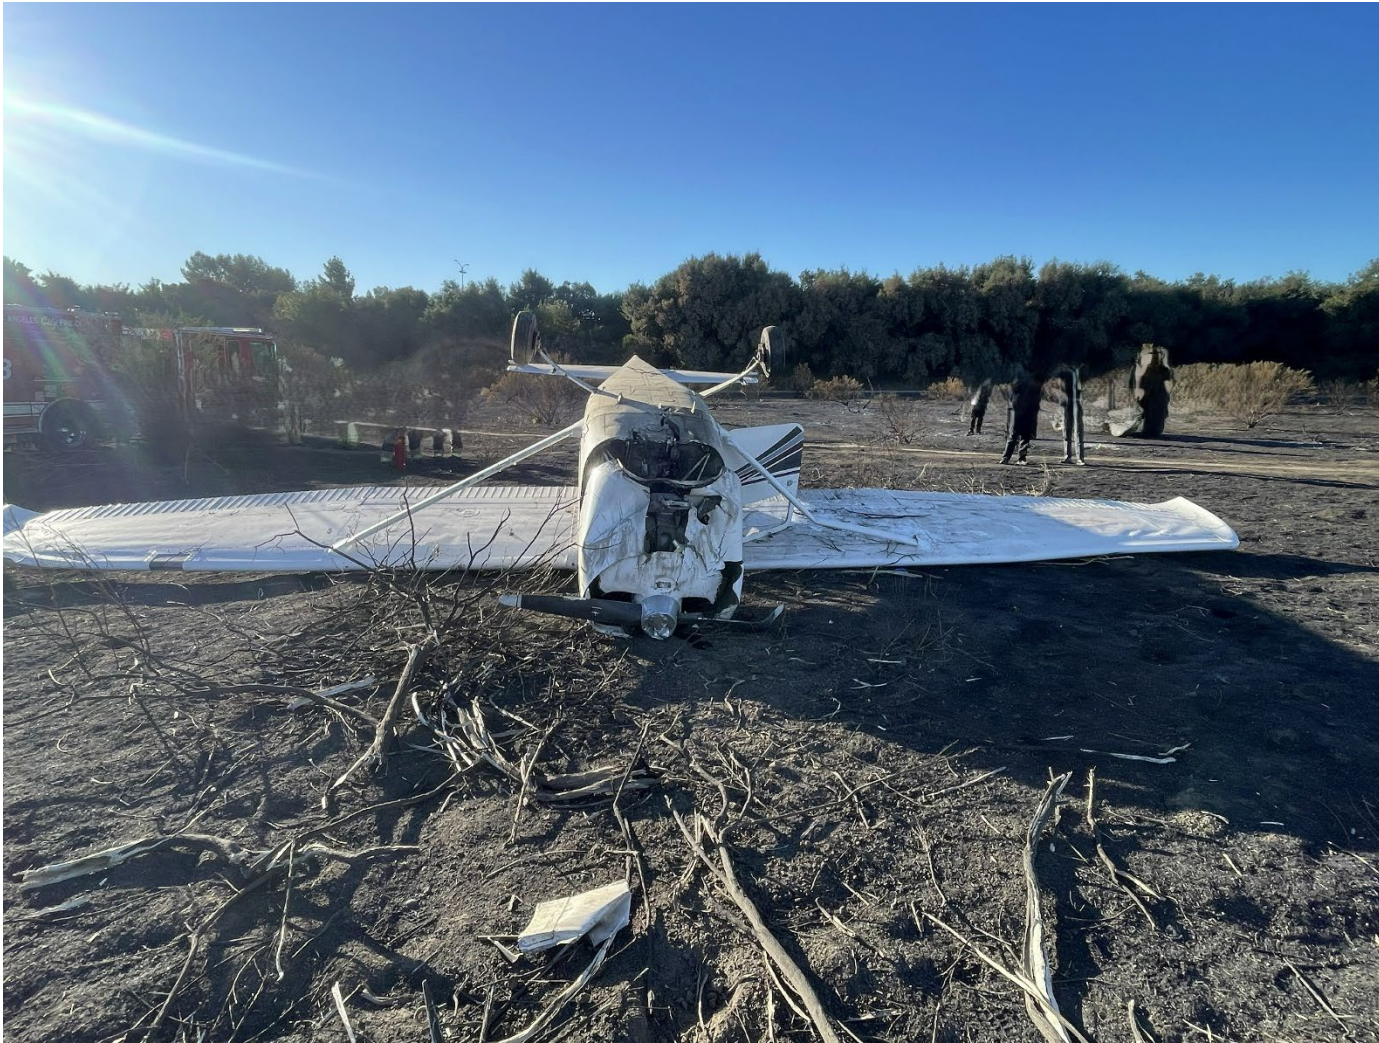
**Photograph 2 - Forward to aft view of inverted airplane with substantial damage to right wing lift strut (Courtesy of FAA)**

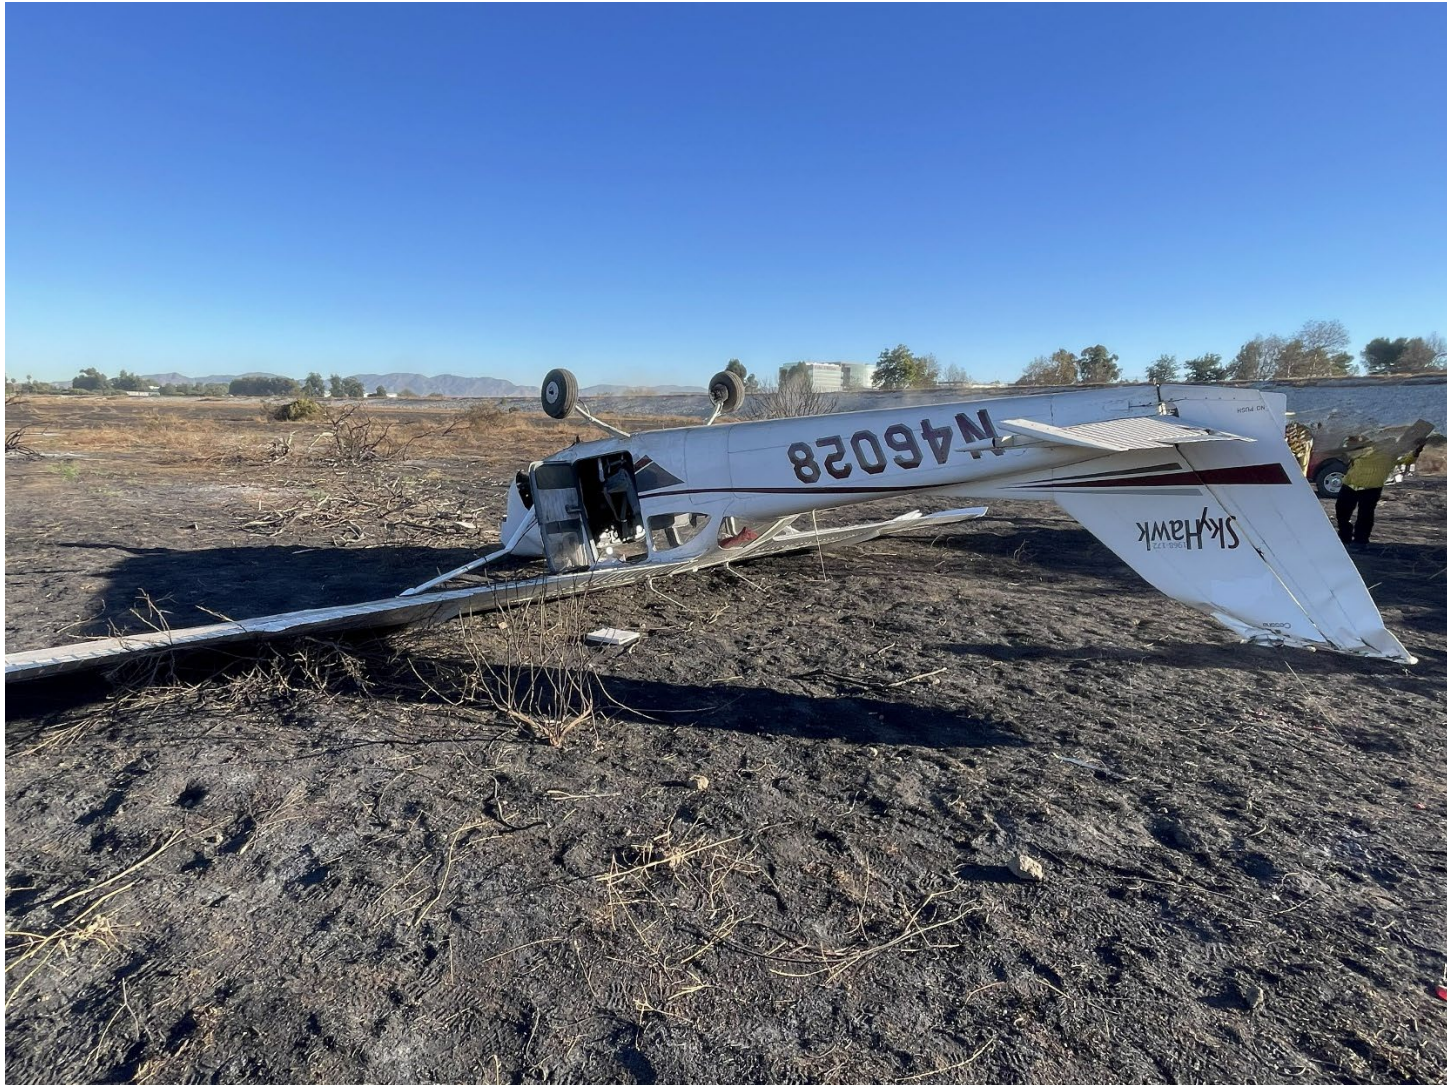
**Photograph 3 - View of inverted airplane with damage to vertical stabilizer and rudder  
(Courtesy of FAA)**

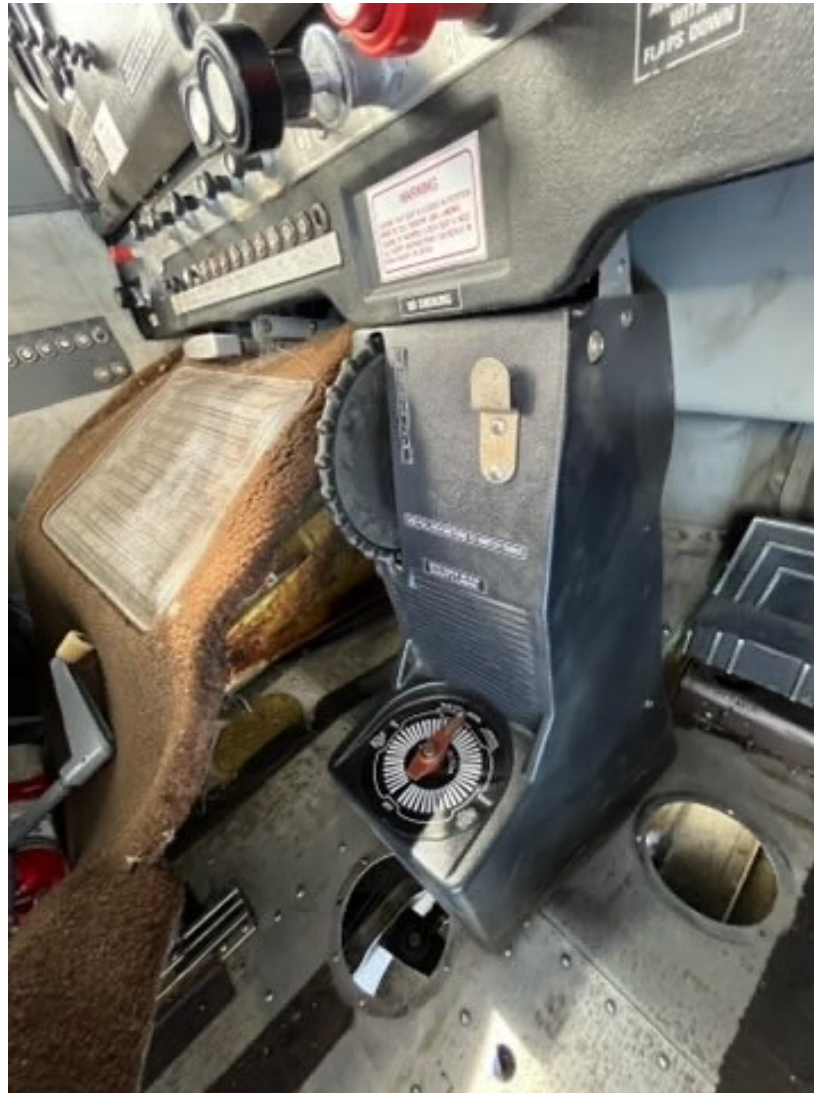
**Photograph 4 - Onsite view of the airplane's fuel selector in the Both position (Courtesy of FAA)**
