# National Transportation Safety Board

WPR25LA037

## **EXAMINATION SUMMARY**

Location: Los Angeles, CA  
Date: November 14, 2024  
Time: 0704PST  
0004UTC  
Airplane: (N46028) 1968 Cessna 172I, S/N: 17256998

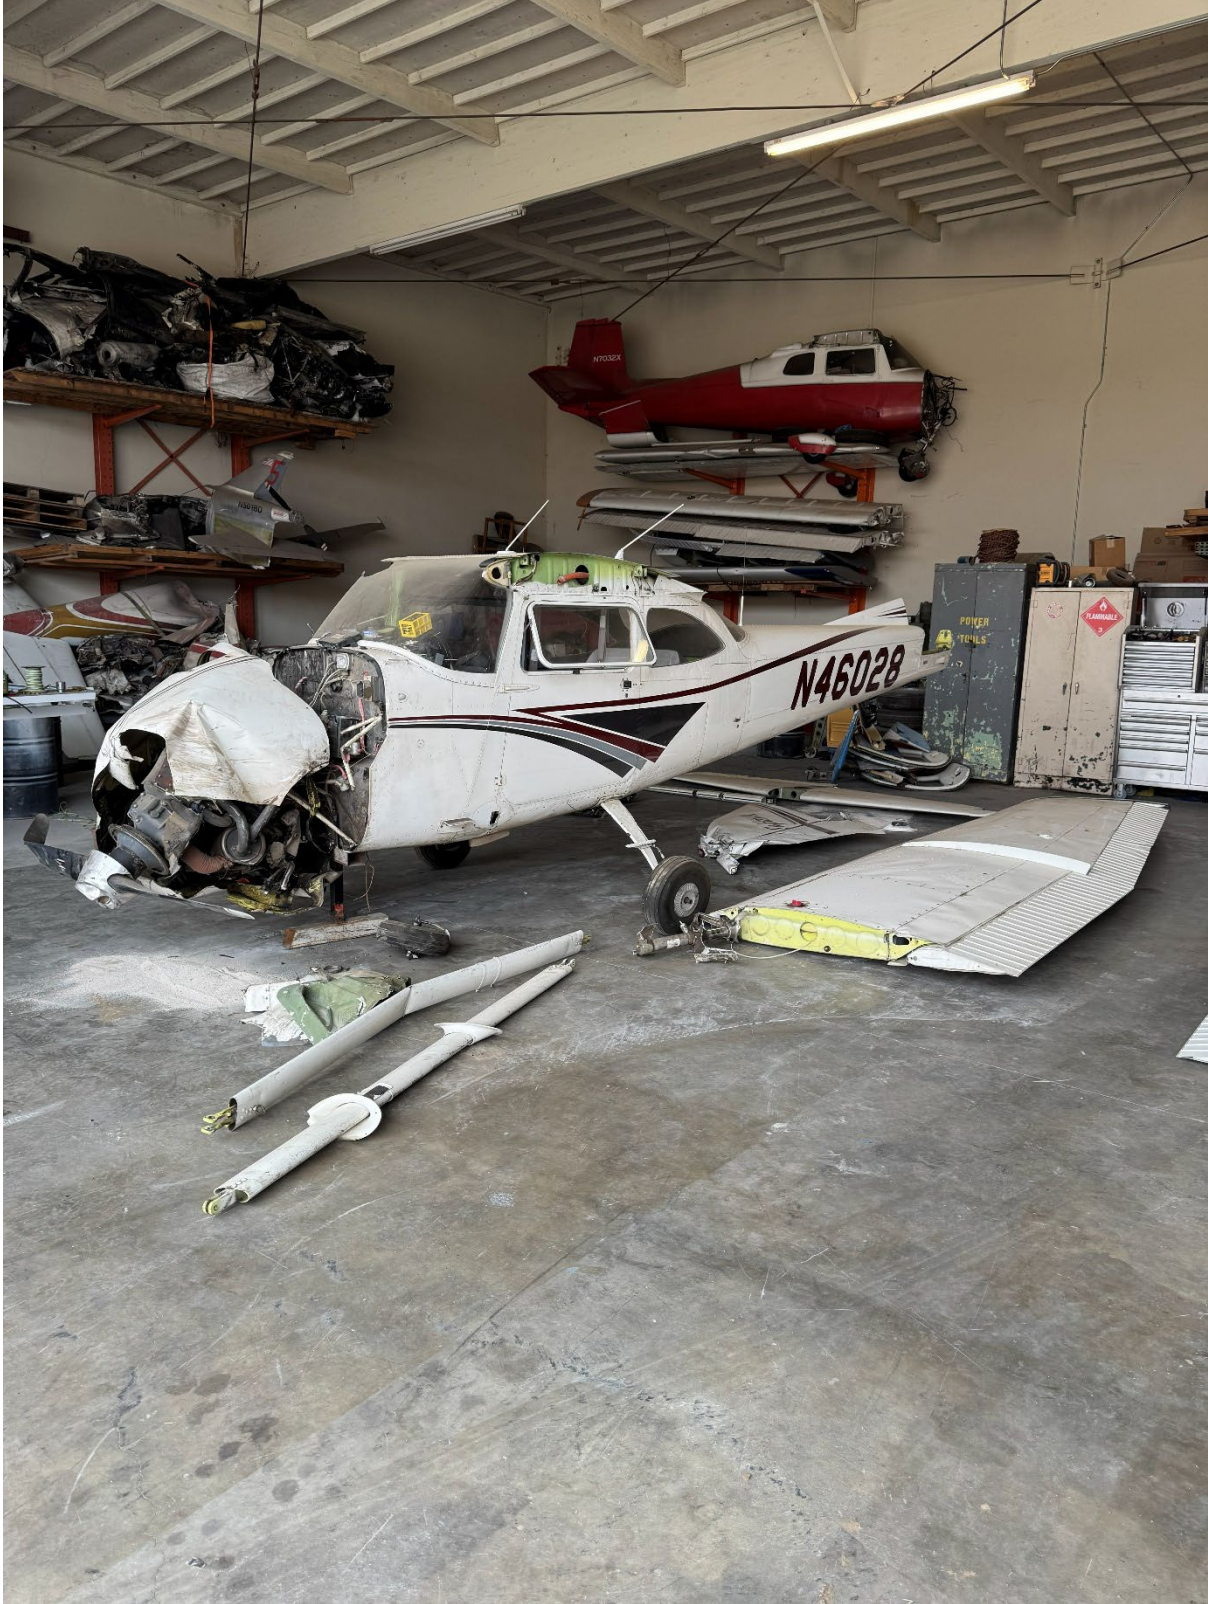
**Figure 1:** Left front to aft view of the airplane prior to examination

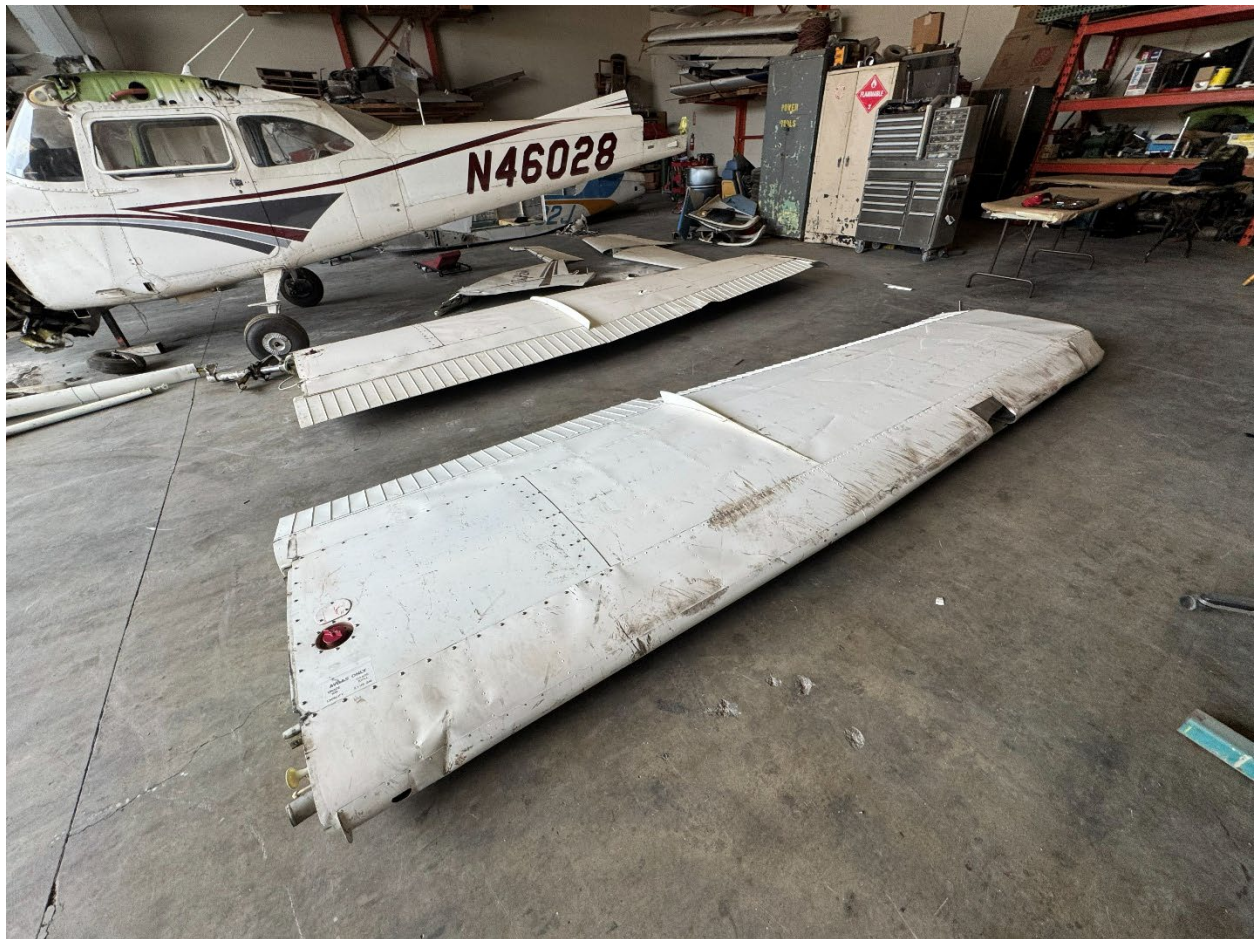
**Figure 2:** Left side view of the airplane with both wings and the empennage

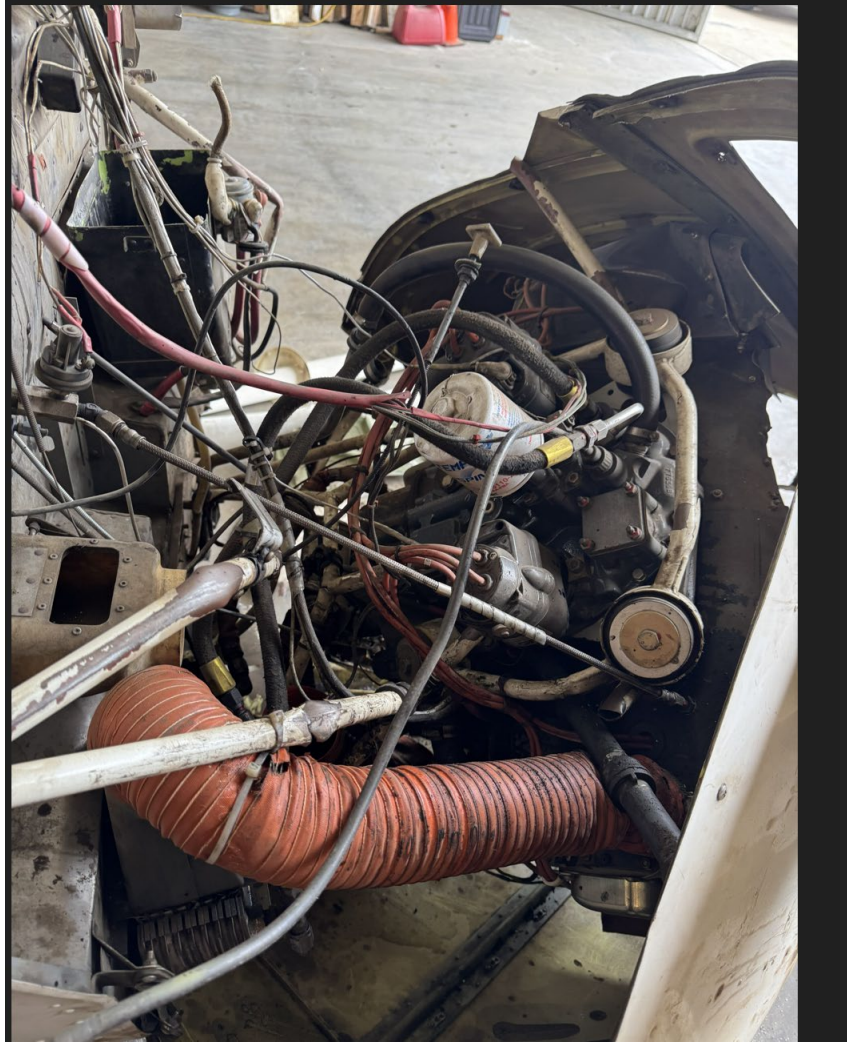
**Figure 3:** Initial overview of accessory case before examination

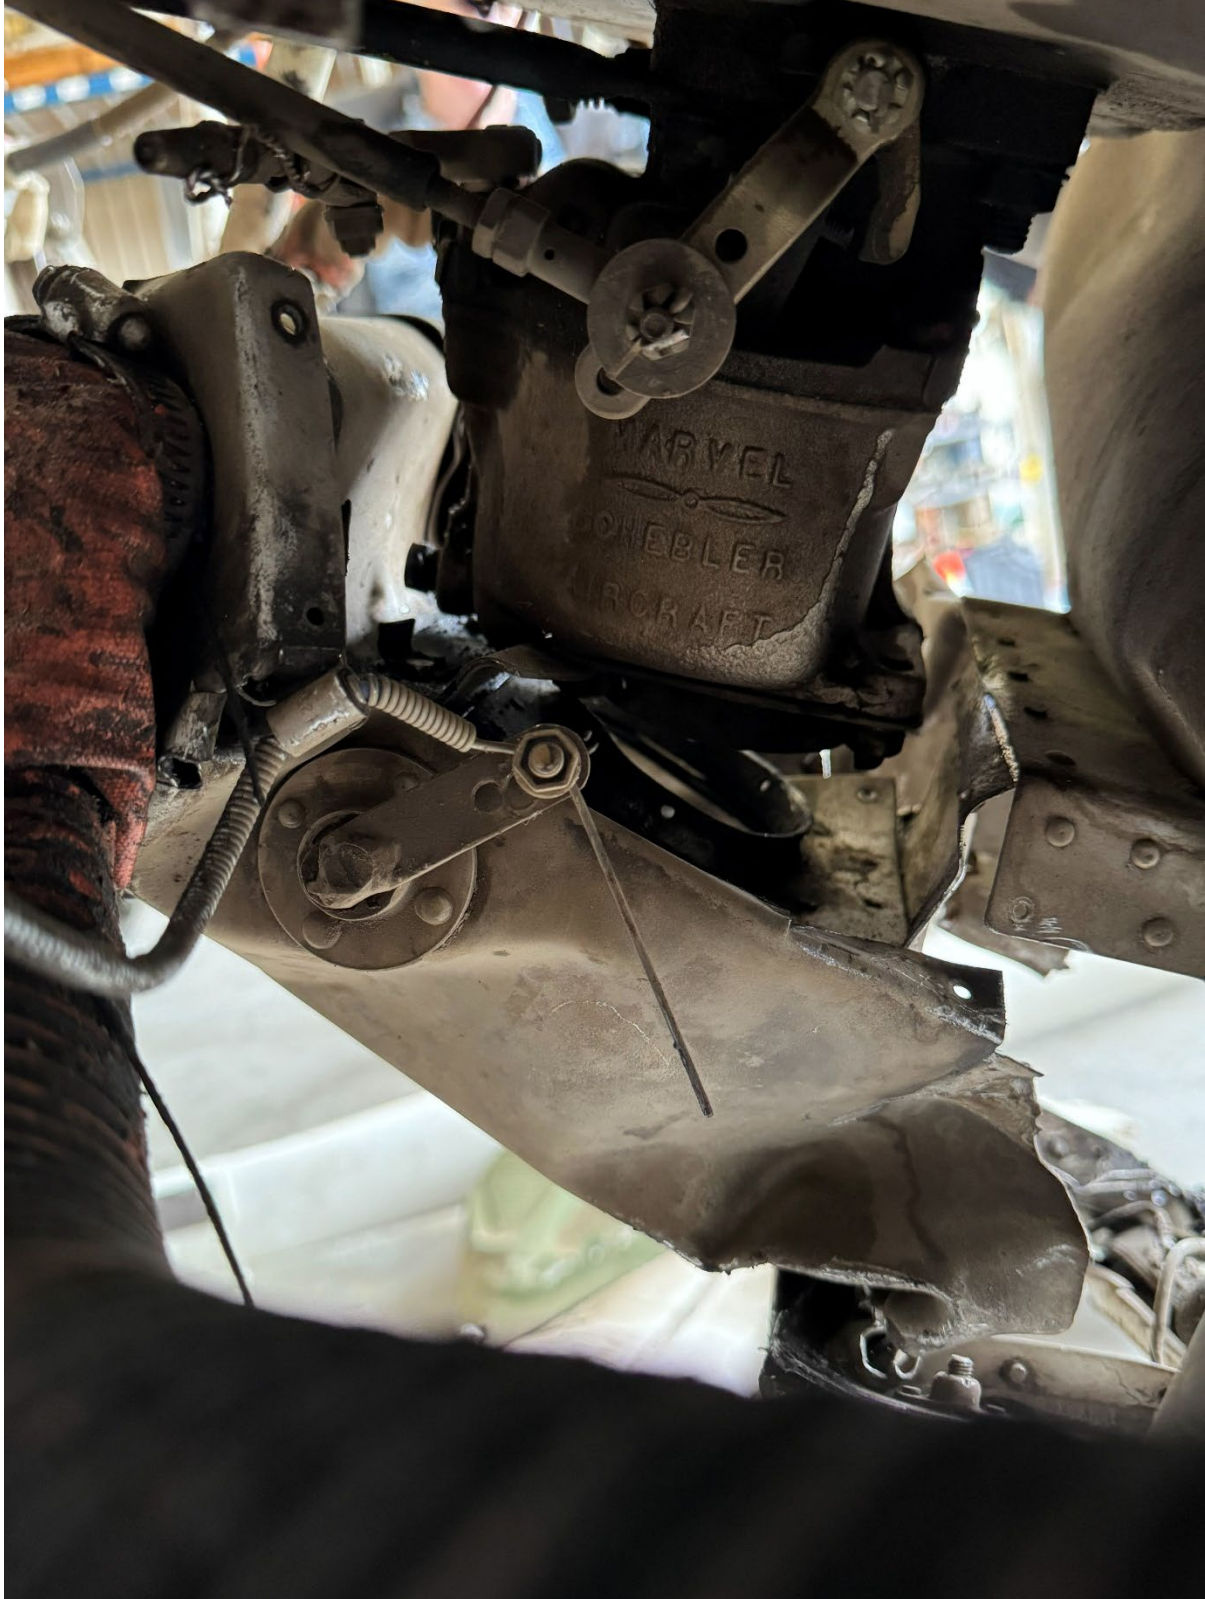
**Figure 4:** Left side view of the carburetor throttle control linkage and carburetor heat linkage intact

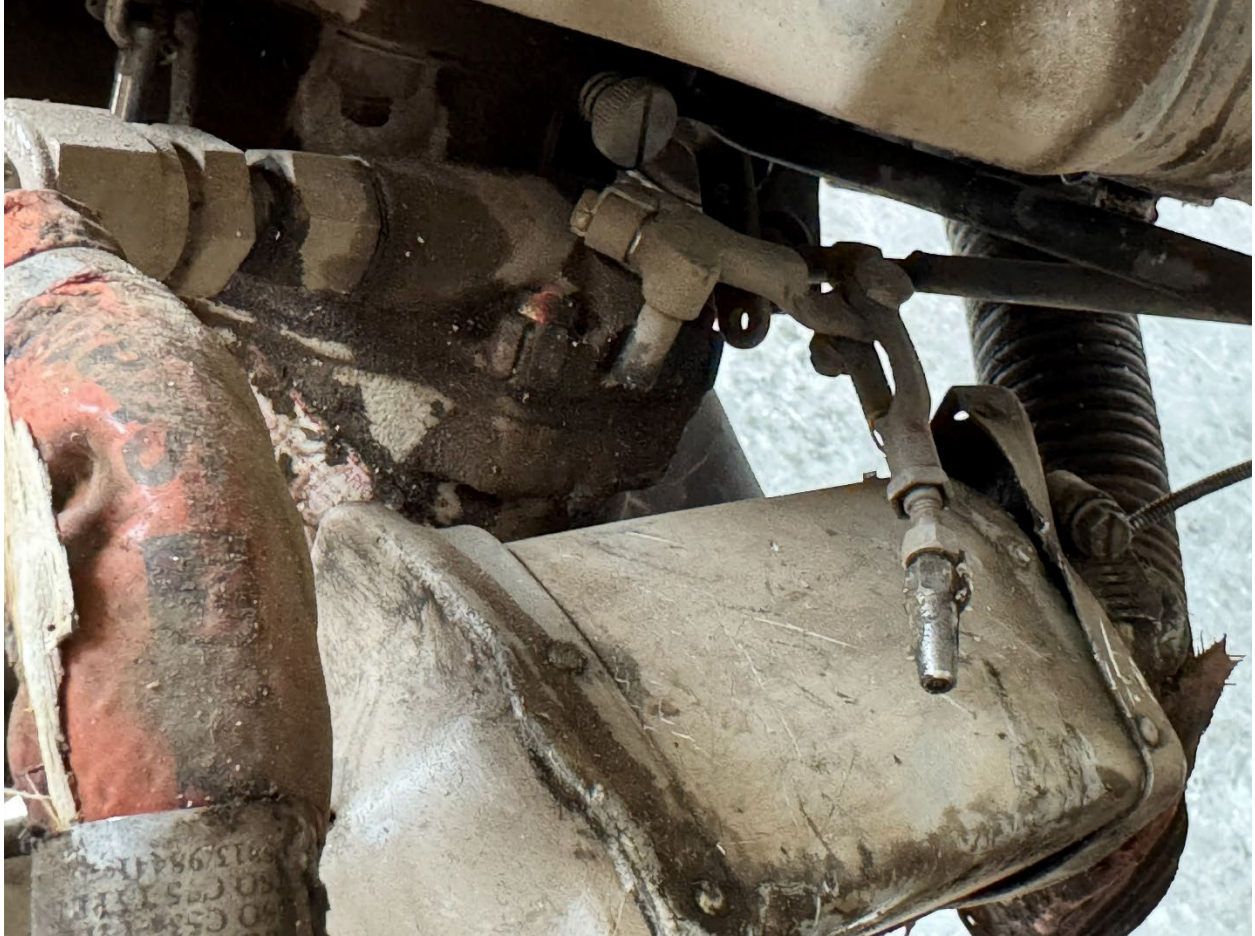
**Figure 5:** View of the impact damaged mixture control linkage

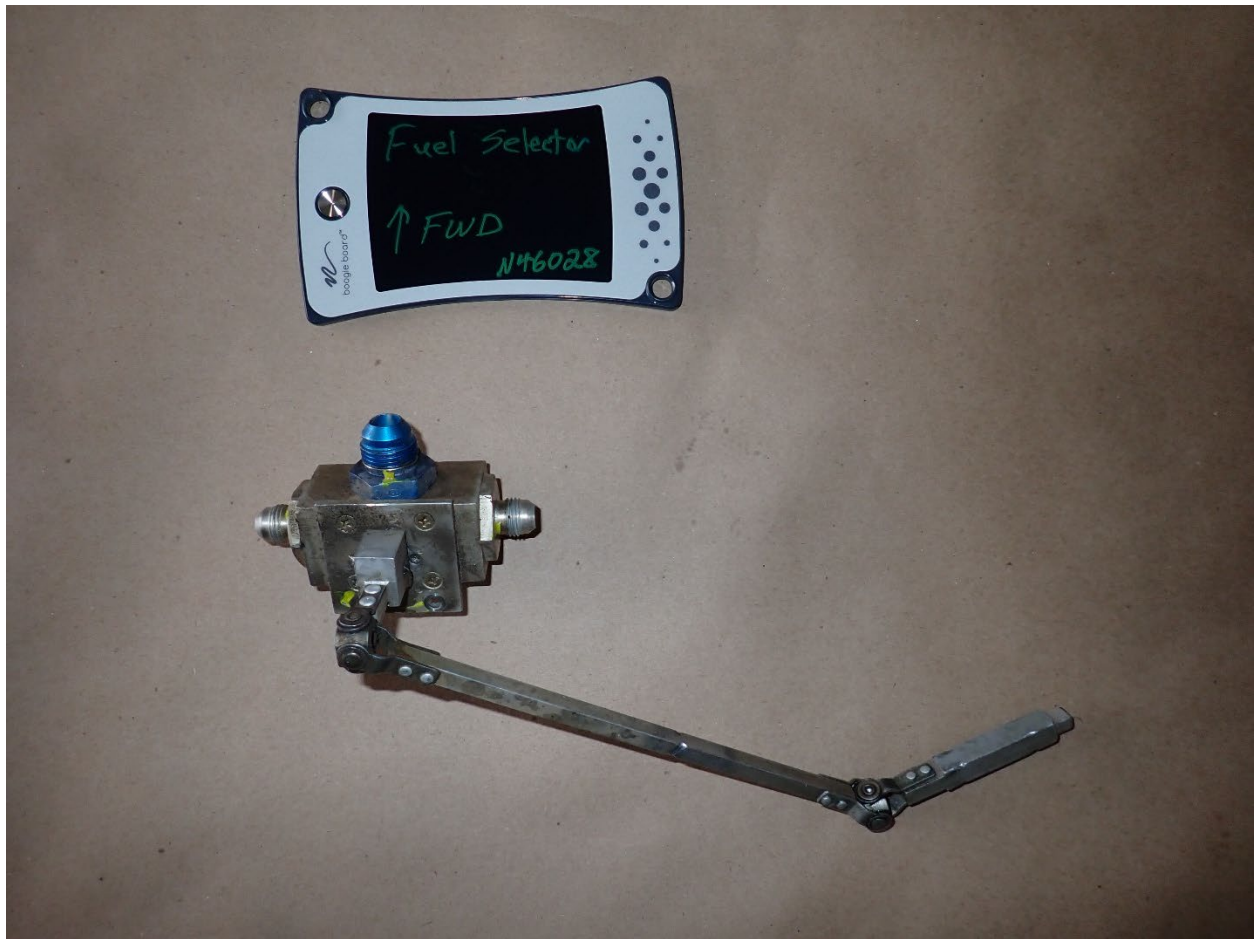
Both fuel caps were secure on the filler necks, seals were firm, but still pliable. Fuel tank outlet screens were clean in both tanks. The fuel selector handle and body were determined to be in the Both position and tested using compressed air for proper functioning in all positions. All the detents were strong, and the linkage had minimal play in the joints. The shaft of the fuel selector exhibited scoring from contact with the floor structure. The fuel strainer screen was clean; the bowl had a limited amount of pitting in the bottom and was clean of debris.

**Figure 6:** View of the fuel selector removed from the airframe for examination and function test

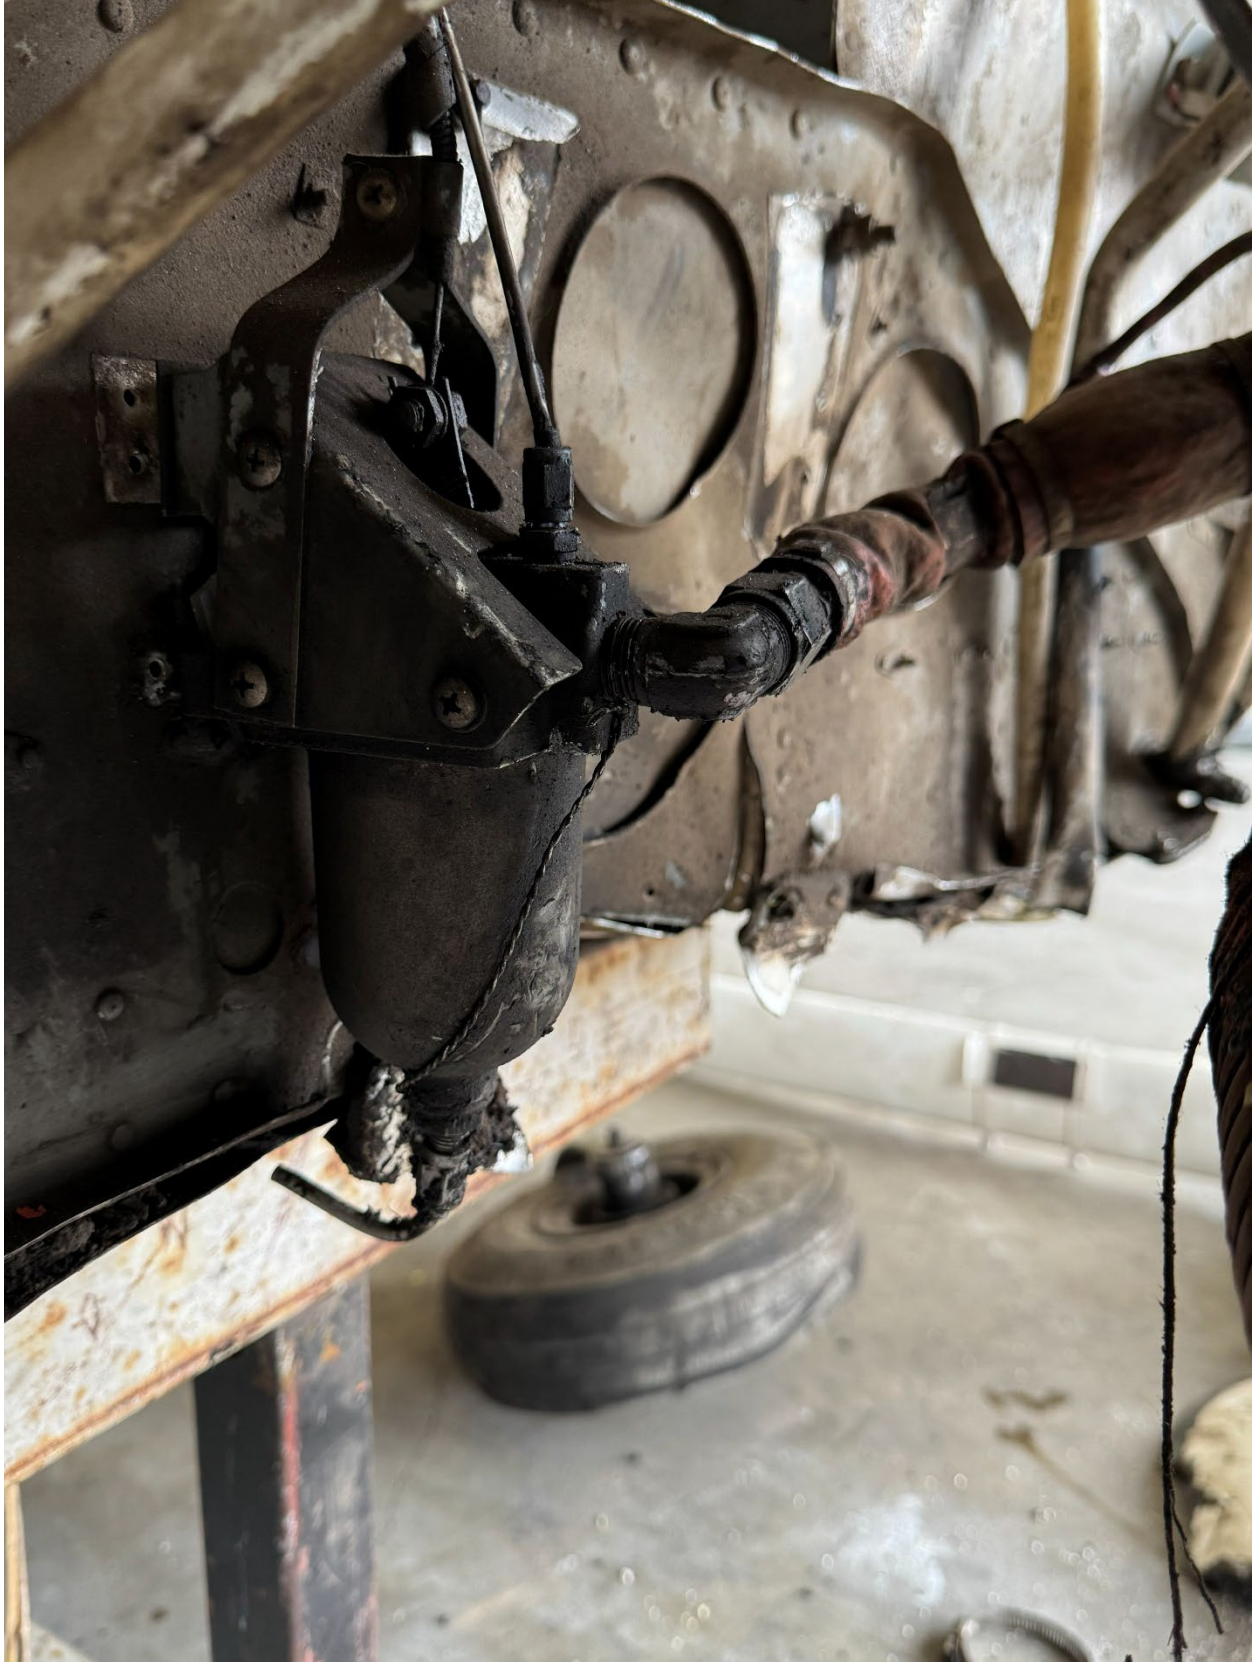
The recovery crew noted little fuel in either fuel tank at the site due to it leaking out while being inverted. Fuel smell was strong in both tanks. Fuel consistent with color and smell of 100LL was present at the fuel selector from both tanks. Fuel consistent with color and smell of 100LL was drained from the fuel strainer and tested negative for water using water finding paste.

**Figure 7:** View of the gascolator prior to removal for examination

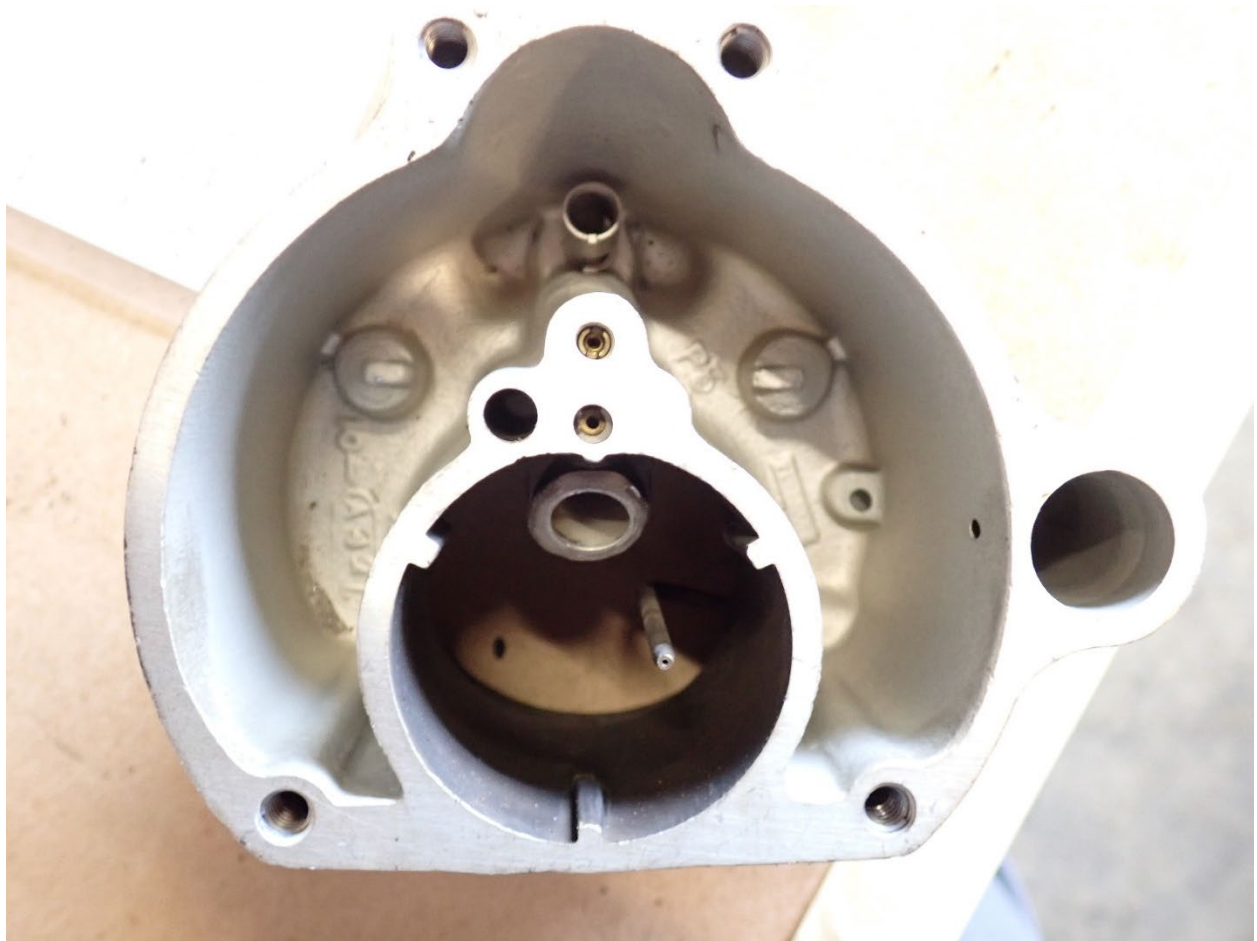
The throttle shaft bushings in the carburetor had minimal play. The carburetor fuel inlet screen assembly was clean. The carburetor was disassembled. The fuel bowl was clean, and the float was tested for leaks. The accelerator pump inlet screen was clean. Compressed air was applied and passed through the passage from the mixture metering sleeve and the discharge nozzle to verify there were no obstructions or debris.

**Figure 9:** View of the carburetor bowl during disassembly for examination
