# National Transportation Safety Board

WPR25LA039

## **ENGINE AND AIRFRAME EXAM SUMMARY**

Location: Pomona, CA  
Date: November 17, 2024  
Time: 11:11 Pacific standard time  
Airplane: N617ET, Piper PA-32-300

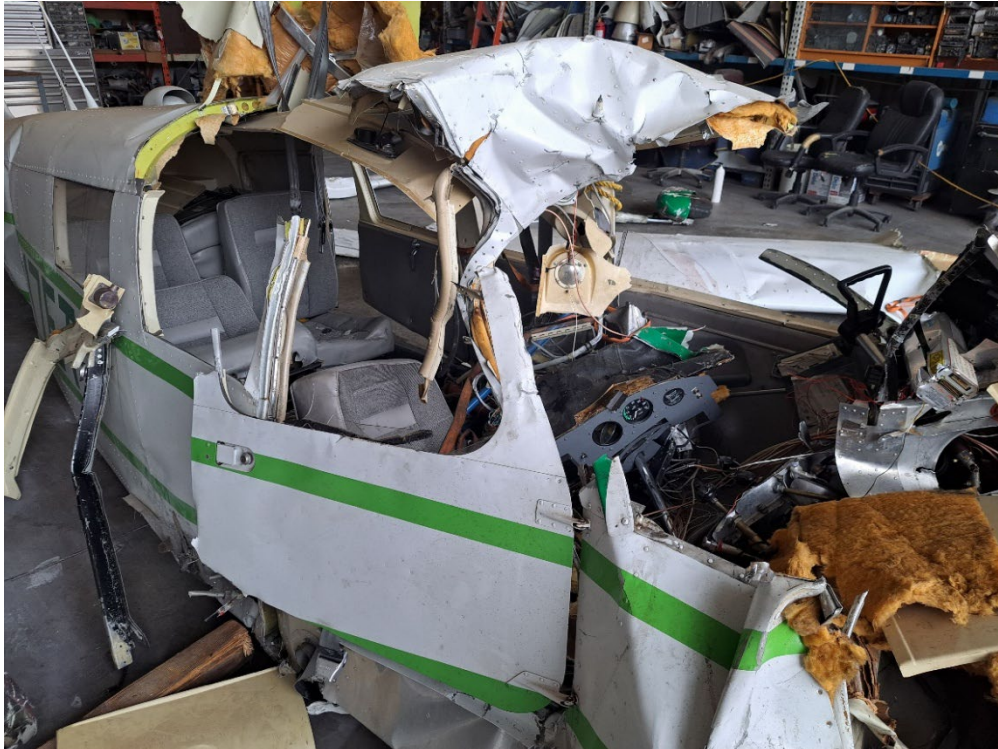
The airframe cabin displayed crushing and denting throughout, consistent with impact damage, as well as areas of the frame that were cut or displaced during emergent first response. (See figure 1.) The seat tracks remained attached to the floor structure. The row 1, left seat frame was securely attached to the seat tracks at two of its four rollers. The forward two rollers were detached from the seat tracks; the rear two rollers were secure in the seat tracks. The row 1, right seat frame was securely attached to the seat tracks at each of its rollers. The row 3, right and left seat frames were both secure and attached.

Figure 1. View of cabin. (Courtesy of Piper Aircraft)

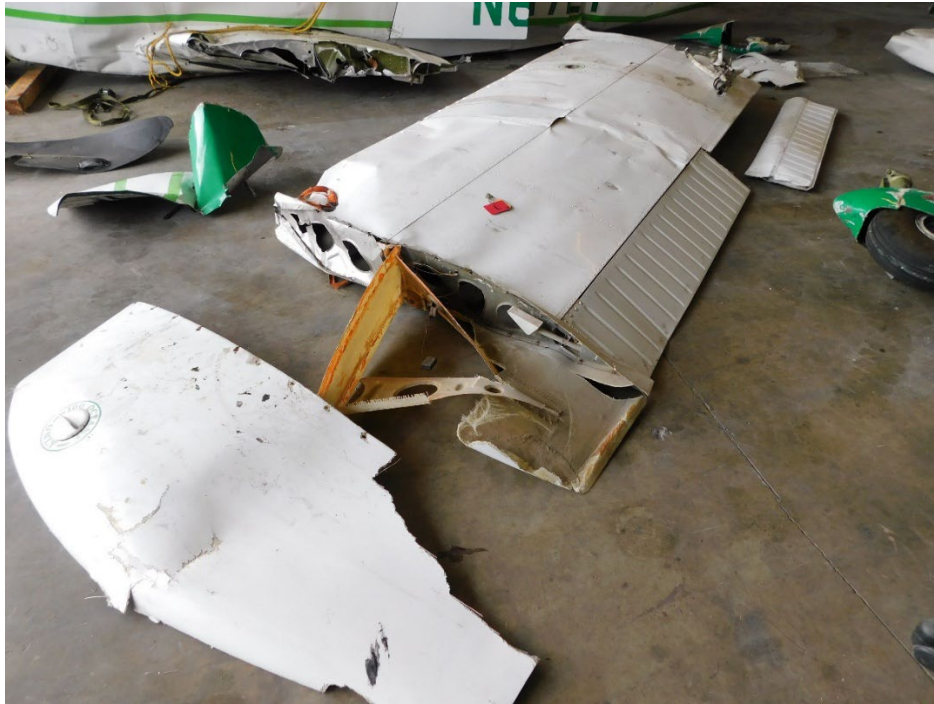
The wings were removed from the fuselage by wreckage recovery personnel. The left wing was removed about 2 ft from the wing root, and displayed leading edge denting and gouging, and was buckled midspan. The left aileron remained attached at its attach points. The left flap was separated from the wing. The left main fuel cap was not in place and was located inside the cabin. The left wing tip fuel cap was

Figure 2. Left wing.

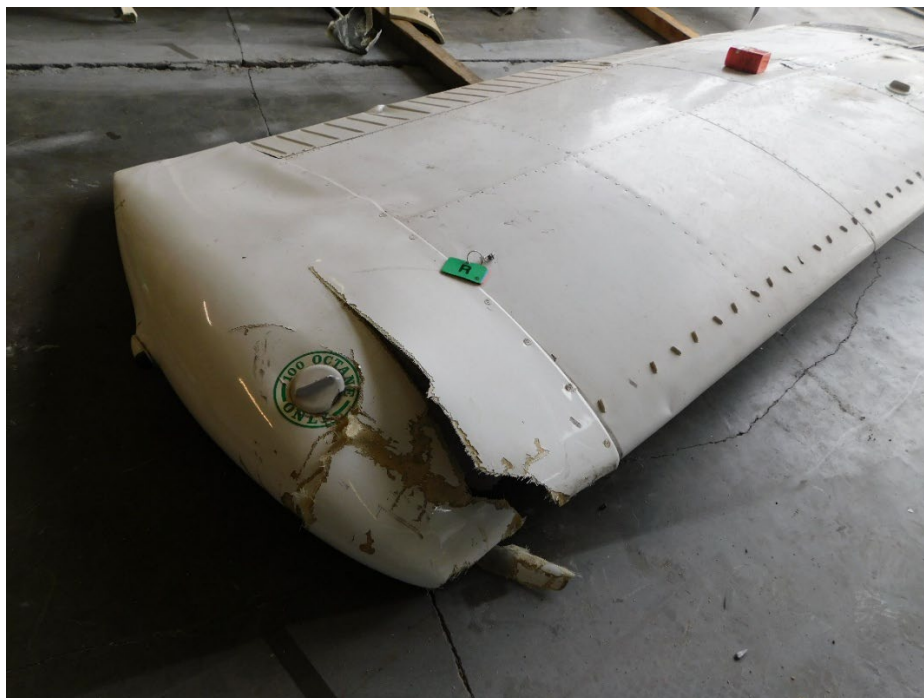
found to be in place and secure. (See figure 2.) The right wing displayed leading edge denting and gouging. The right aileron and flap remained attached at their attach points. The right wing main fuel cap was found to be in place and secure. The right wing tip fuel cap assembly was found to contain areas of fracture separation and denting/distortion and was in place, partially secured. (See figure 3.)

Figure 3. Right wing.

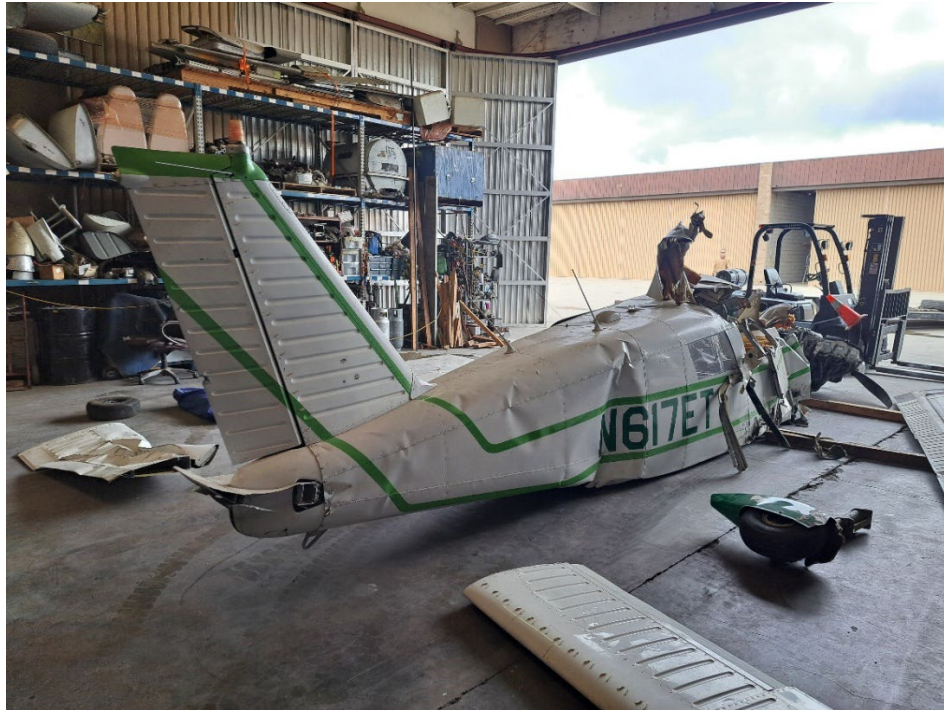
The fuselage displayed areas of denting and buckling throughout, consistent with impact damage. (See figure 4.) The upper forward cockpit, and right side of the instrument panel displayed crush damage and were separated, consistent with impact damage.

Figure 4. View of fuselage. (Courtesy of Piper Aircraft)

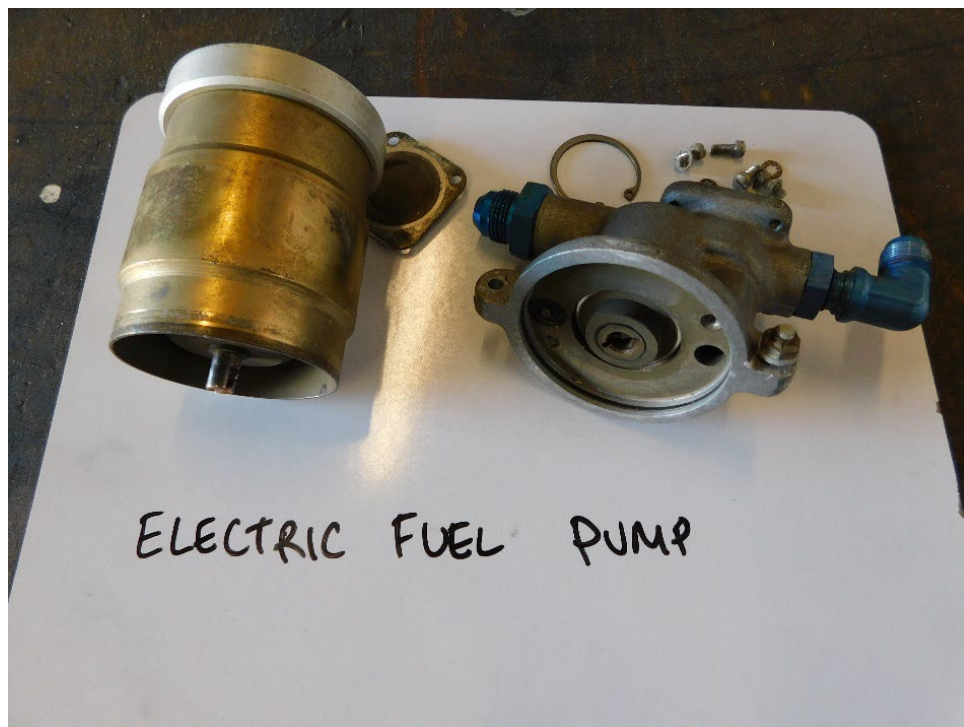
The electric driven fuel pump contained a small amount of liquid, blue in color, consistent with 100LL aviation fuel. The electric driven fuel pump was energized, and an audible pump sound could be heard. The pump was disassembled, and the actuation of the vanes were visually confirmed by manually rotating the pump shaft. (See figure 5.) The motor was again energized and rotation visually confirmed.

Figure 5. Electric driven fuel pump.

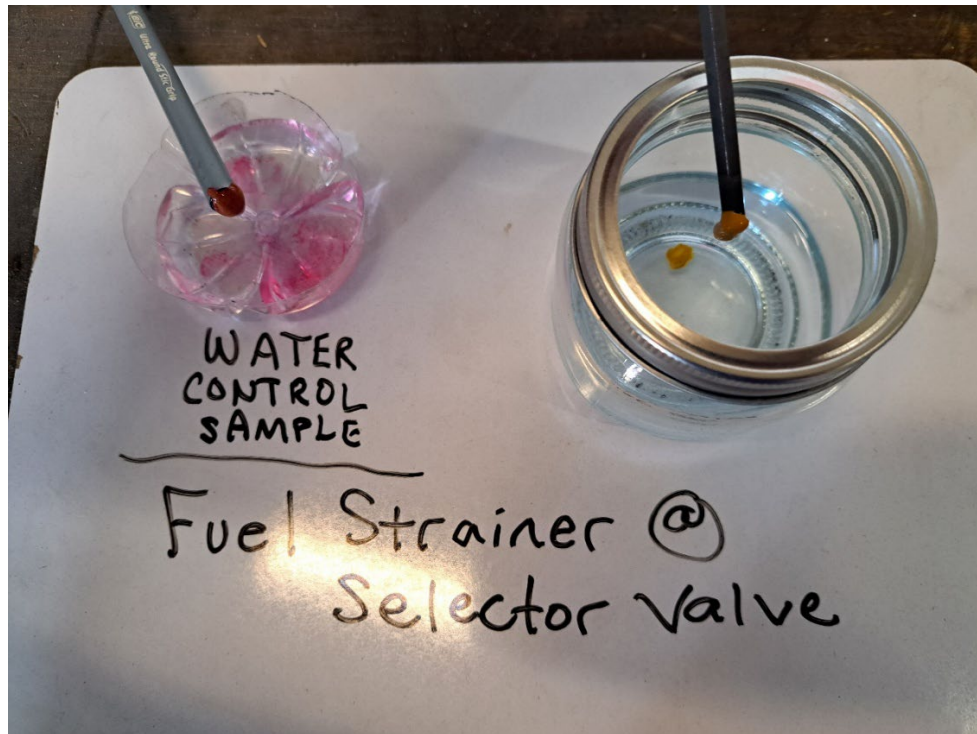
About 4 oz of fuel was recovered from the fuel selector filter bowl, with the quick drain handle. A small amount of fuel had leaked and was not recovered. The recovered fuel was clean, clear, and blue in color. Water detecting paste confirmed that there was no water present in the fuel. (See figure 6.)

Figure 6. Fuel sample with water detecting paste. (Courtesy of Piper Aircraft)

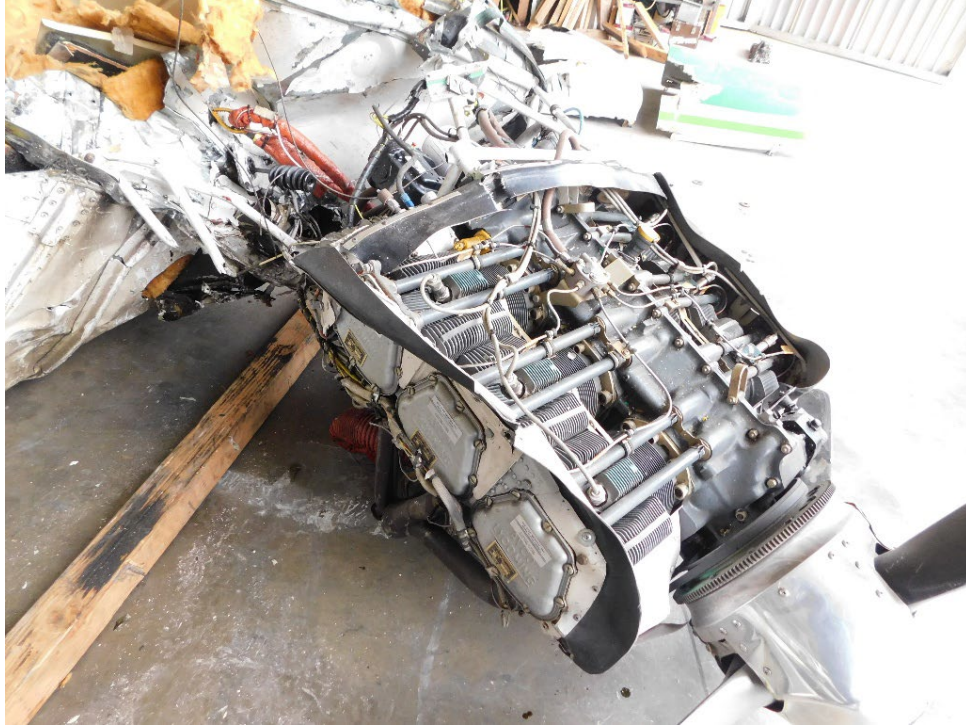
The engine was observed separated from the fuselage and remained attached to the engine mount. The engine mount displayed multiple areas of fracture and buckling, consistent with impact damage. (See figure 7.)

Figure 7. View of engine.

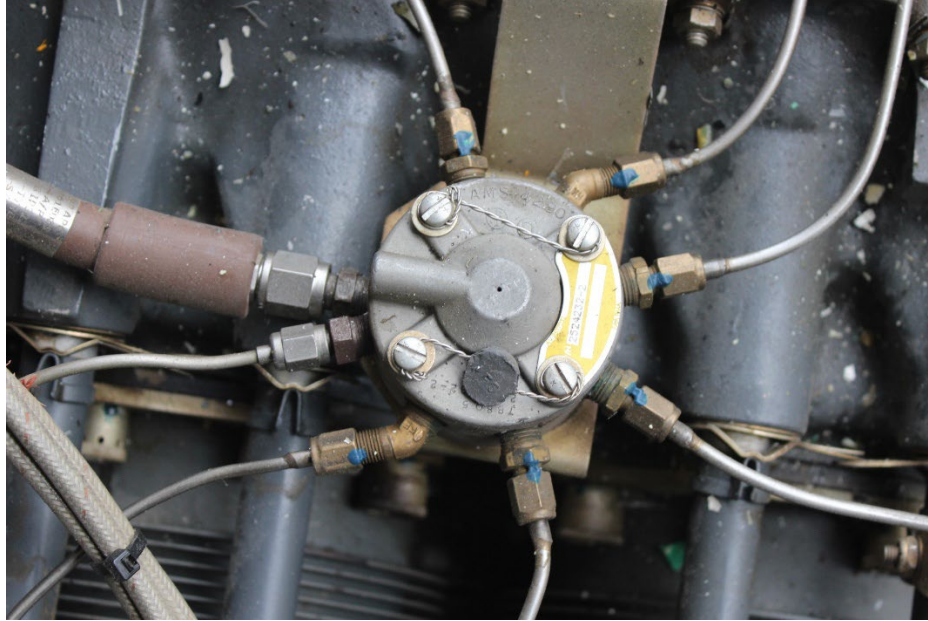
The fuel flow divider remained intact and secure at the mounting bracket. The fuel lines remained secure at each fitting and fuel injector at each cylinder. (See figure 8.) The flow divider was disassembled and observed to be unremarkable and free of obstruction. The diaphragm was observed intact and unremarkable. The fuel injection nozzles remained secure at each cylinder with the respective fuel line attached.

See figure 8. Fuel flow divider. (Courtesy of Lycoming Engines)

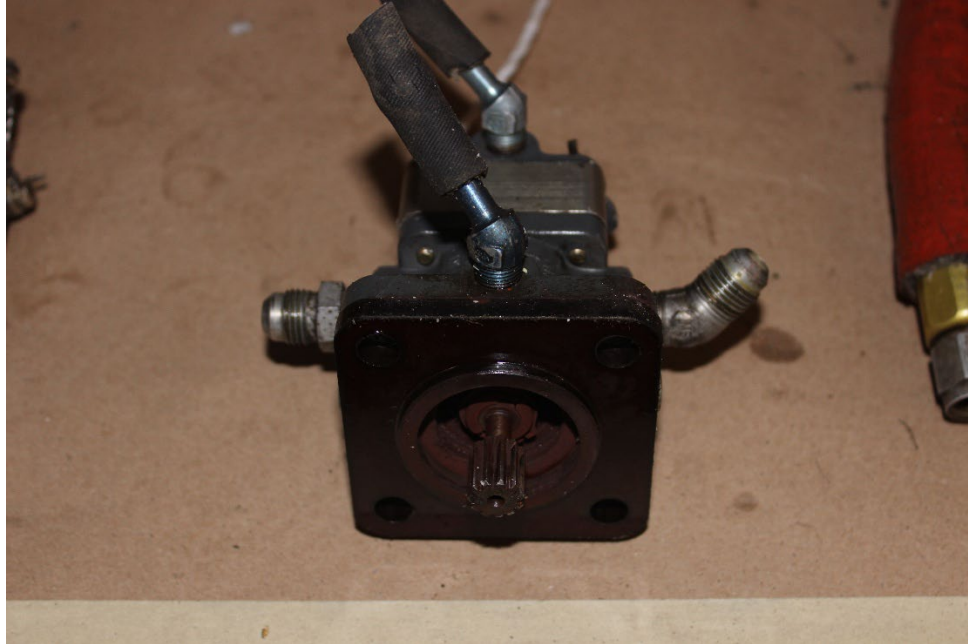
The engine driven fuel pump remained attached at its mounting pad. The fuel lines remained secure at their fittings. The fuel pump was removed; the drive remained intact, and the drive splines displayed a wear pattern consistent with normal wear. (See figure 9.) The fuel pump was tested and delivered a steady state stream of fuel.

Figure 9. Engine driven fuel pump.

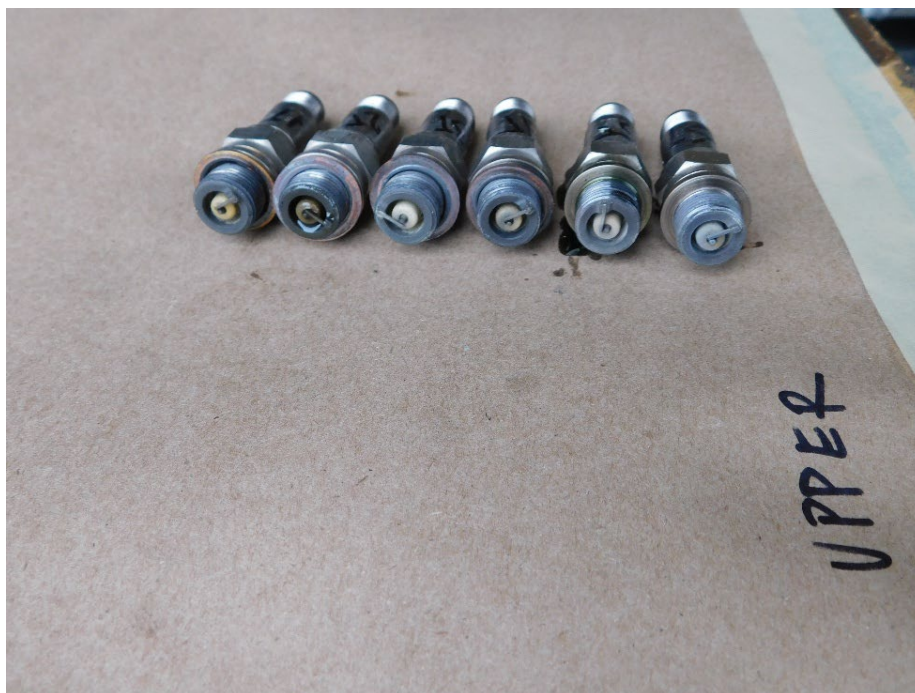
The ignition harness was observed attached to each magneto and spark plug, and unremarkable. The upper spark plugs were removed observed to display coloration consistent with normal operation, according to the Champion Spark Plugs "Check-A-Plug" chart AV-27. The #2 spark plug was oil soaked, consistent with post-accident engine positioning. (See figure 10.)

Figure 10. Upper spark plugs.

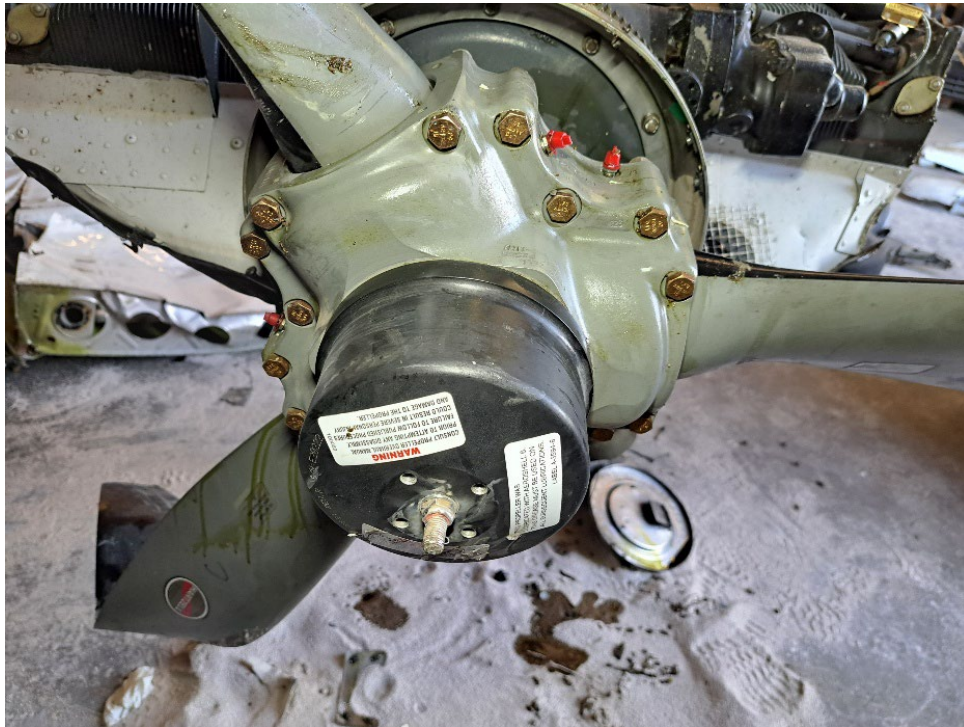
The airplane was equipped with a three bladed, constant speed propeller. Each propeller blade remained attached to the hub and the propeller assembly remained attached to drivetrain. (See figure 11.)

Figure 11. Propeller hub. (Courtesy of Piper Aircraft)

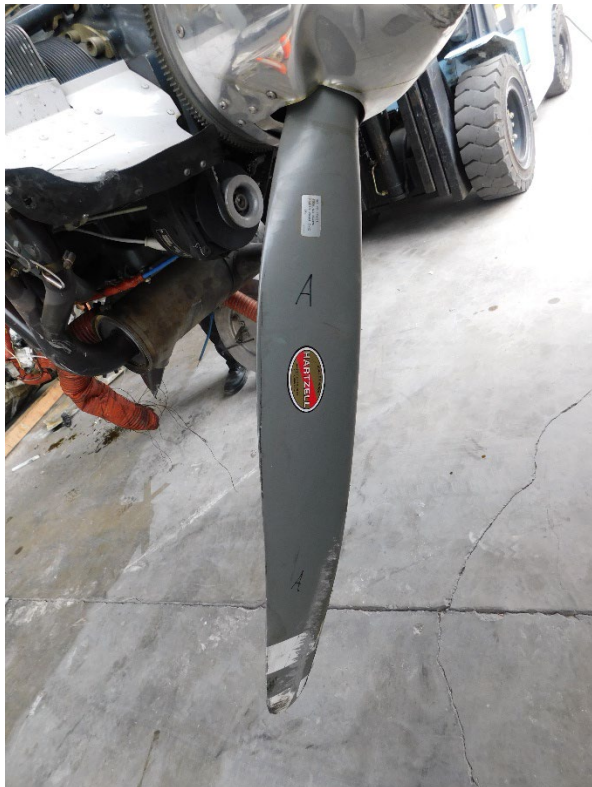
Blade A displayed chordwise scratching along its leading and trailing edges, near the blade tip, and slight aft bending, about mid span. (See figure 12.) Blade B displayed multi directional scratches and gouging, and was bent aft, at mid span. (See figure 13.) Blade C displayed spanwise scratches and gouging throughout the outer two

Figure 12. Blade A.

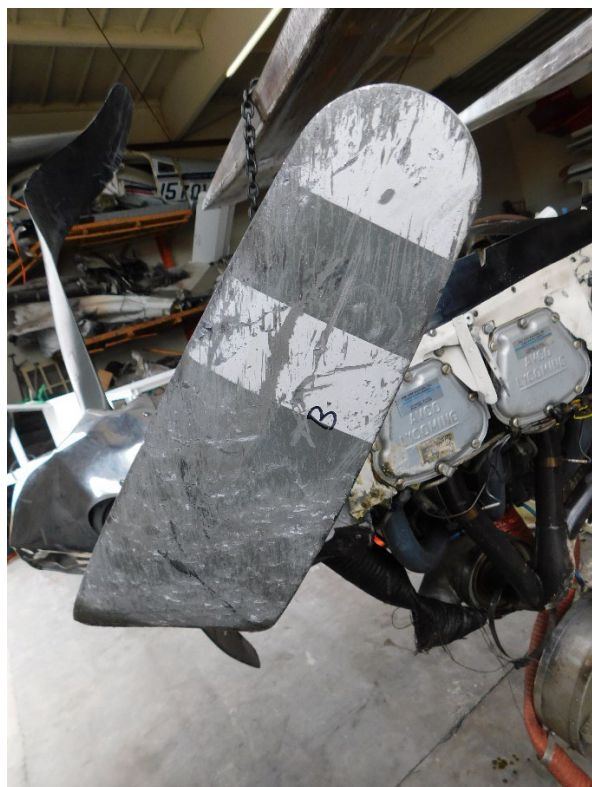
Figure 13. Blade B.

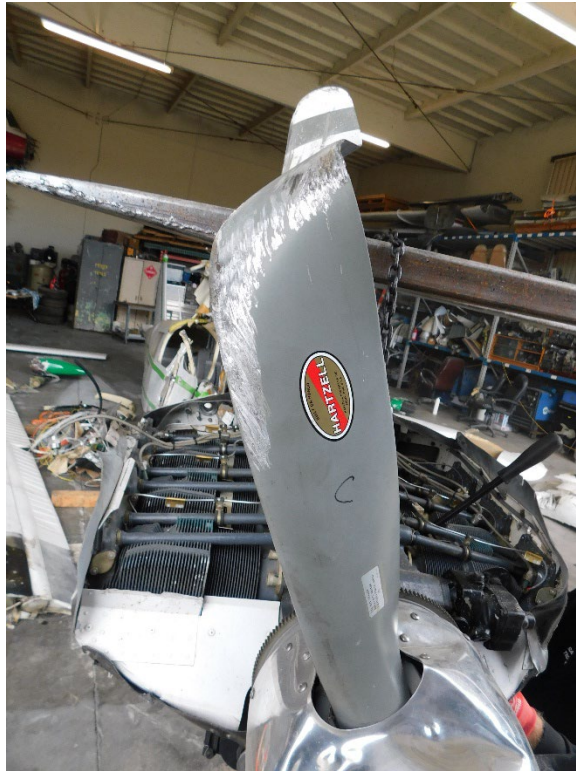
thirds of the blade and along leading and trailing edges. It displayed s bending - bent aft at midspan and bent forward near the tip. (See figure 14.)

Figure 14. Blade C.
