# National Transportation Safety Board

WPR25LA040

## **WRECKAGE FOLLOW-UP EXAMINATION**

Location: Cortes Lakes, Arizona  
Date: November 17, 2024  
Time: 0930 mountain daylight time  
Airplane: Cessna 172l  
Registration: N8390L

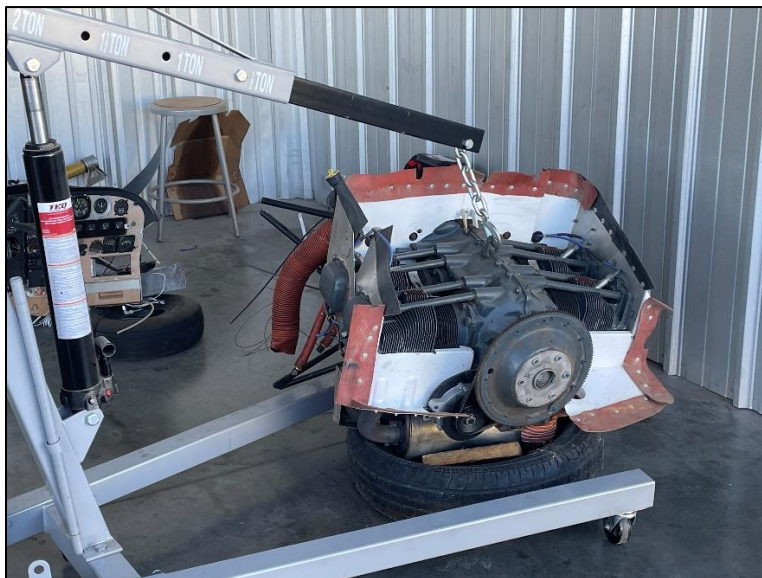
**Figure 1-Recovered engine**

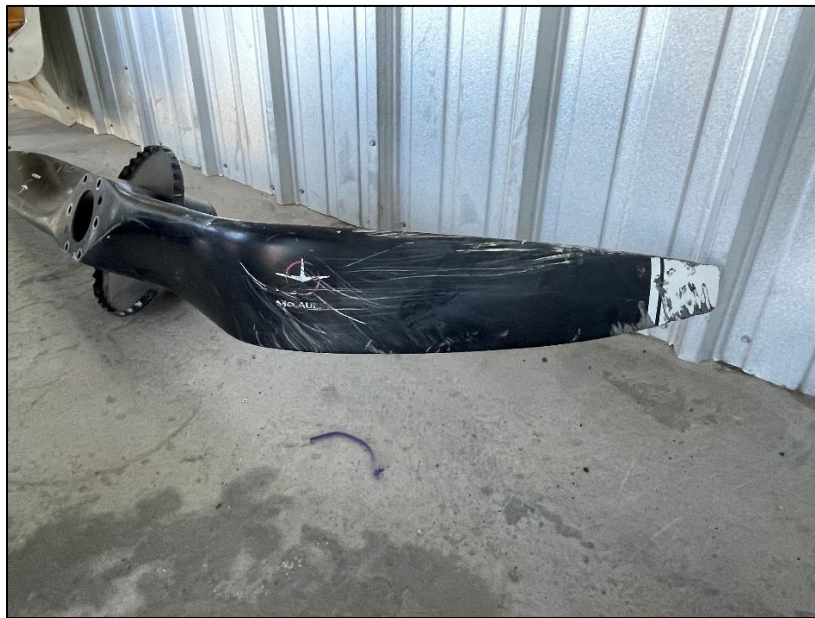
The propeller was examined and showed impact damage to one of the blades. The damaged blade was bent aft near its midsection and had multidirectional scoring.

**Figure 2-Propeller assembly.**

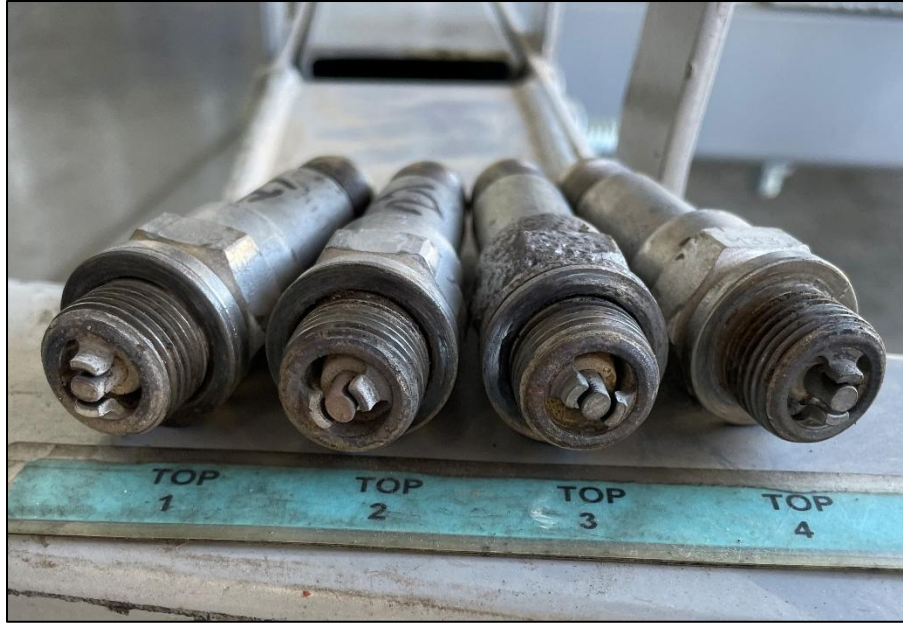
The engine was examined and only revealed impact damage to the exhaust muffler and exhaust pipe. The upper spark plugs were removed from the cylinders and the electrode areas were undamaged and displayed coloration consistent with a lean fuel/air mixture. Both magnetos remained attached to the engine. The magnetos were timed and found to be at about 25° before-top-dead-center (BTDC) at cylinder No. 1. The crankshaft was rotated through the vacuum pump accessory mount and spark was obtained from each ignition lead end, all in firing order.

**Figure 3-Upper spark plugs.**

The gas path and combustion signatures observed at the spark plugs, combustion chambers and exhaust system components displayed coloration consistent with an exceptionally lean fuel/air mixture during operation.

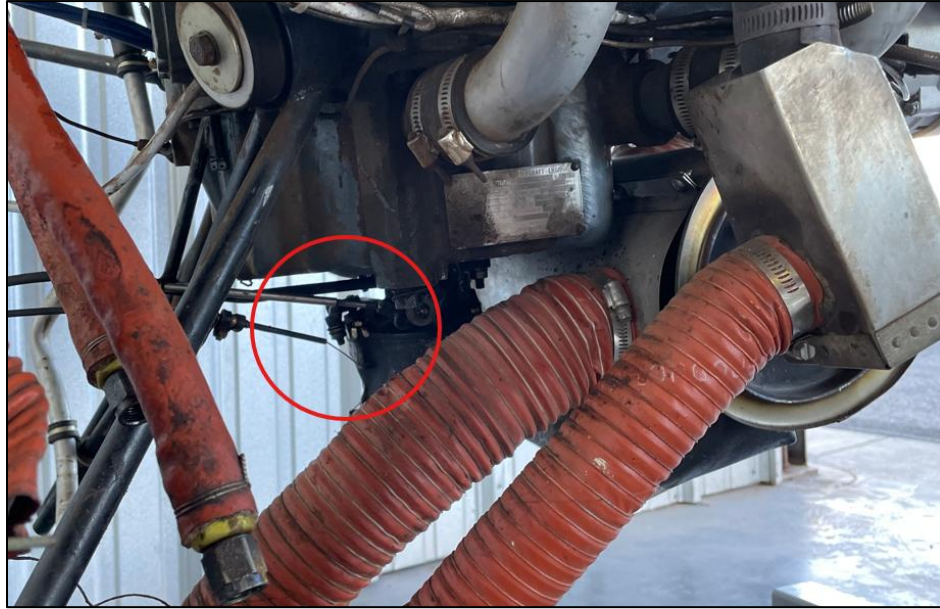
The engine examination revealed a separated mixture control cable near the carburetor mixture linkage arm. The throttle cable hardware at the carburetor was also missing a cotter pin on the castellated nut and the hardware was finger loose. The spark plug electrode areas, cylinder combustion areas and internal surfaces of the exhaust tubes revealed that the engine was operating at a lean condition.

The carburetor remained attached to the oil sump mounting flange. The airbox was removed prior to the examination and was not present. The fuel inlet line separated at the carburetor fitting. The throttle cable remained attached to the throttle linkage arm however the castellated nut was finger loose and the cotter pin was missing. The throttle and mixture cable housing clamping hardware remained secure. The mixture control arm remained attached to the carburetor. The cable was separated near the crimping hardware on the attachment bolt. As viewed through a jeweler's loupe, the cable separation surfaces were rough in appearance and were covered in a carbon residue. The carburetor was disassembled and was free of fuel and contaminants. The carburetor's internal components were undamaged and

**Figure 4-Separated mixture cable near the carburetor.**

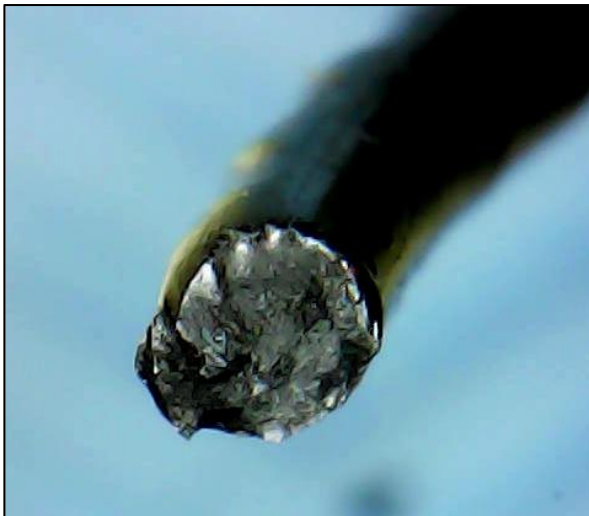
**Figure 5-Mixture cable end.**

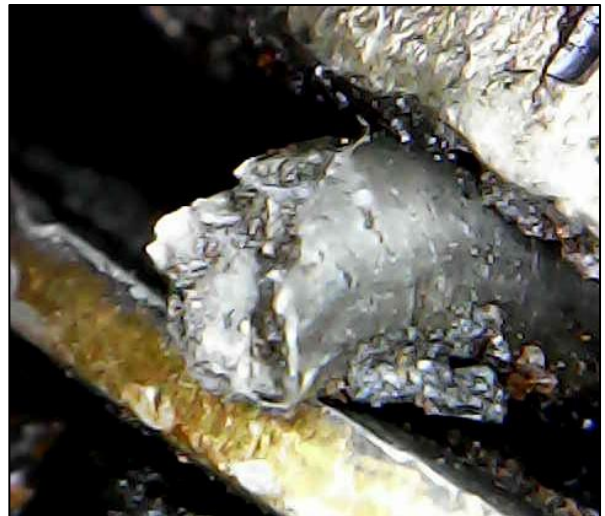
**Figure 6-Mixture cable end at linkage.**
